COMMONWEALTH OF AUSTRALIA  
DEPARTMENT OF CIVIL AVIATION

# AVIATION SAFETY DIGEST

JANUARY, 1954

Prepared by The Accident  
Investigation and Analysis Branch

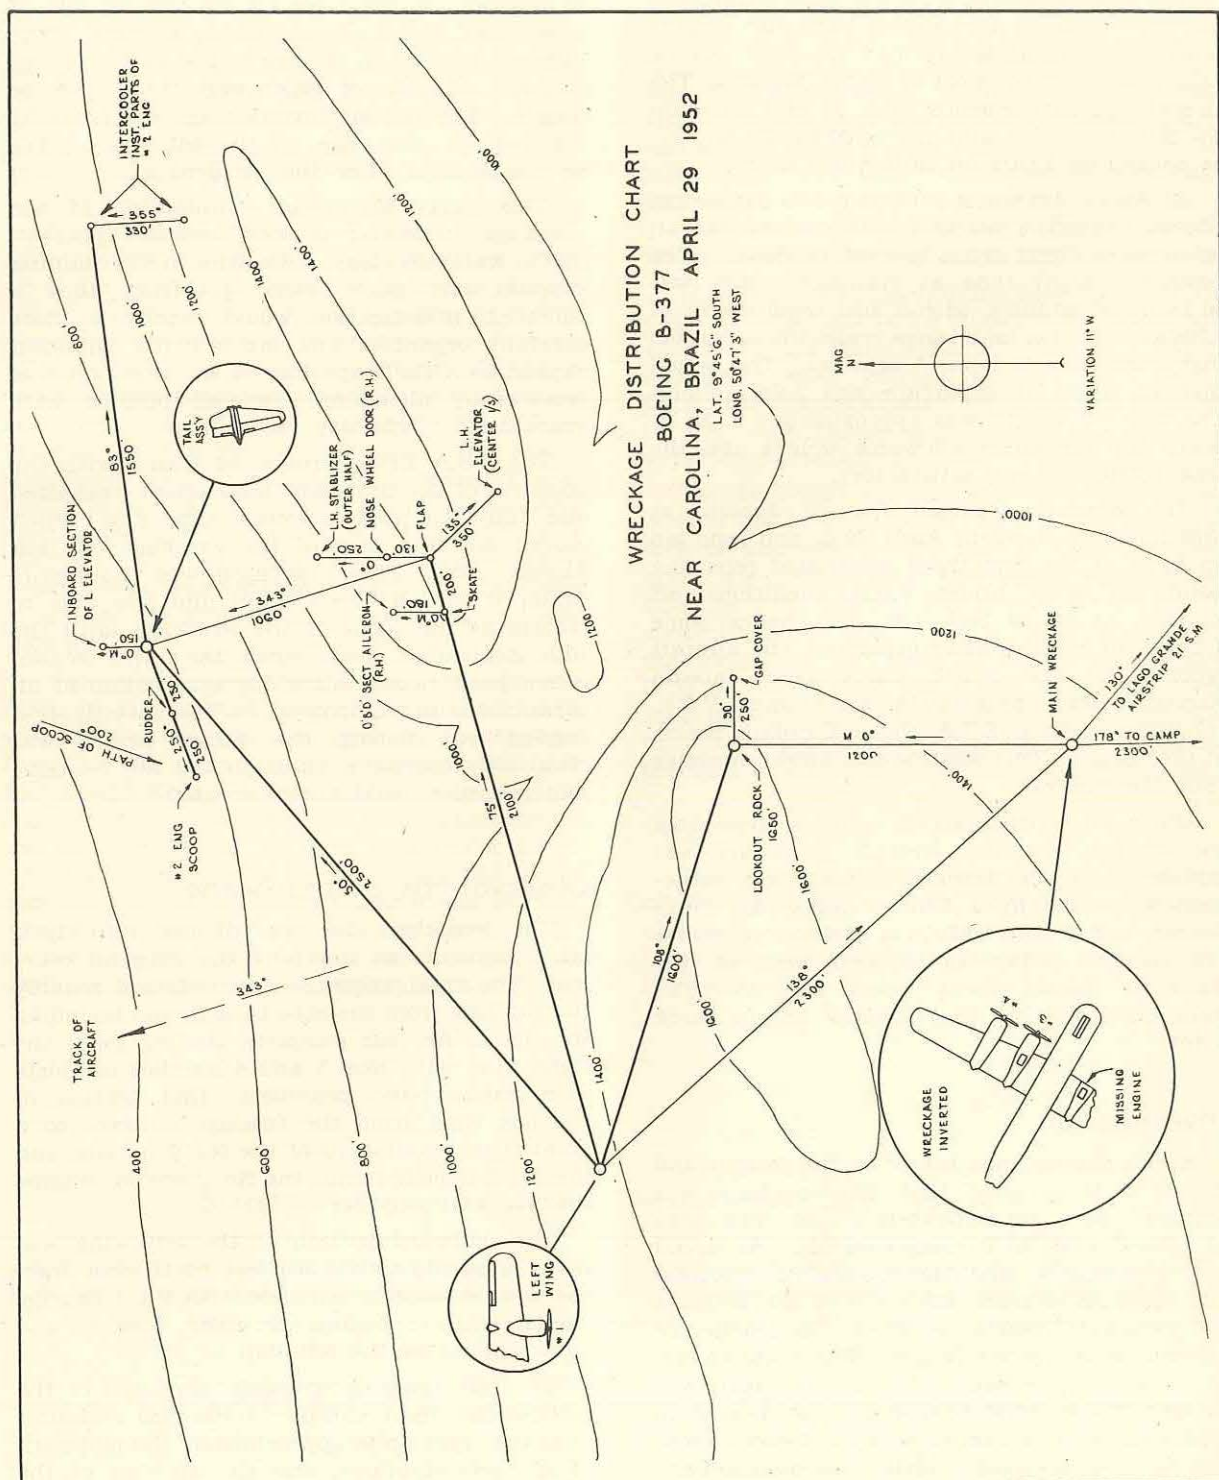
The outboard portion of the left wing was found approximately 2,300 feet north-west from the main wreckage, complete with No. 1 nacelle, engine, engine cowlings, propeller, aileron, and outer portion of the left flap.

The tail assembly wreckage consisted of the vertical fin, right elevator, horizontal stabiliser from the right tip to approximately the mid span of the left stabiliser, and the aft end of the fuselage. This piece of wreckage was found some

2,500 feet north-east from the left wing wreckage. Numerous other parts were found roughly within a circle formed by the main three segments.

The main wreckage was found lying in an inverted position and it was apparent from the condition of the surrounding trees that this portion of the aircraft had made an almost vertical descent while in a horizontal attitude.

From the available evidence it is considered that an emergency occurred in either No. 2 propeller or engine which resulted in these components separating from the aircraft during flight at a relatively high altitude. Very shortly after the loss of No. 2 engine the left wing failed. Almost simultaneously, and as a result of violent pitching of the aircraft during the wing separation, the entire tail section broke from the fuselage in a downward direction at a point just aft of the dorsal fin, probably before the left wing proceeded that far rearward.

Since the No. 2 engine and propeller were not recovered they could not be examined to determine the cause of their separation from the aircraft. However, it was concluded from examination of the No. 2 engine mount, which remained with the aircraft, that separation resulted from the application of forces beyond that for which it was designed. Similar separations of engines from B-377 aircraft in flight, due to excessive loads being applied to the engine mount, are known. In all cases where the engine and propeller were recovered, examination disclosed that the separation resulted from propeller blade failure and the resultant destructive loads due to propeller unbalance.

The Board determines that the probable cause of this accident was the separation of the No. 2 engine and propeller from the aircraft due to highly unbalanced forces, followed by uncontrollability and disintegration of the aircraft for reasons undetermined.

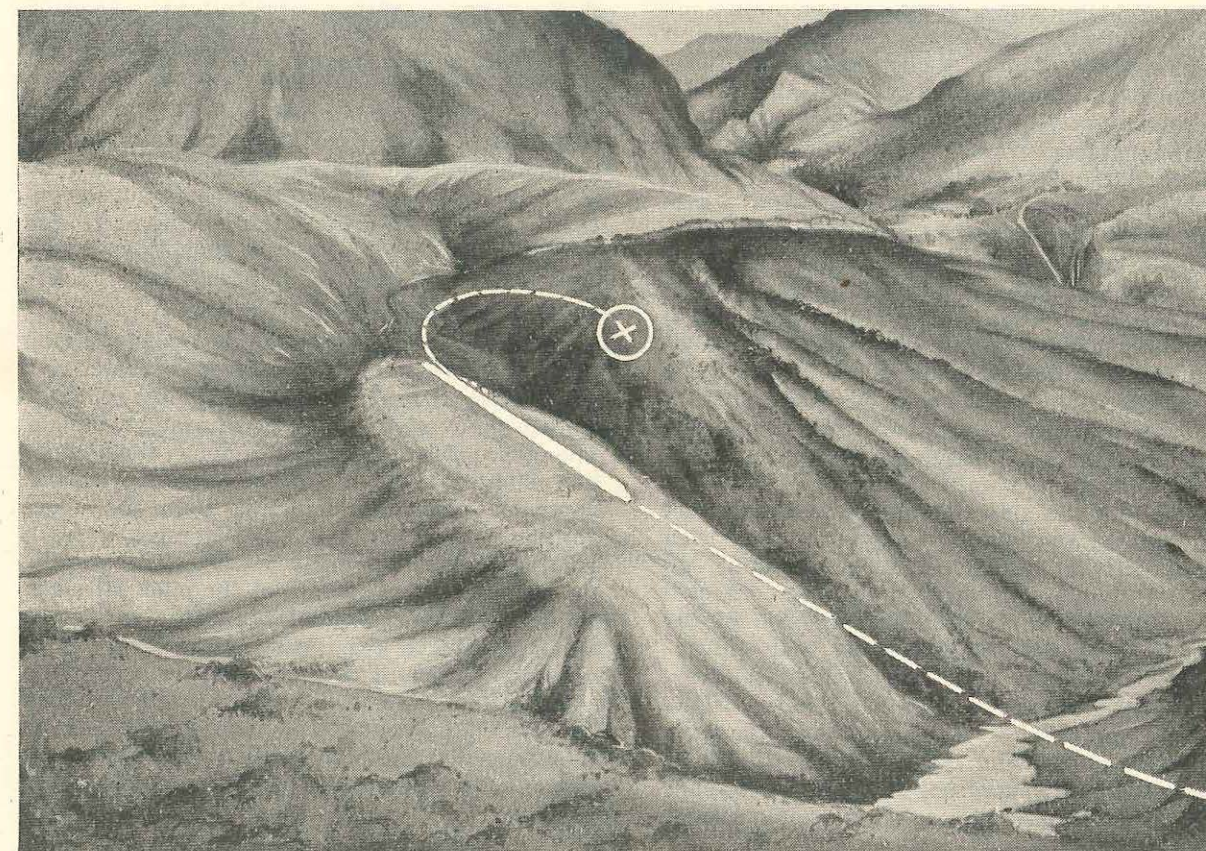
Chimbu airstrip, which is 1,730 feet long, 215 feet wide with a grassed surface, lies in a north-south direction with a down slope of 1 in 25 from the north to the south. The geographical altitude is 4,900 feet, and for aircraft operational purposes, the New Guinea density altitude factor of 2,800 feet is added, giving a density altitude of 7,700 feet.

An Artist's Impression of the Chimbu Airstrip, Wahgi Valley, New Guinea, showing Flight Path and Point of Impact of DH-84.

side, is a gully some 200 to 400 feet below the level of the airstrip, and 300 to 600 feet in width at the level of the strip. On the other side of this gully from the airstrip, the ground rises steeply to the mountain ranges, whilst on the eastern and southern sides of the airstrip, the ground falls away to the Chimbu River.

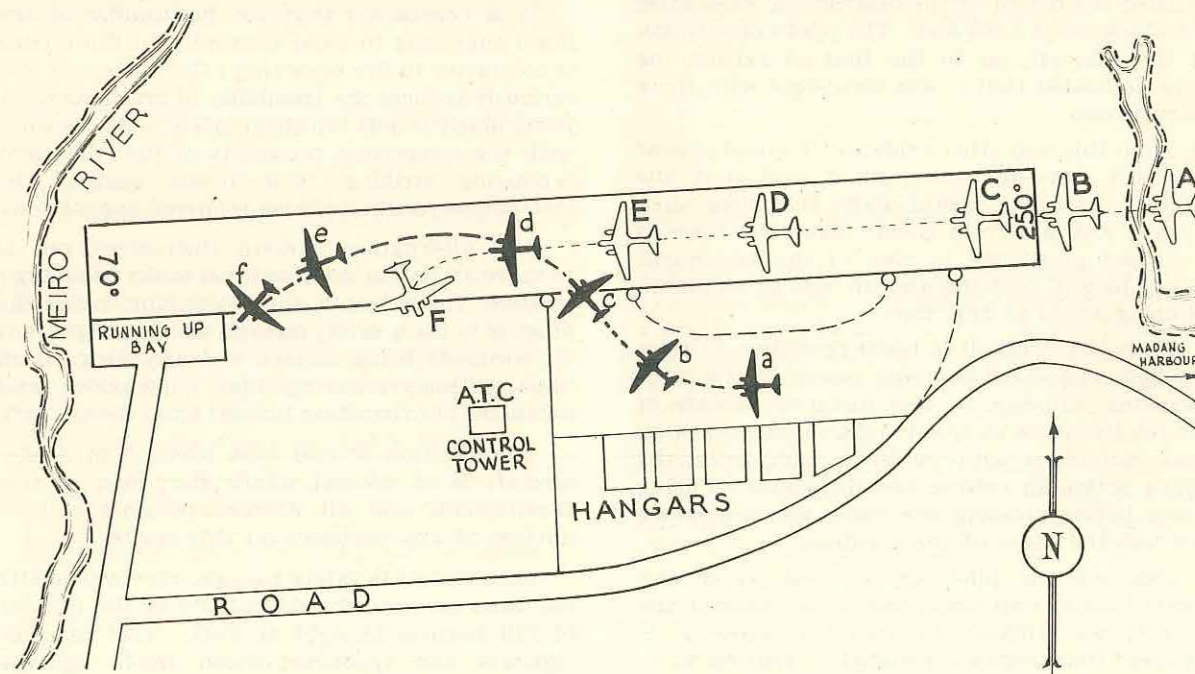
Diagram of Accident at Madang, New Guinea on 10th February, 1953, involving DC-3 Aircraft VH-MAE and VH-EAQ. (Aa, Bb, etc., indicate relative positions of both aircraft during successive intervals of time.).

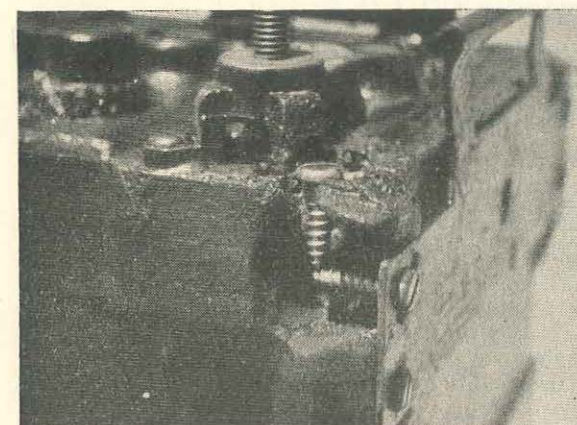
Fig. A:—Burnt Battery fitted with new handle and new  $\frac{3}{4}$ " screws to show origin of short circuit between terminal post and handle.

Further inspection resulted in the starboard battery being released and lowered, and it was found that the fire had originated at this point, being caused by the positive pole of the battery arcing across to the battery housing.

$\frac{3}{4}$ " screws. Action was taken soon after the incident to ensure that all  $\frac{3}{4}$ " screws were removed, and it is now unlikely that battery fires will result from the causes set out here.

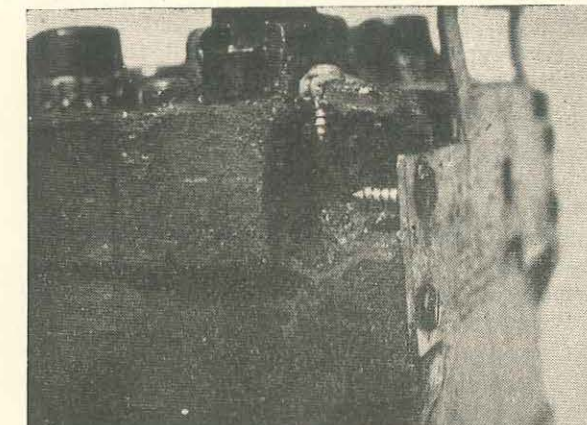
New batteries of the type in use at the time of the fire use  $\frac{1}{2}$ " self-tapping screws for securing the terminal posts and the handles, and these provide adequate clearance, as shown in Fig. B, to ensure that there is no danger of a short to earth occurring through the handle.

However, in some old batteries and replated batteries, the  $\frac{1}{2}$ " screws have been replaced by

Fig. B:—Burnt Battery fitted with new handle and new  $\frac{1}{2}$ " screws to show clearance existing with correct screws.
