**AVIATION  
SAFETY DIGEST**  
No. 4

## ACCIDENT INVESTIGATION SUMMARY

### Accident to Vickers Viscount 720, VH-TVA, at Mangalore Aerodrome, Victoria, on 31st October, 1954

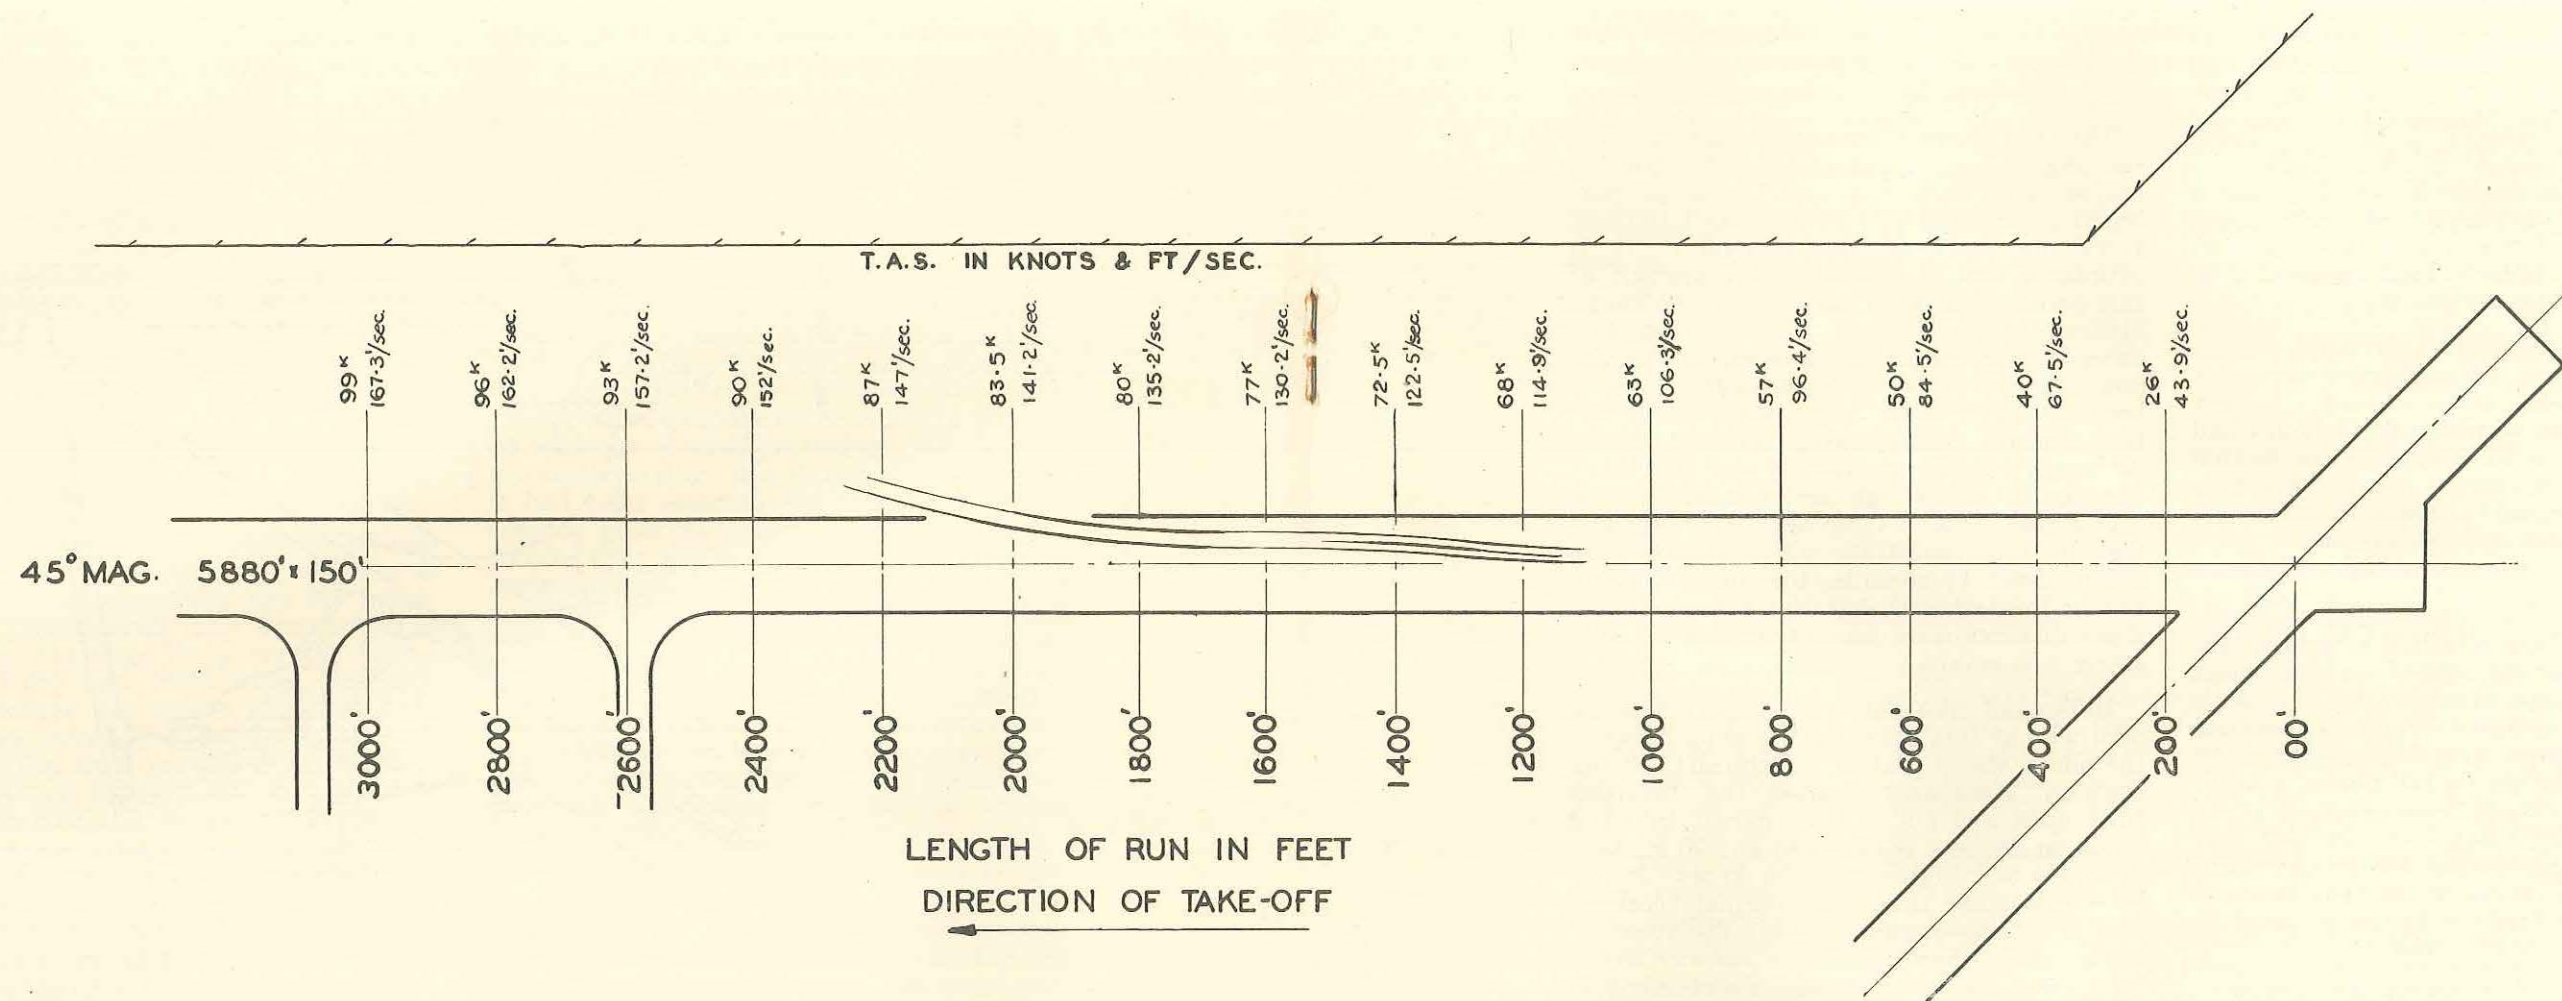
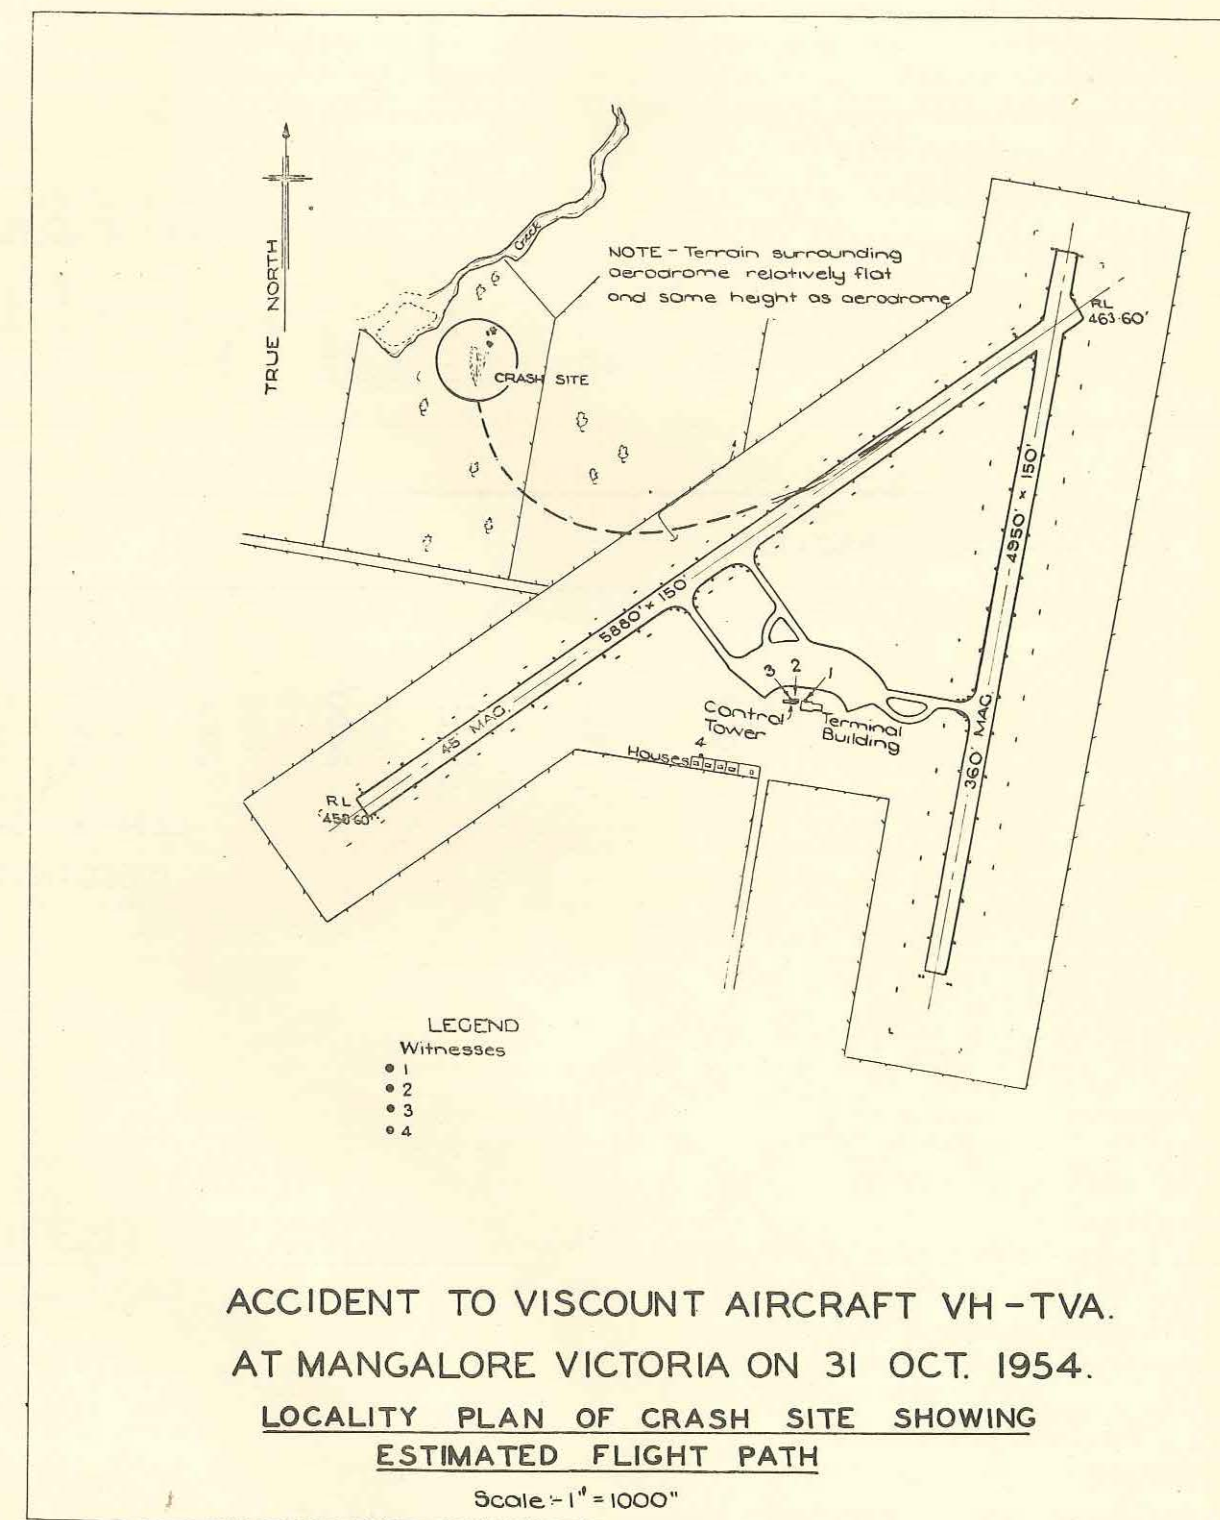
## ACCIDENT TO VISCOUNT AIRCRAFT VH-TVA. AT MANGALORE, VICTORIA ON 31 OCT. 1954.

Tyre marks left on the runway during the take-off reveal that a swing to starboard occurred approximately 1,100 feet from the start of the take-off run and, as indicated by the marks on the runway, nosewheel steering was used to correct it. Marks of a second swing were in evidence 1,800 feet along the runway and it was during this swing that the aircraft left the runway at a point some 2,000 feet from the commencement of the take-off, and became airborne 240 feet further on. There were no nosewheel steering marks during this swing. The path of the aircraft is shown in the attached plans.

### RELATION OF TRUE AIR SPEED TO TAKE-OFF RUN.

The tyre marks show that the aircraft was running 15 feet to the right of the runway centre line, when the first swing to starboard commenced at a point some 1,100 feet from the start of the take-off. It is estimated that the speed of the aircraft at this point would be of the order of 65 knots. Marks on the runway indicate that this swing was corrected by nosewheel steering and as the swing was controlled these marks became lighter until they disappeared when the aircraft was running straight again. Although running straight it was still heading slightly to the right away from the runway centre line. After approximately 200 feet in this condition, which would have taken about 1½ seconds, the aircraft again swung to starboard, left the runway and a short distance later became airborne. This swing was severe.
