DEPARTMENT OF CIVIL AVIATION

**AVIATION
SAFETY DIGEST**

No. 5

FEBRUARY, 1956

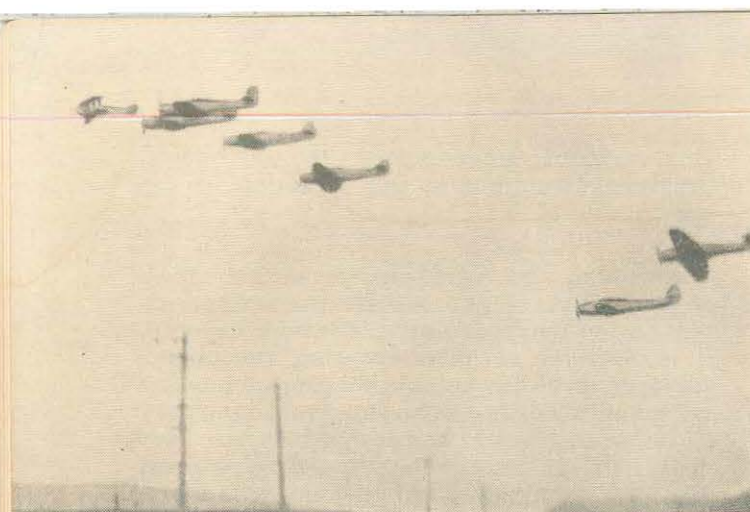
The Naval Sea Fury formation closes on the DH.82 from the rear over the building area at Wagga aerodrome. Note that the pilots of the three leading aircraft have not seen the DH.82 but apparently Nos. 4 and 6 of the formation have and are commencing to "break" to starboard.

The cause of the accident was that the leader of the formation led his aircraft back over the Forrest Hill aerodrome without indicating his intention to do so and without maintaining a lookout adequate to prevent collision with other aerodrome traffic.

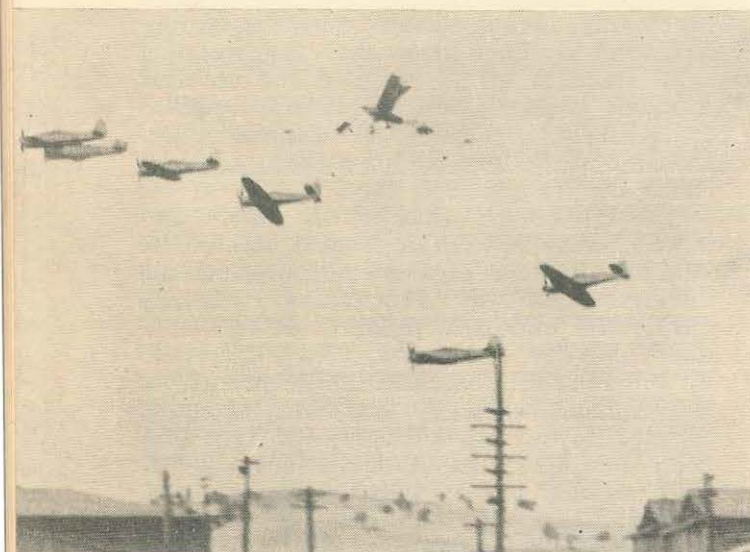
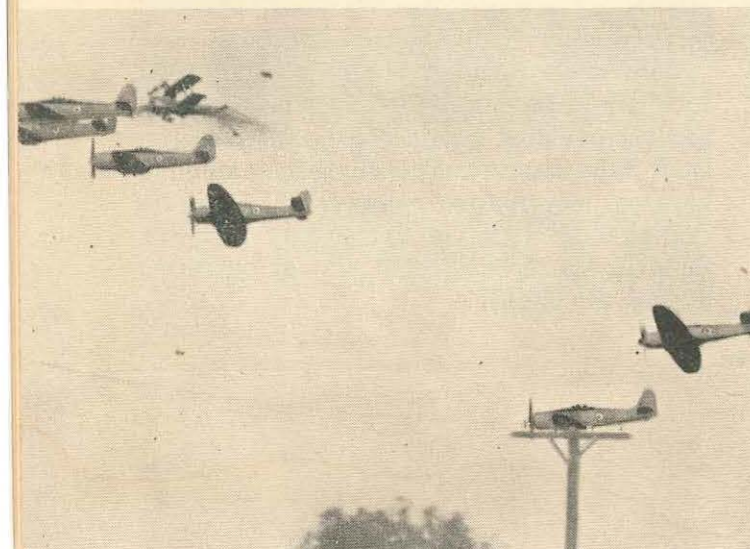
In the view below the formation leader has just hit the DH.82 with propeller, canopy and fin whilst Nos. 4 and 6 continue breaking away. In the view above the DH.82 is seen disintegrating further whilst the damage to the leader's fin and rudder is visible.

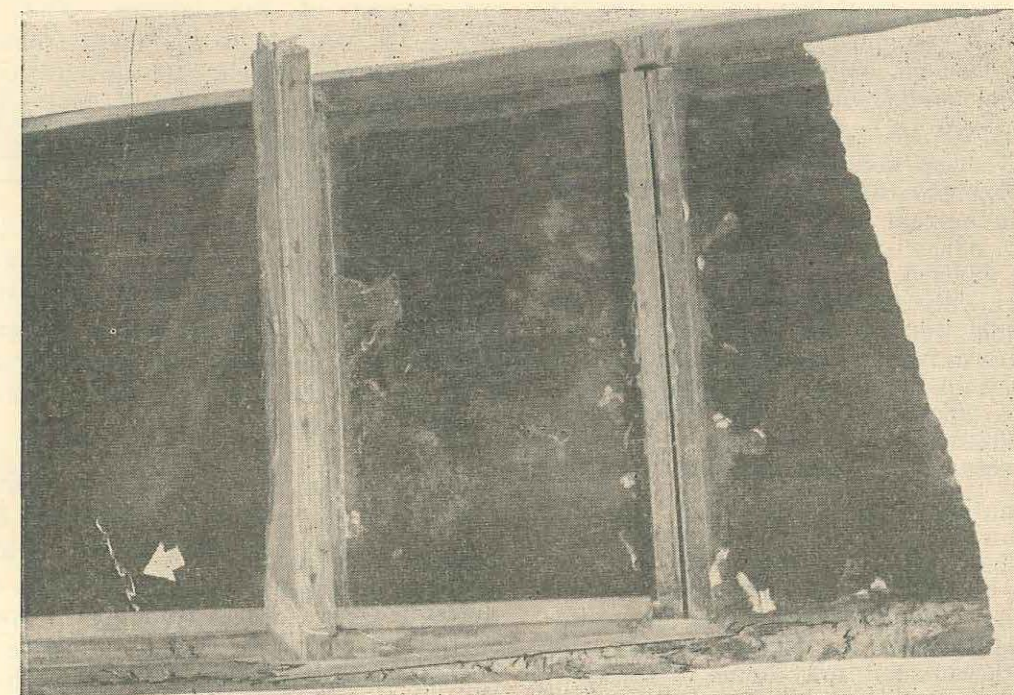
lower boom at station 32 port which resulted in abnormal loads being placed on the other members of the rear-spar with consequent failure under normal operating loads. The inevitable failure of the rear-spar with the boom discontinuous due to the ineffective splice was probably hastened by a heavy landing three days prior to the accident.

3. The splice in the rear-spar lower boom at station 32 port, which was carried out in March, 1951, did not conform with the repair method given in the aircraft manufacturer's overhaul and repair manual, as certified in the airframe log book.
4. Damage, found in December, 1953, to the port wing of the aircraft included a crack in the rear-spar boom at station 32 port and was probably due to a heavy landing or severe ground loop.
5. The repair to the crack in the rear-spar web, whilst effective in transferring loads across the crack, was poorly executed.

Section of port wing rear spar showing (a) separated splice in the lower boom (bottom centre) and the poor standard of glueing in its vicinity (b) effectiveness of splice stiffener lost by sectionalization between spar ribs (c) location of previous crack in plywood web (bottom left) and (d) final break in plywood web (right).
