AVIATION
SAFETY DIGEST

No. 7

SEPTEMBER, 1956

Prepared by the Division of
Accident Investigation and Analysis

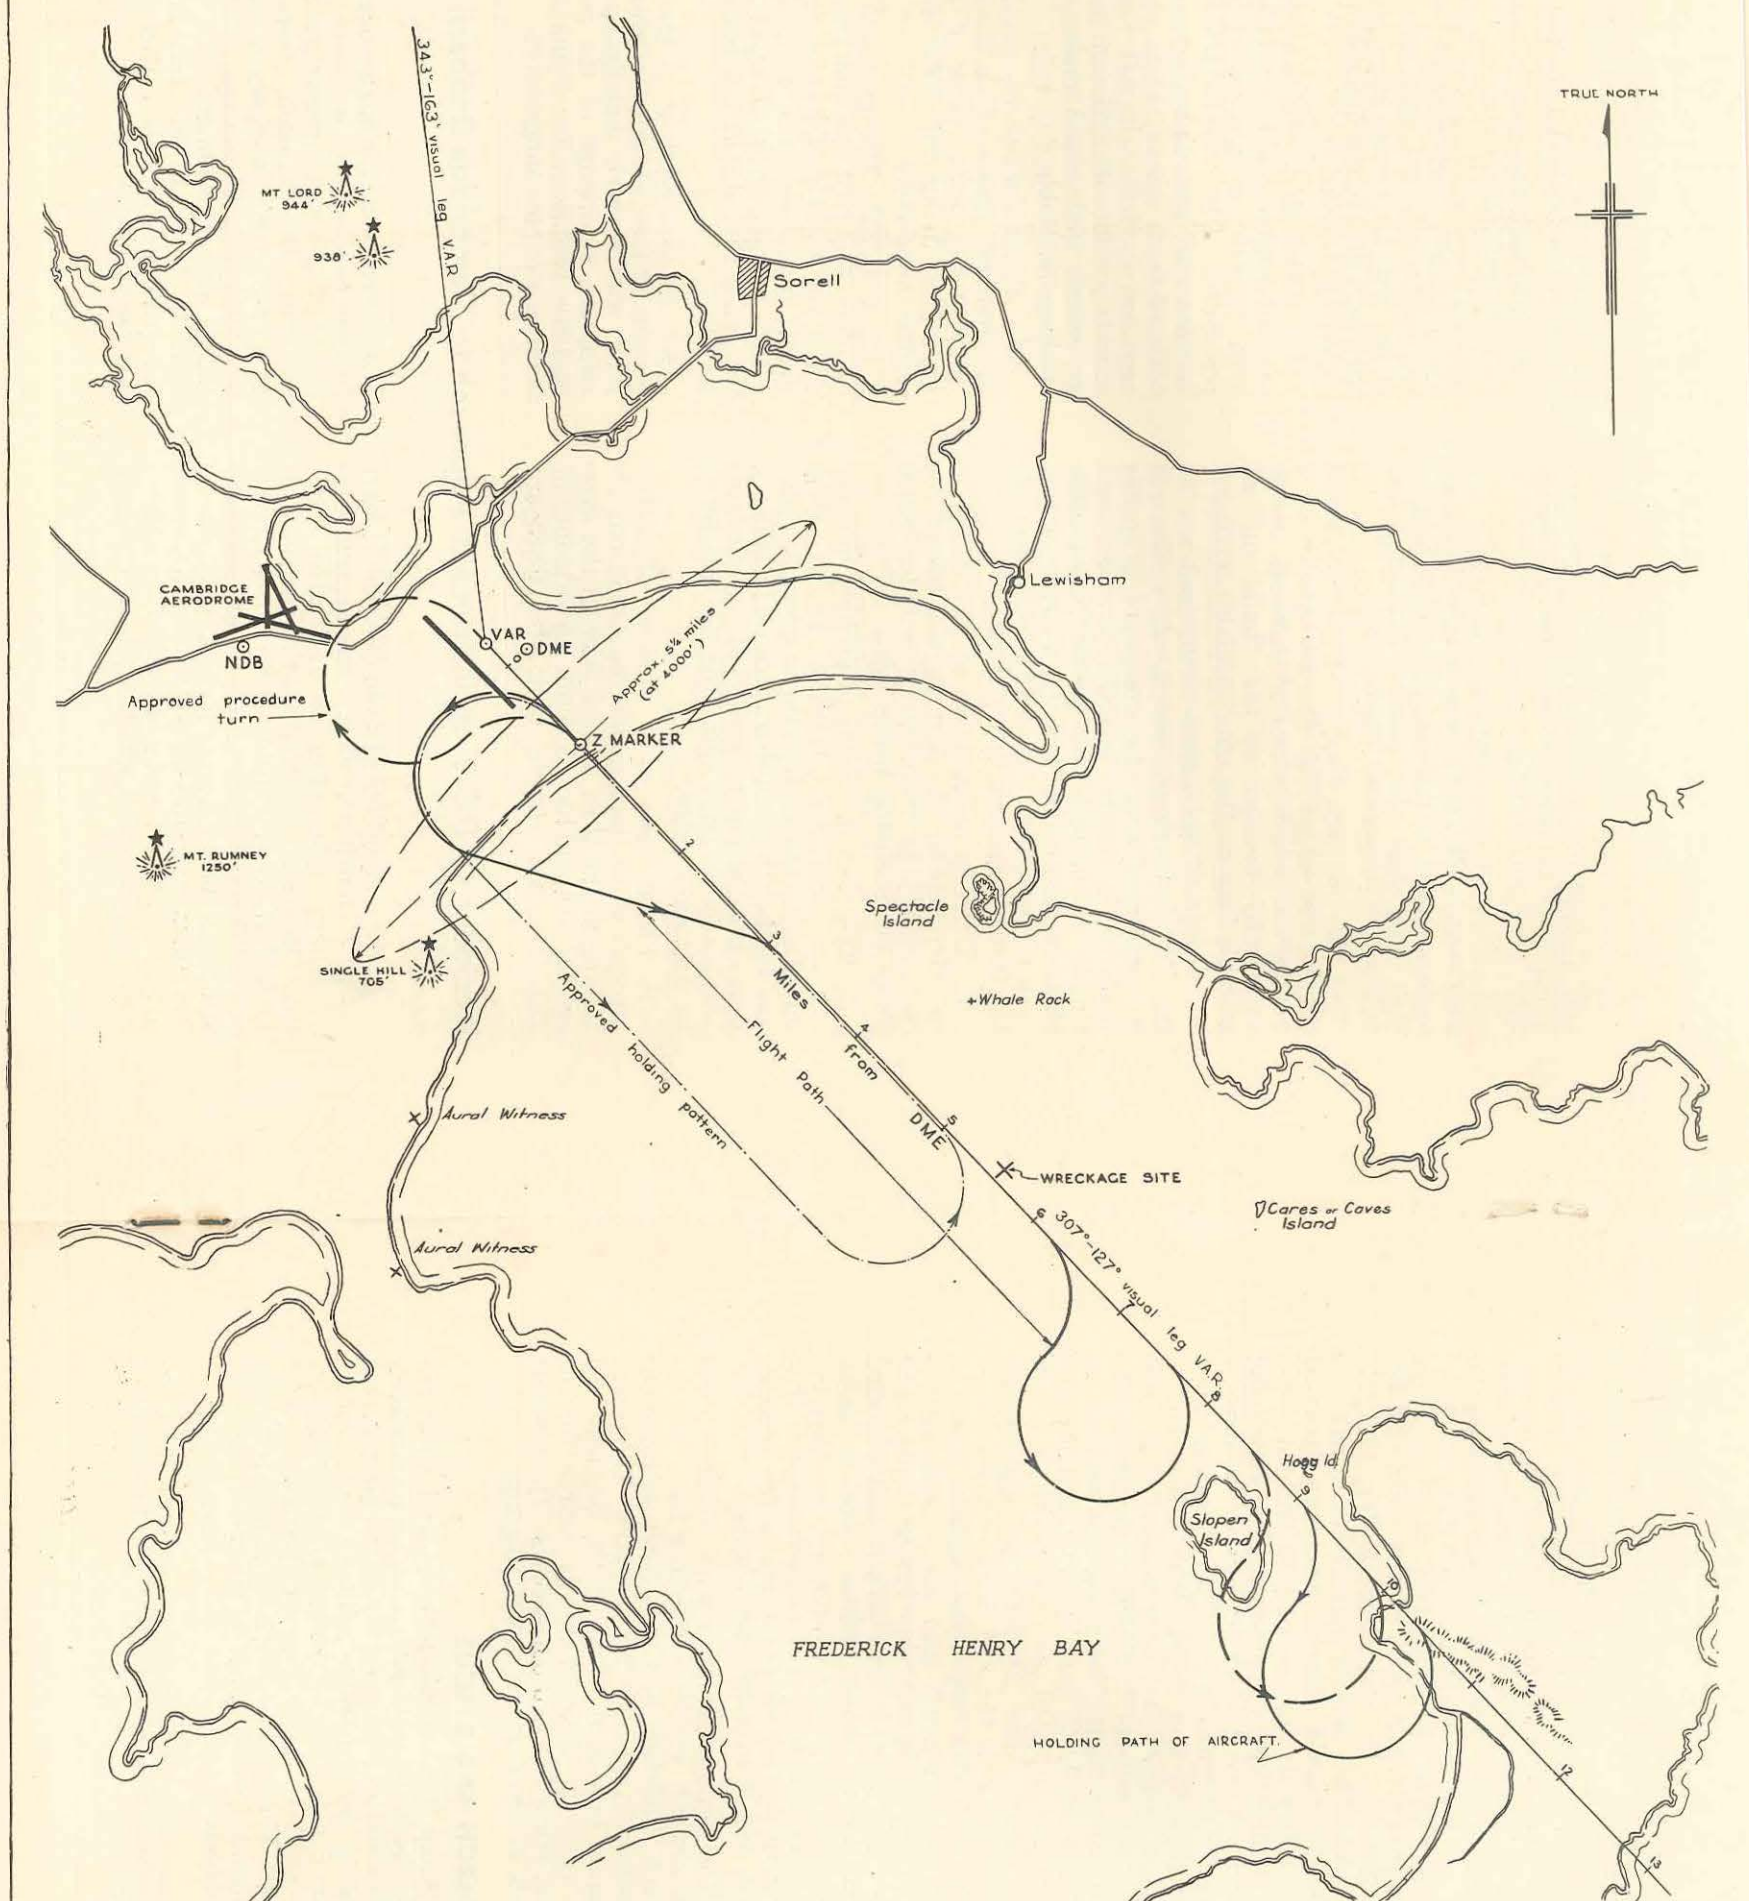
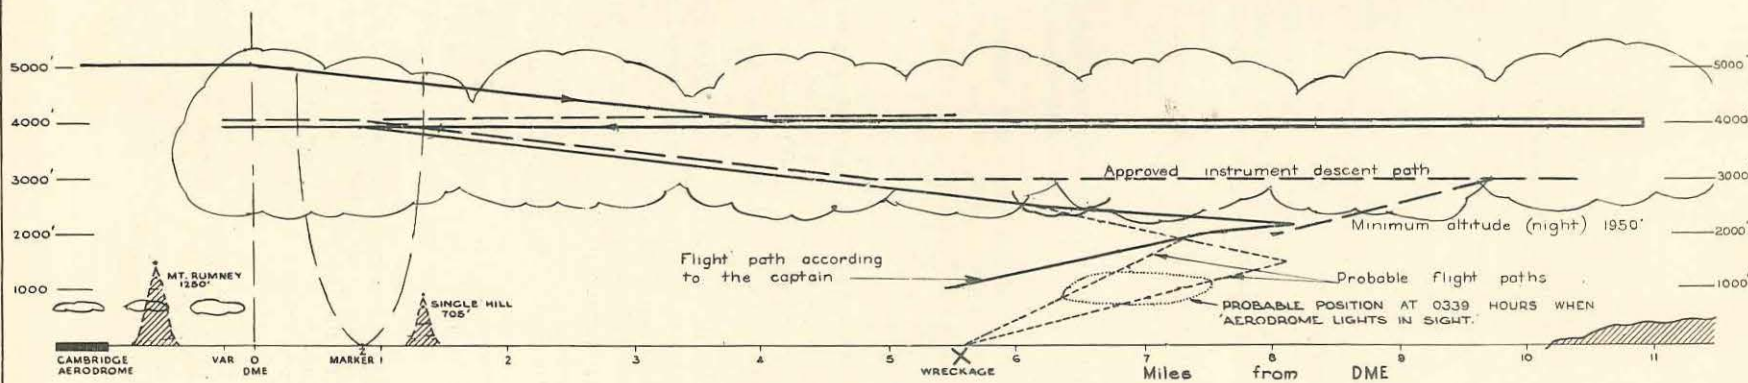
ACCIDENT TO DC3 AIRCRAFT NEAR CAMBRIDGE AERODROME, TASMANIA ON 12TH JANUARY, 1956

An analysis of the approach path adopted on this occasion, indicates that, although non-standard, under the circumstances it was not inherently unsafe, but there were several undesirable features in it. The more serious were that the minimum altitude was not observed during the inbound procedure turn, and, as is discussed later, the rates of descent varied and a high rate of descent was adopted when the aircraft was at a relatively low altitude.

The captain's last recollection before the impact was that the aircraft was "performing normally" and was descending at about 200-300 feet per minute at an airspeed of 100 knots and was at an altitude of 800-1,000 feet. No evidence was found to suggest that the captain could have been rendered unconscious before impact and consequently it appears that the captain's last recollection of the aircraft flying normally was immediately prior to the impact. A reconstruction of the descent described by the captain places the aircraft at approximately 1,000 feet when directly over the point of impact, yet all the evidence contradicts the possibility of any sudden loss of height. Thus, it is concluded that just before impact the aircraft was being flown approximately 1,000 feet lower than the captain believed it to be and was inadvertently flown into the water.

Taking all things into account it is considered that the probable cause of the accident was the reliance the pilot in command placed on inadequate external references for his estimation of altitude and his failure to give enough attention to the flight instruments. The unorthodox approach carried out, whilst not directly unsafe in itself, lacked steadiness and precision in a way that afforded the opportunity for errors, and thereby possibly contributed to the accident.
