DEPARTMENT OF CIVIL AVIATION

# AVIATION SAFETY DIGEST

No. 8

DECEMBER, 1956

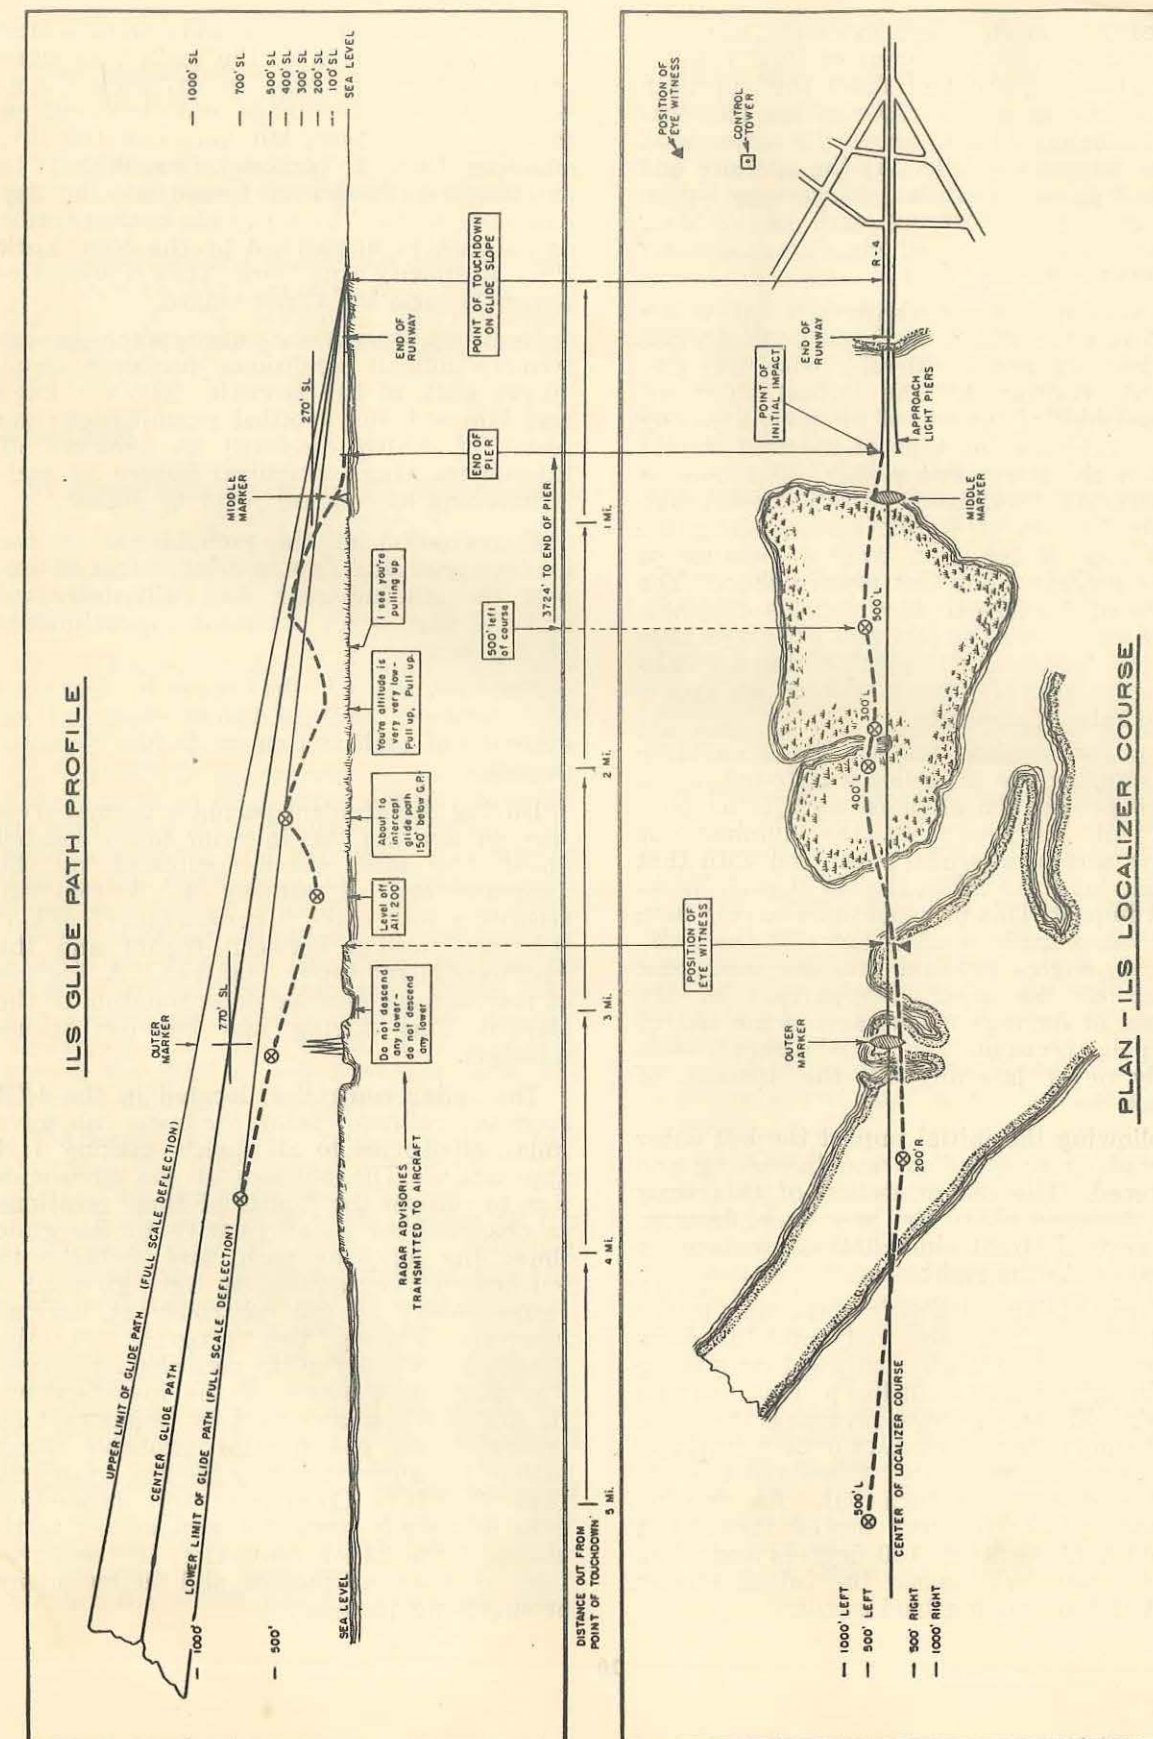
Investigation at the accident scene disclosed that the aircraft struck the left inbound pier. The pier, primarily constructed

of heavy wooden piles, extended approximately 2,000 feet into Jamaica Bay, with its offshore end 2,530 feet from the approach end of runway 4. The floor of the pier was approximately 14 feet above the water level in the Bay at low tide. At the offshore end there was a vehicular turnaround with numerous piles forming each of its four corners, the tops of which were about six feet above the pier floor.

First contact was with the pier only a few feet above the water. At impact the aircraft was moving nearly parallel with the pier towards runway 4. The impact shattered the east half of the end of the pier, breaking and splintering the tops of most of the 11 piles of the south-east corner. The bulk of the aircraft wreckage then sank in approximately 30 feet of water, mainly along the right side of the pier, over a distance of approximately 1,550 feet toward shore. The nature of damage to the pier, its closeness to the water, and the fact that little wreckage came to rest near the point of impact indicated the aircraft struck without an appreciable rate of descent.

A propeller slash mark made by a blade of a number one propeller was found in the centre pile at the offshore end of the pier. This cut disclosed that the number one engine nacelle was nearly centred with that position and the aircraft was slightly nose-up at impact. This propeller axis having been established made it apparent that the number two engine crashed into the south-east corner of the pier. Comparison of the heights of damage marks across the end of the pier revealed that the aircraft was nearly level laterally at the instant of impact.

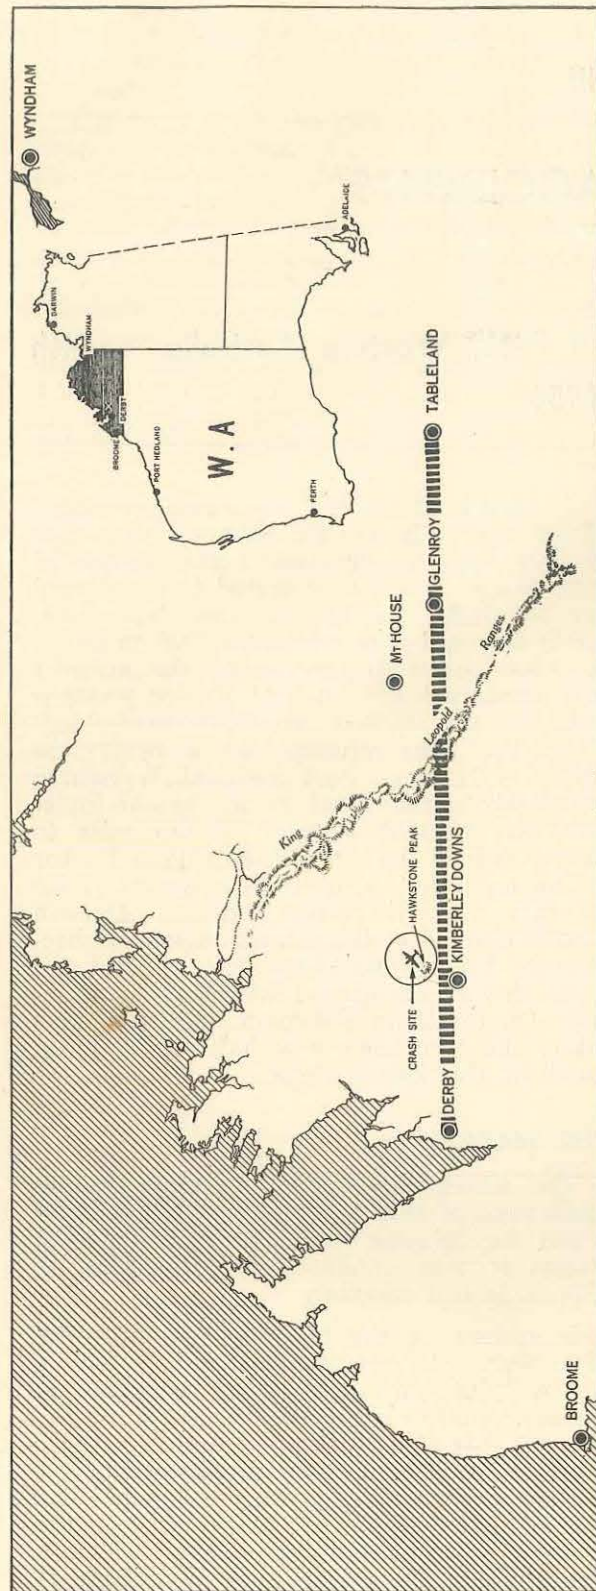
The aircraft virtually disintegrated on impact and the wreckage was confined to a relatively small area. It was apparent from the impact marks, wreckage distribution and nature of the damage that the aircraft had struck the ground in an almost vertical attitude at a high speed. It was established that both engines were operating at the time of the accident. All the components of the airframe were located at the wreckage site but it was impossible to ascertain the serviceability of these components immediately prior to the accident because of the extensive damage they sustained.

From the distribution of the wreckage and the nature of damage to it, it appeared that the aircraft struck the ground when out of control. There was no evidence of disintegration in flight and in view of the extreme severity of the storm, through which the aircraft was flying, in the vicinity of the accident, it can only be concluded that the pilot lost control whilst endeavouring to fly on instruments in extreme turbulence. No evidence was found which in any way conflicted with this conclusion. However, it is possible that other factors could have contributed to the pilot's inability to maintain control, such as erratic airspeed and altimeter readings arising from the effect of heavy rain on the pitot head, loss of the gyroscopic instruments as a result of the aircraft being thrown into attitudes beyond the toppling limits of these instruments, momentary blindness from lightning flashes, etc. Although these possibilities are conjectural, the possibility that some circumstance beyond the pilot's control contributed to his inability to maintain control of the aircraft is indicated by the manner in which it hit the ground with the engines under power.
