AVIATION SAFETY DIGEST

No. 13
MARCH, 1958

(Prepared by Division of Accident Investigation and Analysis. Published by authority of the Director-General)

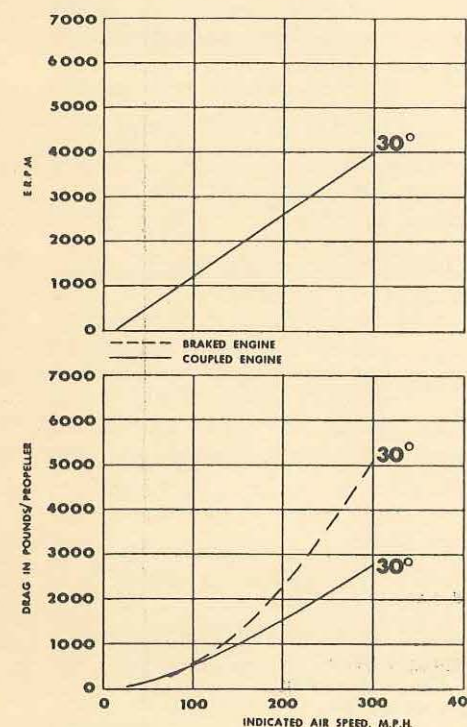
Figure 1

As a general rule the company states that the drag of a frozen propeller is greater than that of a windmilling propeller and freezing is not recommended. MATS crews put in a lot of air miles every day sitting next to fans built by this concern, so let's examine one of their charts. This one (Fig. 1) applies to the C.118 prop at the normal low pitch blade angle of 30 degrees measured at the 42 inch station. These curves illustrate that windmilling engine r.p.m. and drag

are functions of airspeed. The slower the aircraft can be flown the better (within safe control limits).

WINDMILLING DRAG AND E.R.P.M. VS AIRSPEED
AIRPLANE DC-6B, CV-440
ENGINE R2800 G.R. eq. .45
PROPELLER 43E60 6895A-8 DIAM. eq. 13.5'
CONDITION ALTITUDE S.I.
