# AVIATION SAFETY DIGEST

Aviation Safety  
Digest

No. 15                      September, 1958

Prepared in  
the Division of  
Air Safety Investigation

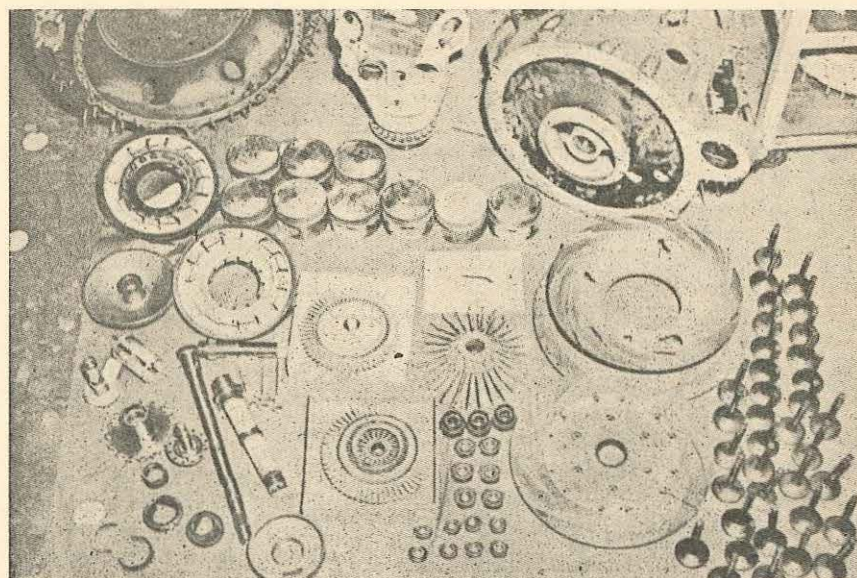
Nestled here in the centre of the engine parts it destroyed is a cotter key extractor that caused big trouble. According to the records the R-3350 engine involved operated 107 hours after it was overhauled. Some time during the period the cotter key extractor sneaked into the air scoop and started things grinding.

It damaged the blower section, two power recovery turbines, the tail-shaft, nine pistons and numerous gears. The damage plus labour amounted to \$20,000.

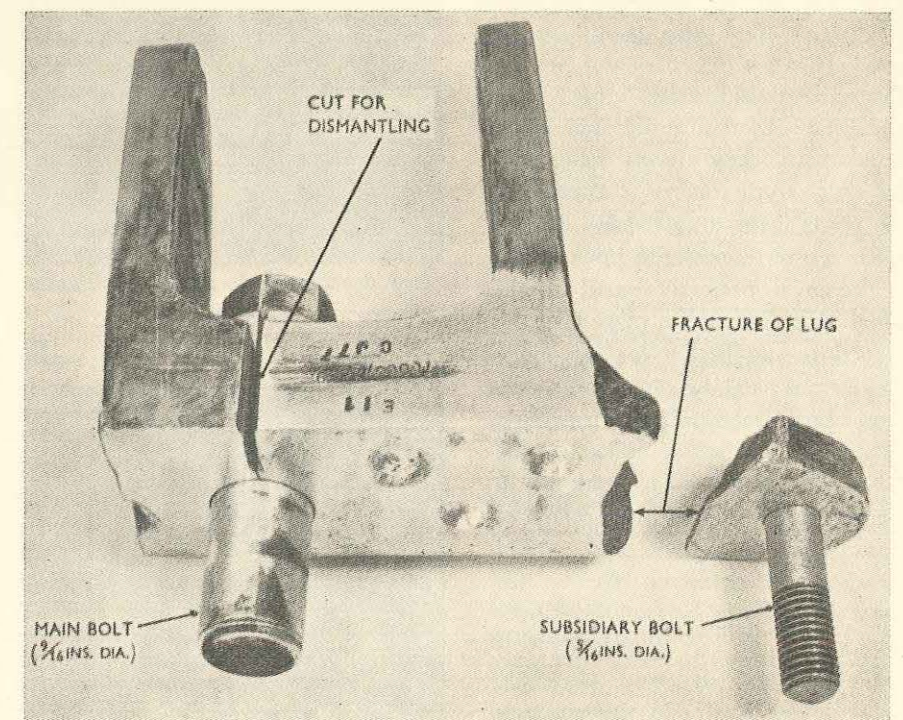
Fig. 3

From the point of view of this report the important flap unit is starboard flap unit No. 2. The important fitting is the aft lower fitting of that unit (see figure 3) and the important bolt is the larger bolt through that fitting. This was a 9/16 inch diameter bolt and the smaller bolt at the same fitting was 5/16 inch. In the wreckage were found the flap unit and the main part of the aft bottom fitting with the head and part of the shank of the 9/16 inch bolt (broken off so as to leave only one thread), while the lug of the fitting was still attached to the trailing edge member by the 5/16 inch bolt. The remainder of the 9/16 inch bolt together with its nut was never found, despite diligent search. The surface of the break in the 9/16 inch bolt showed on examina-

tion an appearance which left no doubt in the mind of an expert (and my Assessor Prof. Redshaw is quite satisfied about this), that the bolt had been subject to fatigue: about 20 per cent of the area appeared to have had a fatigue crack spreading slowly across it, about another 70 per cent showed a more rapid progress of fatigue, and the final 10 per cent had suffered a sudden tension fracture. The break of the lug from the remainder of the fitting cannot be described with particularity because fire had so affected the broken surfaces as to destroy evidence of the metallurgical character of the fracture. When found, the flap unit was completely detached from the wing but the indications were that the top fitting had broken after the lower part of the unit had been detached from the wing and it seems probable

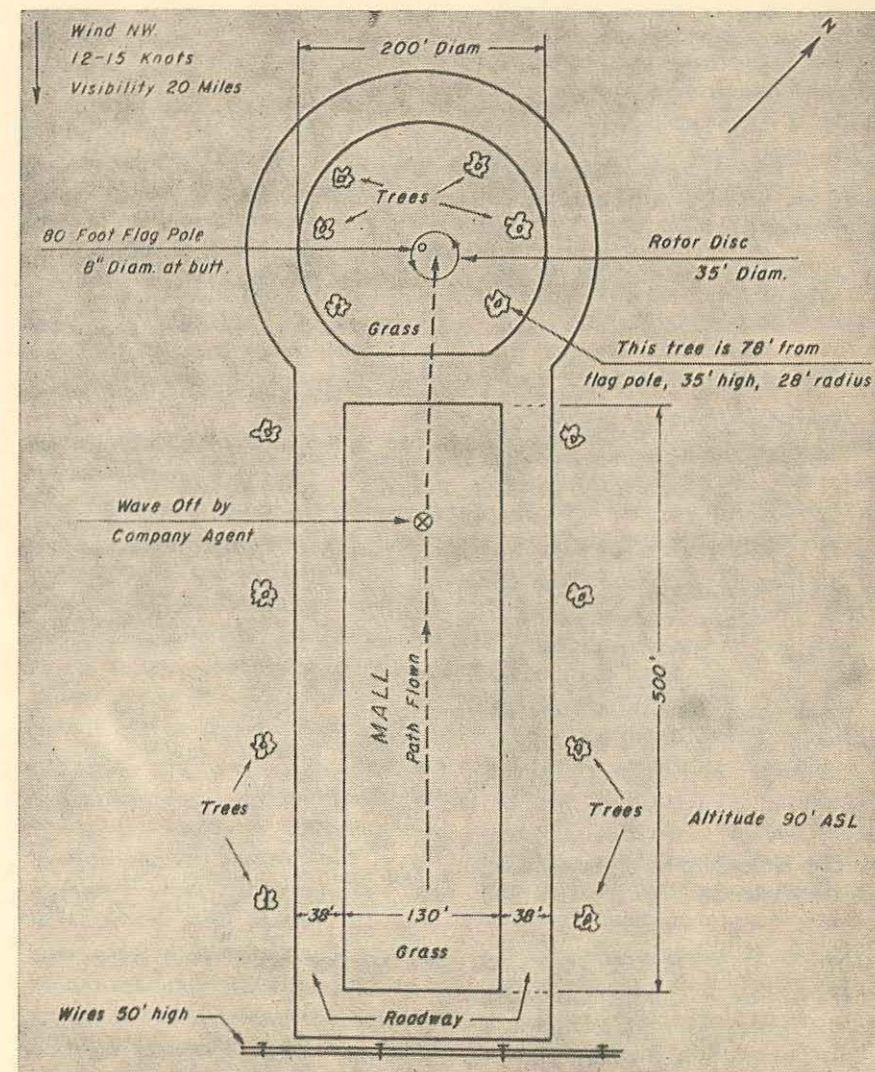
The flagpole which was struck is about 80 feet high. It was painted a drab bluish-green which would not contrast markedly with the

general background. A flag about five feet by three feet at its top stood out with the wind towards the helicopter. One blade of the rotor hit 21 feet 8 inches above the ground and the other three inches higher, the first 3½ feet and the other 4 feet from its tip. The pole was 8 inches in diameter at the point

where the rotor blades made contact and showed only slight scarring. Both rotor blades were destroyed.
