# AVIATION SAFETY DIGEST

DEPARTMENT OF CIVIL AVIATION

No. 17, MARCH 1959

Bogus Aircraft Parts

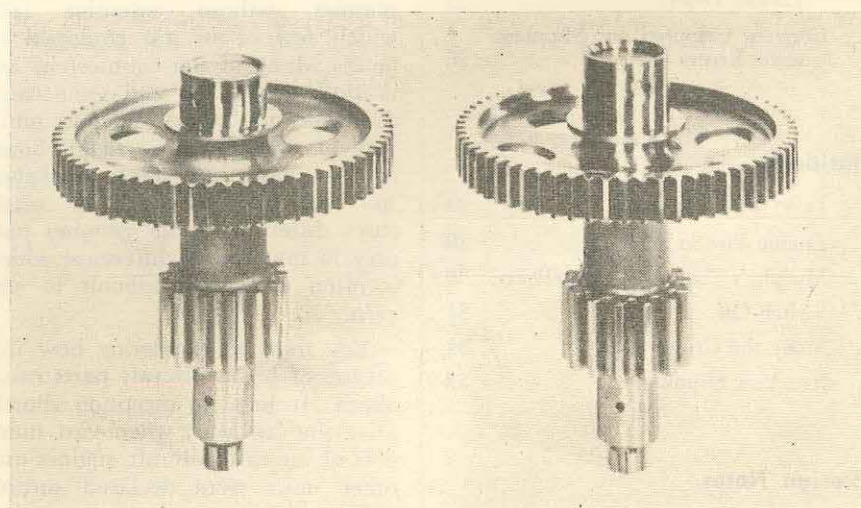
FIG. 2

7. Figure 2 shows another surplus part which was converted for a purpose it was never intended to fill.

The impeller intermediate drive gear was manufactured for R-1830-43 model engine fitted to defence aircraft, it had no commercial application and should have been mutilated for disposal as scrap metal.

However, a genuine gear for an R-1830-75, R-834-94-M2 or R-2000 engine cost approximately \$220 so the scrap gear from R-1830-43 engine was modified to fit the above engines by shrinking and pinning a stud spline on the rear end of the assembly for an estimated cost of two man hours. The job was skilfully done and in some instances the pin can be detected only by magnaflux. Other discrepancies are more obvious. As can be seen in Figure 2, the front journal is  $\frac{1}{4}$  inch too short, which dangerously reduces the bearing surface.

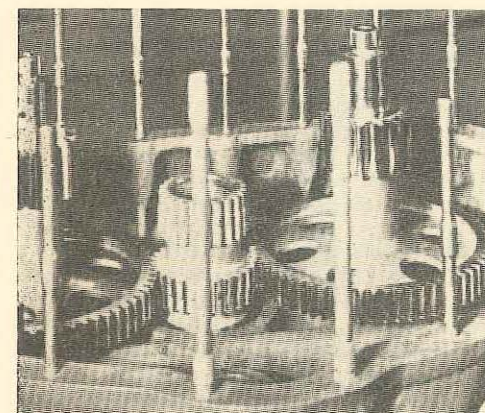
FIG. 3

Figure 3 shows the bogus drive gear on the right, all

other parts in the assembly being genuine. Note that the bogus gear does not mesh properly. This increases the unit loading of the teeth on both the intermediate and impeller gear. Failures in service causing non-operation of hydraulic and fuel pumps have been common.

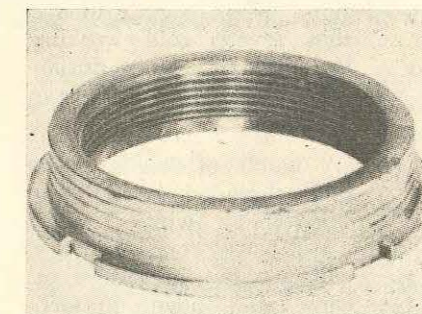
FIG. 4

9. Figure 4 shows a thrust nut. The absence of a trademark, lack of inspection marks, poor threads and sharp edges all indicate that the nut never

passed the prescribed factory inspectional requirements and that there is no doubt the part was rejected by inspection for disposal as scrap metal.

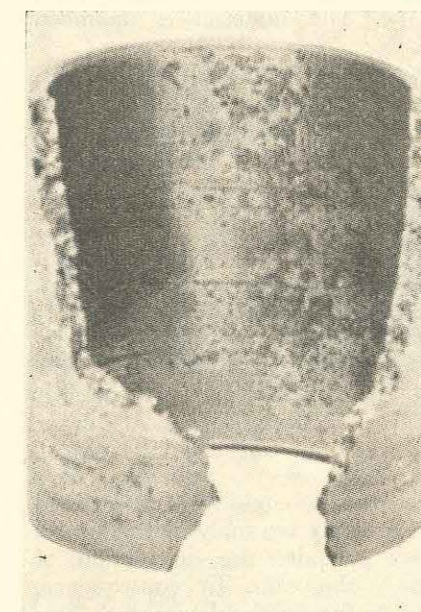
FIG. 5

(a) Figure 5 is an enlarged view of a bush removed from an R-1830 engine which had suffered internal failure. As you see, a portion of the bush is broken away and the fractured surfaces indicate cold working subsequent to the failure as well as shrinkage-porosity, apparent on the inside diameter.

In addition to faulty material, the bush was probably made to an old drawing, consequently, the dimensions are incorrect. The makers of bogus parts cannot be trusted as, not being aware of current en-

gineering changes, the majority of parts they produce are incorrect either in material or dimensions.

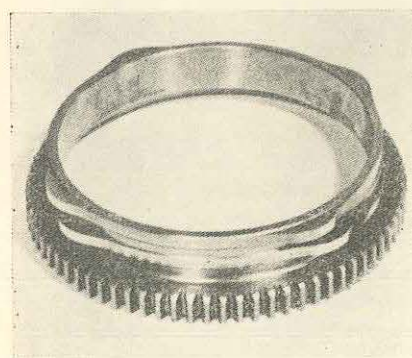
FIG. 6

- (d) The sharp edges on the gear and lack of part and inspection markings identify the cam shown in Figure 6 as a bogus part. The material is unknown

and could be determined only by analysis that would require the destruction of the cam. In consequence, the overhaul workshop was unable to accept it as air-

worthy and the part was scrapped.

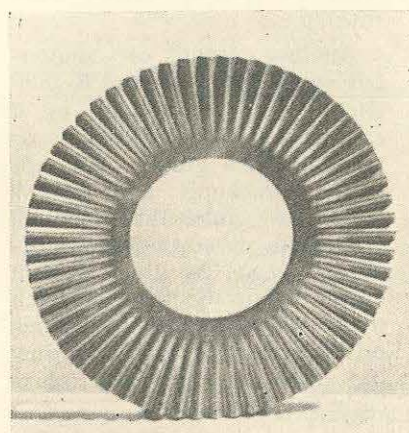
FIG. 7

- (e) Figure 7 is a bogus oil screen inlet spacer for an R-2000 engine. There are short cracks at the roots of the corrugations which appear to be tensile breaks. Micro examination of a section through the spacer revealed that the grain size of the material was up

to four times as large as that prescribed by the relevant material specification. There was evidence that severe cold working had taken place during fabrication of this bogus part.

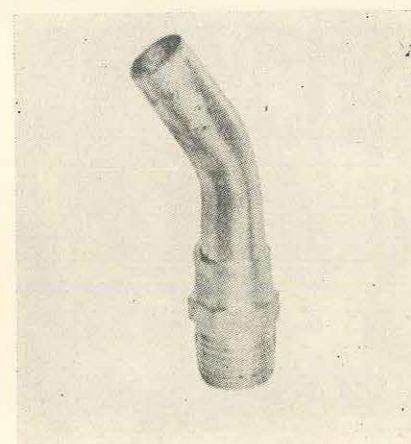
F.G. 8

- (g) Figure 8 illustrates a home made intercylinder drain pipe which is kinked at the radius and the soldering not oil tight. The fabrication is so poor that even an apprentice should have questioned the use of such a part.

It is pictured merely to illustrate the point, that an overhaul organisation which is approved by a government airworthiness authority can keep such un-airworthy parts out of an aircraft.
