AVIATION SAFETY

DIGEST

No 23, SEPT., 1960

DEPARTMENT OF CIVIL AVIATION

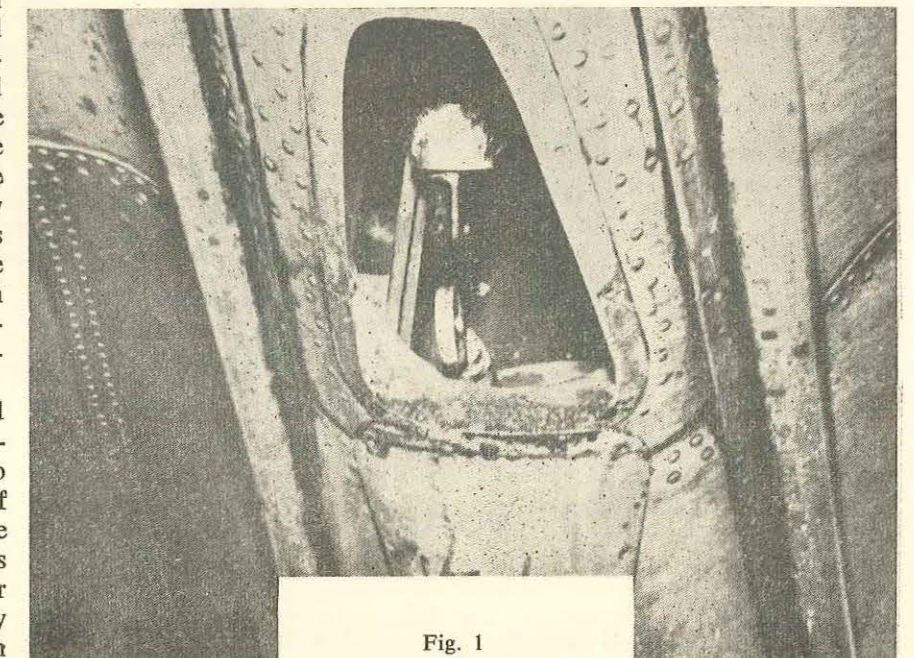
Fig. 1

Because the pilot had indicated an elevator control failure, investigation was immediately directed to the longitudinal control system of the aircraft. Upon removal of the yoke assembly access panel, it was immediately noted that the aft or bearing end of the link assembly was not connected to the clevis in

the elevator control tail section assembly (see Fig. 1). The bolt which normally connects the clevis and link assembly was missing.

During a search of the tail area, a bolt of the same size and specification, AN5-12, as the missing bolt was found. It was found lodged on the right side of a shelf of a bracket in the tail compartment. The shelf where the bolt was found is located aft of and above the link assembly and clevis attachment and

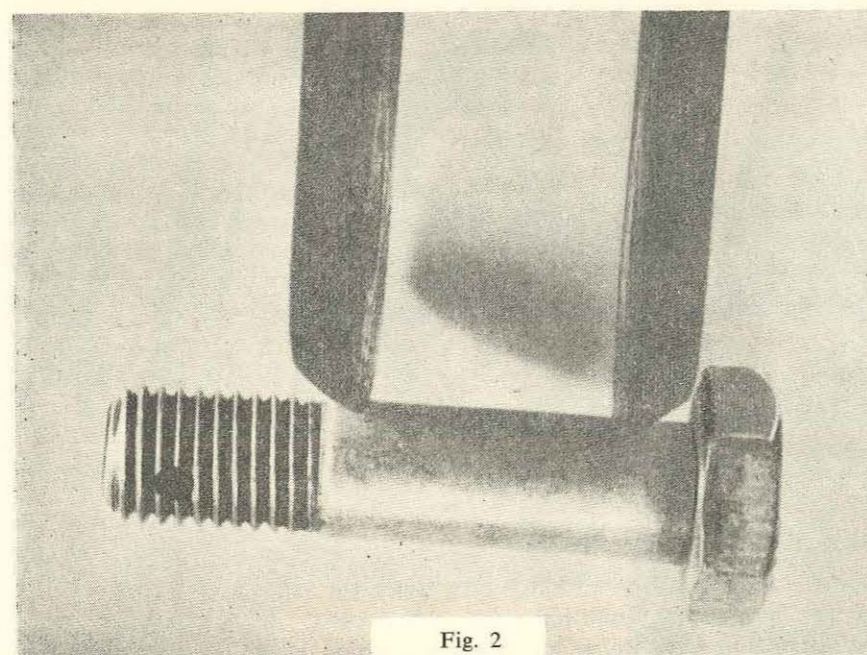
Fig. 2

From the examination it was not possible to identify the bolt with the specific link assembly and clevis from N5140B. It was possible, however, to determine from marks on the bolt that it had been installed in an assembly with the same dimensions as the clevis forks and bearing bore of the link assembly (see Fig. 2).

forces could not have sheared the bolt but would have badly damaged the components. It is on this irrefutable physical evidence that the Board concluded the AN5-12 bolt which normally secures the link assembly-clevis attachment was not in place when the aircraft crashed.
