AVIATION SAFETY

DIGEST

No 24, DEC., 1960

DEPARTMENT OF CIVIL AVIATION

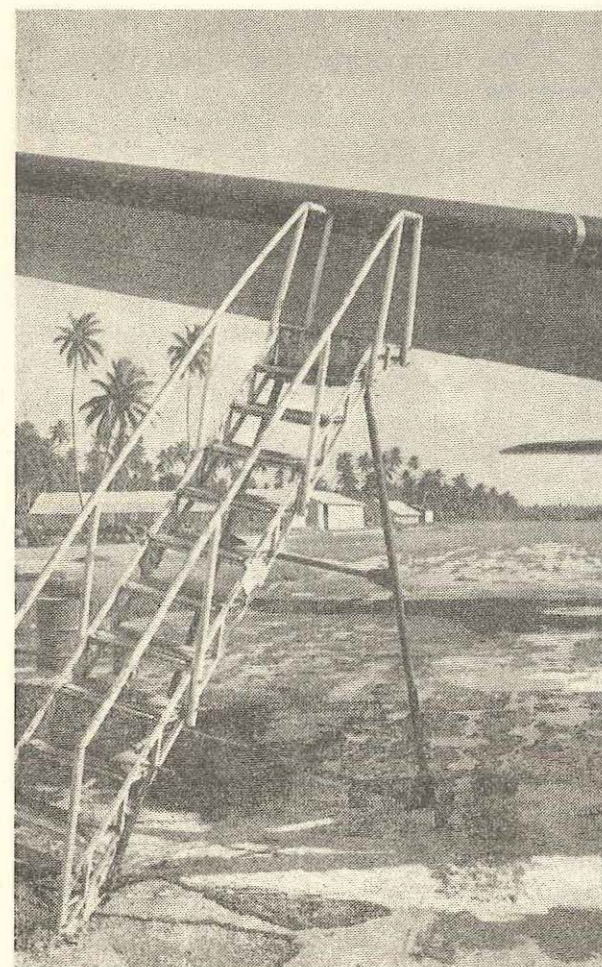
A DC.4 collided with maintenance equipment when the aircraft was moved forward during maintenance. The wing was punctured and a considerable quantity of fuel spilt on the tarmac. In addition, a propeller and several servicing stands were damaged. The photograph on this page shows one stand wedged underneath the outer wing.

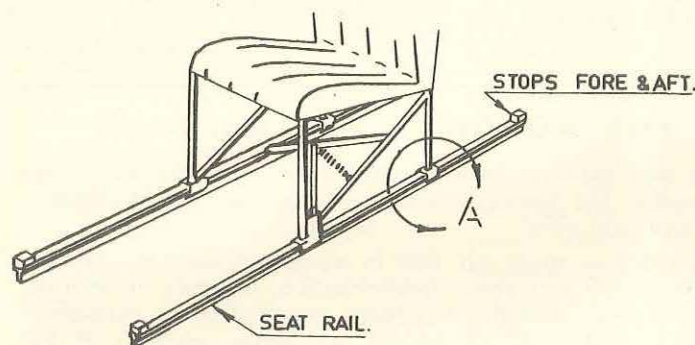
FIG 1

The seats slide on light alloy extruded rails which in some types of aircraft form part of the fuselage structure. The seats are adjustable to different positions, being moved for either pilot comfort or entry to the aircraft. The seat is then locked by means of a spring loaded pin engaging a hole in the seat rail. Stops are attached to the rails fore and aft to prevent excessive seat travel. Fig. 1 shows a typical arrangement where the seat is

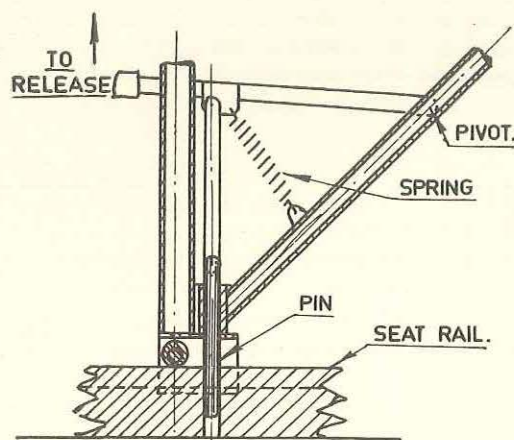
FIG. 2

Holes are spaced at intervals along the rails to receive the locking pins, which when engaged provide a positive lock restraining the seat from fore and aft movement. The pins have a tapered end to facilitate engagement and are forced toward the closed position by means of a spring. Fig 2.

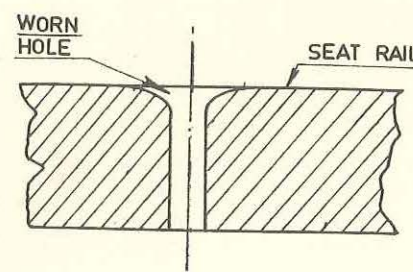
FIG. 3

However, with continued use the holes are liable to become worn and elongated as shown in Fig. 3. This worn condition will not detract from the effectiveness of the lock itself. However, it is possible for the pin, if not properly engaged prior

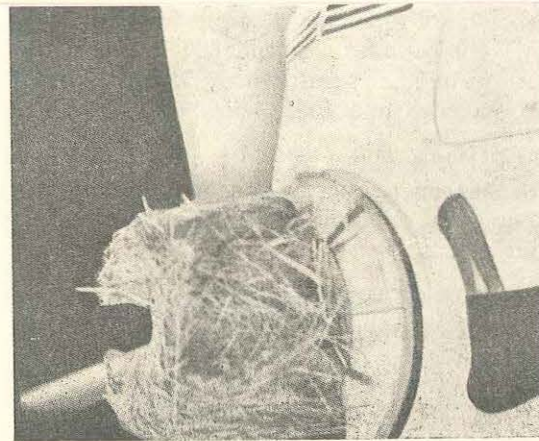
The bird's nest in the picture was discovered during pre-flight inspection of a Beechcraft Bonanza. The aircraft had not been flown for six days. Had the bird used shorter raw material so that none protruded from the blade cutouts in the propeller spinner, the nest might have gone unnoticed.

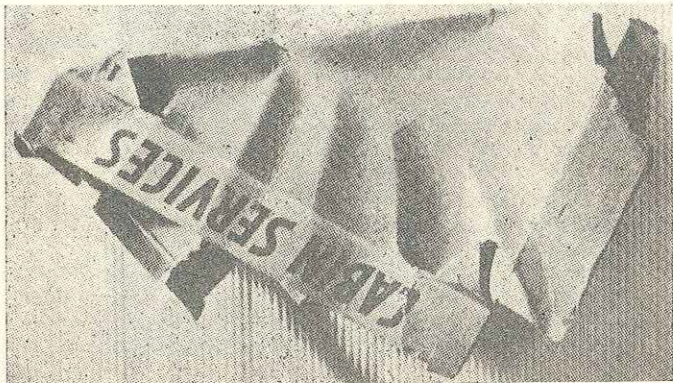
During cruise No. 3 engine was shut down because of vibration accompanied by a drop in r.p.m. and jet pipe temperature. After landing, part of a cabin services cardboard food box was found in the engine air intake pressed tightly against the entry guide vanes. The compressor blades were damaged and the engine was changed.

The aircraft had transmitted a station during the hours of darkness and during the transit the empty food boxes were placed on the platform of the steps at the crew entrance door. It seems that one piece of box was knocked or was blown into No. 3 engine intake.

When the engine was started the box pressed against the entry guide vanes and by partially blocking off the intake air caused the compressor to stall. The resultant high frequency vibration led to fracture in fatigue of a first stage rotor blade.

The photograph shows the extent of the resultant compressor damage. Approximate cost — £20,000.
