AVIATION SAFETY

DIGEST

No 25, MARCH, 1961

DEPARTMENT OF CIVIL AVIATION

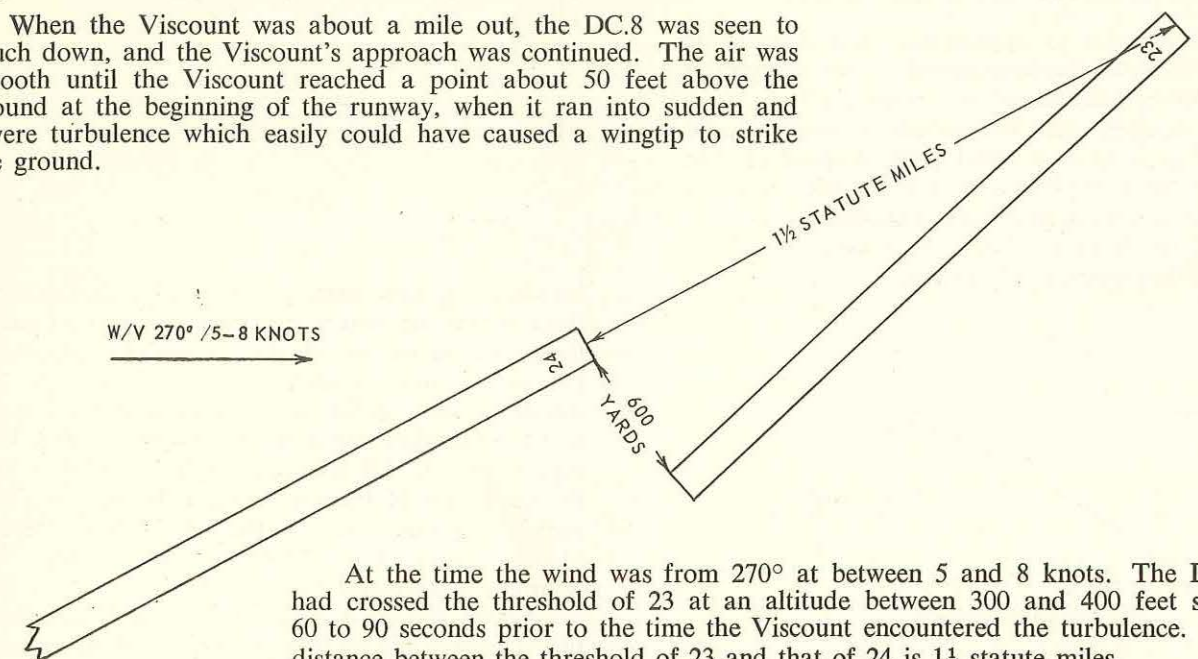
Before turning on final for Runway 23, the captain of a Viscount was warned by A.T.C. of the presence of a DC.8 doing circuits and landings on the new Runway 24. Runway 24 lies starboard of 23, with its threshold level with and about 600 yards from the far end of 23. The angle between 24 and 23 brings the centreline approach to 24 about over the threshold of 23. See sketch below.

When the Viscount was about a mile out, the DC.8 was seen to touch down, and the Viscount's approach was continued. The air was smooth until the Viscount reached a point about 50 feet above the ground at the beginning of the runway, when it ran into sudden and severe turbulence which easily could have caused a wingtip to strike the ground.

At the time the wind was from 270° at between 5 and 8 knots. The DC.8 had crossed the threshold of 23 at an altitude between 300 and 400 feet some 60 to 90 seconds prior to the time the Viscount encountered the turbulence. The distance between the threshold of 23 and that of 24 is 1½ statute miles.

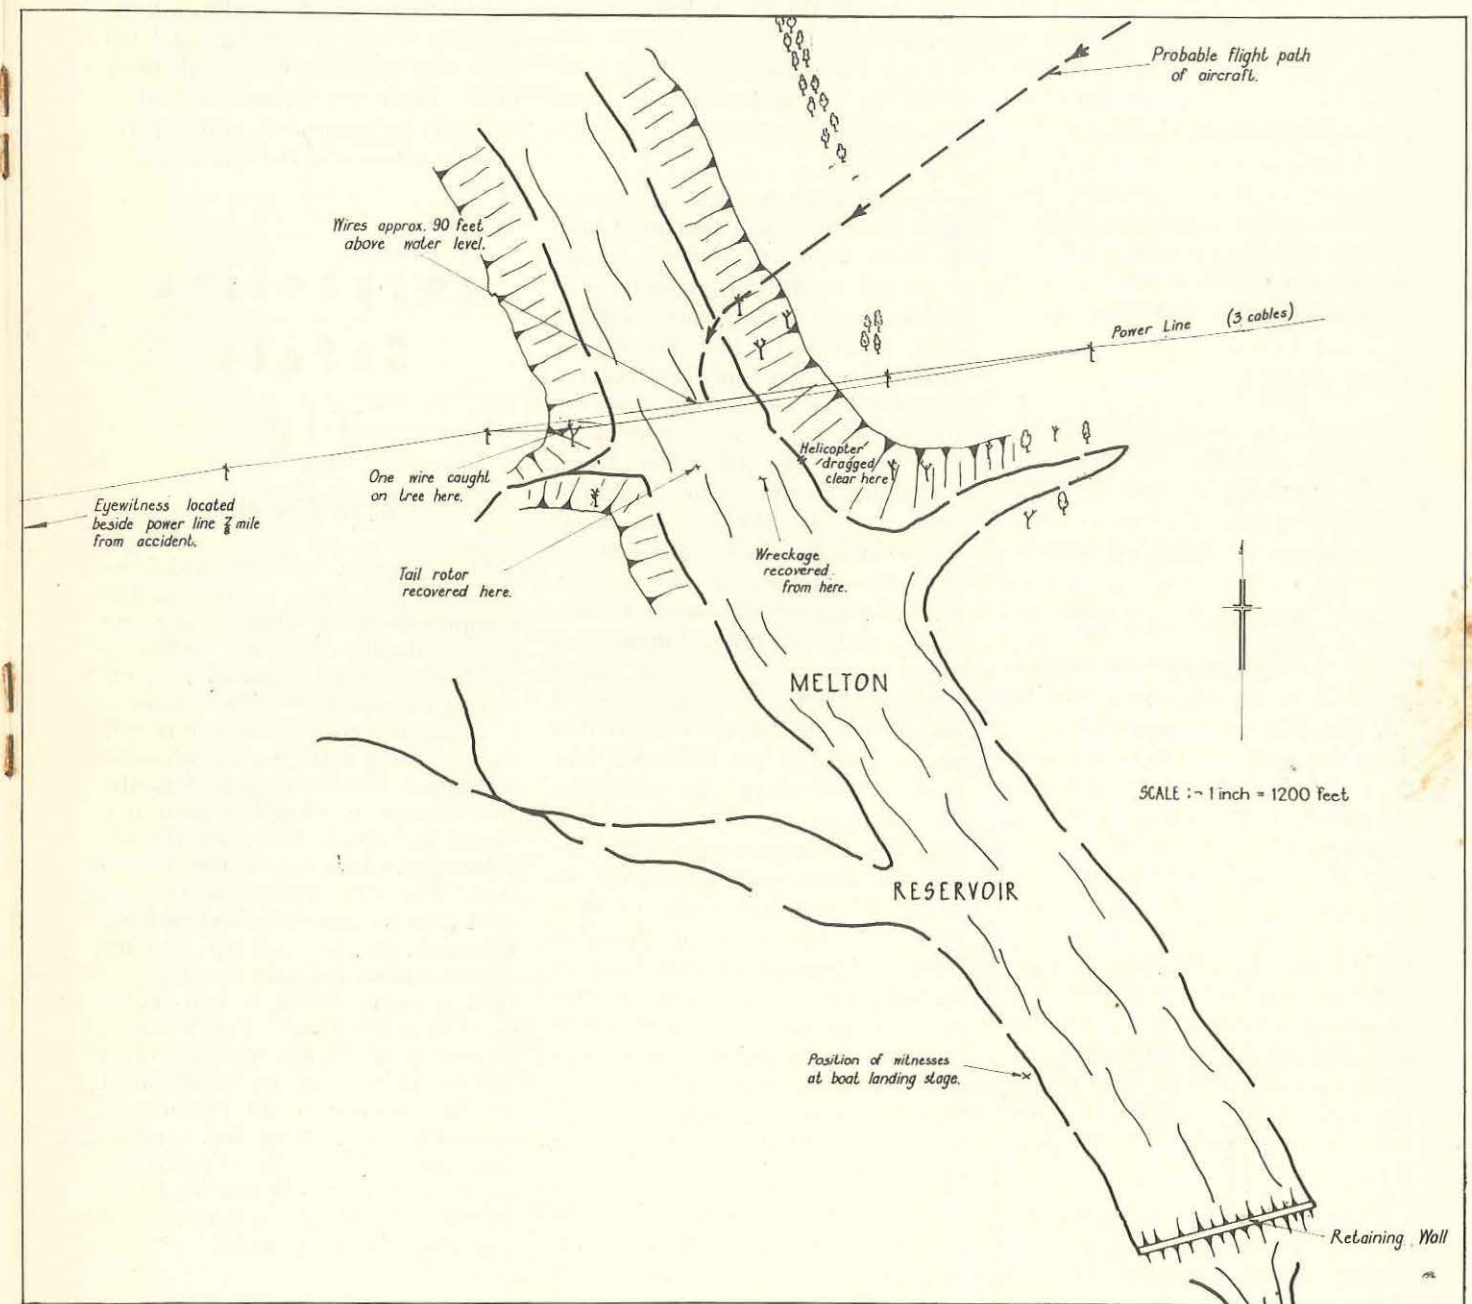
The main body of the wreckage came to rest on the floor of the reservoir in some 80 feet of water and approximately 350 feet downstream from the point of collision with the power cables. The wreckage was brought to the water's edge

some three hours after the accident. It was then established that all major components of the helicopter were present except for the tail-boom extension, the tail-rotor assembly and port synchronized elevator. Subsequent diving opera-

tions succeeded in recovering the tail-rotor assembly, the port synchronized elevator and shattered fragments of the tail-boom extension casting; thus there was almost a complete recovery of wreckage which was subjected to a detailed examination. No evidence was found of any defect or malfunctioning which might have contributed to this accident. The tail-rotor assembly had separated from the main wreckage when the main rotor blades had struck and severed the tail boom extension as a result of flexing due to the forces brought about by the contact with the wires. The port synchronized elevator spar had failed in the impact with the water and there was clear evidence that the power cable had been in contact with the forward cross bow and the runner on the port side of the undercarriage assembly.

A thorough examination of the helicopter structure, and its control systems, the main and tail-rotors and the engine has failed to reveal any evidence of defect or malfunction which might have preceded the collision with the power cable and thus contributed to it. This conclusion is strengthened by the evidence of the survivor, who has said that the helicopter appeared to be operating quite normally right up to the point where there was a violent change of attitude and an immediate spiralling into the reservoir. The other eye-witnesses have introduced no evidence which runs contrary to this proposition. There is no suggestion that the pilot was incapacitated or impeded in any way in exercising normal control and there does not appear to have been any factor present which was outside the control of the pilot and which might have contributed to this accident.

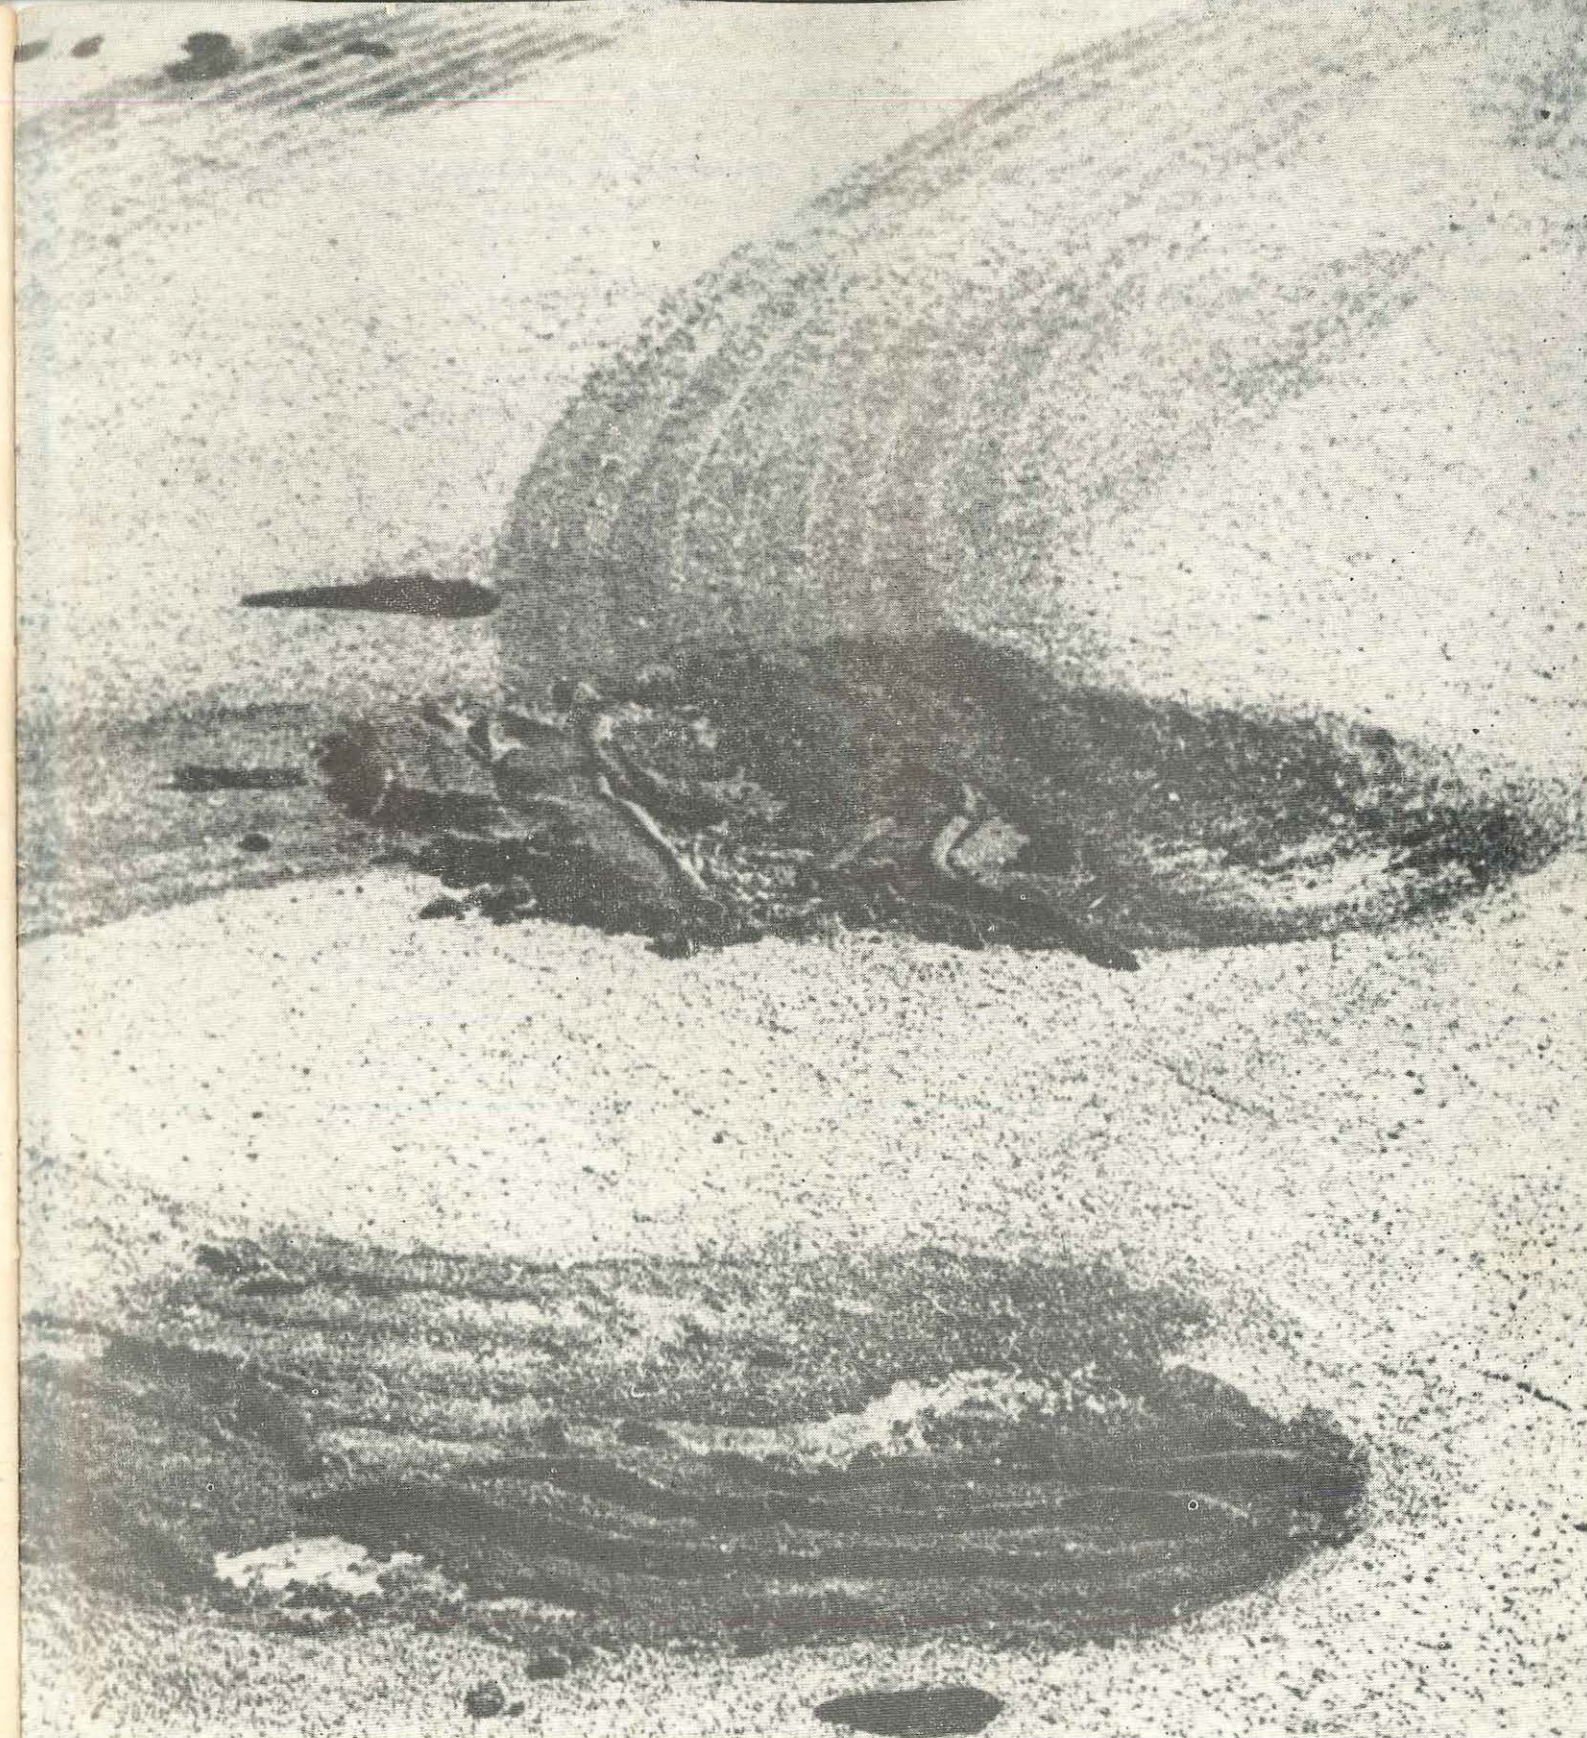
Damage to Pavement at one of our International Airports

NOT A PROFESSIONAL TURN :
EXPENSIVE TOO!
