AVIATION SAFETY

DIGEST

No. 28, DEC., 1961

DEPARTMENT OF CIVIL AVIATION

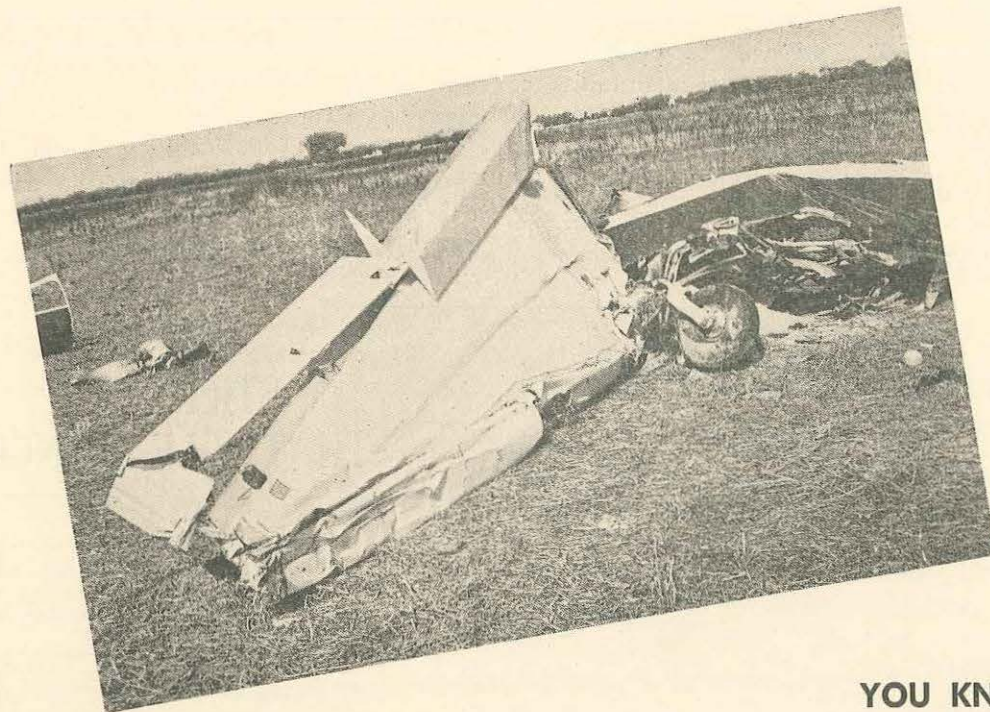
CROPMASTER. Forgetting flight time and ignoring the presence of fuel gauges, the pilot carried on until all fuel in one tank was exhausted. When the engine failed the aircraft stalled, crashed and burned. The pilot lost all in the gamble of being able to switch to the other tank.

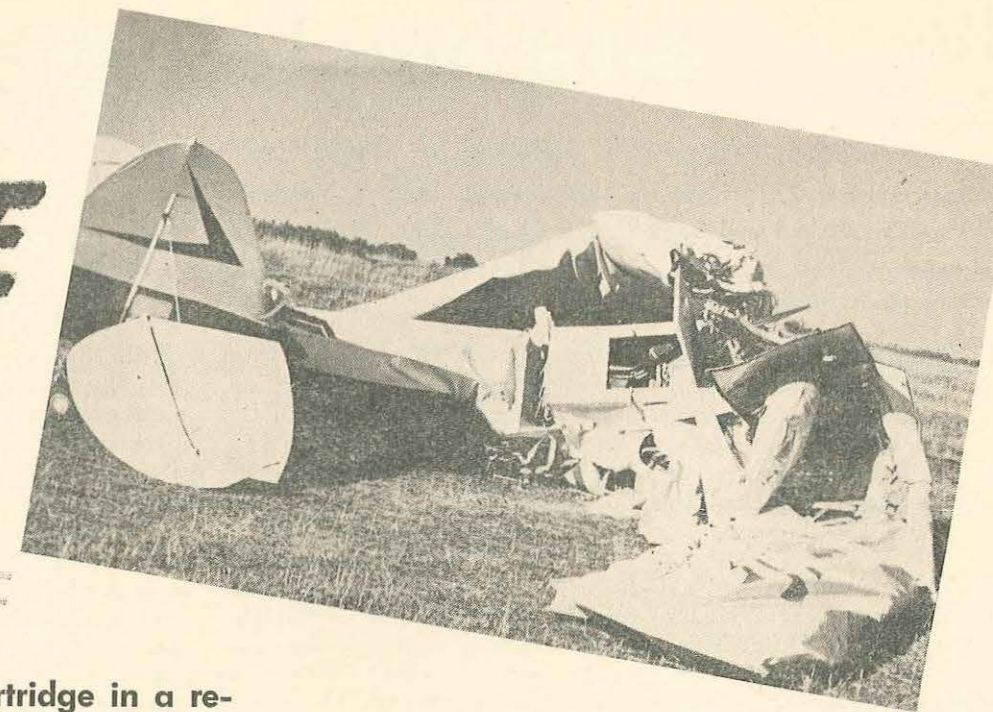
PIPER PA18A. The pilot of this aircraft was the loser when the engine cut out during the turn at the end of a spreading run. One fuel tank was empty—the other full. He, too, lost the tank switch gamble.

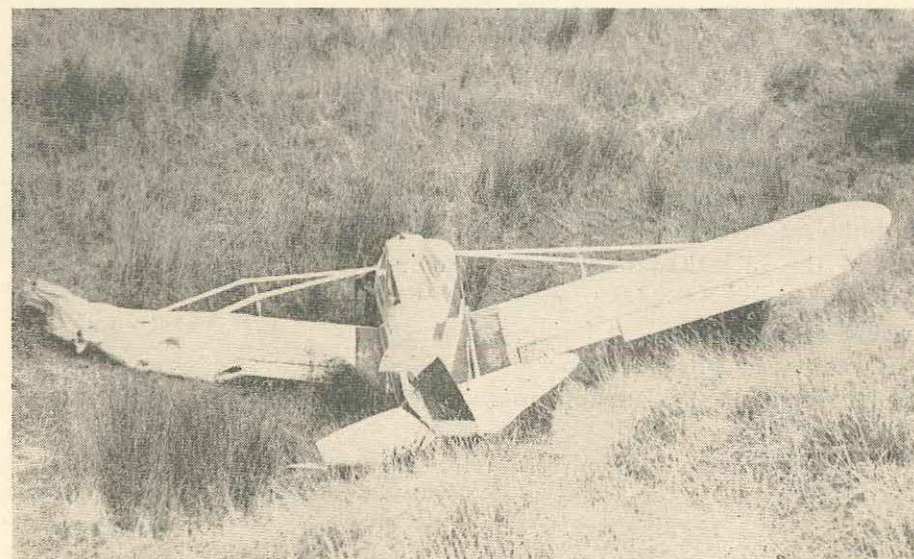
EP.9. Making a guess at the fuel distribution was equivalent to loading the gun. An attempted tank change at a critical stage of the approach led to confusion in the manipulation of engine controls and a premature landing on rocky ground.

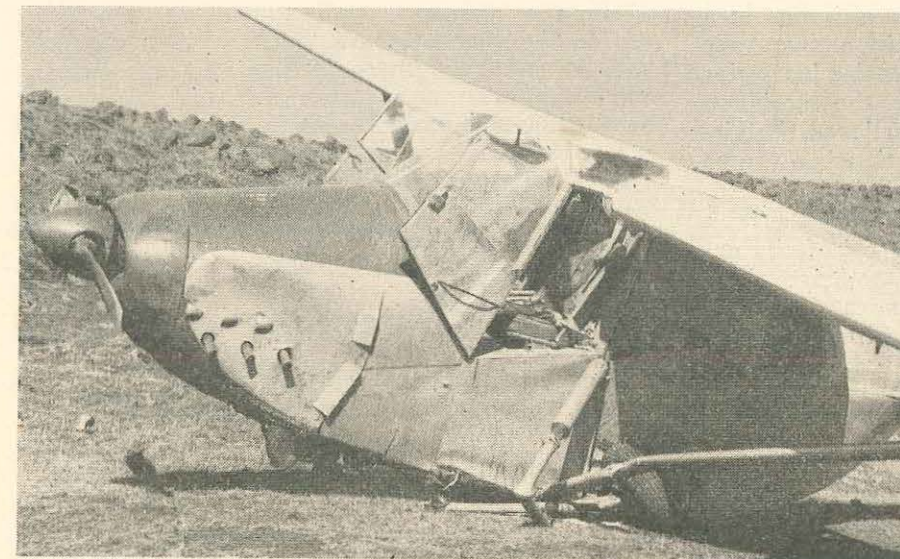
PIPER "PAWNEE". This aircraft was wrecked when the pilot attempted a forced landing, brought about by fuel exhaustion during the 24th flight after refueling. He forgot to consult the fuel gauge, which was tantamount to pulling the trigger. The rest was left to pure chance.
