AVIATION SAFETY DIGEST

DEPARTMENT OF
CIVIL AVIATION

No. 30 JUNE, 1962

Prepared in the Division of Air Safety Investigation
Department of Civil Aviation

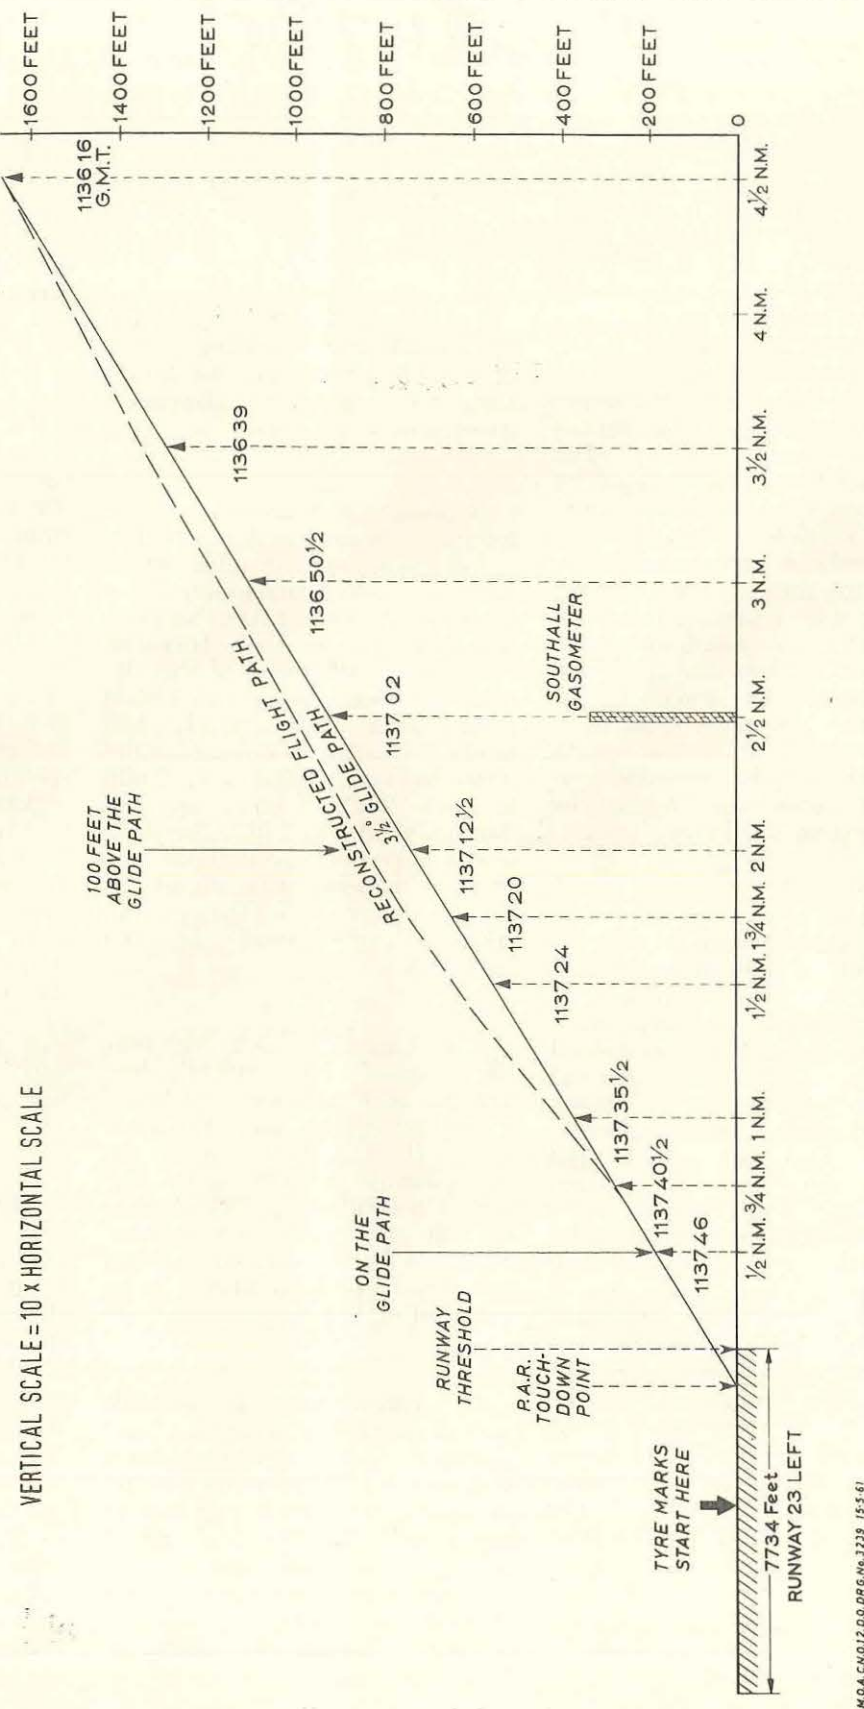
RECONSTRUCTION OF P.A.R. TALKDOWN OF BOEING 707 G-APFN (Side Elevation)

In considering a possible reason why the approach and threshold speeds were too high it is necessary to examine the relationship between the glide path angle and the approach speed in light wind conditions. If the glide path angle is steeper than normal the resultant rate-of-descent will be greater than normal; also in conditions of no wind the rate-of-descent will be

The Captain carried out the final stage of the approach to land at too high an airspeed. As a result the aircraft touched down too far along the runway and failed to stop within the remaining length.

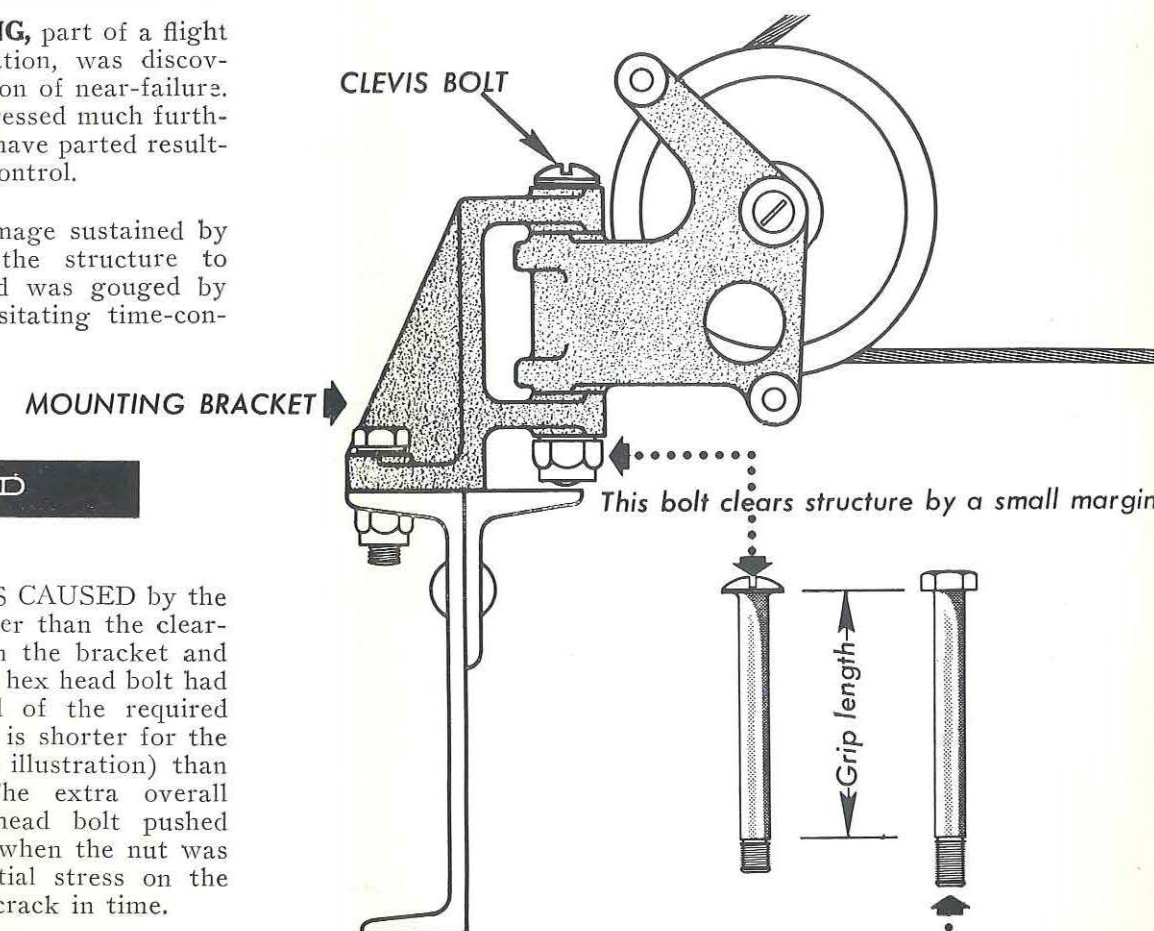
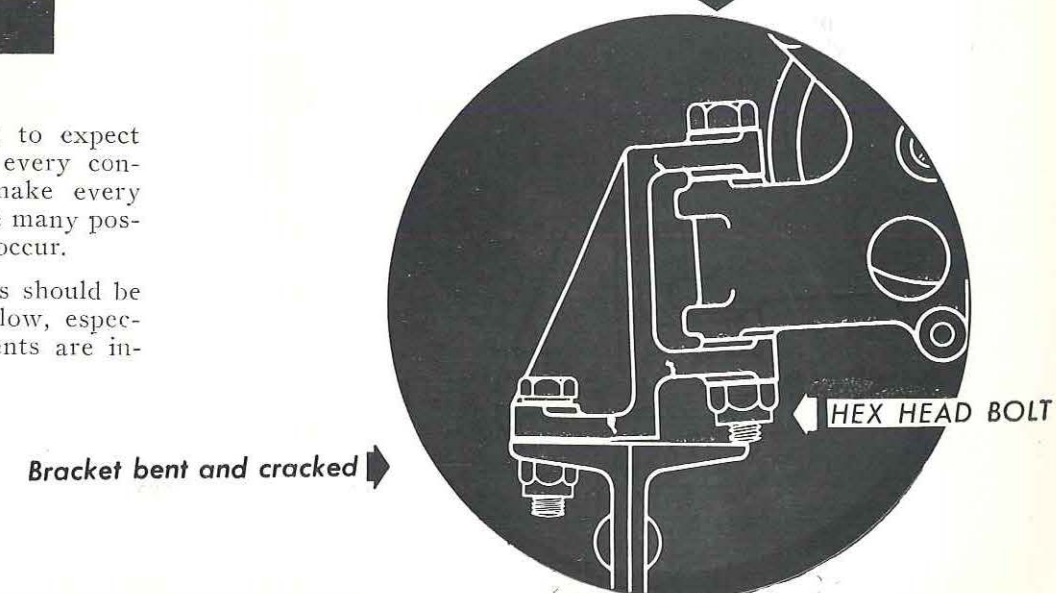
IT IS NOT REASONABLE to expect aircraft designers to foresee every contingency but they should make every effort to become aware of the many possibilities for malfunction to occur.

This bolt has same grip length but is longer overall

Whenever possible, clearances should be as generous as space will allow, especially where moving components are involved.
