AVIATION SAFETY

No. 31, SEPT., 1962

DEPARTMENT OF CIVIL AVIATION

In-Flight Wing Failure

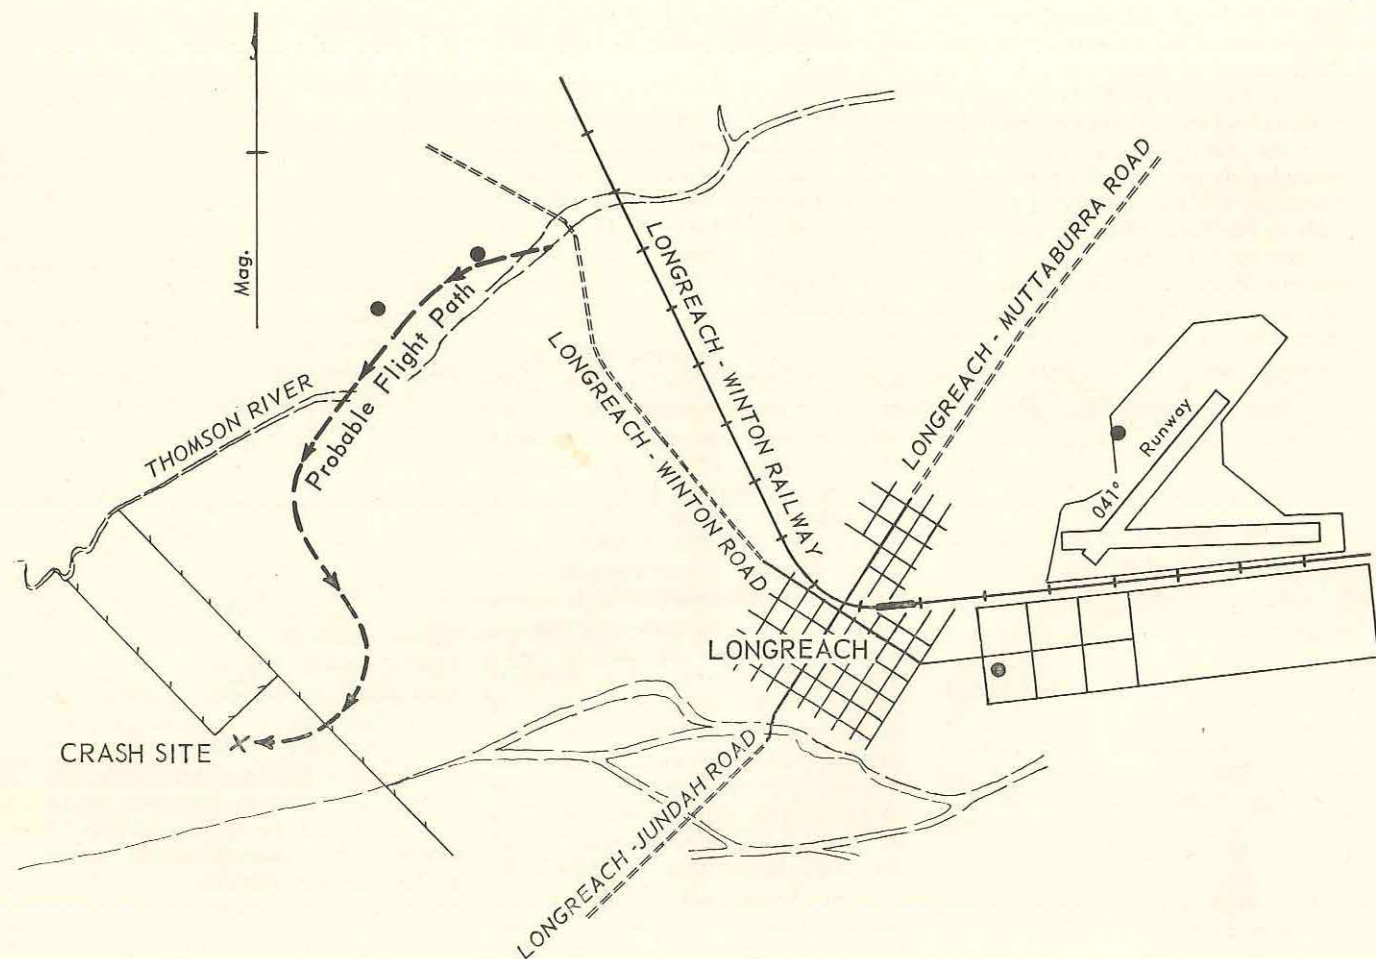
WITNESS LOCATIONS AND PROBABLE FLIGHT PATH

The evidence of all three witnesses indicates that the flight path on the last flight was in a south-westerly direction and one of the witnesses, who watched the aircraft for a longer period of time than the others, saw it bank to the left with the nose going down. He did not continue to watch the aircraft beyond this point. All three witnesses agreed that, at this stage of the flight, the aircraft was much lower than others which they have frequently observed flying in the vicinity of the Longreach Aerodrome. The witnesses compared the height of the aircraft with that of the Longreach water tower which is 130 feet above ground level.
