AVIATION SAFETY

No. 36, DECEMBER 1963

DEPARTMENT OF CIVIL AVIATION

Prepared in the Division of Air Safety Investigation
Department of Civil Aviation, Commonwealth of Australia

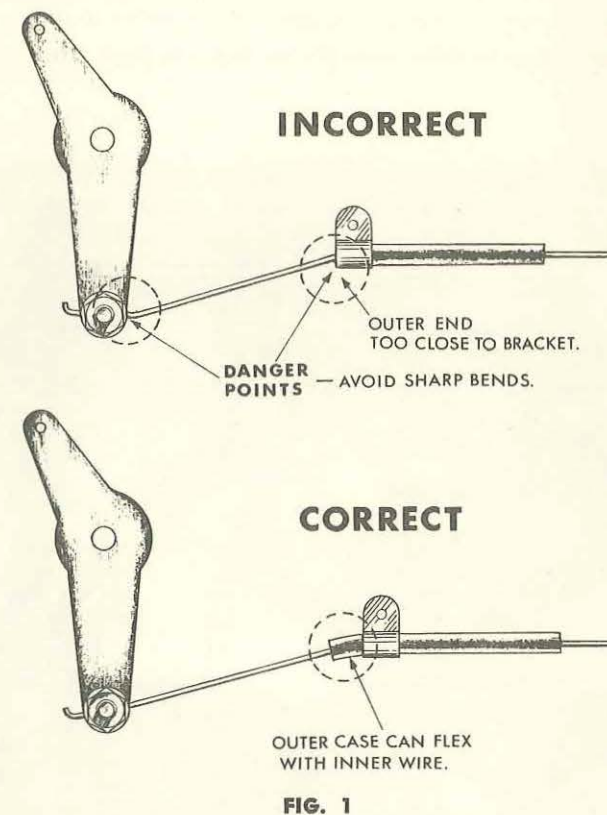
For example, a control installation which includes excessively sharp bends is likely to suffer from fretting and wear of the wire inside the casing. A more common fault, which can easily be introduced accidentally during normal service adjustments, is to place the final clamp or attachment of

the outer casing right at its forward end. In that case, normal movement of the control lever on the engine may cause undue flexing of the control wire, with consequent risk either of a metal fatigue failure of the wire or of excessive abrasion against the open end of the casing. (See Fig. 1.)

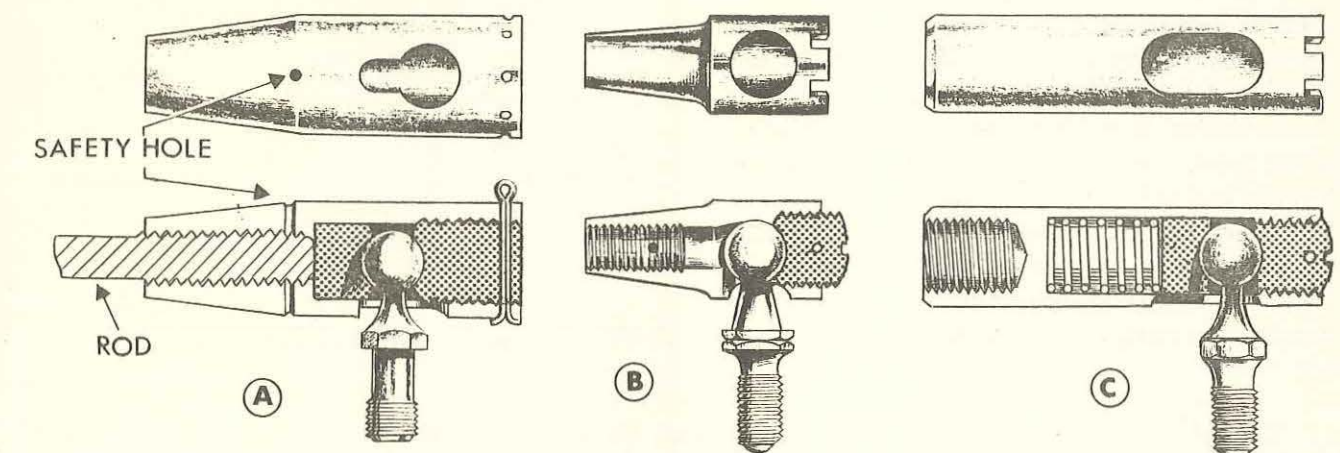
1. Rod end must not be screwed in too far.
2. Neck of ball must be in narrow section when correctly adjusted.
3. Adjust ball clearance with pinned nut.
4. Correctly adjusted ball cannot slip out with normal wear.

1. Socket hole larger than ball end. Excessive wear on ball and pads will allow rod to come adrift from ball.

1. Wear is normally compensated for by spring but broken or damaged spring will allow rod to come adrift from ball. Modified version has slot in end fitting narrowed similar to Fig. (a).

of which there are several different types in general use. Probably the worst offender is the common ball-and-socket joint with its tendency to wear and come adrift in service—usually at a very awkward moment. This type has its short-comings even though modified versions have been brought out over the years to improve serviceability. (See Fig. 2.)

Regular, careful inspections are thus essential if trouble is to be avoided. When checking for signs of undue looseness or wear, the checks should be made over the full range of travel of the control and not merely in the fully open and fully closed positions. Since engine controls spend most of their actual operating life in the cruise power range, it naturally follows that the danger signal of excessive looseness at joints can often be most readily detected when the controls are in this intermediate position.
