# AVIATION SAFETY DIGEST

DEPARTMENT OF  
CIVIL AVIATION

No. 37      MARCH, 1964

Prepared in the Air Safety Investigation Branch,  
Department of Civil Aviation, Commonwealth of Australia

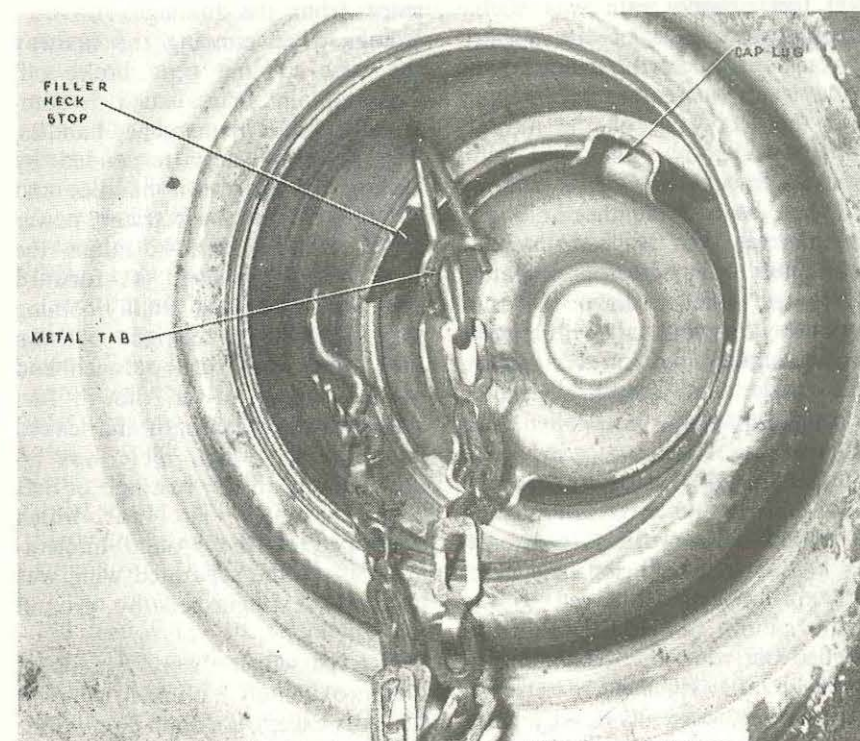
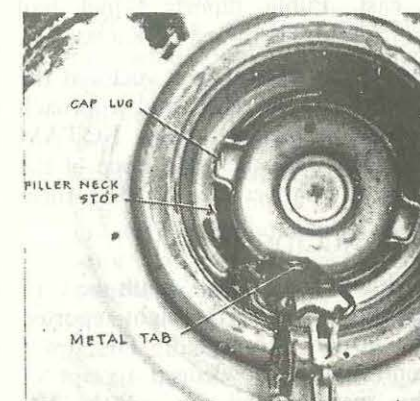
safety pin fouls the stop in this way the cap feels secure but does not provide an effective seal, thus setting up a condition where fuel can be sucked past the cap into the low pressure area above the wing.

Checks made on a number of aircraft using this type of tank cap and retaining chain configuration revealed that the lug on the under-surface of the tank cap had been twisted as a result of the pin contacting the stop, with corresponding marks evident on the stop. This condition can, of course, be avoided by careful fitting of the tank cap but is difficult to detect once the cap is installed, as there is no ready means of determining whether the cap has rotated into the fully locked position. Witness marks painted on the cap and the adjoining structure, which align when the cap is in the fully locked position, will provide such a reference and are a worthwhile precaution on any aircraft.

Close up views from underneath tank cap assembly shows (left) retaining pin fouling between metal tab on cap and the stop on the filler neck and preventing further movement to closed position, and (right) fuel cap in locked position.
