AVIATION SAFETY

DIGEST

No. 40, DECEMBER, 1964

DEPARTMENT OF CIVIL AVIATION

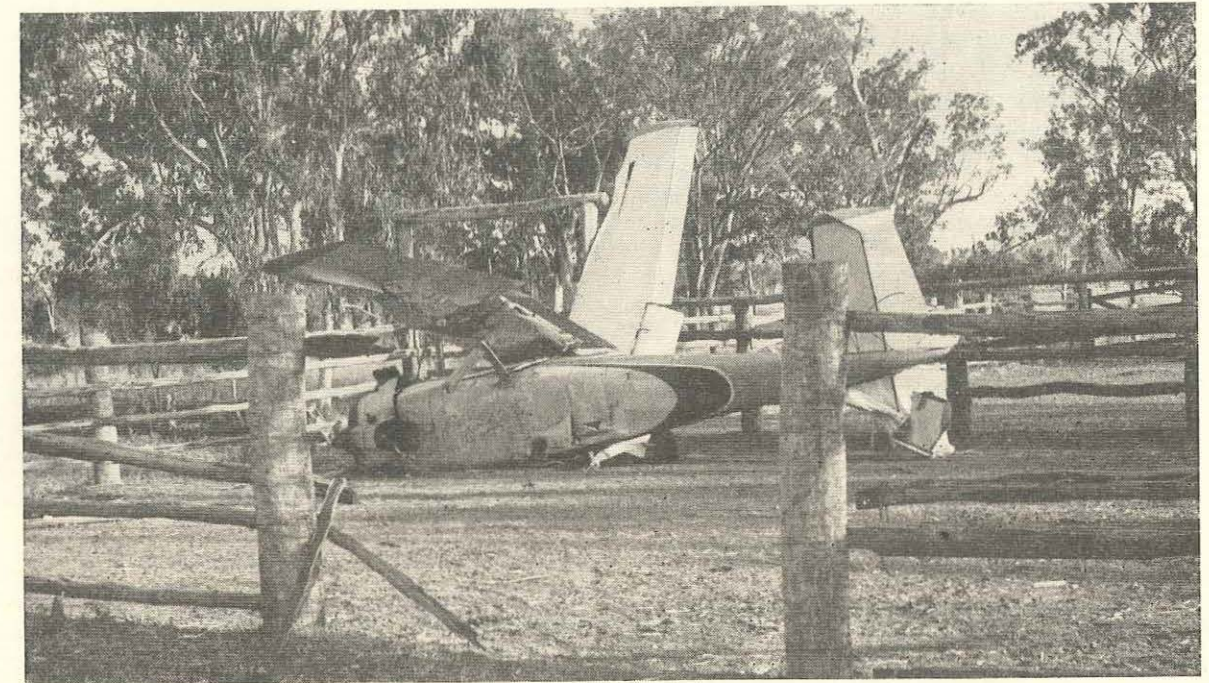
Shortly before this picture was taken, that pile of wreckage was a smart Cessna 182. Engaged on a charter flight with only the pilot on board, it had landed at a Queensland cattle station to deliver supplies and was about to depart for another station property. Describing the shattering experience that followed, the pilot told us:

"The aircraft continued along the ground for approximately 165 yds. on a slightly semi-circular path to the left and was extensively damaged on impact with cattle yards."

Only a small particle of foreign matter in the system's hydraulic fluid could be sufficient to cause a slight leakage past a master or wheel cylinder valve, and while this would have a negligible effect on the brakes while taxiing, brake pressure could gradually be lost while the aircraft is parked.

Air Navigation Regulation 223B allows a pilot to hand-start an unoccupied single pilot aircraft on the condition that "adequate provision is made to prevent the aircraft moving forward". To satisfy this requirement, a hand brake system must obviously have design characteristics which will provide restraint over the range of powers that might be developed immediately following a hand-start **and** it must be maintained to a standard which will ensure that the designed degree of restraint will continue to be achieved.

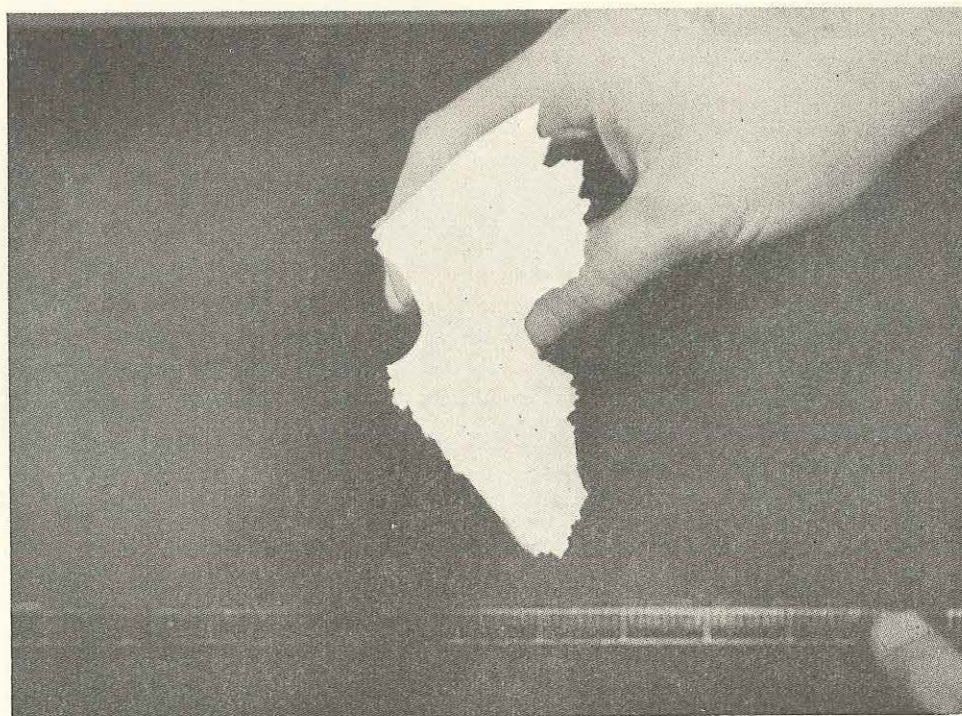
Cross section of horn type ice formation produced on the leading edge of an unheated aerofoil section during a wind tunnel test of 15 minutes duration.

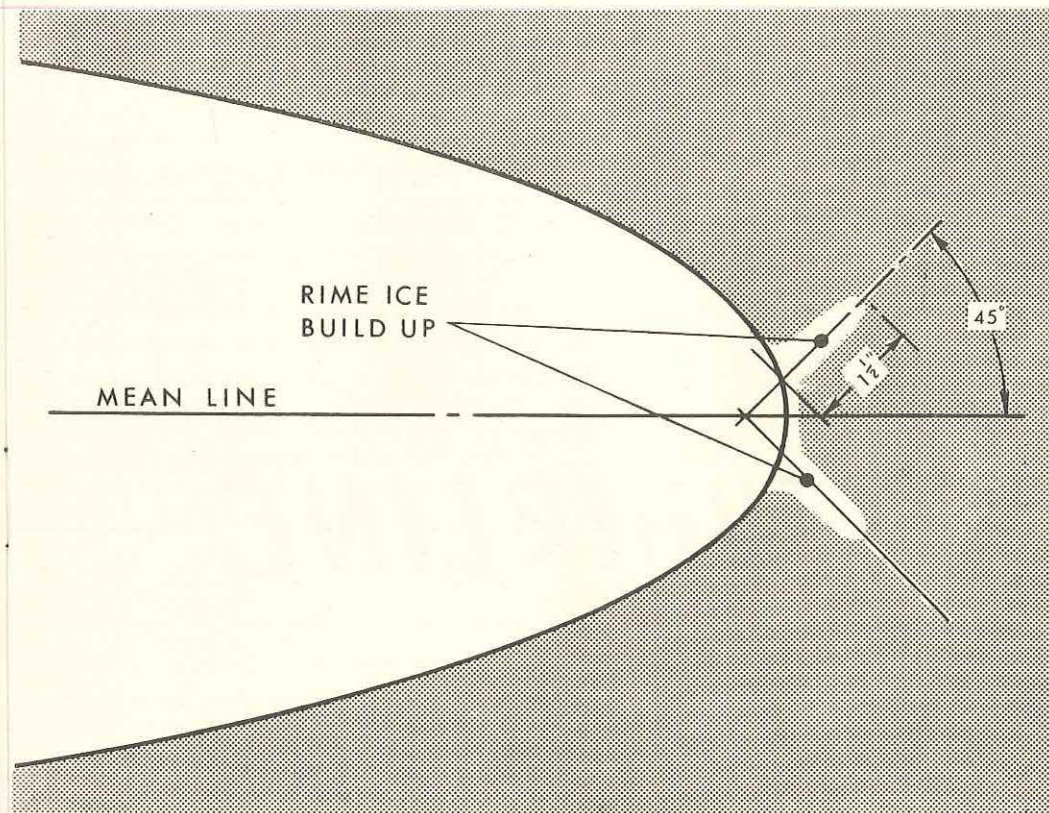
LEADING EDGE OF TAILPLANE AT STN.76

plished without further difficulty. Examination of the aircraft showed a concave build-up of ice on the leading edge of the tailplane.

Sketch by pilot illustrating ice formation found on tailplane of Viscount 812 on 20th February, 1963.

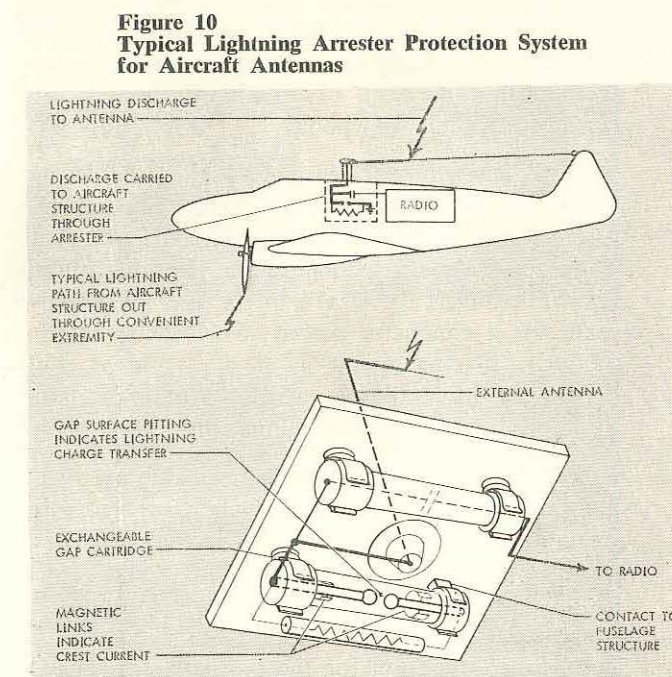
Figure 10
Typical Lightning Arrester Protection System for Aircraft Antennas

These are often instrumental in leading lightning into the cabin where it damages transmitting-receiving equipment and exposes personnel to hazardous voltage. For this reason, lightning arresters (such as that shown in Figure 10) have been developed. These usually include a special spark gap between antenna and aircraft structure, a dc blocking condenser, and a static leak resistor all encased in metal/glass enclosures. They are located in the antenna lead-in adjacent to the aircraft skin. The arresters are expendable, that is, they must be expected to sustain some damage in diverting the heavy current, and should be frequently inspected to ensure that the correct spark-gap is maintained. Note that they are not intended to protect the external antenna, but are simply intended to provide a calibrated weak point in the antenna system which will break down and carry off the destructive peak voltage through a safe path rather than allowing the lightning to flashover to structure inside the fuselage at a spot of its own choosing. Arresters are not pro-
