AVIATION SAFETY DIGEST

DEPARTMENT OF CIVIL AVIATION

No. 42, JUNE, 1965

Prepared in the Air Safety Investigation Branch,
Department of Civil Aviation, Commonwealth of Australia.

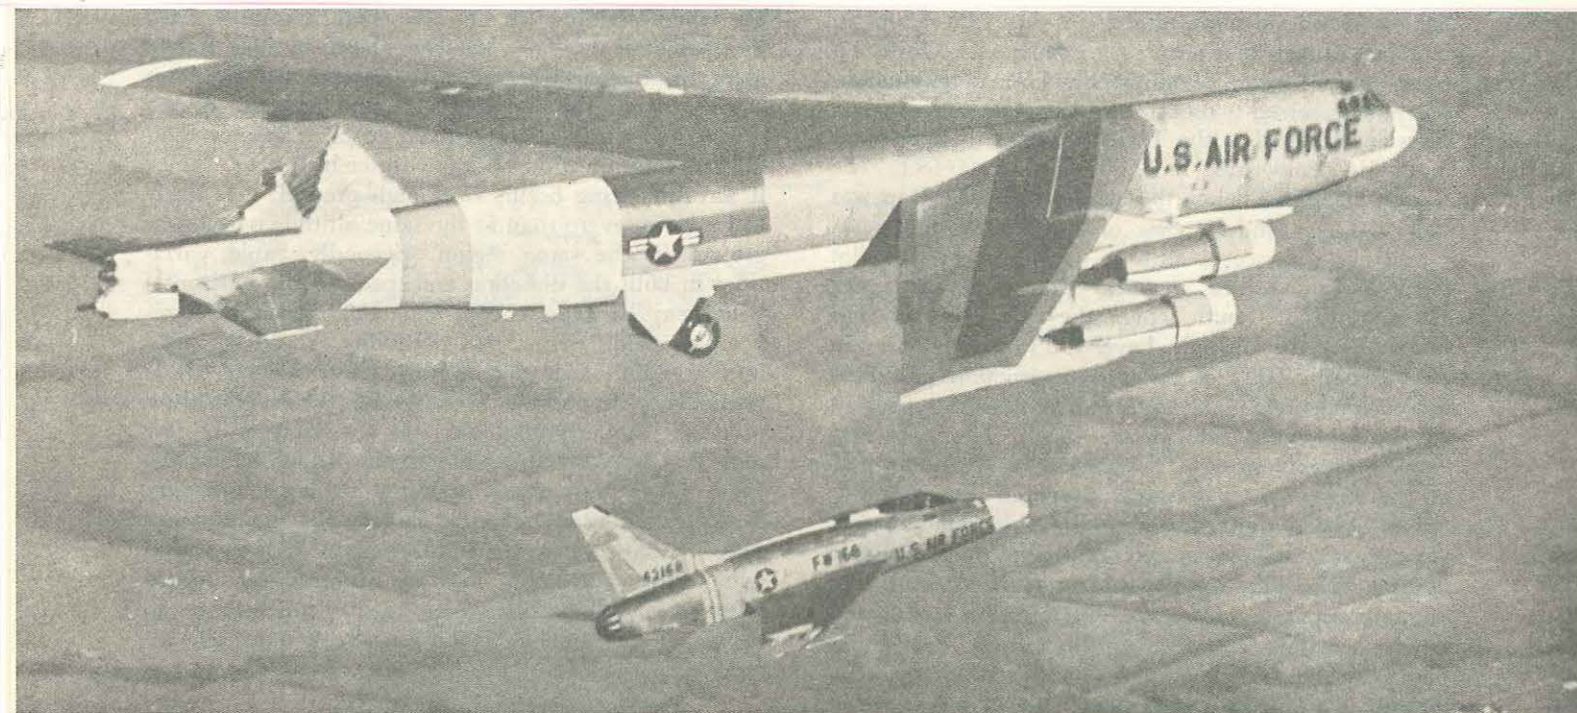
This B52 bomber lost its fin and rudder in an encounter with extreme rotor zone turbulence. Despite control difficulties the pilot was able to make a safe landing.

from the recent experience of the crew of a Boeing B52 engaged on a test flight along the lee-side of the Sangre de Cristo Mountains, Colorado. After flying through a region of noticeably smooth air, the aircraft suddenly encountered turbulence which the pilot later described as "near catastrophic". The encounter lasted less than 10 seconds, but was so violent that control was all but lost, and the aircraft developed a rapid rolling tendency which required the application of almost full aileron to correct. After checking the controls, the pilot concluded that the tail unit had been badly damaged. This was confirmed by the pilot of a "chase" aircraft, who reported that most of the fin and rudder had been torn away, but that the tailplane was intact. Fortunately, the B52 still had a clearance of about 5,000 feet above the mountains and, after a 3-hour fuel burn-off period, the pilot managed to make a safe landing. Had height over the mountains been marginal at the time of the encounter, the incident might have ended differently.

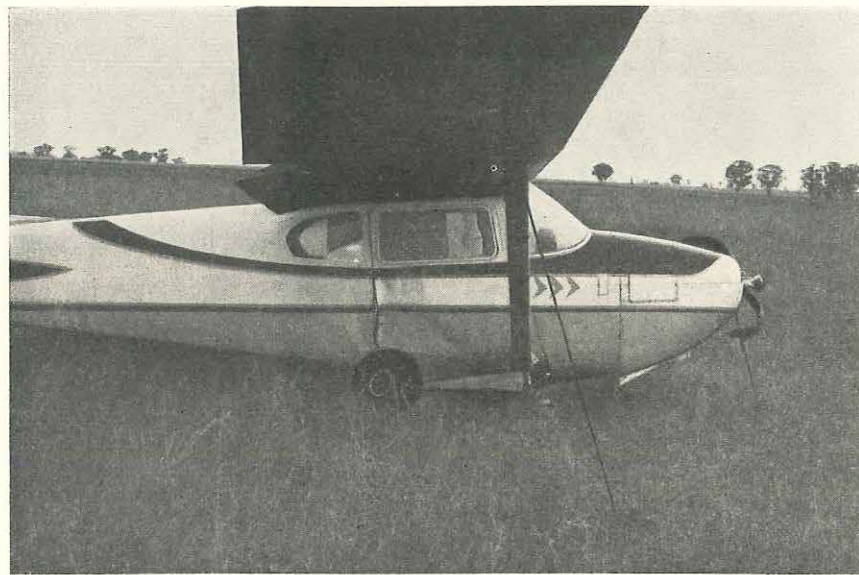
After reaching the base strip and making a run to alert the ground crew, the pilot completed a successful belly landing, causing little further damage other than bending the propeller blades.

What he did not know, was that in this type of aircraft, damage to the undercarriage attachments invariably means that the lift strut attachments to the fuselage have also been damaged. When the aircraft was inspected, it was found that the starboard lift strut attachment had been damaged to such an extent that the aircraft might well have lost a wing during the homeward flight. The pilot was present during the inspection and was horrified to see the seriousness of the damage to the strut fitting.

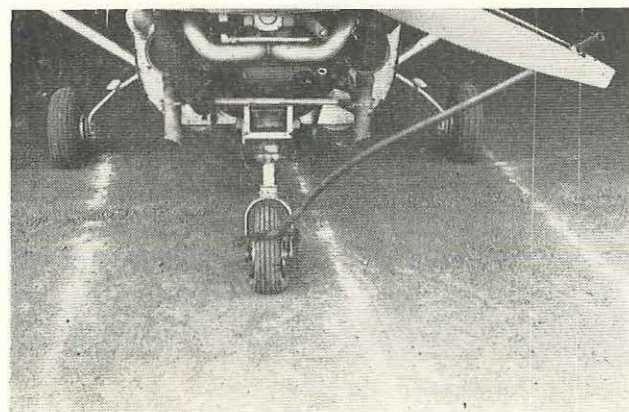
The damaged tow bar repositioned, showing how it had been caught by the propeller blade.

Two days later, a station employee found the badly bent nosewheel tow bar lying in scrub 75 yards away, where it had been flung by the propeller.

The tow bar, made from $\frac{3}{4}$ " black iron water pipe, had been in position on the nosewheel when the aircraft was pushed out of the hangar, but had not been noticed. The bar was unpainted and its natural rust colour made little contrast with the gravel floor of the hangar.

This is the sixth accident of this type that we have had to report in the Digest in two years (see "The Importance of Pre-Flight Checks", June 1963, and "Look Before You Leap Aboard", June 1964). On these other occasions we have expressed our amazement that anything as obvious as a tow bar could go unnoticed. We still find it hard to believe, even though circumstances seem to be proving us wrong. This case of the RUSTY tow bar offers a clue to the problem. Perhaps if tow bars were painted in bright colours they wouldn't be so easily missed!

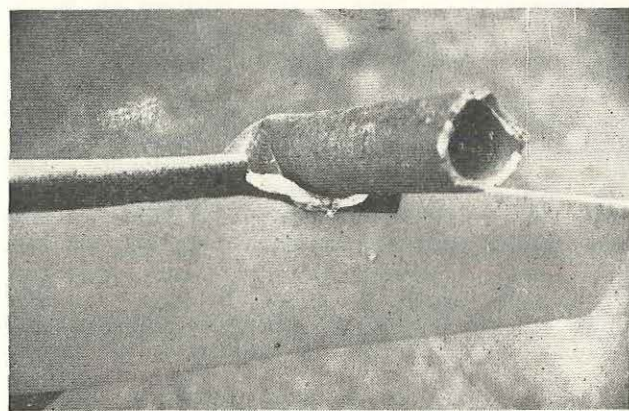
After starting up and taxiing forward a few yards there was a loud metallic bang from the front of the aeroplane. The pilot immediately stopped the engine and climbed out to see what had happened. He found the nose wheel tyre flat, a piece of metal missing from the wheel rim, a badly damaged propeller blade and a cracked reduction gear housing, but could find nothing on the apron that could have caused the damage.

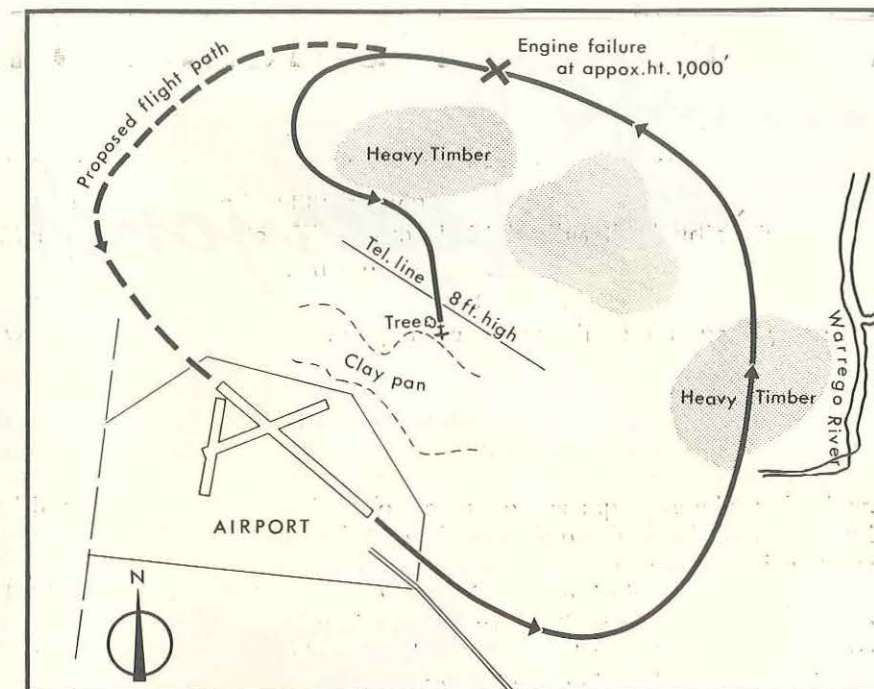
Investigation showed that the engine failure had been caused by fuel starvation. The fuel selector was still positioned to the port tank which was empty. The pupil pilot had apparently been misled by the instructor's advice that the aircraft had sufficient fuel and did not press the point during the down-wind checks, despite the fact that the fuel gauge must have been indicating almost zero for the last few circuits. Because "touch and go" circuits were being flown, no pre-take off checks were made after the first take off.

On the other hand the instructor had failed to physically check the pupil's cockpit drill on the down-wind legs. The fuel tank selector in the PA24 is located between the

pilot seats and can be seen readily from either position. He also failed to carry out the emergency procedures for engine failure as set out in the Pilot's Handbook for the air-

craft type. Had the starboard fuel tank been selected when the engine failed, there is little doubt that the engine would have regained power almost immediately.
