AVIATION SAFETY DIGEST

DEPARTMENT OF CIVIL AVIATION

No. 46

JUNE, 1966

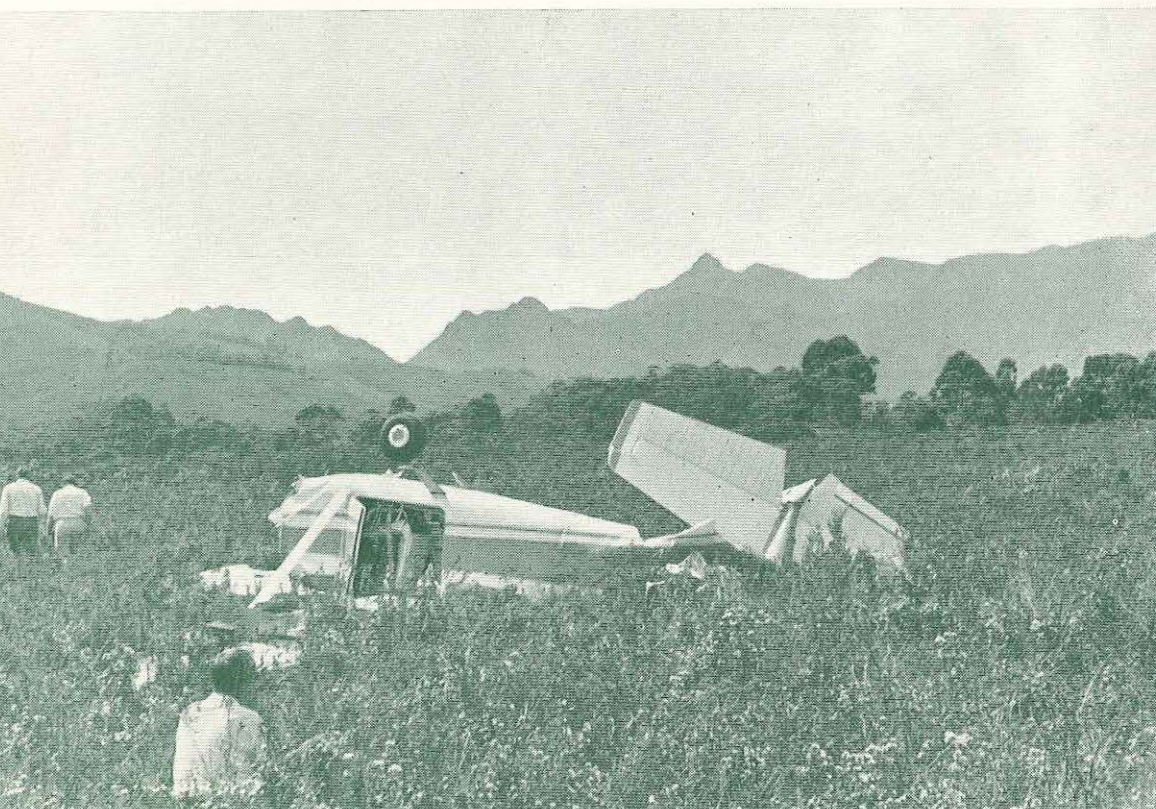
Examination of the wreckage showed that at the time of the crash, the elevator trim was almost in the full nose-down position. Flight tests carried out in another Cessna 172 confirmed that this type of aircraft, in common with many others, will become nose heavy if it is not re-trimmed after the flaps are raised. The test aircraft was loaded to establish a centre of gravity position similar to that of the crashed Cessna and, with the aircraft trimmed to climb with 20 deg. of flap selected, the elevator trim indicator position was found to correspond with that found in the wreckage. Immediately the flaps were raised with the elevator trim left in this position, the aircraft developed a strong

Above right: The tail assembly as it came to rest, showing the elevator trim tab set almost fully nose down.

Left: The wreckage on the scrub-covered plain five miles east of Lake Pedder. The mountain range and Mt. Anne can be seen in the background.

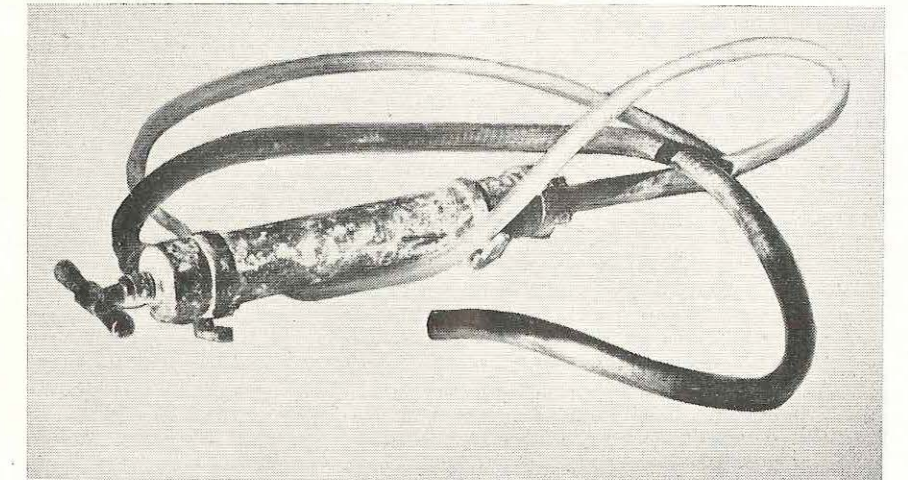
Examination of the pump showed that portion of the rubber pump valve had been eroded away exposing the cotton fibre reinforcement in the valve rubber. The rubber hose attached to the pump, was also found to be in an advanced state of decay and the in-

(Above): The marine bilge pump used to refuel the aircraft at Strahan.

COMMENT: This accident provides yet another object lesson on the absolute importance of adhering to established refuelling practices. The aircraft refuelling procedures laid down by the Department and by some of the oil companies have not been arbitrarily devised. They have been evolved in the hard school of experience. To disregard them, therefore, is to ignore facts made manifest in many accidents arising from faulty refuelling practices. This pilot **thought** he was taking all reasonable precautions by cleaning the pump, to begin with, and then by carefully carrying out fuel draining checks after each refuelling operation. But it is now obvious that there were two weaknesses in his refuelling procedure — the old marine bilge pump itself, the rubber components of which deteriorated under the effect of the aircraft fuel, and the inadequate method of filtering the fuel. The accident would not have happened if the pilot had employed an effective filtering system and a pump designed for handling petroleum products.

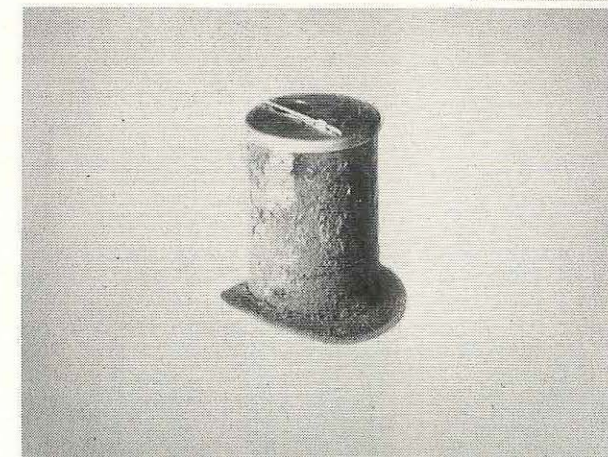
side surface was covered with a layer of rust. Particles of rubber and rust could be loosened by flexing the hose. Laboratory examination of the material accumulated on the fuel filter gauze identified it as having come from the pump valve and hose.

(Left): The aircraft's fuel filter after being removed from the filter bowl. Note the matted material completely covering the metal gauze.

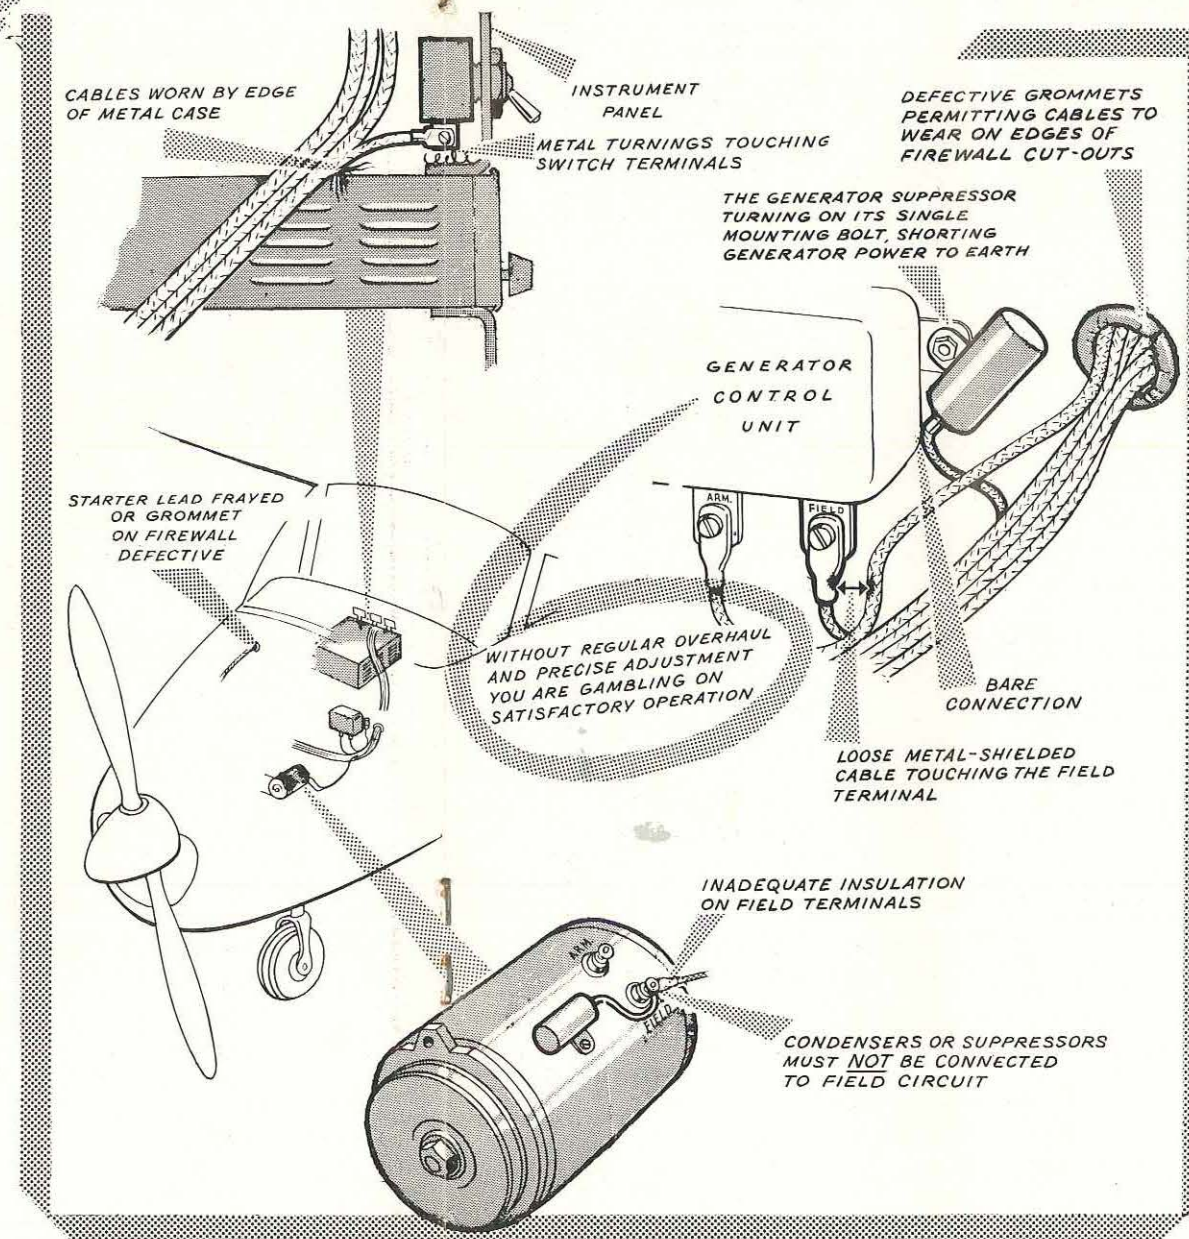
In the drawing we have shown some of the faults which in the past have been responsible for generator failures in flight. These, of course, are only a few of the possible causes, but they may provide food for thought on "where to look" and "what to look for" next time an inspection is due.

**CHECK
YOUR AIRCRAFT
REGULARLY
FOR
FAULTS
SUCH AS
THESE**

Generator system servicing instructions provided by the manufacturers are normally adequate to achieve satisfactory reliability. Details given, usually include such things as brush length, lubrication, commutator condition, belt tension and so on. But such checks obviously cannot cover EVERY aspect that may lead to a generator failure. In carrying out routine servicing therefore, every effort should be made to watch the general condition of the various components used in the generating system.

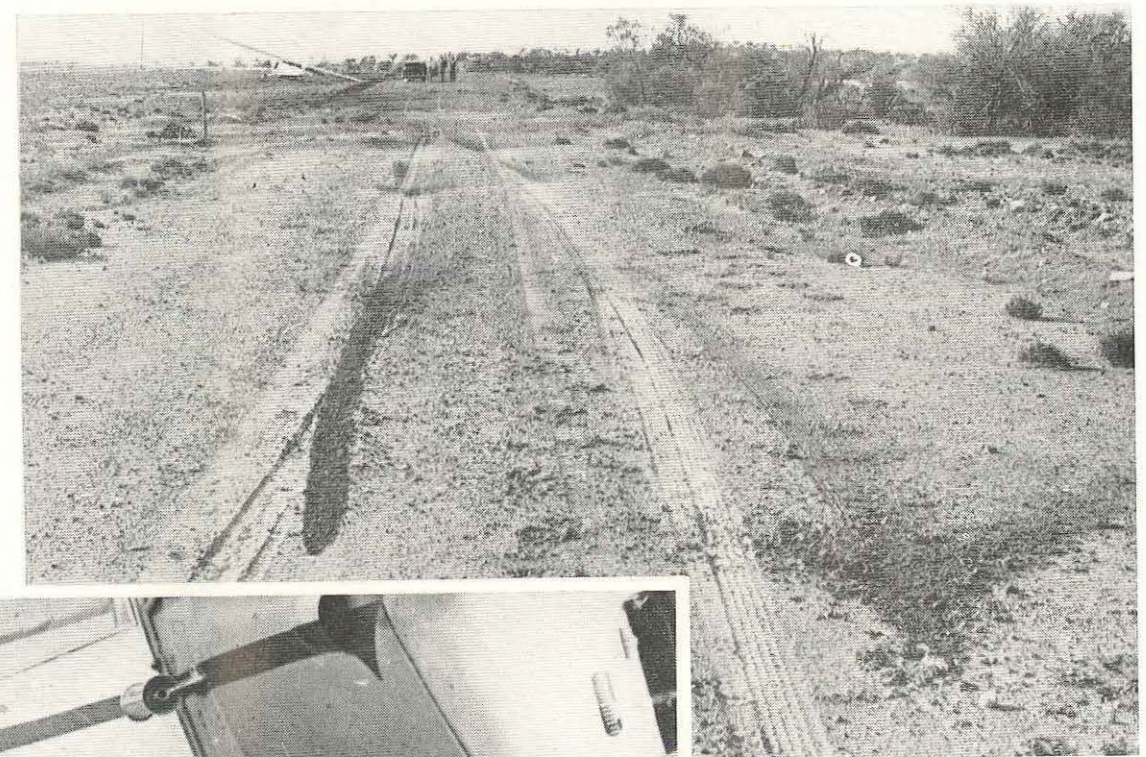
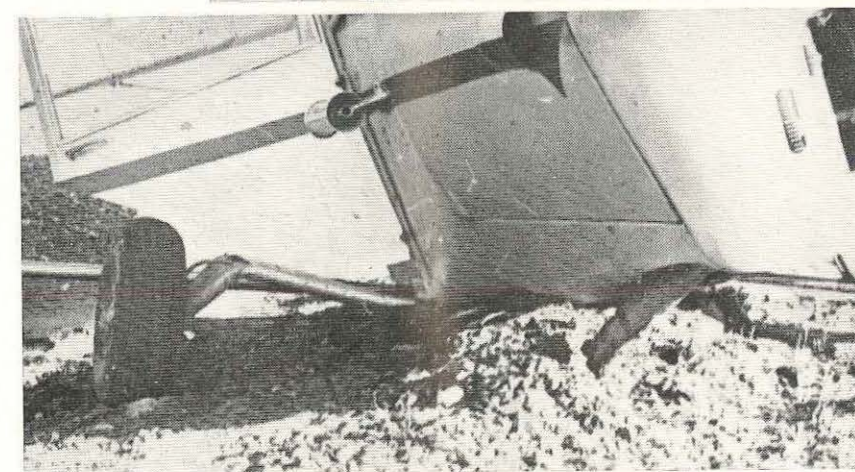
Landing path of the Auster, with initial touchdown marks in the foreground.

Inset: The collapsed undercarriage.

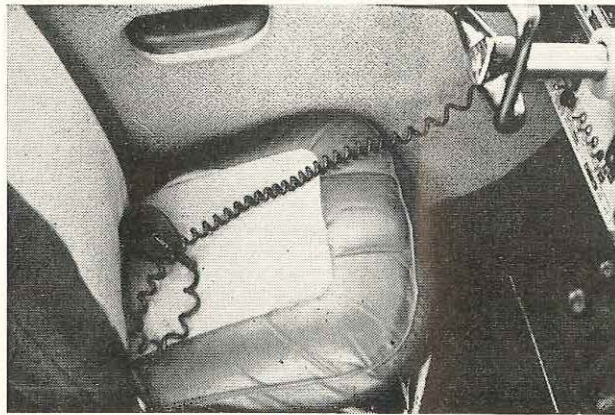
When the incident was discussed with the pilot on his return to Sydney, he explained that he had experienced transmitter troubles throughout the whole flight. He had heard the calls from ground stations but had been unable to contact them on either HF or VHF. He had made the return flight to Sydney NOSAR to avoid a repetition of the incident. The pilot said he believed the fault lay in the aircraft's microphone and pointed out that it was in

a "knocked around" condition. It did not fit the stowage bracket in the aircraft and would repeatedly fall to the floor of the cockpit. It was obvious that this had been going on for some time and the microphone had eventually succumbed to such treatment.
