AVIATION SAFETY DIGEST

Department of Civil
Aviation . . Australia

No. 47

SEPTEMBER, 1966

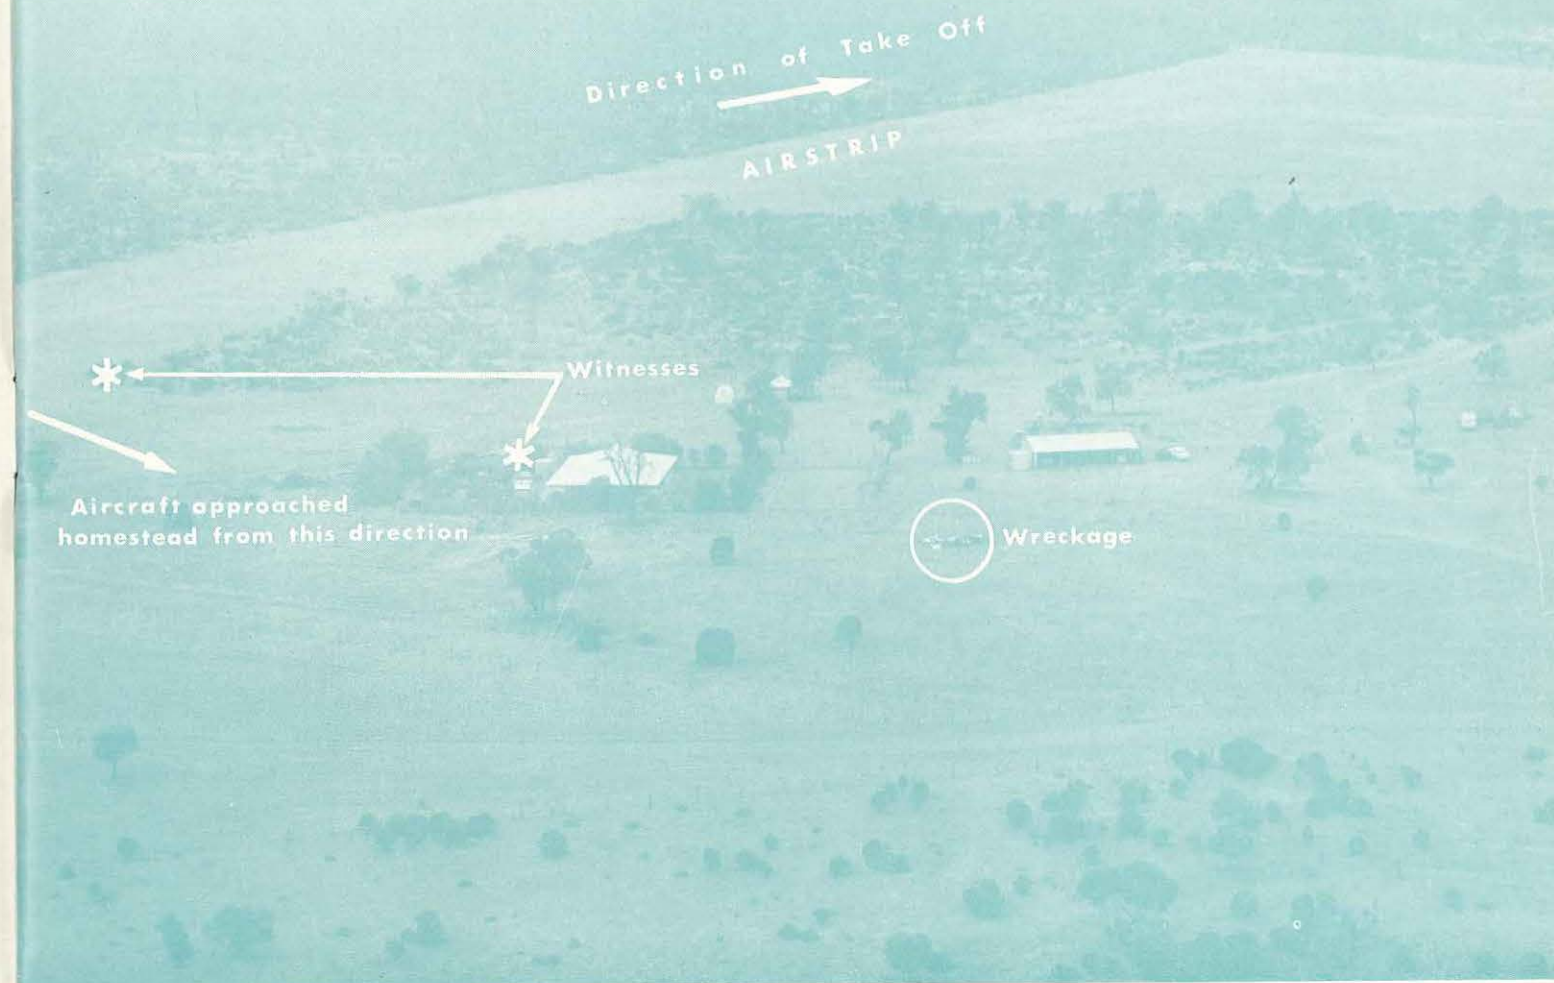
Investigation of the burnt-out wreckage confirmed that the aircraft had struck the ground while still in a steep nose-down attitude and while banked steeply to the left.

The port wing tip had struck the ground first, followed almost at once by the nose of the aircraft, and the ground marks and wreckage distribution indicated that there had been no forward motion of the aircraft after the initial impact. The centre section had been subjected to severe impact forces, which were followed by fire of such intensity that many components of the engine and the fuel tank and cockpit areas, had fused into a mass of molten metal. Both mainplanes, with the fuel tank areas burnt out, were found in their normal position in relation to the fuselage. The flaps were found extended between 10 and 20 degrees. The fuselage behind the luggage compartment had folded to the left but was otherwise generally intact. The engine tachometer and the pilot's wrist watch were found in the burnt out cockpit area. The tachometer was jammed at 2500 r.p.m. and the watch had stopped at 1804 hours. No other readable instruments were found. The only aircraft components found away from the main wreckage were the lower section of the starboard door, found to the rear of the starboard wing tip and small fragments of perspex in and around the scorched area in front of the aircraft.

The steep angle of the final dive and the lack of forward movement of the wreckage after the initial impact, indicated that the aircraft was out of control, and probably in a stalled condition. The wreckage examination did not reveal any defect which might have contributed to this loss of control. No significant variation in the engine noise was noted during the latter stages of the flight and the jammed and burnt out tachometer found in the wreckage was indicating in the normal engine operating range. Although the propeller had been subjected to intense heat after the impact result-

ing in further distortion of the blades, there was still evidence of impact damage suggesting that considerable power was being delivered by the engine when the aircraft struck the ground.

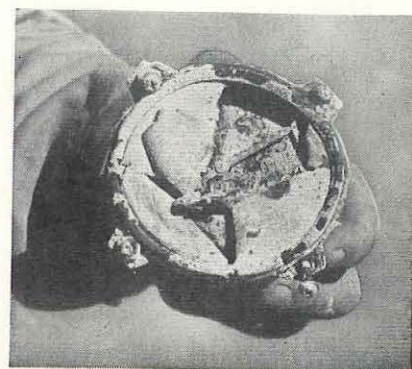
The engine tachometer as recovered from the wreckage. The needle is jammed in the 2,500 r.p.m. position.

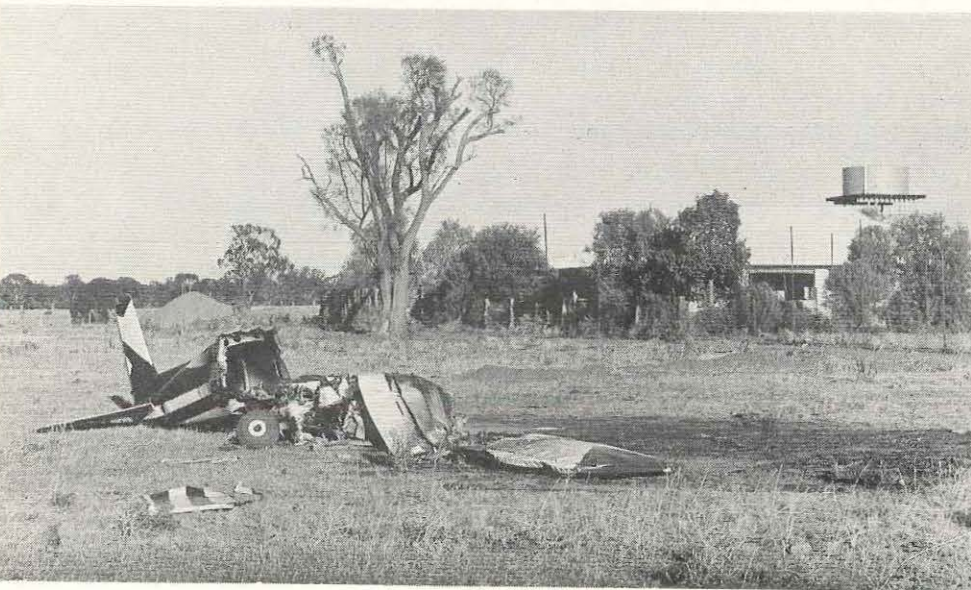
Subsequent examination of the burnt-out wreckage at the scene of the crash did not reveal any defect or malfunction which might have contributed to the accident. The aircraft had struck the ground while rotating to the left in a steep nose-down attitude, the initial impact being taken by the port wing. After the main impact, taken on the nose, the aircraft had bounced and slid for 30 feet and come to rest upside down.

The burnt out wreckage of the aircraft. The homestead around which the aircraft was turning is in the background.

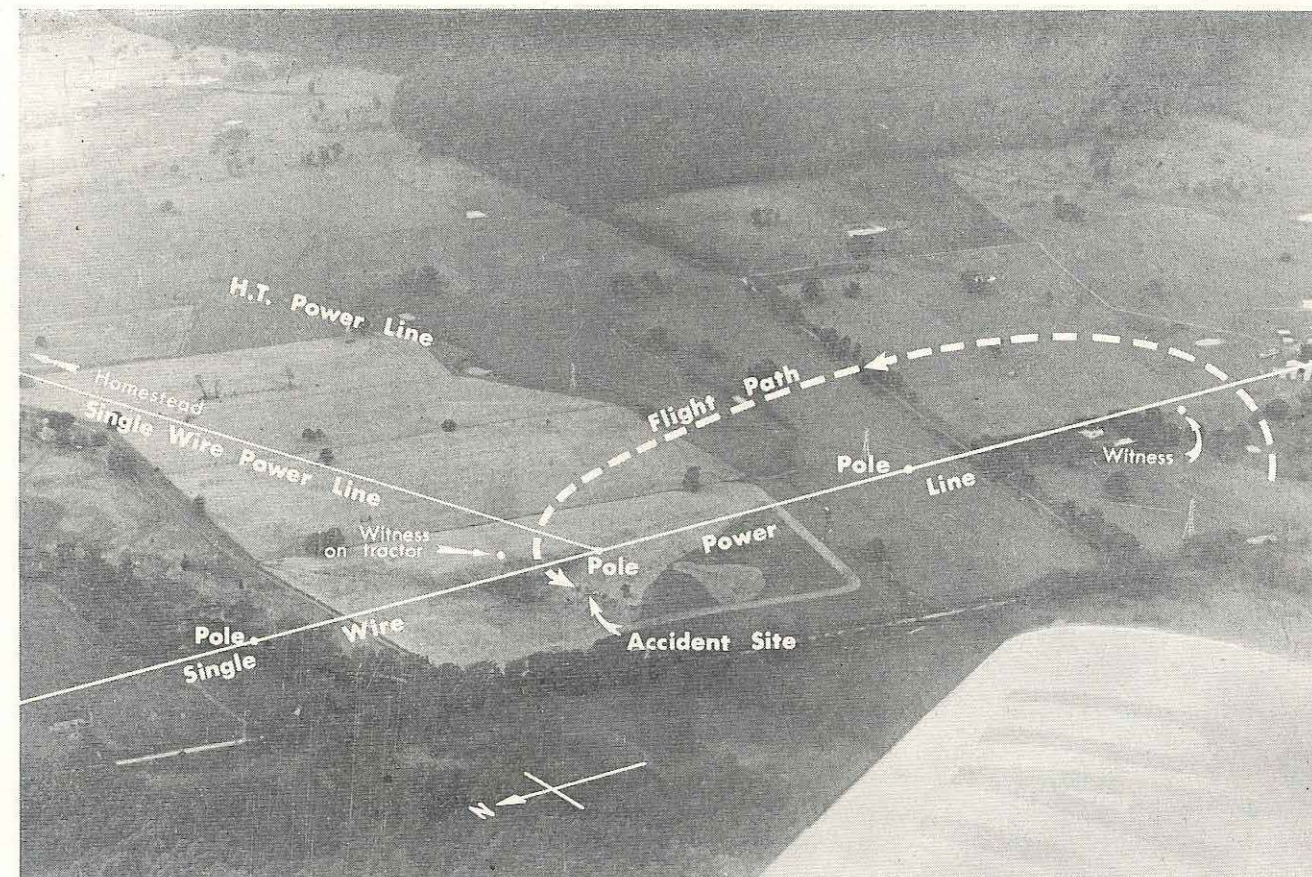
Aerial view of accident site showing approximate final flight path.

The evidence given by the manager of the adjoining property, describing the last minute of the fatal flight, is consistent with the pilot throttling back the engine and diving towards the tractor driven by the son, wagging his wings as he did so to attract attention. Whether the collision with the power line resulted from an error of judgment or was the result of the pilot forgetting and fail-

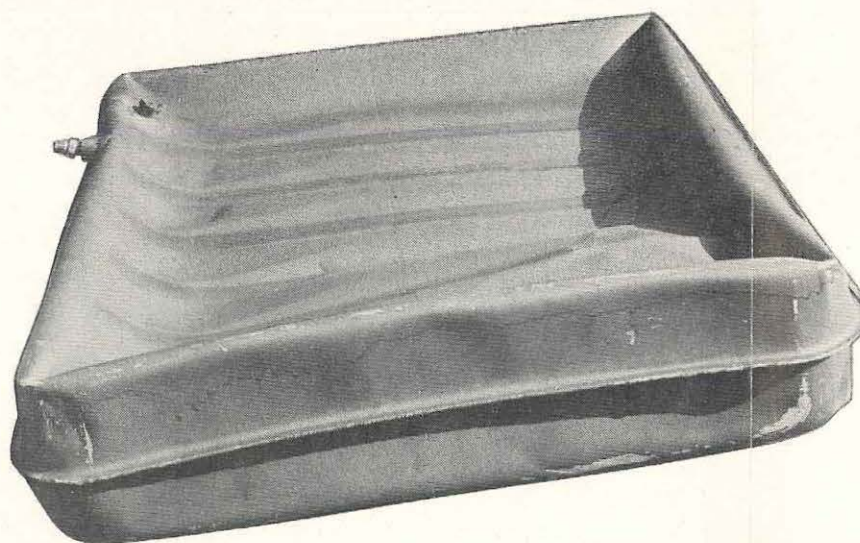
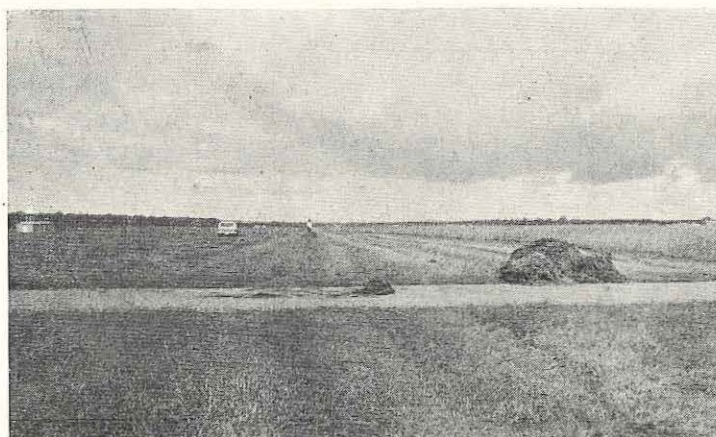
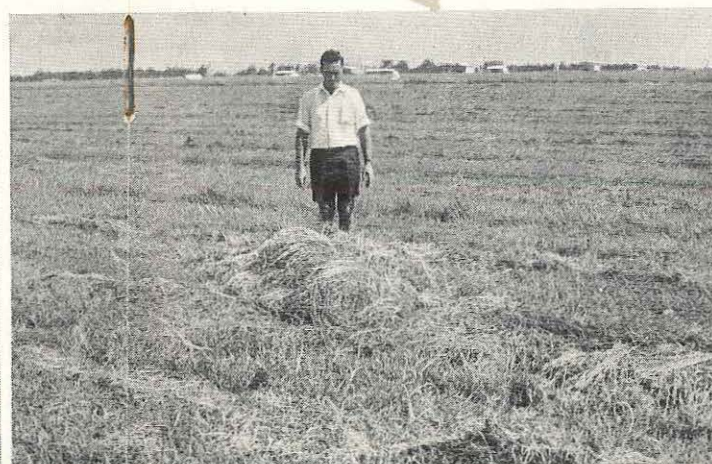
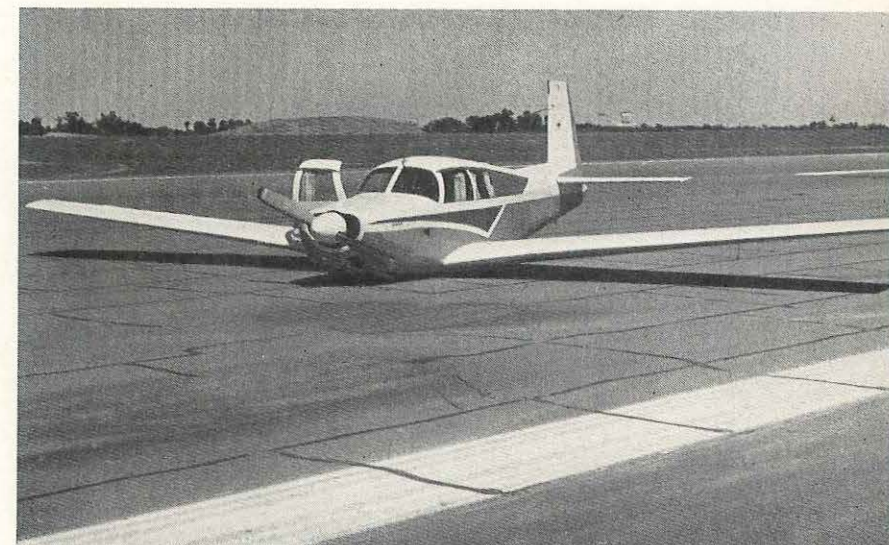
COLLAPSED FUEL TANK (Right) This was what a L.A.M.E. found when he inspected a Cessna 337 at Port Moresby after the pilot had reported that the fuel gauge was inaccurate. Wasps were the culprit. They had built a mud nest in the air vent line, and as fuel was drawn from the tank, atmospheric pressure compressed the walls of the tank, substantially reducing its capacity.

UNUSUAL OBSTRUCTION (Below and Right) The mown grass shown in these airport pictures was responsible for delaying a Britannia for two hours. The aircraft was taxi-ing to the terminal when mown grass at the edge of the taxiway was caught in the slip-stream and ingested into the engine where it obstructed the engine air intakes. The presence of the grass in the engine was not detected until the aircraft was preparing to take-off.

It is probably not generally realised that mown grass can pose an ingestion hazard to all turbine powered aircraft and to turbo-props in particular. This is especially so when large aircraft are using narrow taxiways and grass at the sides is freshly mown. Mown grass can also pose a problem with helicopters if it is whipped up by the rotor wash and drawn into air intakes.

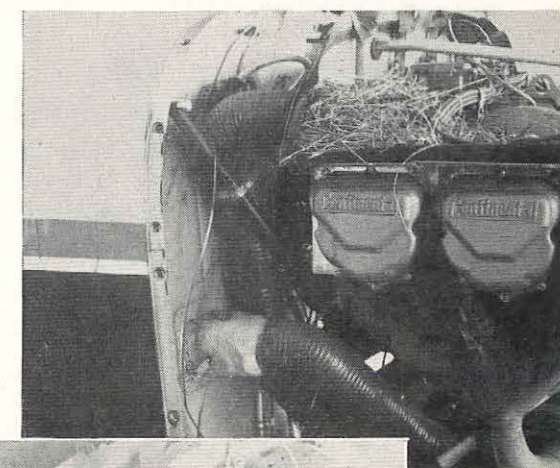
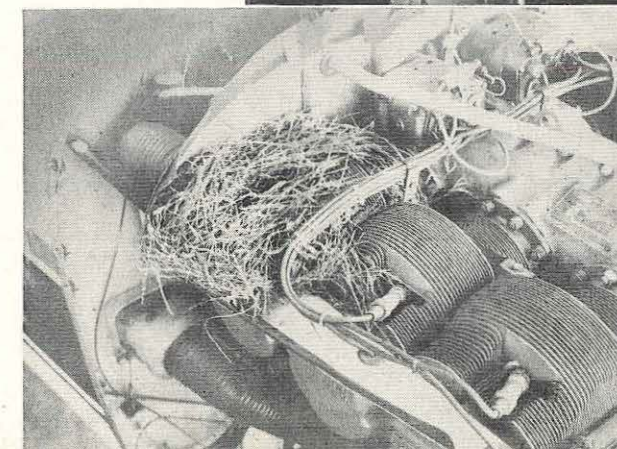
BIRDS AMONGST THE BARRELS (Below and Right) And making themselves at home too! This is but one of several instances of birds trying to nest inside the cowlings of aircraft left in the open, in some cases for only a few hours! On one occasion, the nest had been built in the air intake hose leading to the exhaust muffler shroud, and it caught fire when the engine was shut down after a cross-country flight. The fire was quickly doused with a CO2 extinguisher. The pilot had made a complete pre-flight inspection before taking off and had not seen any obstruction in the air intake. The nest had evidently been built well down the air intake hose and out of sight.

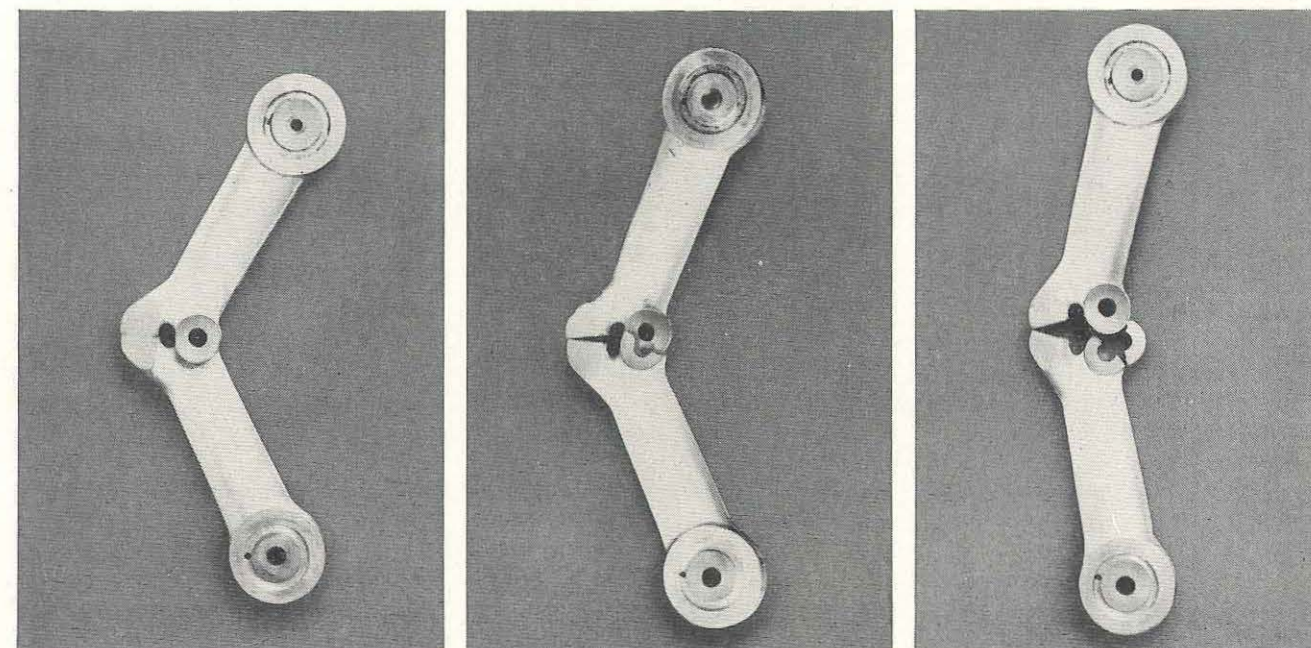
Torque links as fitted to some types of light aircraft oleo legs. The sequence shows how the links can be fractured in over-extension, as is likely to occur if the return stroke of the oleo leg piston is not adequately dampened. The torque links are fully extended in the photograph at left. Fracture of one of the links is inevitable as they are forced beyond this fully extended position.
