# AVIATION SAFETY DIGEST

DEPARTMENT OF CIVIL AVIATION

No. 48

DECEMBER, 1966

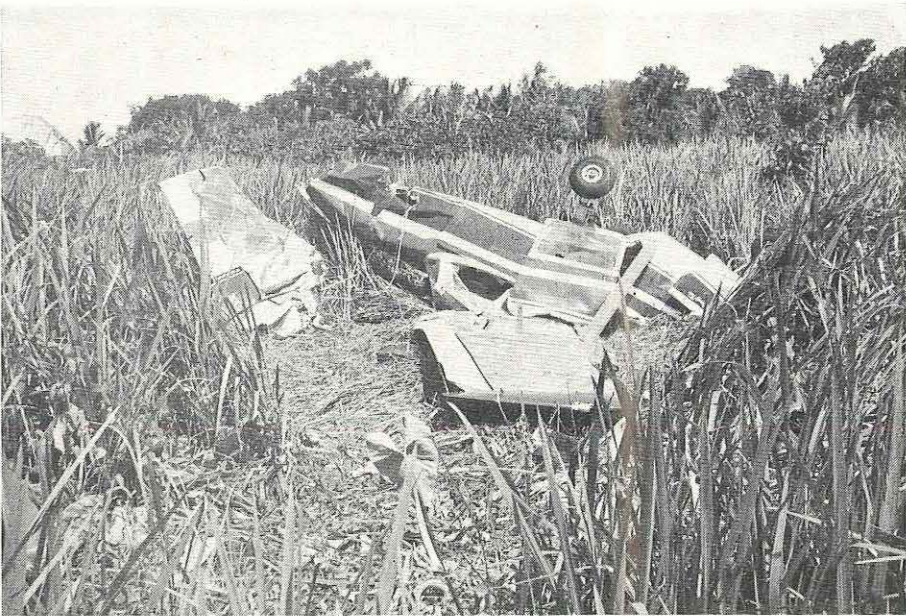
The wreckage lying where it fell in kunai grass. The tail assembly is separated from the fuselage and held only by the control cables.

Examination of the aircraft wreckage indicated that the rear section of the fuselage had failed in flight. It is probable that the failure was initiated by the impact of the parachutist against the tailplane. There was no evidence of any malfunction in the aircraft which might have contributed to the accident. The engine was not running when the aircraft struck the ground, but as the parachute canopy and rigging lines were entangled around the propeller, it was considered that the engine would have stalled under the load imposed upon it.

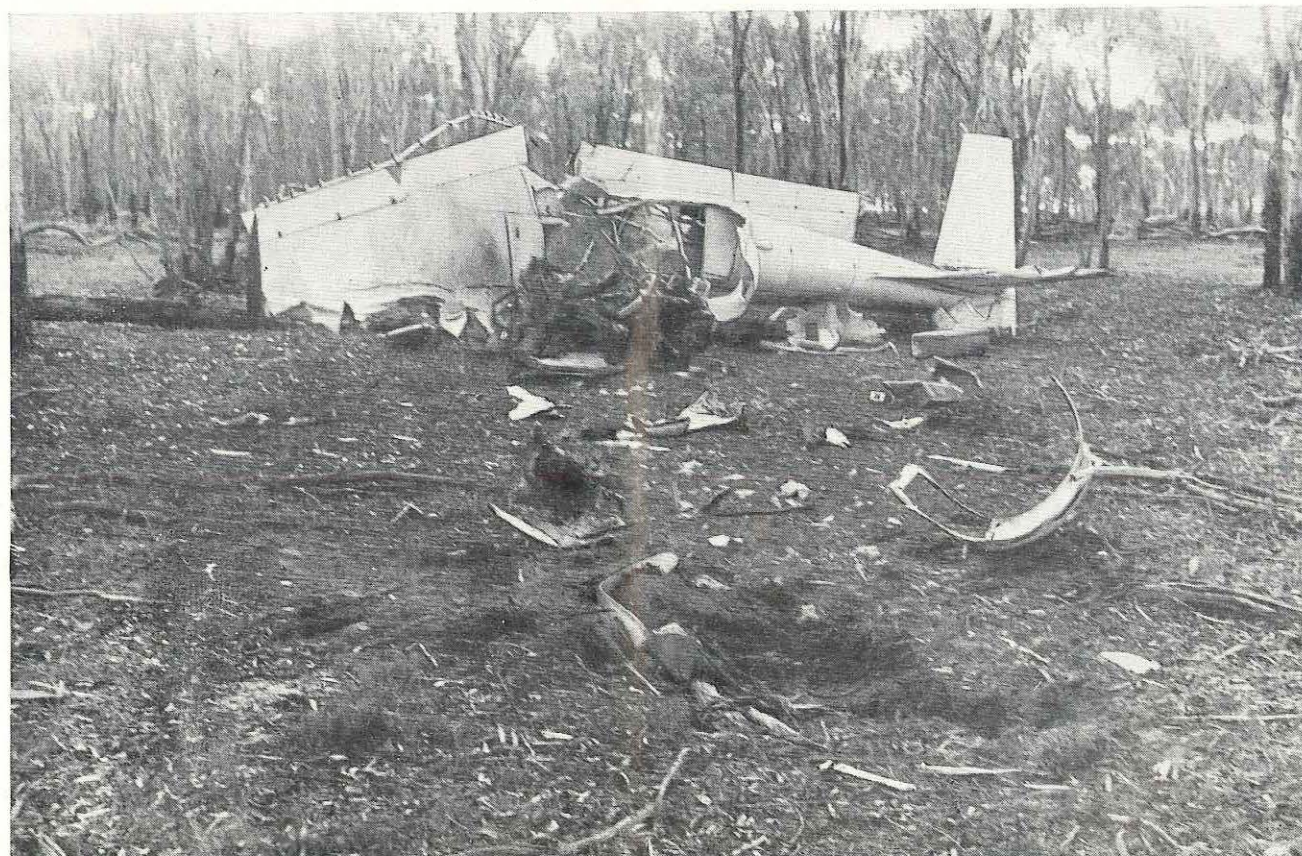
*The wreckage as it came to rest amongst the trees. The propeller lies half-buried at the point of initial impact with the ground.*

Examination of the wreckage disclosed no evidence of any pre-impact structural or control system failure, or that any engine malfunction had occurred. Branches of trees cut by the propeller, and damage to the propeller itself indicated that the engine was delivering substantial power at impact. The aircraft was

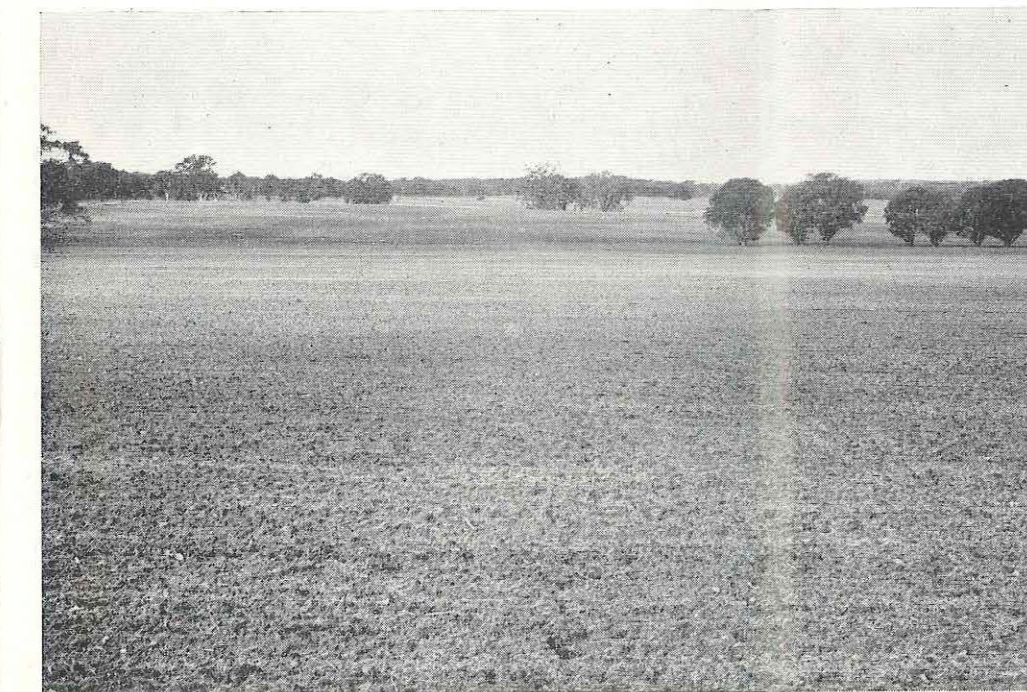
*Left: View back along path flown by aircraft on its final run, as seen from western boundary of paddock.*

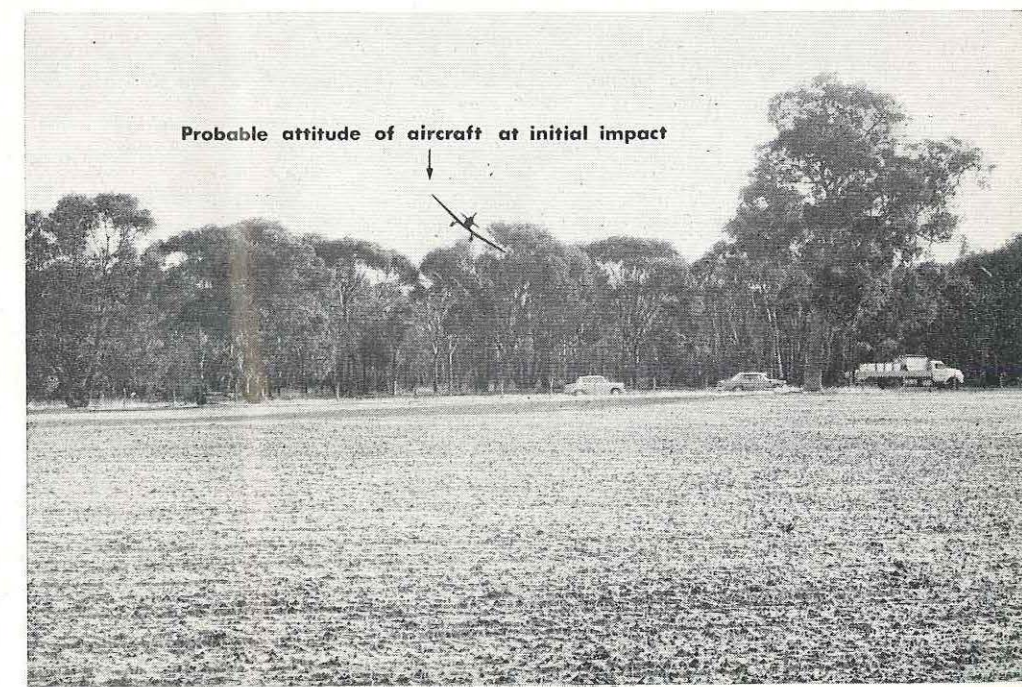
*Below: View from paddock showing trees over which the pilot had attempted to climb, and point of first impact.*

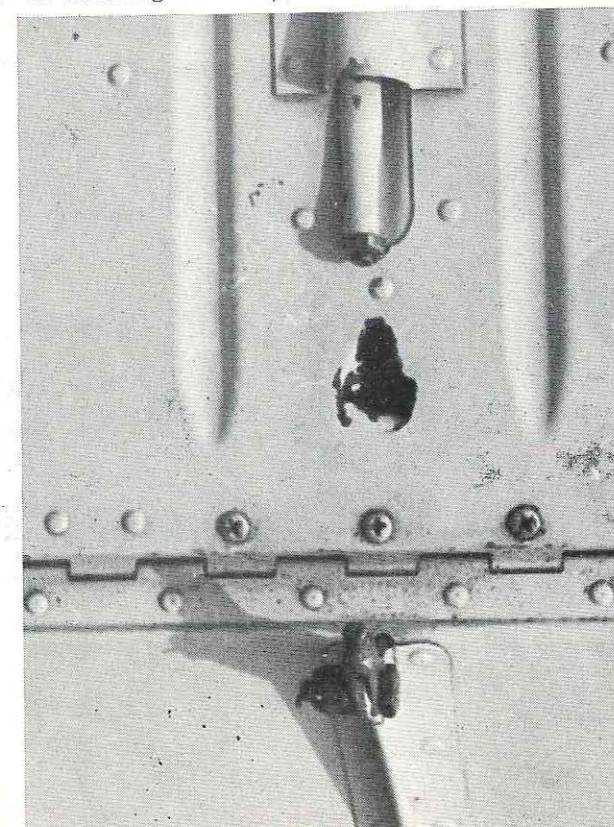
- (1) **BEECH BARON**—"Inspection showed that the pivot bolt had seized in the trim tab horn bush. The bolt's retaining nut had previously been too firmly tightened down on the assembly. These conditions had caused a bending load to be imposed on the elevator trim tab actuating rod each time the tab was moved up or down from the neutral position. Over a period of time the load reversals had caused fatigue failure through the threaded section of the adjustable end of the rod."

*This photograph shows a broken elevator tab actuating rod on a Beech Baron. Flapping of the tab after the rod failed, forced the broken end through the skin of the elevator. The failure occurred soon after the aircraft had taken off and induced severe buffeting. The pilot experienced difficulty in controlling the aircraft while he returned to land.*

The fork pivots on a bolt carried in the trim tab horn bush, and the assembly is secured by a castellated nut and split pin. During assembly, the pivot bolt had been clamped tightly on to the fork and horn. This was evident from the shape of the fork and the amount of galling on the sides of the horn. Because the pivot bolt is a clearance fit in both the horn and the fork end, it should have been obvious that, for the fork

to remain free to pivot, the retaining nut must be tightened only sufficiently to be firm against the fork, without causing distortion. By using a little grease on the bolt during assembly and at subsequent inspections, the corrosion that had occurred could also have been considerably reduced.

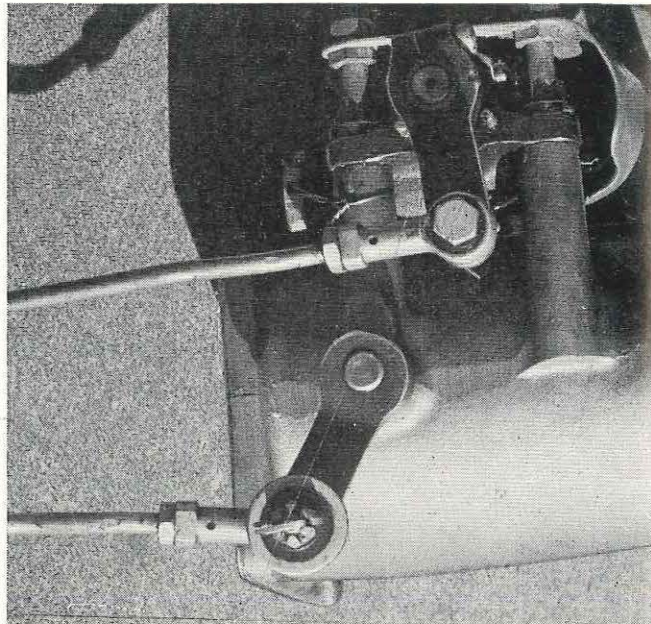
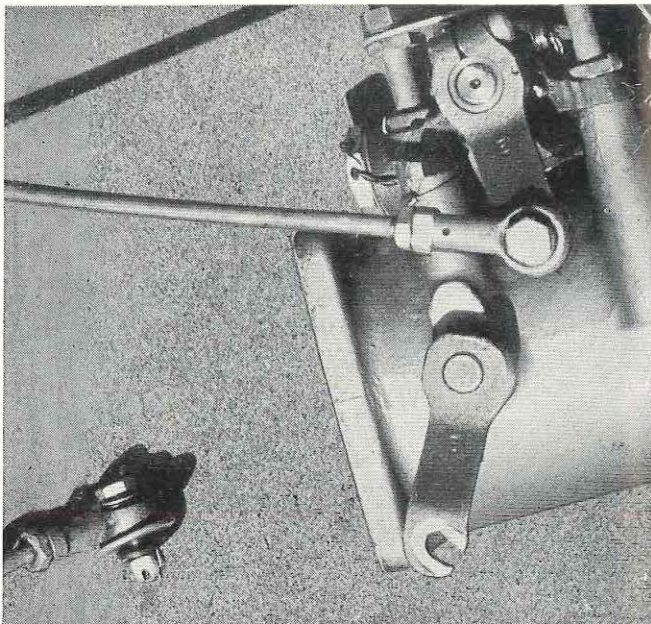
- (2) **CESSNA 185**—"Examination of the wreckage showed that the throttle control rod had separated from the throttle as a result of wear at the bolt hole in the throttle arm connection. This was caused by inadequate tightening of the bolt's retaining nut."

The throttle control failure illustrated in these two pictures was responsible for a Cessna 185 making a forced landing in timbered country. The aircraft was very severely damaged.

**CASE 2**— The assembly that failed on the Cessna 185, consists of a solid arm attached to the throttle butterfly spindle, and a self-aligning ball race, on the end of the throttle control rod, held together with a bolt and a split-pinned castellated nut. All relative movement between the arm and the rod is taken up by the ball race, and the bolt's only function is to secure the two components together. If the bolt is not tightened properly it will tend to rock back and forth until it becomes loose in the arm, and once this point is reached, the chatter caused by vibration will cause accelerated wear until the hole in arm is elongated to the point of failure. Another fault often found in these assemblies is that the threaded portion of the bolt, instead of the shank, is used as the bearing surface in the arm. This is incorrect and should be avoided whenever possible. Good maintenance consists of checking the bolt for tightness by placing a spanner on the BOLT HEAD and testing to see whether or not the bolt can be rotated. If it can, then obviously the nut needs adjustment. This looseness will become apparent a long time before the damage reaches failure point. Such a check had obviously not been made during recent maintenance of the engine.

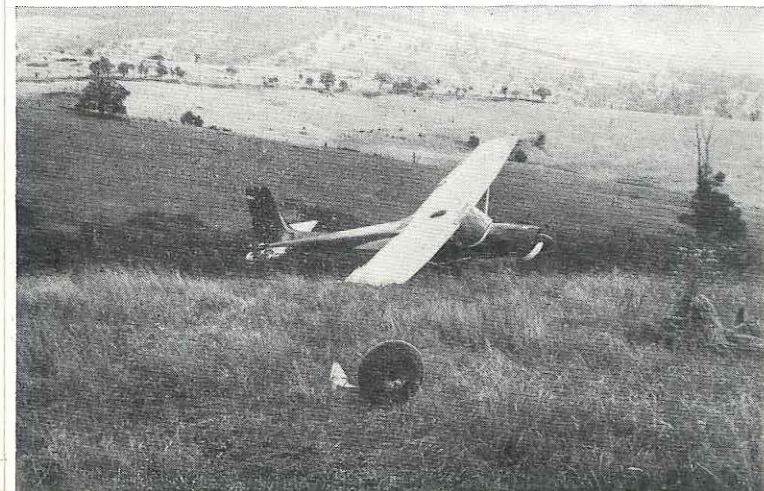
- (3) **CESSNA 180**—"Investigation disclosed that the rudder cable clevis pin had pulled free of the attachment hole in the starboard rudder bellcrank. Elongation of the holes as a result of wear had progressed to the extent that the metal remaining between the hole and the outer edge of the bellcrank provided insufficient strength to withstand normal operational loads. Inspection of the port control attachment showed that

the clevis pin hole in the port bellcrank had worn to twice its original diameter. A similar failure would certainly have occurred at this point within the next few hours of operation."

Because the rudder controls failed during take-off this Cessna 180 ran off an agricultural strip, ground-looped and was badly damaged.

Below right: The cause of the loss of control. The clevis pin hole in the rudder bell-crank on the starboard side, had become elongated to the point of failure.

Below left: The rubber bell-crank on the port side, though still intact, was also found to be badly worn.

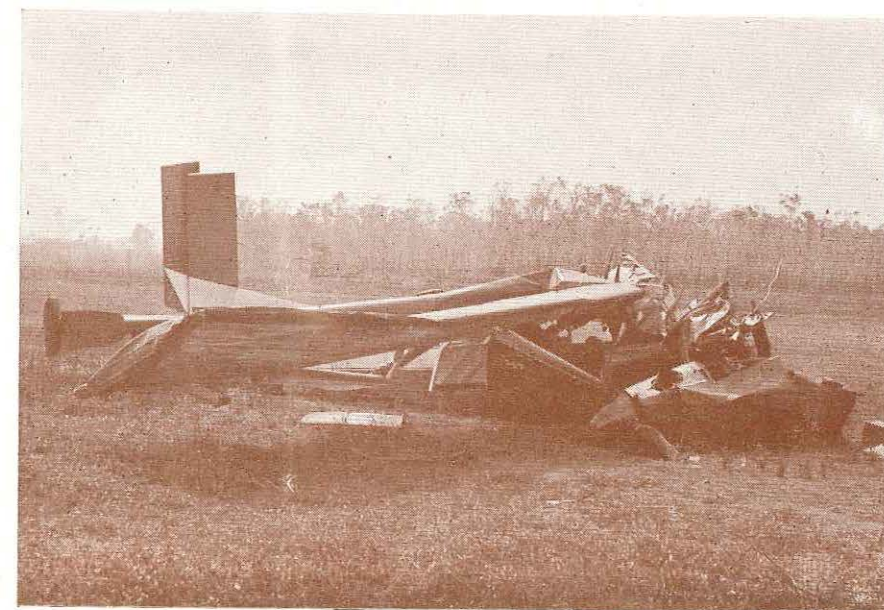
Examination of the wreckage showed that the flaps were in the retracted position and that the tailplane trim was set four degrees nose-up. The engine had been running when the aircraft struck the ground and there was nothing to suggest that any malfunction or failure in the engine or airframe had contributed to the accident. The loaded weight of the aircraft was well within the maximum permissible figure and the centre of gravity was within the specified loading envelope, though well towards the aft limit.

*General view of wreckage from the starboard side. The engine has been torn bodily from the fuselage.*

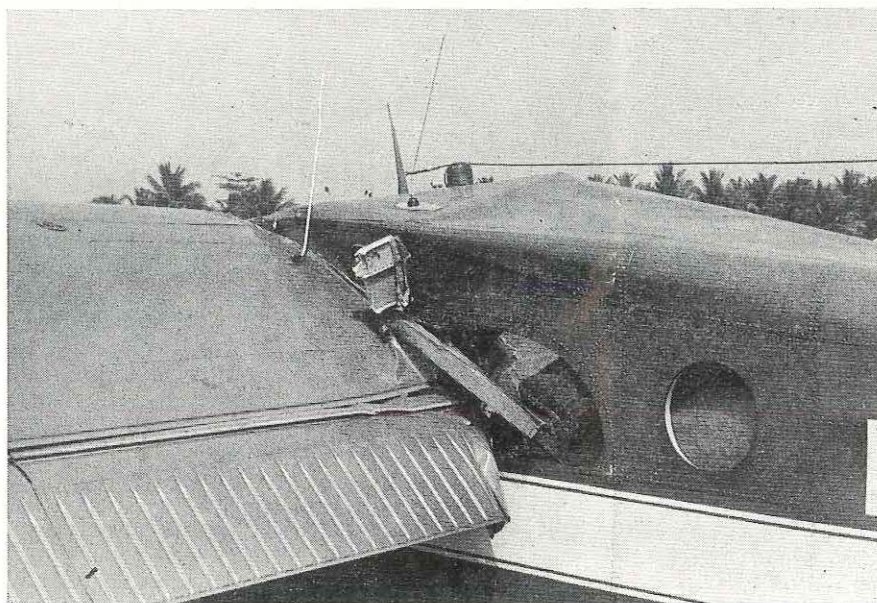
*The port wing almost severed from the fuselage. Note the extensive fuselage buckling of the top of the cabin.*

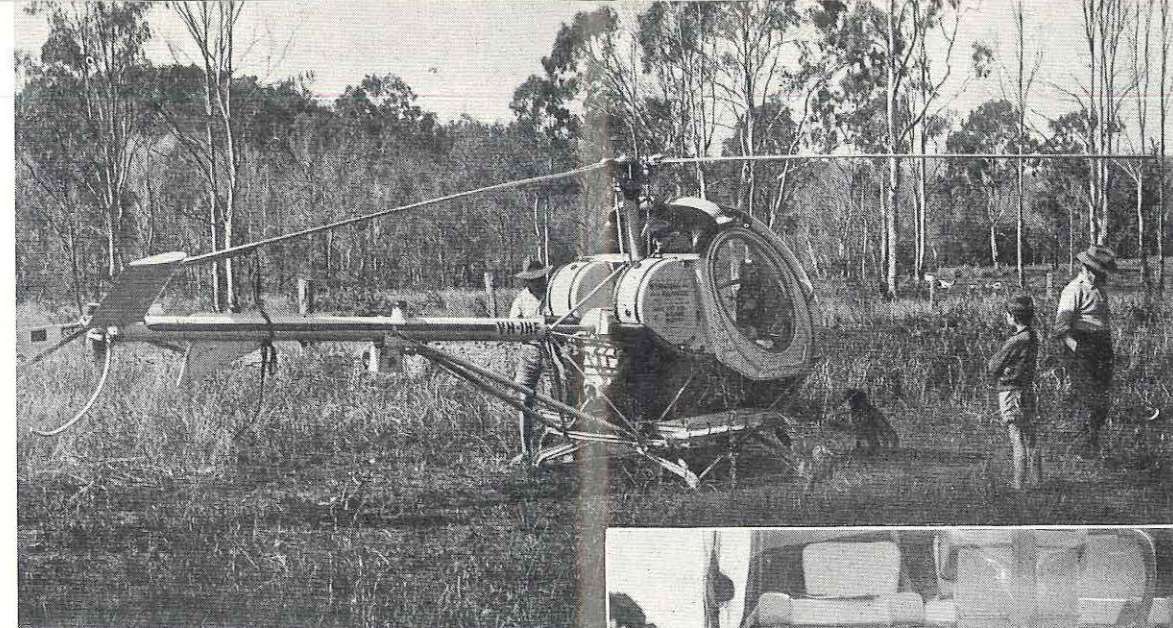
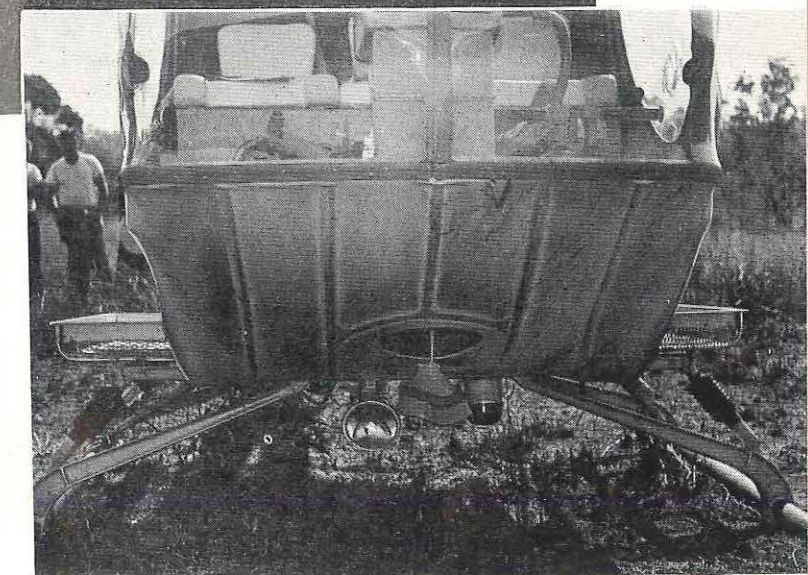
These photographs show what happened to two helicopters when they landed in dry grass in the Northern Territory and in Queensland. In both instances the engine exhausts set fire to the surrounding grass. In the case of the Hughes (above and inset) the pilot climbed out to find the grass on fire beneath his aircraft. He immediately scrambled back into the cockpit to fly the helicopter to safety, but although he was unable to start the engine, probably because of the heat generated, the fire burnt itself out without spreading to the aircraft's fuel system. Damage was confined to the cockpit bubble, engine wiring and other plastic components such as the air cleaner and the engine fan shroud.

The pilot of the Bell (below) wasn't so fortunate. After landing in a clearing in the course of a gravity survey flight, the engine stopped before the pilot had time to shut it down. He climbed out to investigate and found that the long grass under the engine area was burning and had set the aircraft on fire behind the fire wall. Almost immediately afterwards, and before he could take any preventative action, flames engulfed the aircraft and it was completely burnt out.
