# AVIATION SAFETY DIGEST

Department of Civil  
Aviation . . Australia

No. 49

MARCH, 1967

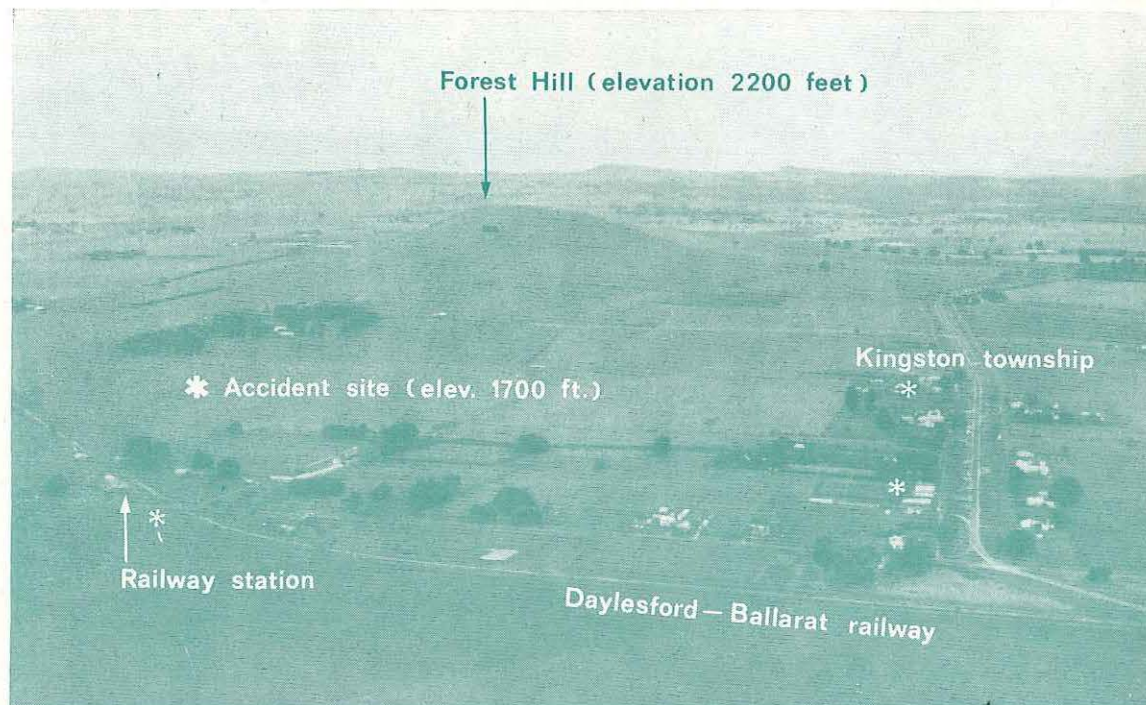
Aerial view of township of Kingston, looking south, showing positions of witnesses (\*) and accident site

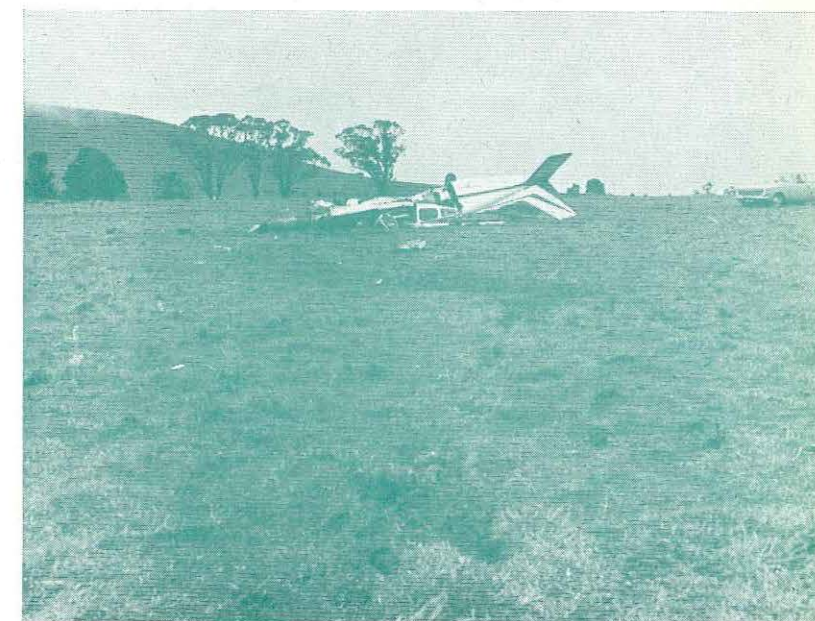
and propeller. The occupants had been hurled from the cabin and the aircraft had come to rest on its back with the fuselage grossly distorted and completely broken in two places. The port fuel tank had burst open when the wing had broken off, spilling the contents on to the ground, but the aircraft did not catch fire. The starboard fuel tank was undamaged and still full of fuel. The flying control cables were still connected to their respective surfaces and there was no evidence that the flying controls were anything but serviceable up to the moment of impact. The magneto switches were both on and the fuel selector was positioned to the port tank. The flaps were in the up position. The propeller, which was badly distorted from striking the ground under power, had snapped off from the crankshaft, complete with its mounting flange. This condition had clearly been brought about by a sudden, violent stoppage of the engine, from high RPM. Spark plugs taken from the engine showed that it had been operating satisfactorily before the crash.

The impact marks in the foreground give some indication of the force with which the aircraft flew into the ground.

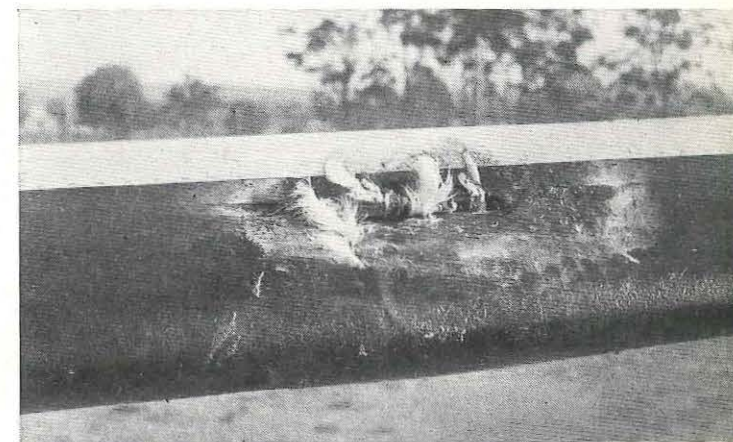
Inspection of the wing showed that the bird had struck the leading edge of the wing, fracturing the de-icer boot, and opening up a six inch tear in the upper surface of the leading edge. The bird had then been forced through the hole into the leading edge section of the wing until it came to rest against the main spar. The spar was not damaged. (see photograph)

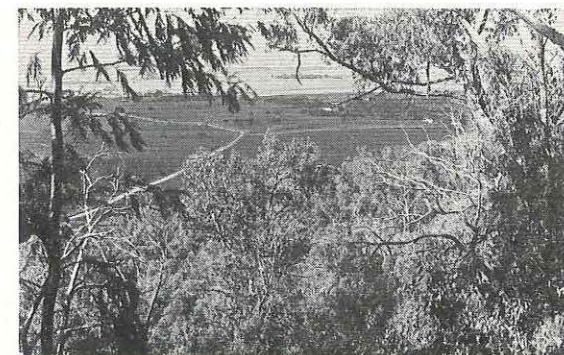
This view, from the accident site back in the direction of flight, gives some idea of the height and steepness of the ridge over which the pilot attempted to climb. The paddock into which the pilot approached is in the centre of the picture, obscured by the line of trees in the foreground.

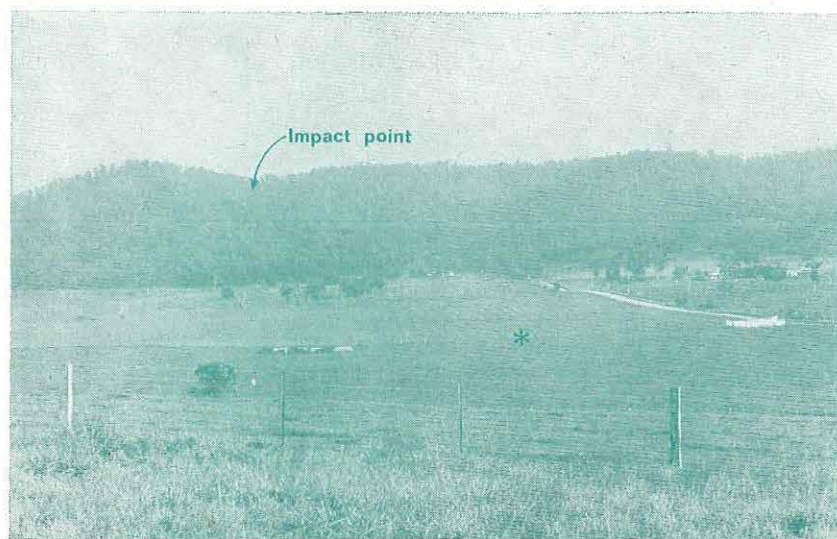
View of ridge from the point at which the pilot commenced to overshoot. Note the illusion created by the line of timber—the paddock adjoining the timbered slopes appears to be almost level, whereas in fact it has an upward slope of more than three degrees. Compare the impression of the height of the ridge in this picture with that in the one at the top of the page.

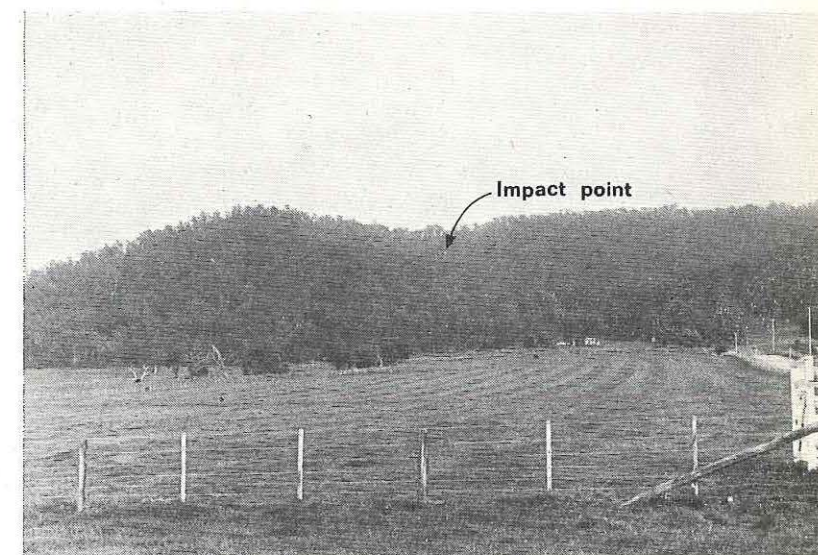
The paddock into which the student carried out his last practice forced landing approach, looking in the direction of flight. The asterisk indicates the position from which the pilot re-applied power to overshoot. The point of impact can be seen close to the top of the timbered ridge.

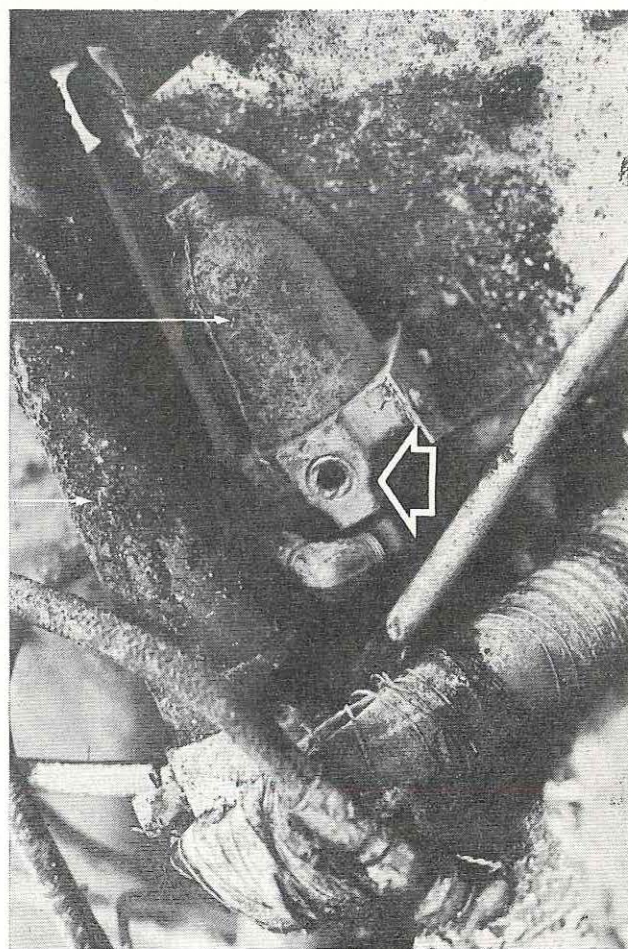
The probable source of the fire which consumed the aircraft—the fuel filter bowl in the engine compartment of the inverted wreckage. As the aircraft struck the ground nose-first, the nosewheel strut was evidently forced back against the fuel filter bowl, fracturing the fuel line elbow and allowing fuel to spill over the engine.

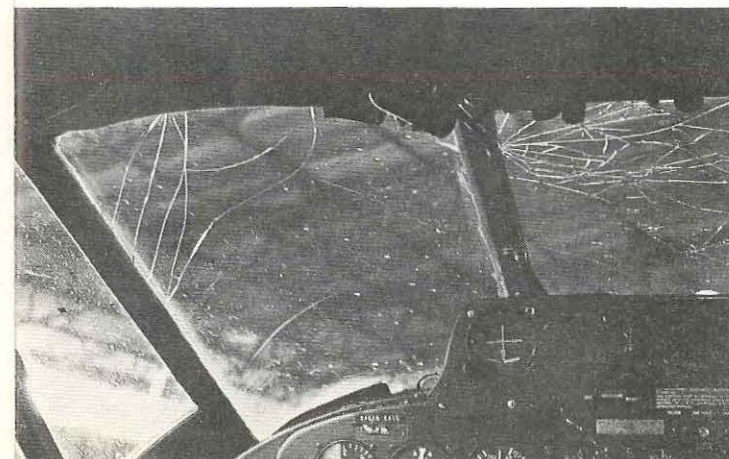
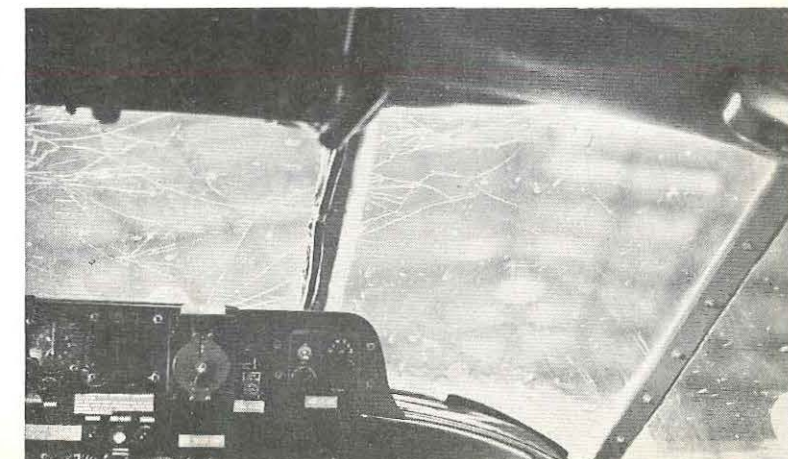
*The cracked windscreen panels as seen from inside the cockpit.*

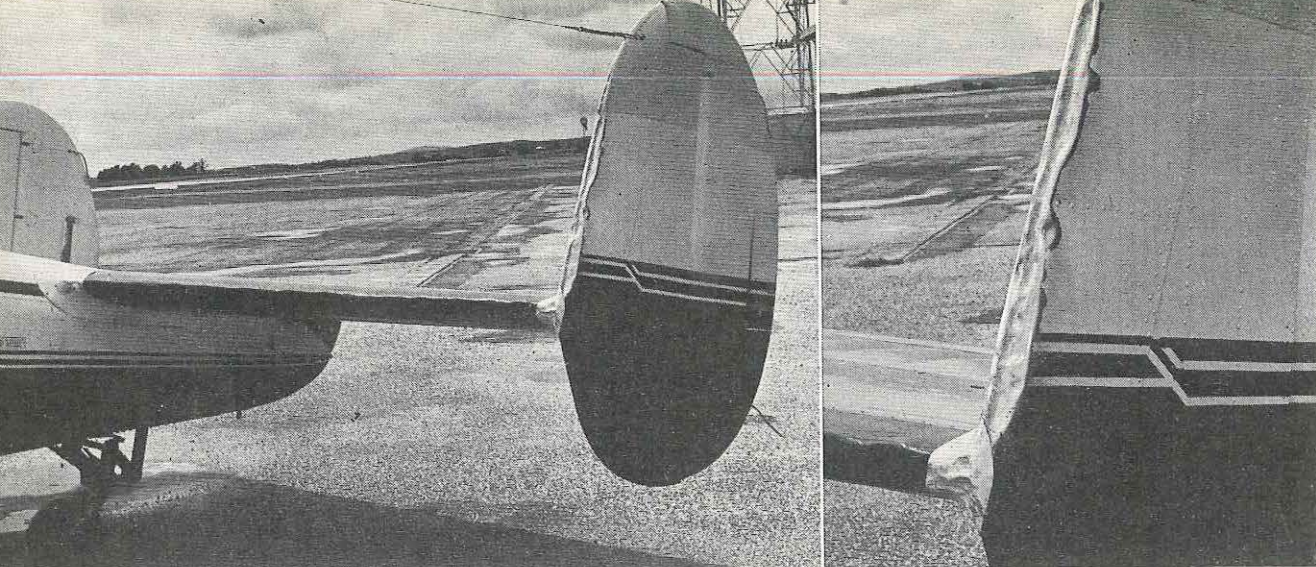
*The leading edges of the aircraft's twin fins were literally flattened by the impact of the hail.*

The aircraft had been considerably damaged by the hail. The nose dome was a mass of large indentations and there were smaller dents along the fuselage back as far as the rear cabin door. The rotating beacon was completely destroyed, all the windscreen panels had been broken and two of the panels of the cockpit's side windows were cracked. On the tail assembly, the entire leading edge of the tail plane was dented and the leading edges of the fins were literally flattened.

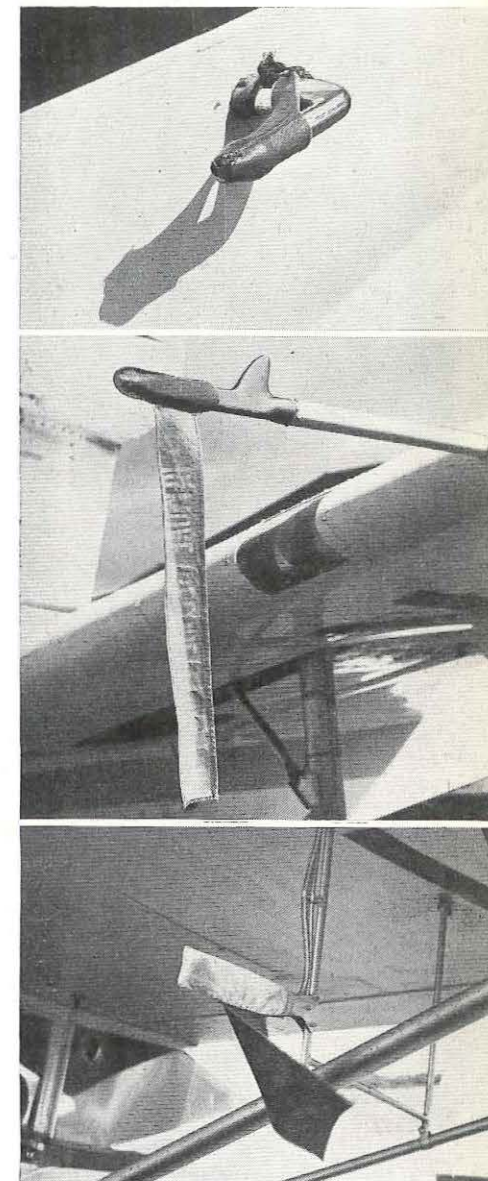
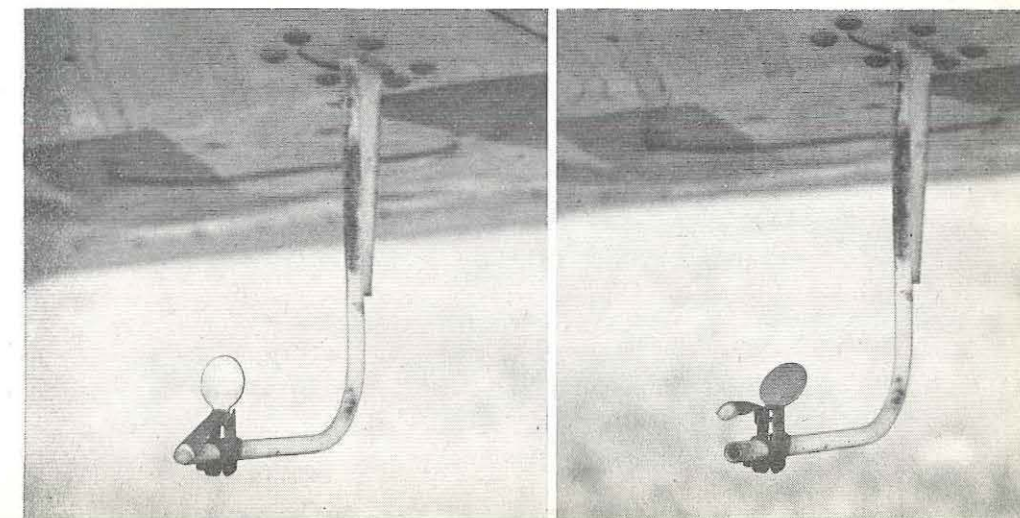
Automatically opening mechanical pitot cover as fitted to Mooney aircraft.  
Left: Cover closed.  
Right: Cover open as in flight.  
Note the flat plate exposed to the airflow, deflection of which lifts the cover off the front of the pitot tube.

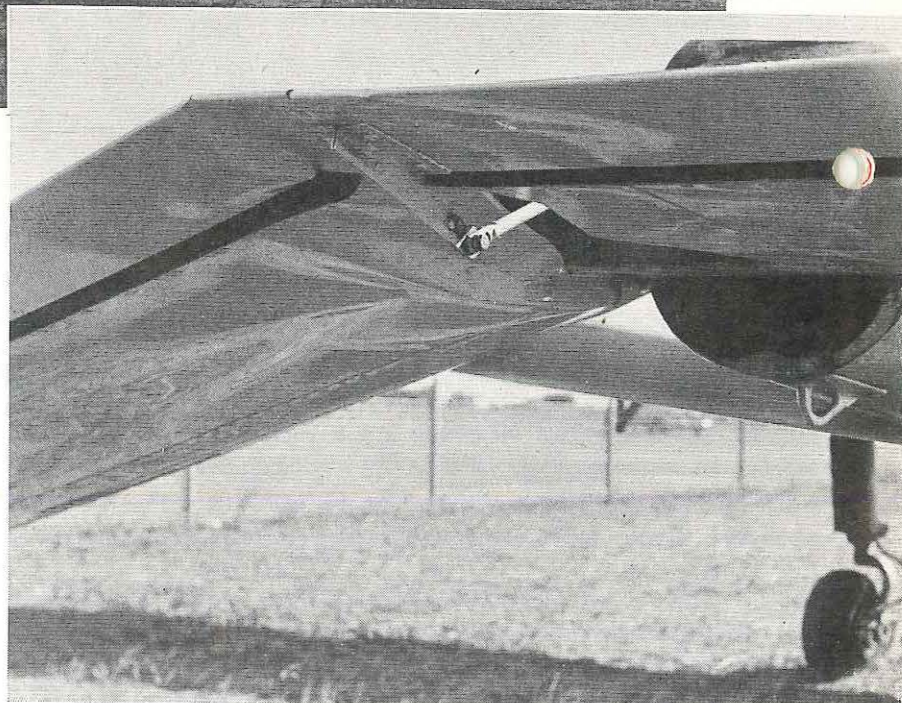
The pilot nursed the aircraft to the aerodrome, lined up with the runway and made an approach to land. As he tried to flare for landing, he found the elevator was jamming and he could not raise the nose to place the aircraft in a landing attitude. He opened the throttle, went round again and made another approach. This time, by judiciously manipulating the throttle, he managed a successful landing. After the pilot had taxied in and switched off, he climbed out of the aircraft and found that the port tailplane was bent downwards some 20 degrees.

load. The port tailplane had moved forward as it had bent downwards, forcing its inboard edge against the side of fuselage, thus restricting its movement as an elevator. In being bent downwards almost 20 degrees, the upper surface of the port tailplane was wrinkled and strained and the lower skin severely buckled and distorted. The upper and lower surfaces of the starboard tailplane, though not so obviously damaged, had also been wrinkled and buckled in a similar but less severe manner.

It requires no great technical knowledge to see that the tail surfaces of this aircraft came unbelievably close to failing completely. Obviously the high speed developed in the spiral dive, combined with heavy control forces which the pilot applied at a high rate, had imposed a load on the structure well beyond its design strength. The stall warning blowing during the recovery was of course indicative of a high speed stall.

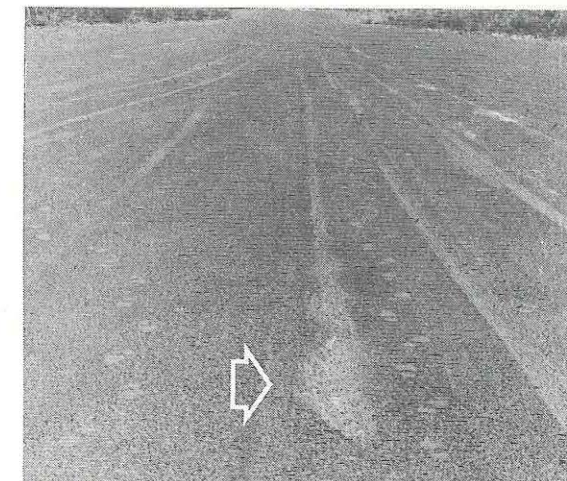
An examination of the aircraft's initial touchdown marks, and the track left by the wheels on the gravel surface of the strip, showed clearly that the port wheel was running erratically when the aircraft landed. Parts of the wheel's inner bearing were found on the ground near the aircraft. There was no trace anywhere on the airstrip of parts of the outer wheel bearing, and it was apparent that this bearing had failed while the aircraft was taking off from Warburton Mission. This was confirmed later when a search of the Warburton Mission airstrip found several bearing rollers and broken pieces of the outer bearing cage. Further examination of the aircraft, revealed that the port landing wheel had been out

*The track left by the port landing wheel as it touched down, clearly shows the erratic movement of the wheel on the axle.*

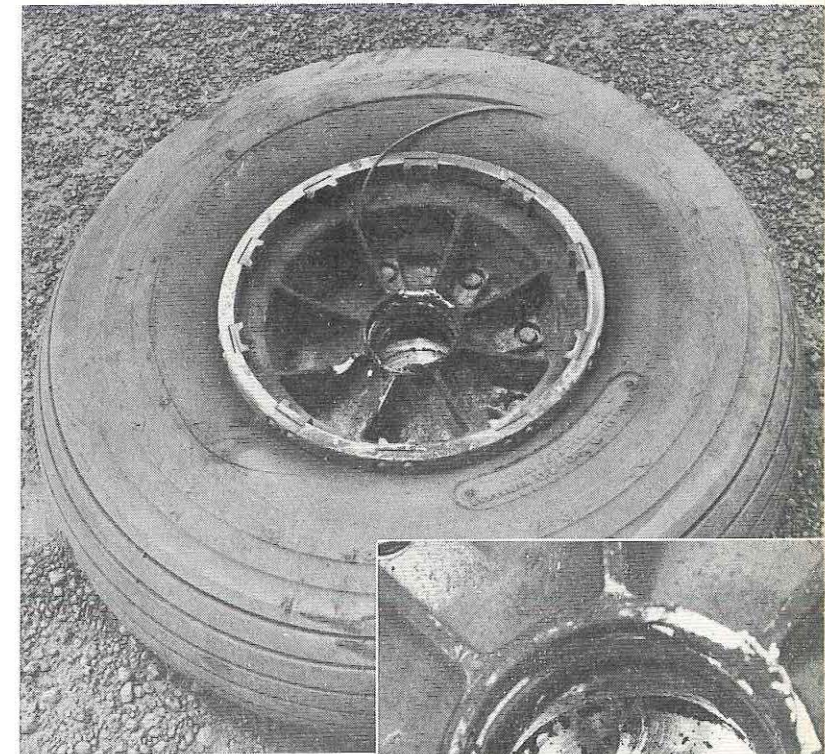
Inspection of the failed wheel assembly, showed that the wheel retaining nut was still in place and locked on the stub axle. The wheel bearings had failed and broken up, allowing the wheel itself to ride over the retaining nut and become detached from the axle. The ground loop had torn off the port undercarriage leg damaging the adjacent wing structure. The port propeller, the flap and the outer section of the port wing had also been damaged when they struck the ground.

*The port landing wheel showing metal gouged from the centre of the hub as the wheel rode out over the retaining nut, after the bearings had failed.*

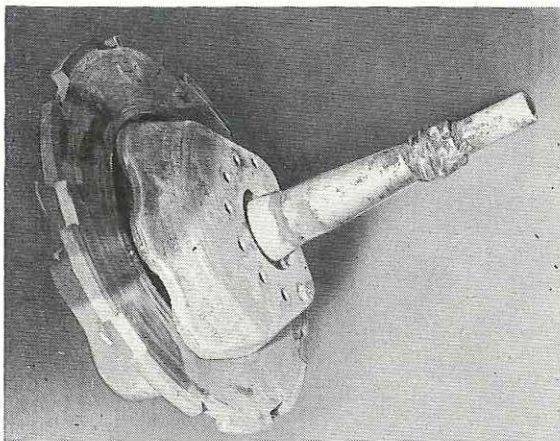
The stub axle after being removed from the aircraft showing the wheel retaining nut and split pin still in place.

- The wheel bearing seal, which is simply a felt washer in an alloy housing held in place by a spring clip, was ineffective. Its condition was such that it should have been replaced during the 100 hourly maintenance inspection, and it had allowed dust to enter the outer bearing cage and build up on the bearing races.

- The split pin used to lock the castellated nut holding the wheel on the axle, was secured in the normal way, but it was long enough for one of the split pin legs to foul the alloy seal housing. This had circumferentially gouged a substantial amount of metal from the seal housing and the particles had found their way into the outer bearing cage.

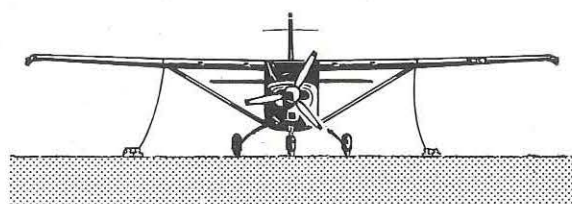
*Aircraft tied down into wind.*

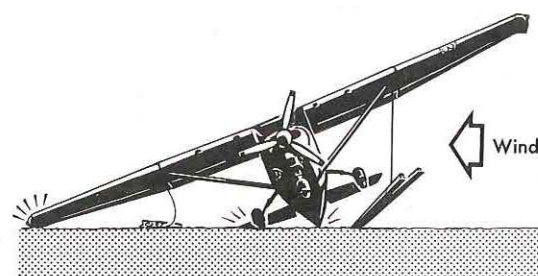
*Wind backs without abating in strength, lifting port wing. Starboard wing tip and tailplane are forced on to the ground.*

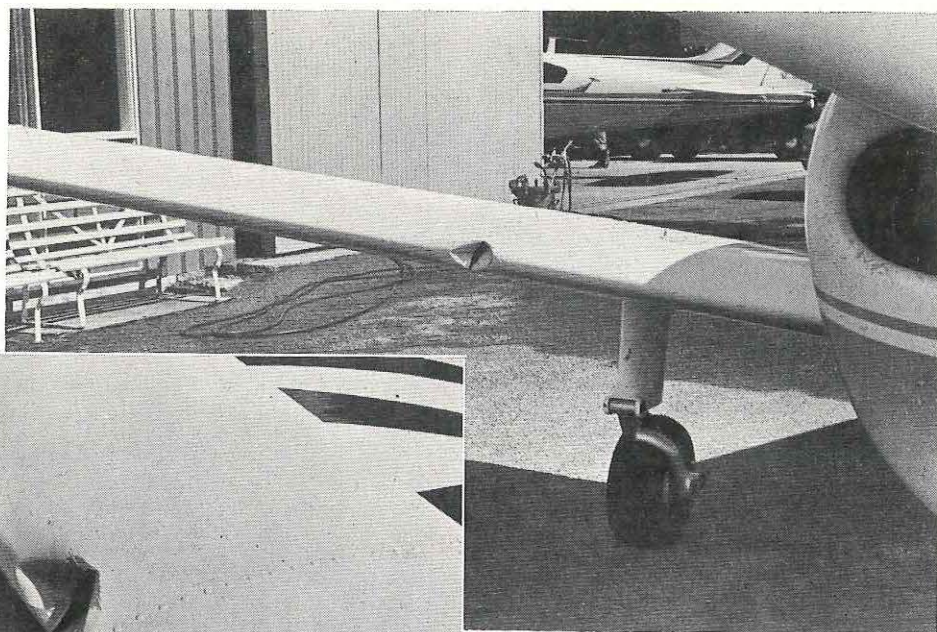
The damage to the aircraft shown in these photographs was caused by a station wagon that was being driven on the apron by an aircraft refuelling attendant. The attendant had just seated himself behind the wheel of the vehicle to drive away, when someone hailed him. To speak to the person without getting out again, the attendant started the engine, and without so much as a glance behind, reversed his vehicle.
