AVIATION SAFETY DIGEST

DEPARTMENT OF CIVIL AVIATION

No. 50

MAY, 1967

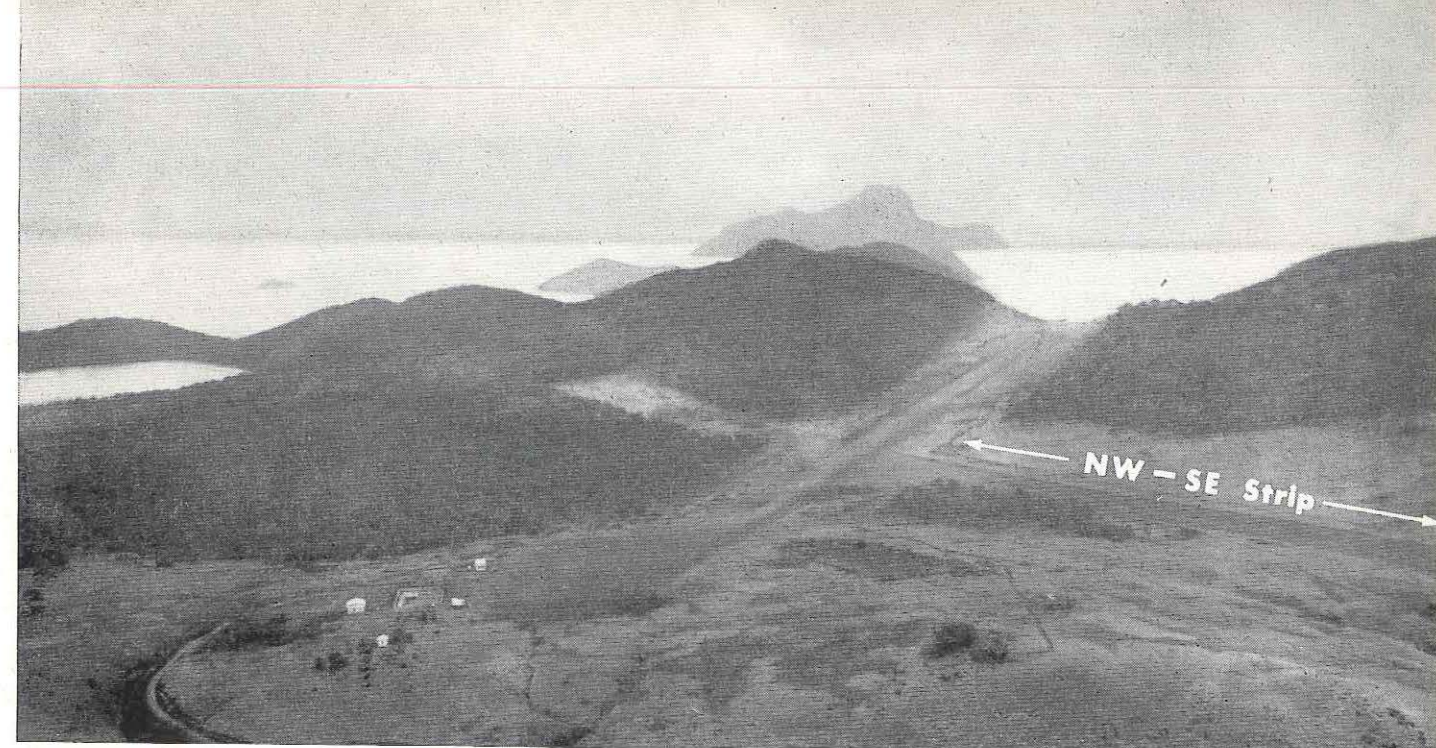
Aerial view of Lindeman Island aerodrome looking north, showing the disposition of the two strips. This is very much the view the pilot of the Cessna would have had as he approached the island from Mackay

strips is not easy to appreciate from the air. This is particularly so in the case of the north-west, south-east strip and it would be easy for a pilot to be misled from a hurried observation. Because the partly cleared over-run beyond the north-western end of the strip slopes upwards towards the hills on the north-western coast of the island, it can at first glance, give the impression of an overall upward slope on the strip, towards the north-west. This could be especially so in the case of a person with a preconceived idea that the strip sloped upwards in this direction. Nevertheless, a detailed examination of the strip from circuit altitude could have assisted in assessing the slope more accurately. In this case however, the pilot did not complete a circuit of the aerodrome before landing, and approaching the island as he did from the south-west, before turning on to final approach for a landing into the north-west, his view of the aerodrome would have been very much as shown in the picture on Page 3.

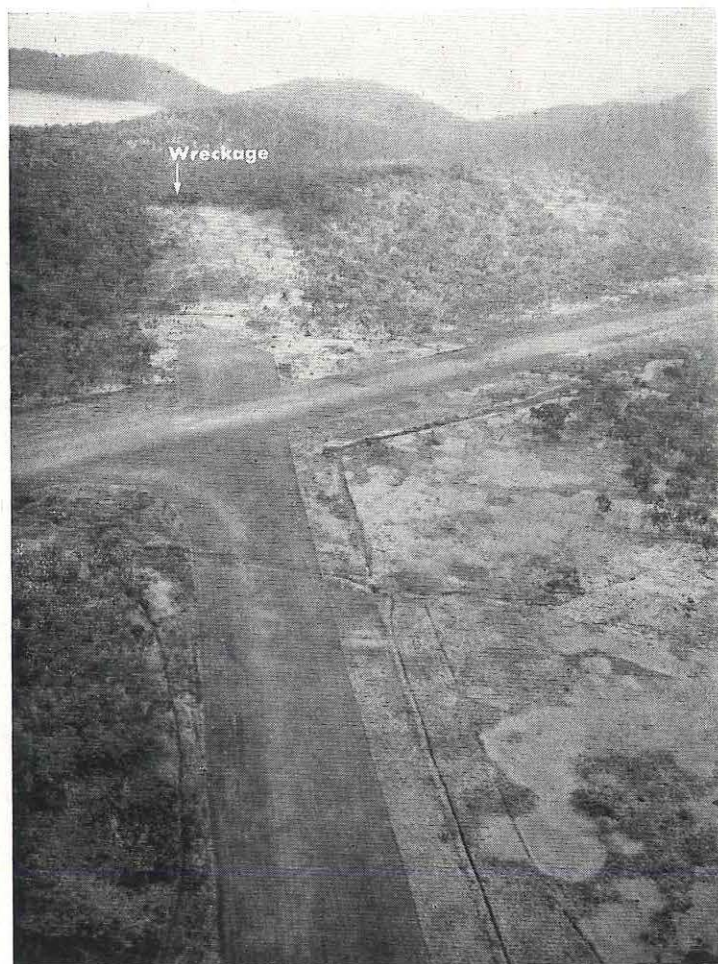
Aerial view of the strip from which the pilot attempted the missed approach, showing the position of the wreckage at the end of the over-run which lies beyond the north-western end of the strip

In actual fact, this strip, which is aligned north-west, south-east is 2,150 feet long, and over much of its length it slopes downwards towards the north-west.

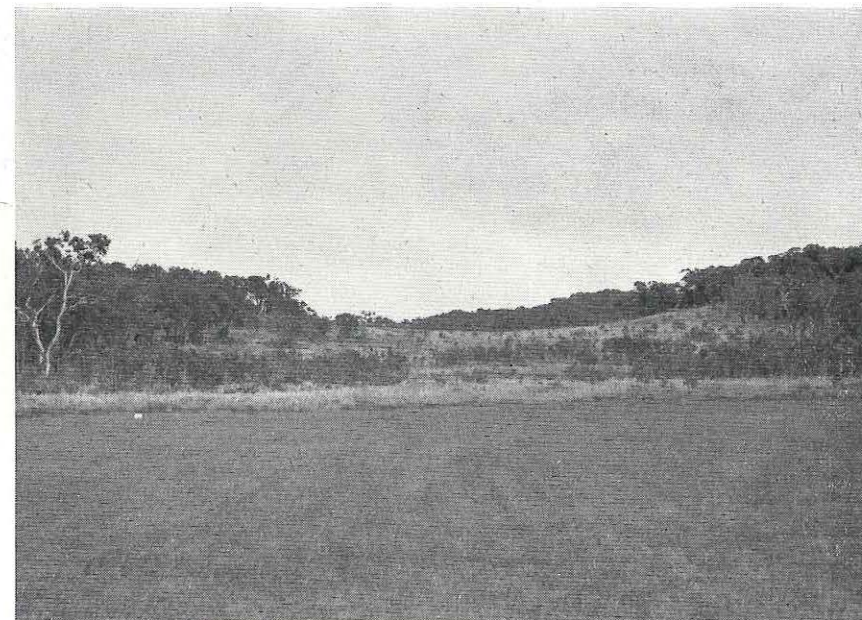
View looking north-west from approximately the point at which the missed approach was commenced. Note the rising ground on the over-run beyond the end of the strip.

On touching down, the pilot said that he braked lightly, and only then realised that he did not have sufficient strip left in which to safely bring the aircraft to a stop. With the aircraft in a pronounced nose-up attitude during the hold-off before touching down, the pilot had not appreciated the amount of strip the aircraft was using and the hazardous situation in which it was being placed. An accident or an incident of some sort was now inevitable, for even if the pilot had braked harshly, immediately on touching down, the aircraft could not have been brought to a stop in the distance remaining and would have over-run the end of the strip. The over-run area is covered with long grass two to three feet high, and scattered small bushes and saplings up to six feet in height. There is a gully eight feet deep across the over-run, 230 feet beyond the end of the strip, and the aircraft would almost certainly have overturned if it had run this far.

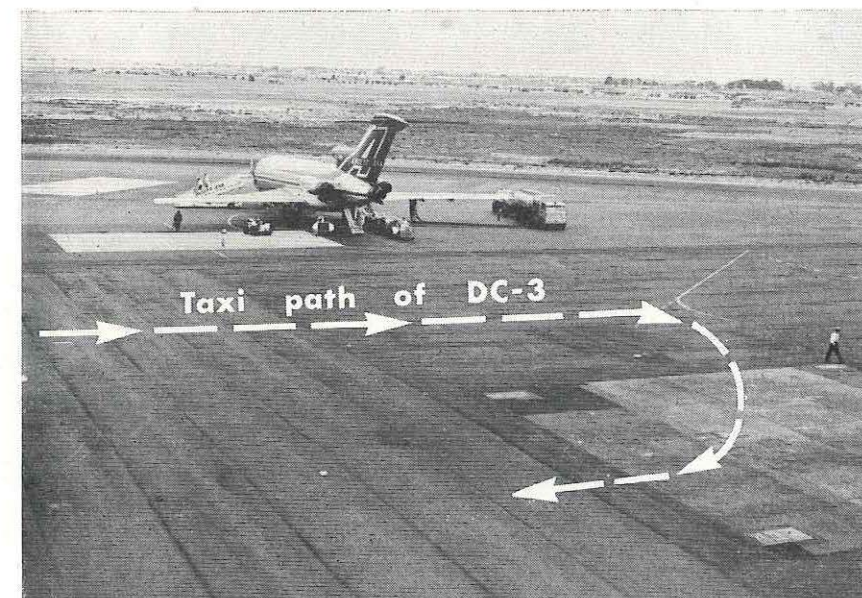
As the DC-3 turned half right and passed slowly behind the Boeing, the control surfaces and tail section of the DC-3 were suddenly subjected to severe buffeting as they entered the efflux from the Boeing's engines. Despite the efforts of the DC-3's crew to restrict the movement of the controls, the rudder was flung heavily against its stops, the elevators flapped up and down violently and the aircraft itself was swung rapidly to the right. The captain of the DC-3 opened the starboard throttle to stop the swing and succeeded in regaining control, but before he could taxi his aircraft clear, the port elevator drooped, tore away

Fig. 1 Approximate taxi path followed by the DC-3 as seen from upper floor of terminal building. The Boeing 727 depicted, is in the position which a similar aircraft occupied at the time of the accident.

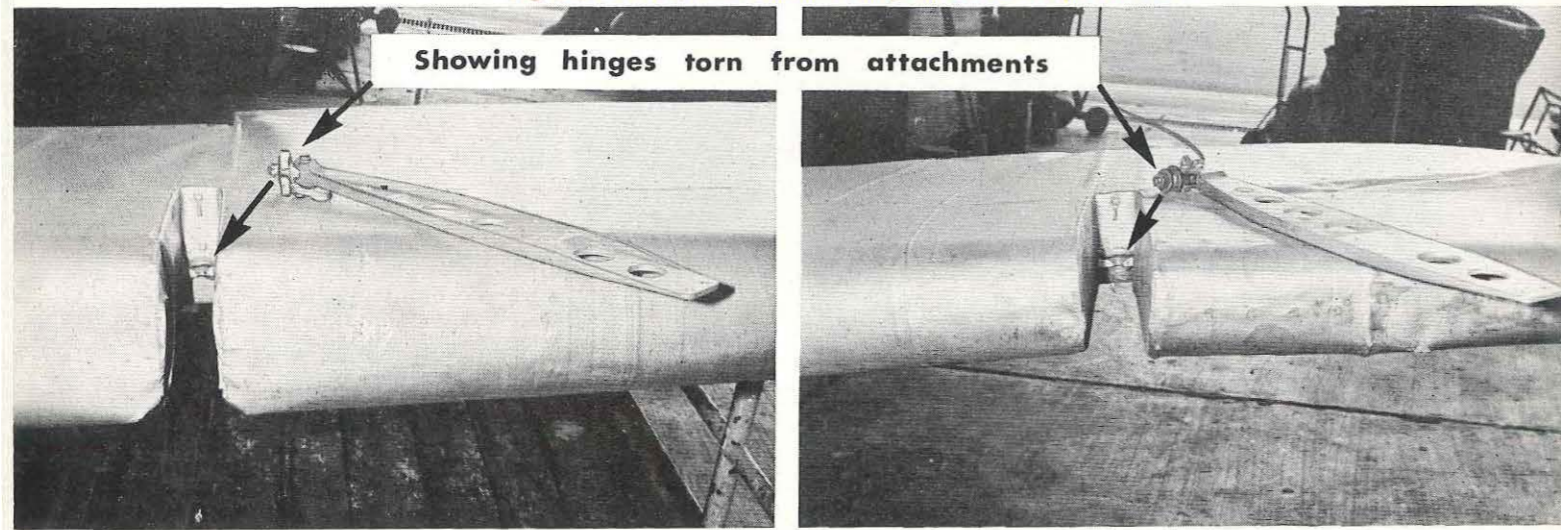
from its attachments, and was blown high in the air behind the DC-3. Afterwards, when the damaged aircraft was inspected, it was found that the starboard elevator and rudder assemblies had also been damaged substantially. (see Figures 2, 3, and 4).

Fig. 2 and 3. The inner and outer hinge of the DC-3's port elevator.

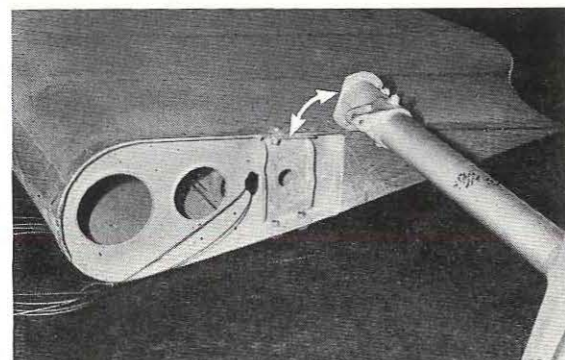
Fig. 4. Portion of the DC-3's elevator torque tube assembly, showing how the rivets which secure the tube to the starboard elevator were sheared off by the violence of the elevator's movement.

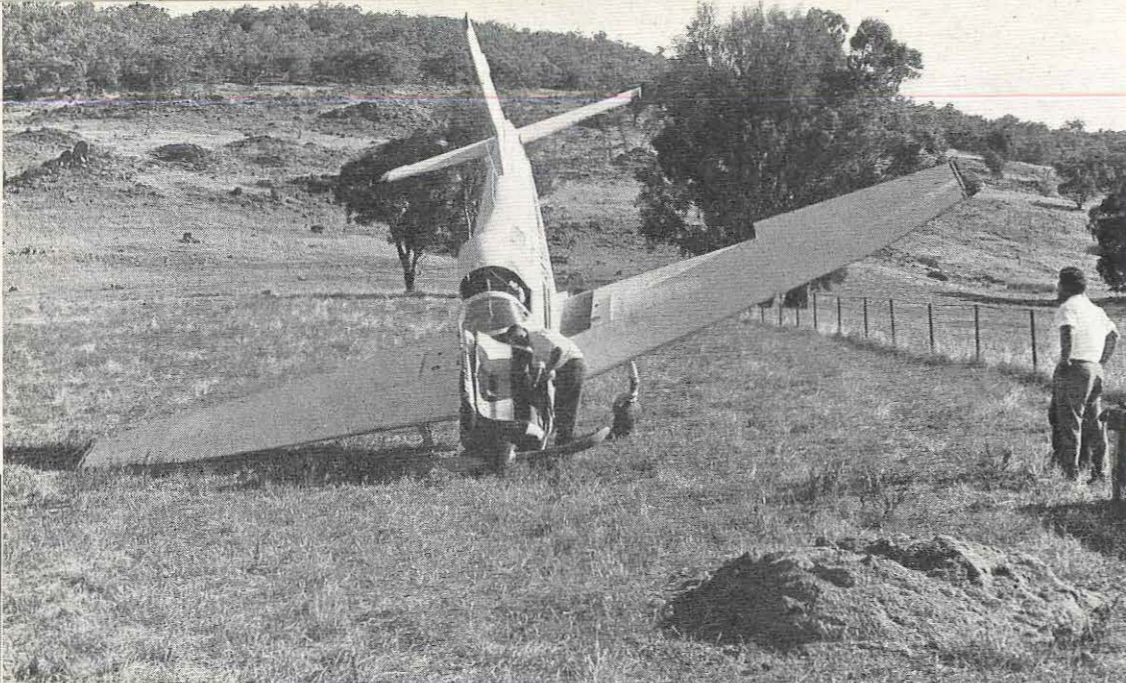
The pilot of the Cropmaster in this picture was carrying out a superphosphate top dressing operation in hilly country south-west of Albury, N.S.W. Before taking off from Albury to begin the day's work, he had refuelled his aircraft, filling both tanks to capacity. The pilot then flew to the agricultural airstrip from which he was to work and began spreading.

An examination of the aircraft established that the engine had failed only from lack of fuel. The starboard tank was almost full but the port tank was virtually empty.

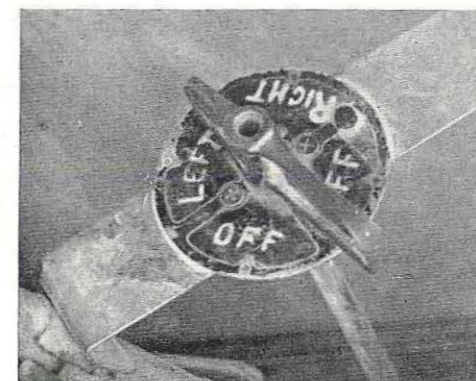
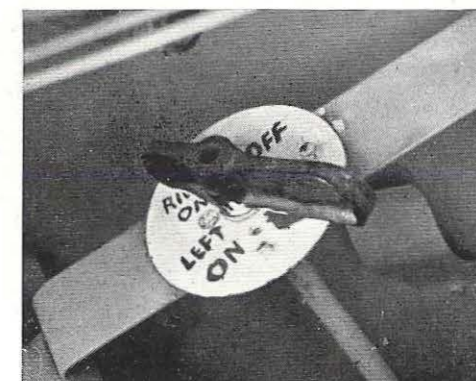
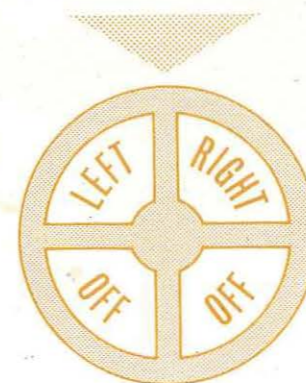
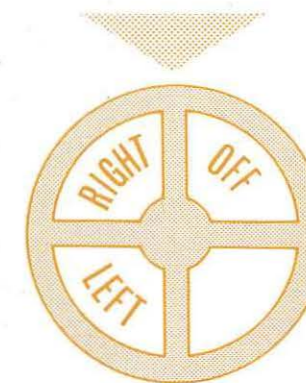
In the absence of any other reason for the failure of the engine, it is possible that from force of habit, the pilot positioned the fuel selector in the way he had been accustomed to in the aircraft he had been flying previously, but this in effect had turned the fuel off. The fuel remaining in the lines and carburettor had been sufficient for the aircraft to take off and climb to 50 feet but at this point the engine failed from fuel starvation.

Left: Fuel selector in aircraft pilot was flying previously. Right: Fuel selector in aircraft involved in accident.

The moral for operators should be clear.

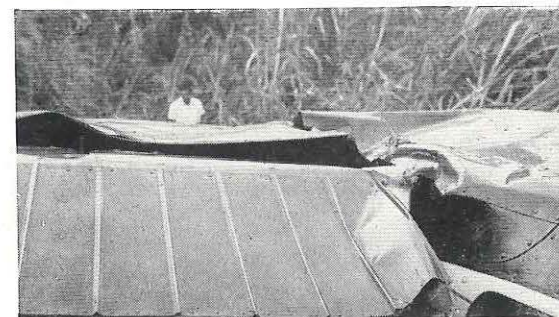
This view of the port wing root gives some idea of the very extensive damage sustained by the aircraft.

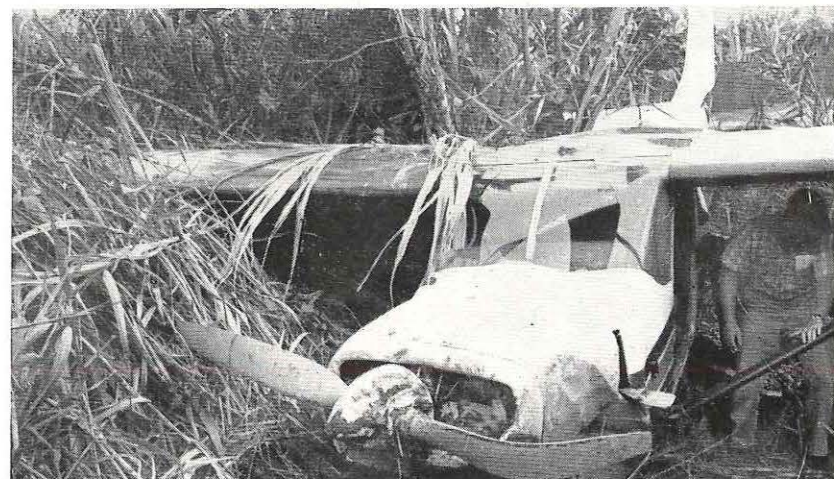
The badly damaged aircraft as it came to rest in the undergrowth beyond the end of the strip.

The probable cause of this accident was that the pilot elected to take-off at a time when the condition of the strip demanded a level of performance from his aircraft which was beyond its capability at the weight at which it was being operated.

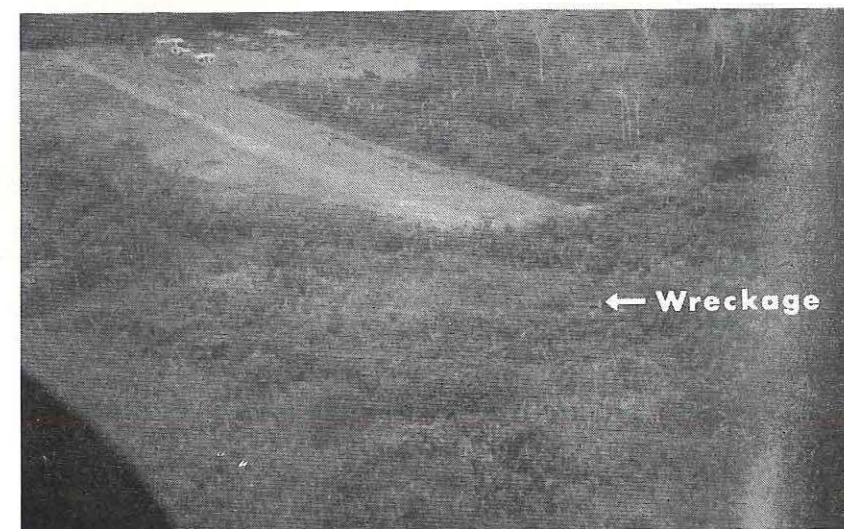
Aerial view of Dona airstrip showing the wreckage of the aircraft lying in the undergrowth beyond the northern end of the strip.

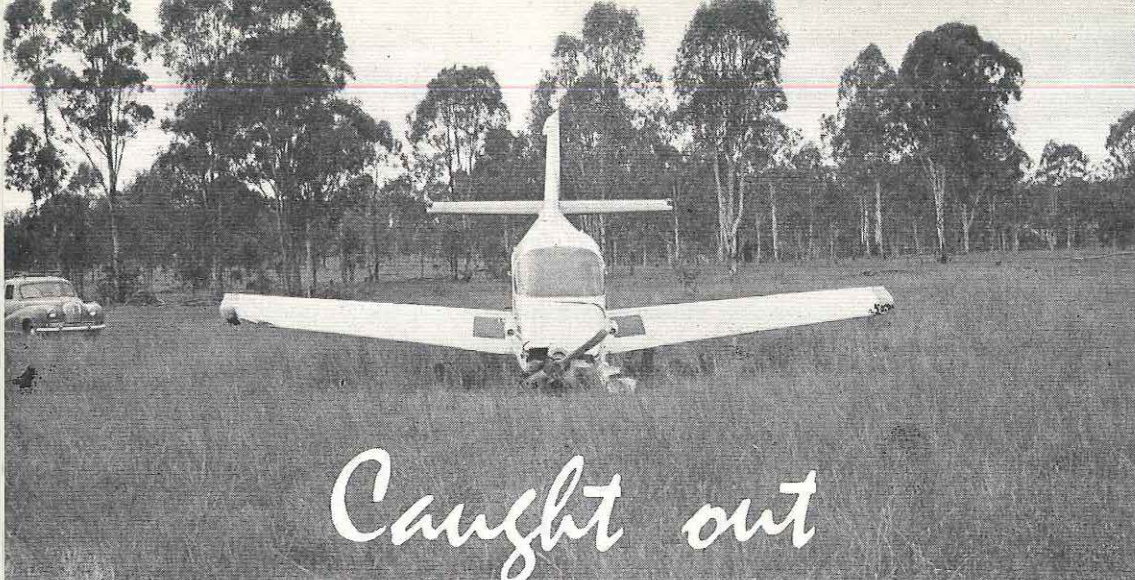
THIS forlorn looking Victa Airtourer was being flown on a cross country navigational exercise in Queensland, by a woman pilot holding a restricted private pilot licence.
