# AVIATION SAFETY DIGEST

DEPARTMENT OF CIVIL AVIATION

No. 51

JULY, 1967

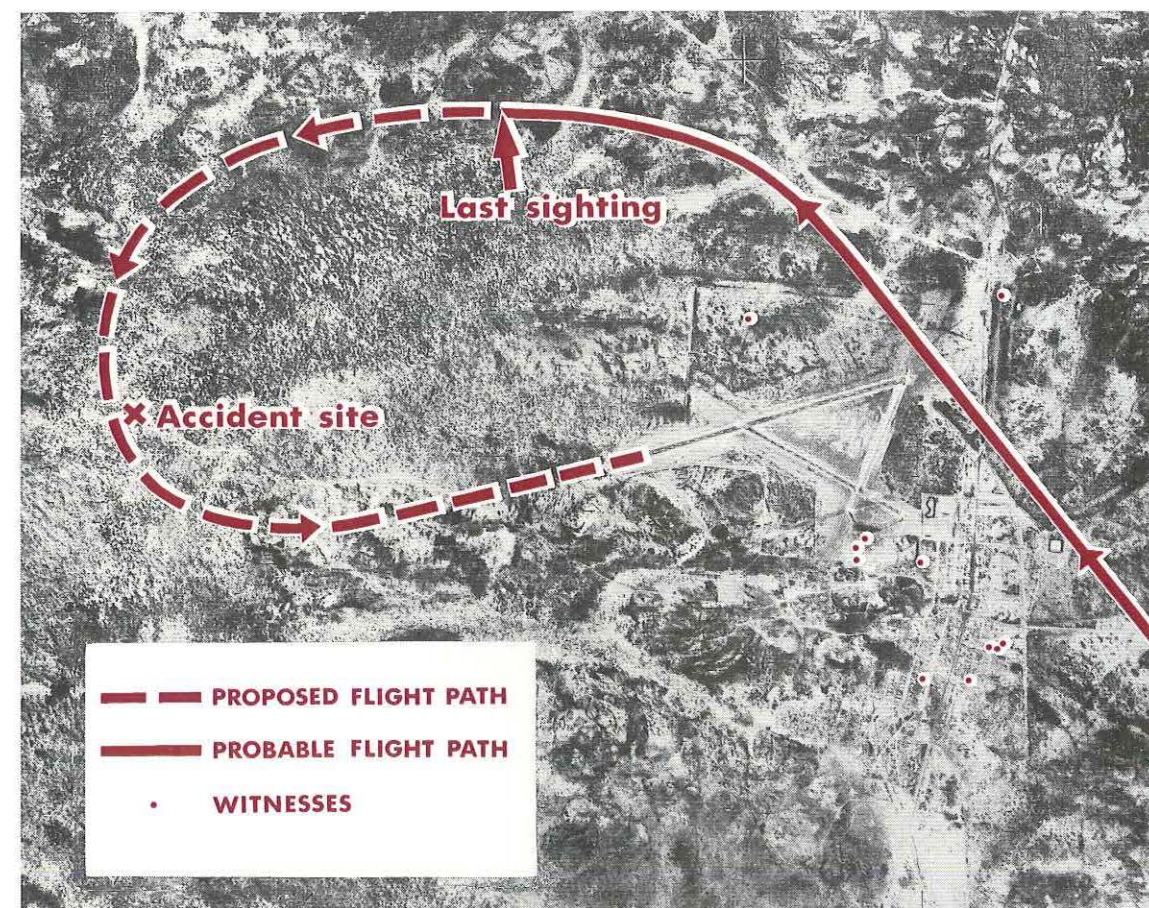
Aerial photograph of Tennant Creek area, showing township, aerodrome, final flight path and accident site.

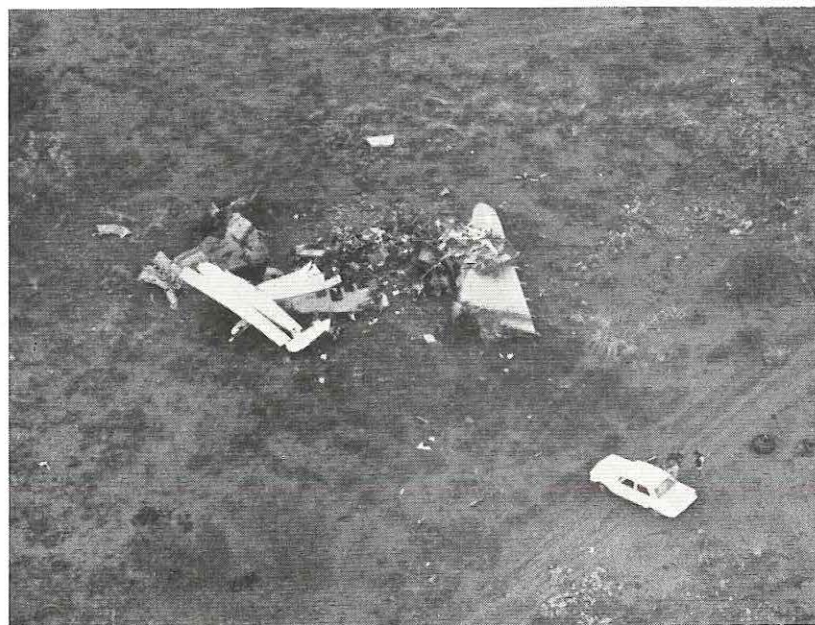
The aircraft appeared to have struck the ground at low forward speed and all major components of the aircraft were found in the area of impact. There was no evidence of any structural failure, fire or explosion which could

The most significant finding to emerge from the examination of the wreckage was that one of the duplicated aileron control chains in the pilot's control column was broken in the region of the control wheel sprocket. The breakage had occurred when a link pin of the chain had failed, and there was evidence that the broken link pin could have subsequently jammed the assembly as the control wheel was being rotated. Following further extensive examination and laboratory testing, it was concluded that the failure of the chain and the associated damage to the control column assembly, were not consistent with impact damage, but the investigation could not positively establish

*Aerial view of the wreckage.  
The initial point of impact is at  
the extreme left of the picture.*

Firstly, it was found that one of the duplicated aileron control chains in the pilot's control column assembly had broken and there was evidence that it had temporarily jammed. The damage was believed to be inconsistent with impact damage and consideration was therefore given to the effect of such a situation occurring in flight. Flight and ground tests conducted to simulate such sudden jamming, showed that although the pilot would be temporarily deprived of aileron control, the aircraft could still be controlled to maintain level flight with the elevator and rudder controls alone. The tests could not however, simulate the element of surprise. Similarly, it was not possible to test the reaction of a pilot to circumstances in which he would not only be required to control the aircraft, while it was turning to the left, probably at low airspeed, but would also be required to try and overcome the restriction by exerting considerable force on the control wheel. It was found that the physical force required to free the aileron controls in such a situation, would be well within the capacity of one person. While it could not be conclusively established what overall effect the total situation would have on the control of the aircraft, the test results showed that the very least effect would be a gross distraction of the pilot from his task.

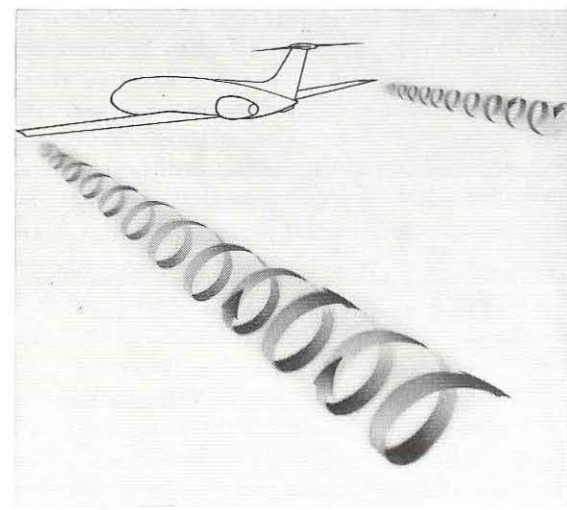
Fig. 1. Diagram showing direction of rotation of wing tip vortices generated behind an aircraft in flight.

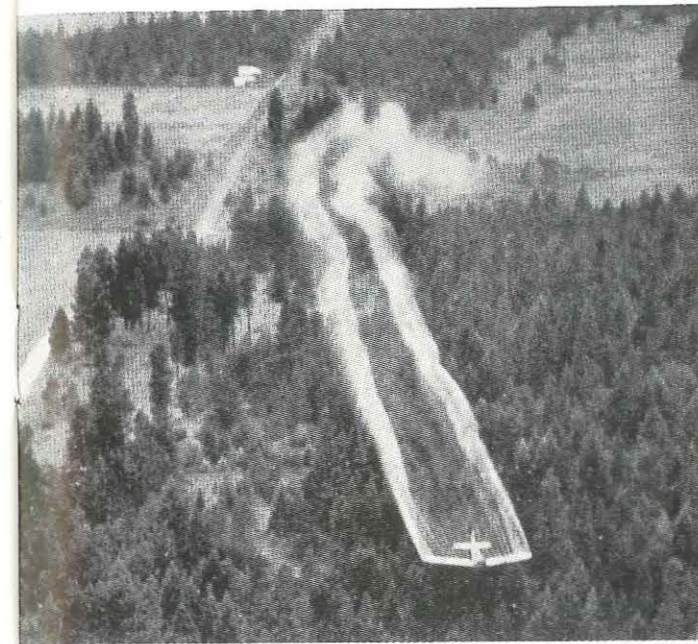
Fig. 2. This photograph of an aircraft dusting trees with insecticide clearly shows the edges of the dust sheet being rolled into the wing tip vortices. Note how compactly the vortices persist behind the aircraft, before beginning to dissipate.

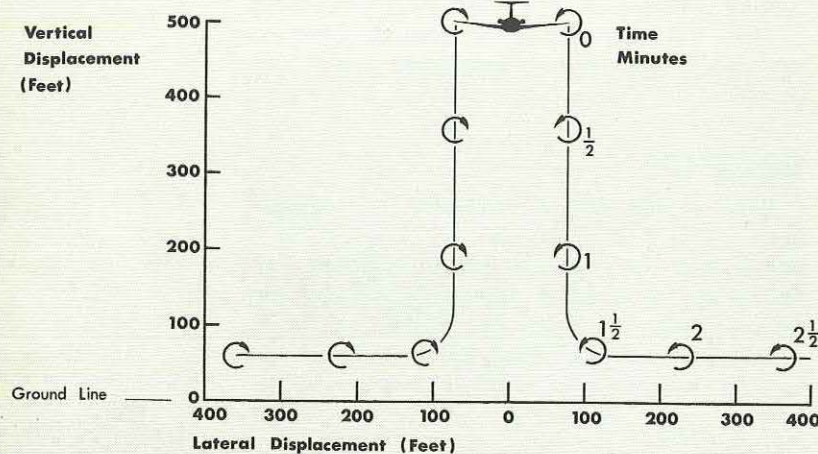
siderable distances behind. In calm conditions, the vortices can persist for up to three minutes after the aircraft has passed. As a result of their own motion, the vortices tend to settle below and behind the generating aircraft, but if the aircraft is close to the ground as in an approach to land, the vortices will reach the ground and tend to fan out laterally behind the aircraft. (See figure 3.)

Fig. 3. Wing tip vortices tend to settle behind the generating aircraft, and to spread out laterally on reaching the ground. The graph shows the rate of sink and lateral movement which can be expected in calm conditions.

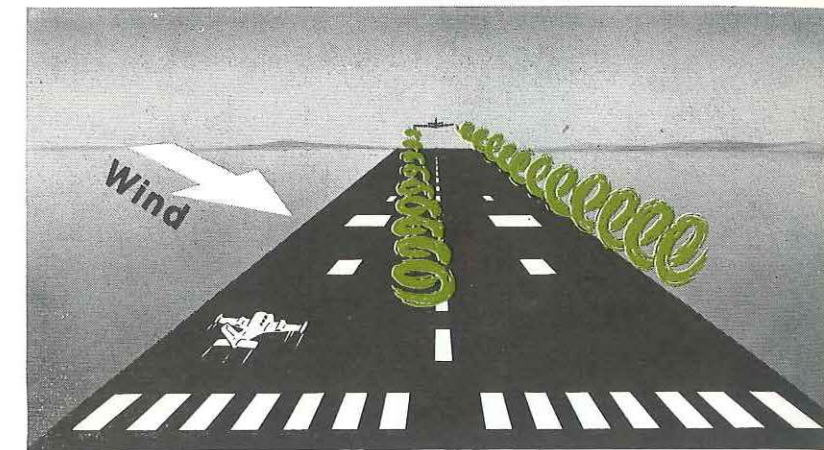
Fig. 4. A typical example of planning to avoid vortex turbulence. The light aircraft is landing as near to the threshold as possible, using the up-wind side of the runway, to keep clear of the vortices generated by the large departing aircraft. In such a case, the direction and rate of movement of the "up-wind" vortex would depend on the strength of the cross-wind and would need to be assessed in the light of the information shown in Fig. 3.
