No. 54

AVIATION SAFETY DIGEST

DEPARTMENT OF CIVIL AVIATION AUSTRALIA

No. 54 JANUARY 1968
DEPARTMENT OF CIVIL AVIATION, AUSTRALIA

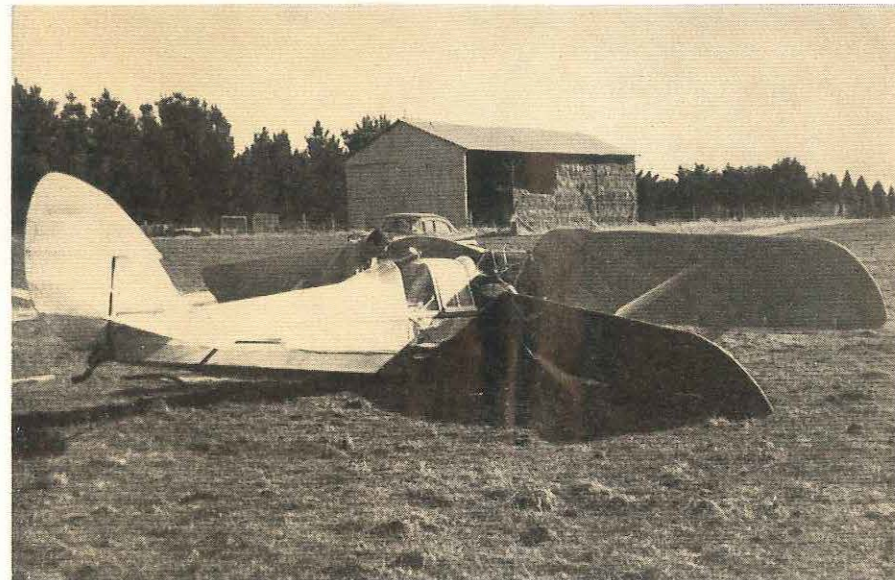
Left: The wrecked DH-82 as it came to rest.

Right: The child passenger's boot re-positioned in the control column aperture. Note how the distortion of the sole matches the shape of the control column socket.

During the examination of the wreckage, this cover plate was found open and buckling of the

plate and marks on its undersurface indicated that it was open at the time of impact. It was also found that scratch marks on one of the leather boots which the boy-passenger was wearing, and the way in which the leather sole of his boot was distorted, could be accounted for if the boot were placed in the control box aperture and compressed by sideways movement of the control column. Subsequent laboratory examination of dried mud and other matter adhering to the boy's boots, and scraped on to the structure surrounding the control column aperture, showed that at least one of the boy's boots had been in the aperture at some stage of the flight.

From the investigation it is obvious that the cover plate provided to protect the front control column socket from interference, had not been closed before the flight began. It is equally obvious that if the cover had been properly secured, the control restriction could not have occurred and the accident would not have happened.

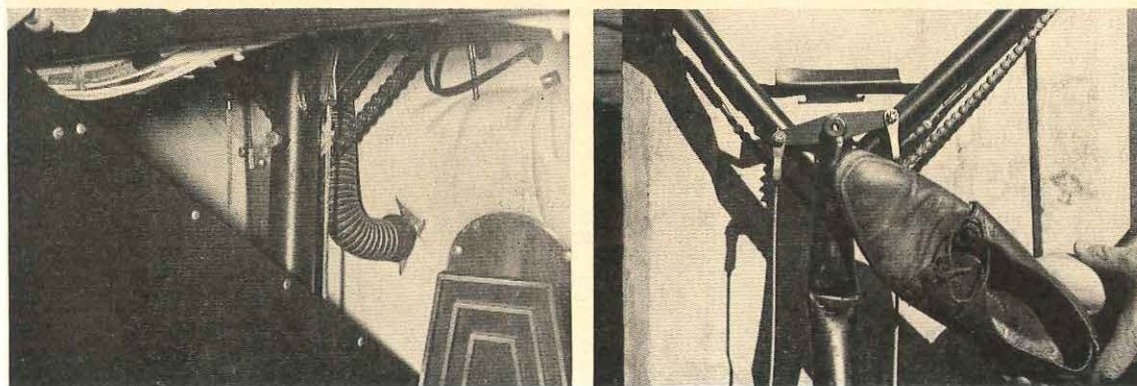
The photographer killed in the accident was wearing rubber soled shoes at the time and it was found that the left shoe had a series of distinct marks imprinted diagonally across the sole. These marks matched the shape of the aileron cable attached to the lower right hand section of the control yoke assembly and it was evident that the shoe had been in this position at the moment of impact. This was confirmed by subsequent laboratory examination of the shoe and control yoke assembly, which established that matter adhering to the aileron cable on the lower right hand side of the yoke, had come from the sole of the shoe. With the shoe in this position the

Below left: The central control column yoke beneath the instrument panel of a Cessna 150. This photograph was taken from the starboard side. Dual rudder pedals are installed in this particular aircraft. Below right: Position occupied by passenger's shoe against control yoke of crashed aircraft, when marks on the sole were re-aligned with aileron cable.

Pilots who carry passengers in the control seats of any dual control aircraft should make themselves thoroughly familiar with the layout of the dual control system and any particular parts which appear vulnerable to passenger interference. Armed with this knowledge, a pilot is then in a position to properly brief his passengers on the potential interference hazards of the system.

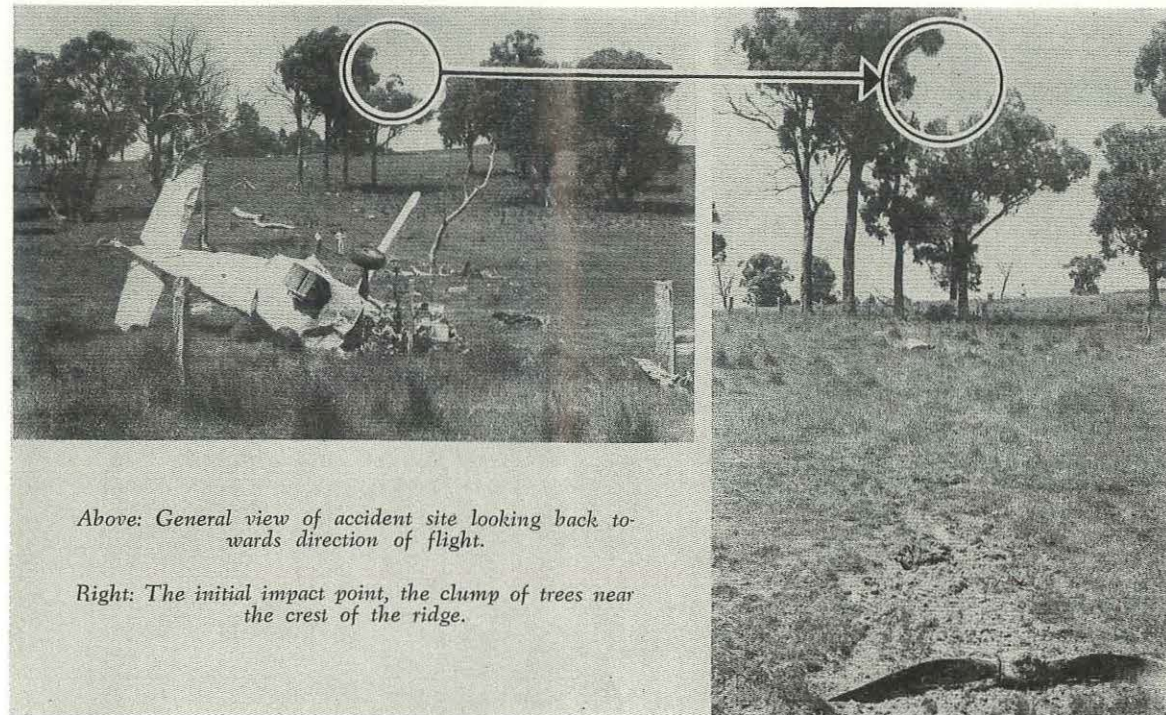
maintain visual reference, he turned left from the highway to follow a shallow valley. The ridge at the head of the valley was also in cloud however, and there was insufficient airspace in the valley below the cloud base for the aircraft to turn back. The pilot apparently attempted to cross the ridge in cloud but losing visual reference, collided with the trees just beyond the top of the ridge.

Above: General view of accident site looking back towards direction of flight.

Right: The initial impact point, the clump of trees near the crest of the ridge.

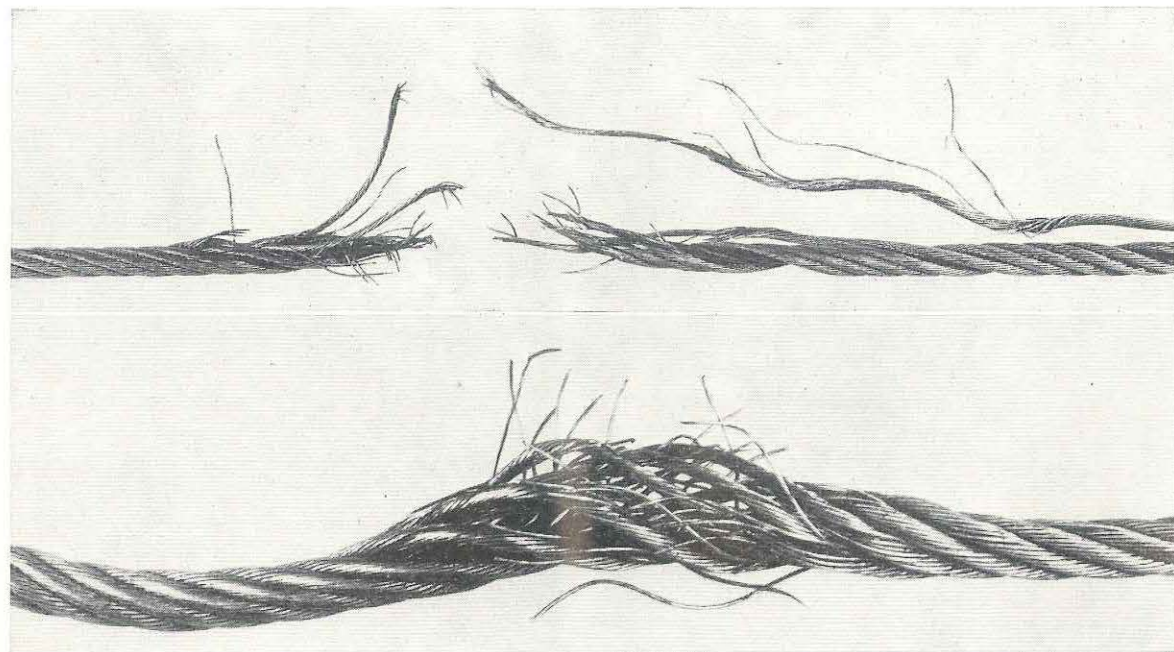
Inspection of the aircraft after it landed, showed the port rudder cable had broken where it passes over a pulley $2\frac{1}{4}$ inches in diameter, and changes direction by ten degrees. The cable had been in service for about 8,500 hours. The corresponding starboard rudder cable was found to be similarly worn and contained a number of broken strands.

The external wear consisted of a reduction in the overall diameter of the cable, and was easily discernible to the naked eye, showing up as flats on the external surfaces of the cable strands. On this appearance alone the condition of the cable was such that it should have been replaced some considerable time before the failure occurred. The standards by which the serviceability of cables should be determined during inspections are set out in Air Navigation Order 108.2.19., and in this case both the failed cable and the corresponding starboard cable were worn to dimensions considerably below the limits specified.

Fig. 1: (Top) The failure in the port rudder cable. Tapering of the wires towards the fracture area has been caused by wear.

Fig. 2: (Lower) Portion of the starboard rudder cable. The cable has been opened by manipulation with pliers, allowing previously broken wires to protrude. Patches of external wear can also be seen on the surface of the cable.

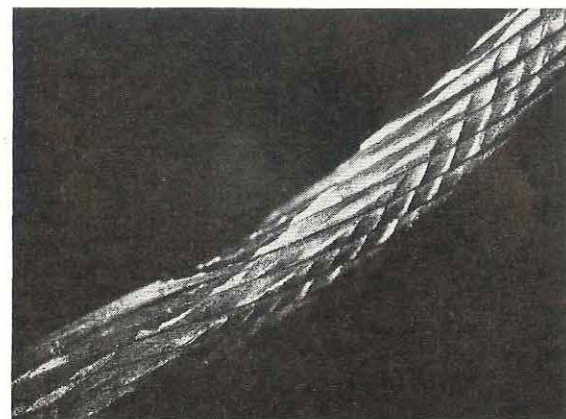
The internal wear and loss of strength in the failed cable consisted of wear on the inner surfaces of the cable strands produced by relative motion of the strands against each other over a long period. This had reached the stage where some of the wire strands had been cut through completely. Most of the others had been reduced to only about 20 per cent of their original diameter. Wear of this sort is not easy to see unless the strands of the cable are forcibly separated and for this reason it is necessary to accept external signs of wear on a cable as a means of monitoring the wear taking place within the cable. It was to achieve this purpose that the limits set down in Air Navigation Order 108.2.19. were devised.

Fig. 3: (Below) A section of the port cable magnified ten times. All the wires are seriously reduced in thickness.

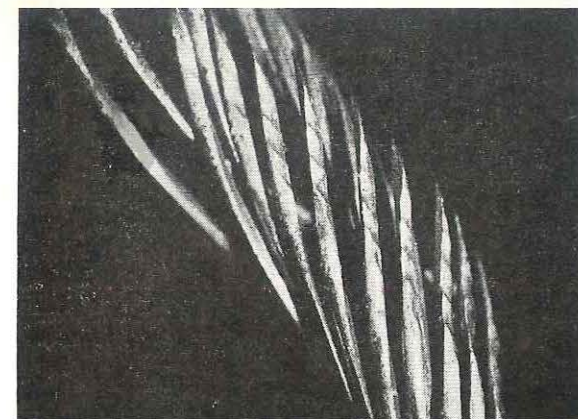
Fig. 4: Another section of the port cable seen under magnification. Wear has progressed to the point of cutting right through several wires.

- Ensuring that cable runs are clear of obstructions between pulleys and fairleads.
- Maintaining their rigging tension to the specified figure.
- Examining cables critically at all pulley and fairlead contact points paying particular attention to the mid-travel positions, and using the limits specified in A.N.O. 108.2.19. as the standard of serviceability.
- Reporting to the Department any instances in which cable wear appears to be unusually rapid. It is probable that a minor modification will eliminate the hazard, and save repeated early cable replacements.

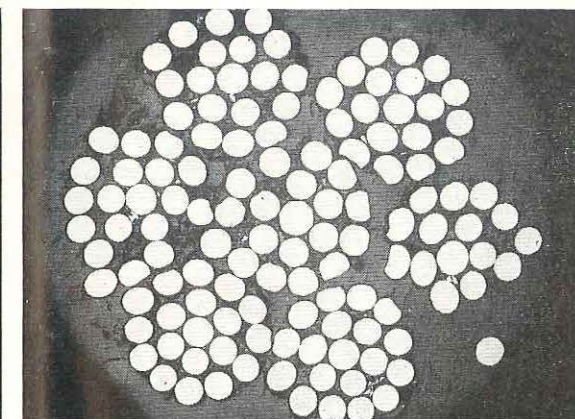
Fig. 5: Photograph of a cross section of the port cable, away from the failure area, magnified 20 times. Although wear on the surface is negligible, severe damage has already taken place within the cable.

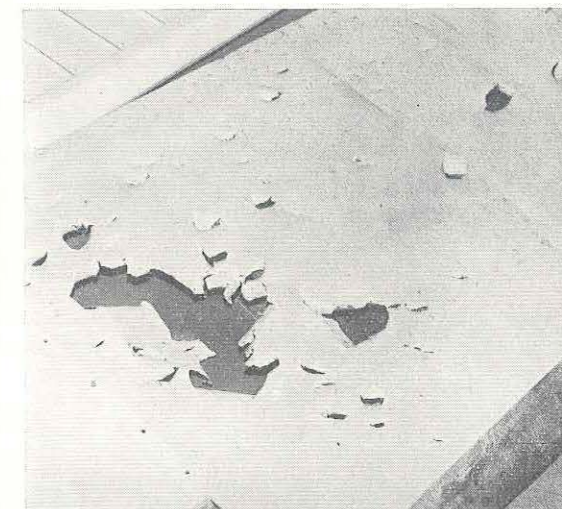
Shortly after passing Bunbury, 50 miles further on, the Cessna 180 was joined by another aircraft, the pilot of which confirmed that the tail wheel spring was broken and that the tail wheel assembly was thrashing about in the slip-stream and appeared to be causing damage to the underside of the tail plane.

This photograph, taken after the tail plane was removed from the aircraft for repair, shows the extensive skin damage inflicted by the flailing tail wheel assembly.

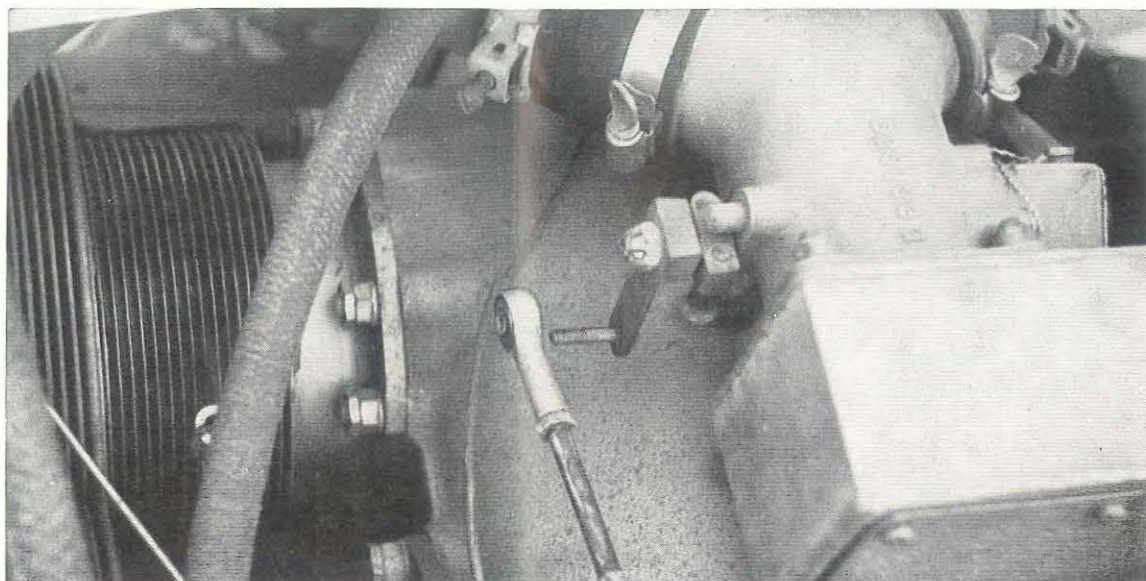
The disconnected throttle linkage found on the Maule after the forced landing.

The standard of a 100 hourly inspection must be such that the aircraft will be in a fit condition to operate until the next scheduled inspection,
