DEPARTMENT OF CIVIL AVIATION AUSTRALIA

AVIATION SAFETY DIGEST

No. 55

MARCH 1968

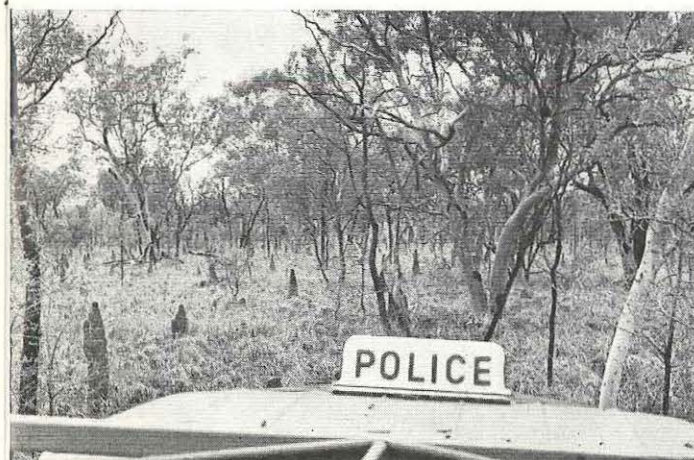
The difficulty encountered by the ground party in reaching the accident site is clearly evident from this photograph.

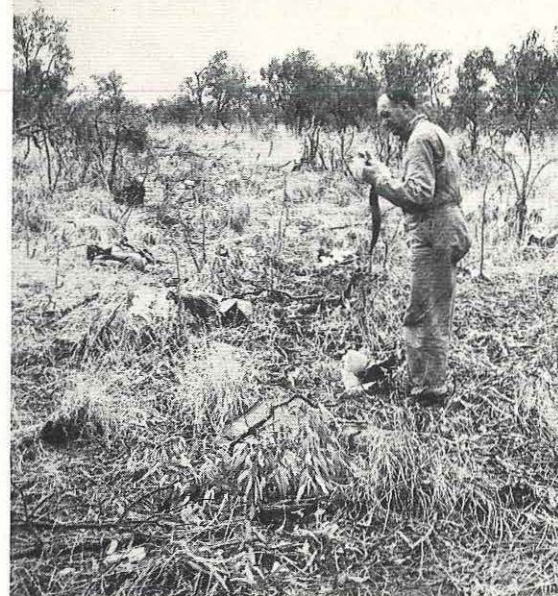
Examination of the wreckage indicated that the flaps were almost fully extended at impact, and that the propeller was rotating, but not under power. No trace of fuel could be found in the fuel system. Although the cockpit area was demolished, it was possible to determine that the master switch had been turned off.

A Departmental investigator examining components distributed along the wreckage trail.

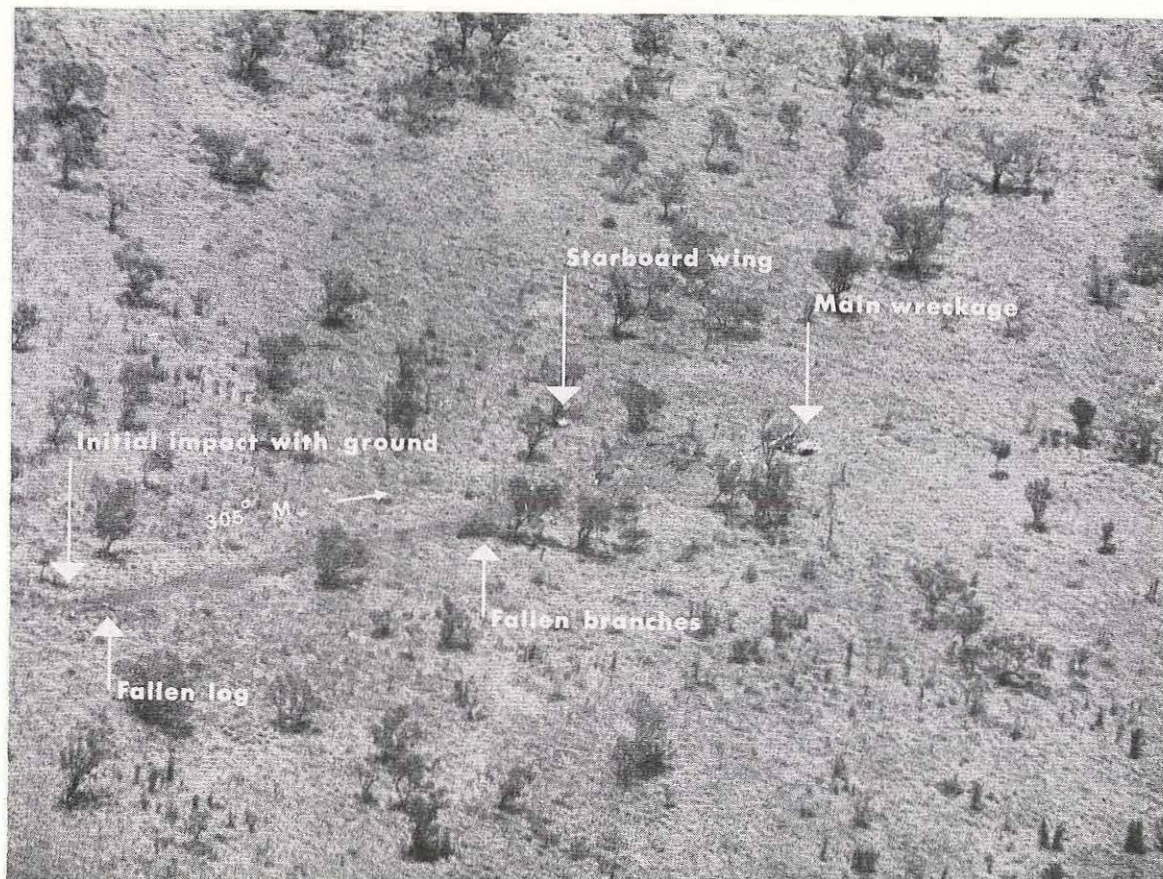
Aerial view of crash site showing wreckage trail.

After careful consideration of all the evidence, it has been determined that the probable cause of the accident was that the pilot did not give due regard, at a sufficiently early time, to the availability of alternative courses of action, when faced with a situation of adverse weather and approaching darkness in the vicinity of his intended destination.

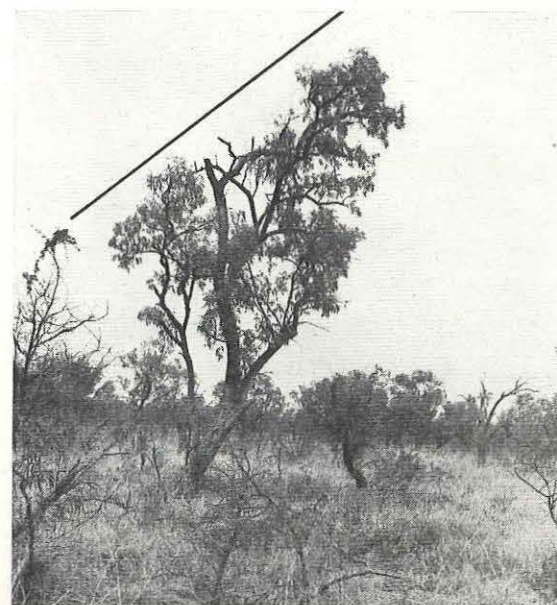
The tree struck first by the aircraft, looking back towards approach path. The line shows the angle at which the branches were broken off by the port wing.

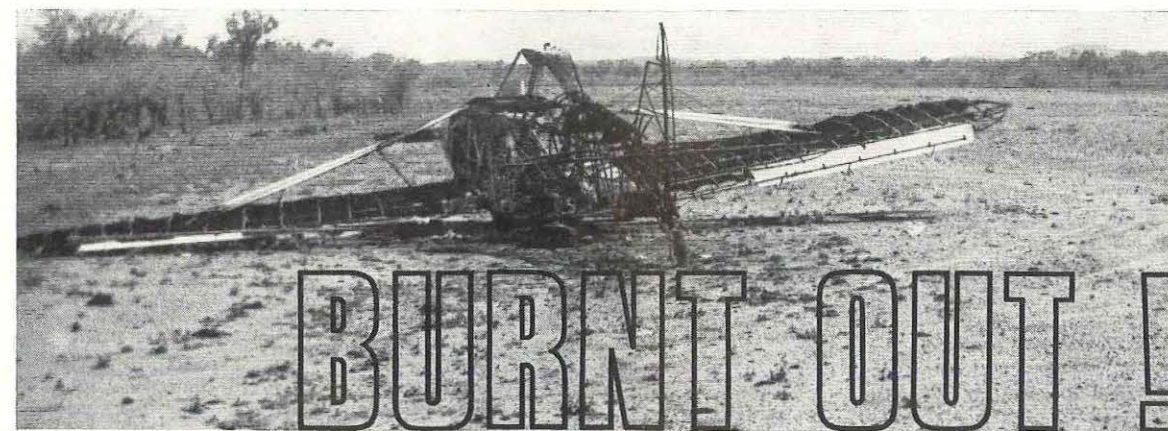
No, this one WASN'T a fatal accident! In fact, it began as the most minor of incidents. Even so, as the picture shows, it cost an agricultural operator a valuable aircraft and the pilot a very red face!

Jumping quickly to the ground to pick up the spilling can, the pilot found it alight. The fire quickly spread, via the spilt fuel to the aircraft fuel tank and, at the same time, the fabric covered underside of the fuselage caught fire from the flames on the ground. The entire aircraft, with the exception of the engine compartment in front of the firewall was consumed in a very short time.

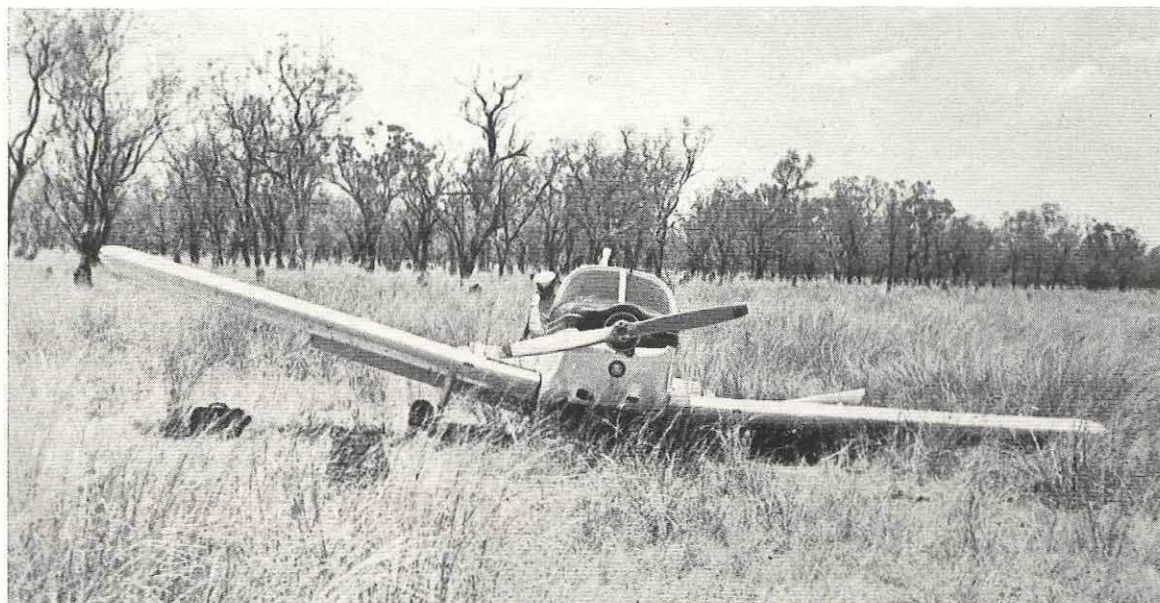
one and three cylinders were fouled by excessive carbon deposits. It was also found that the carburettor was delivering an over-rich mixture and that, because new piston rings had been fitted to the engine only 25 engine hours previously and were still "bedding in", a more than normal amount of oil was draining past the rings into the combustion chambers.

As well as this, it was learned that because the condition of the airstrip was very dusty, the pilot had selected the carburettor heat control to "hot", before beginning the take-off, in the belief that the flame trap element would filter the air being drawn into the engine.

The operating instructions for the aircraft specify that the air intake control should be set to cold air except under suspected icing conditions, pointing out that the selection of hot air causes a reduction in the power available for take-off. It was considered that the pilot's use of hot air, which would have reduced the air mass flow to the carburettor, in conjunction with the excessively rich mixture and the surplus oil in the combustion chambers, had led to the fouling of the spark plugs.

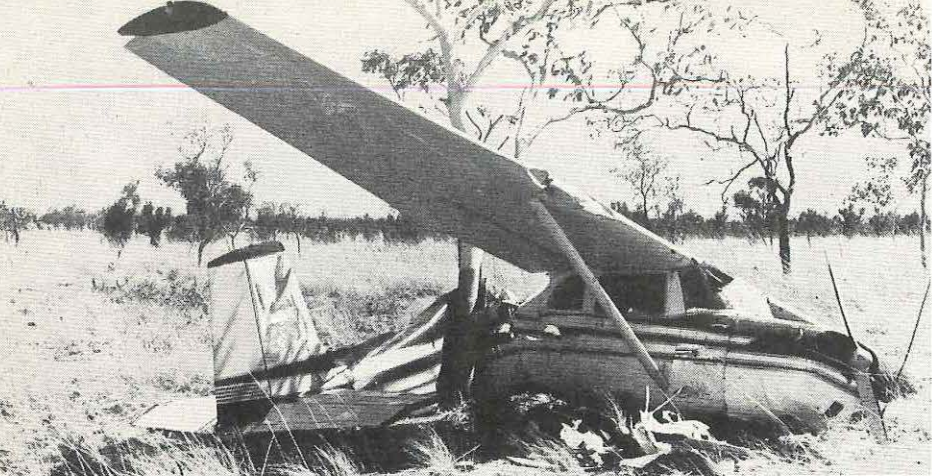
Just before this Cessna 150 was wrapped around the tree shown in the picture, it was being used to spot cattle on a station property in Western Australia.

As the aircraft settled into the dense long grass, the undercarriage became more entangled, and despite the pilot's application of full back stick, it began to nose-down in the grass. The lower part of the nose cowling then dug into the soft ground and the aircraft somersaulted on to its back. Fortunately the soft grass cushioned the impact and damage was confined to the nose cowling, fuel tank and rudder. The pilot and his wife escaped with a shaking.

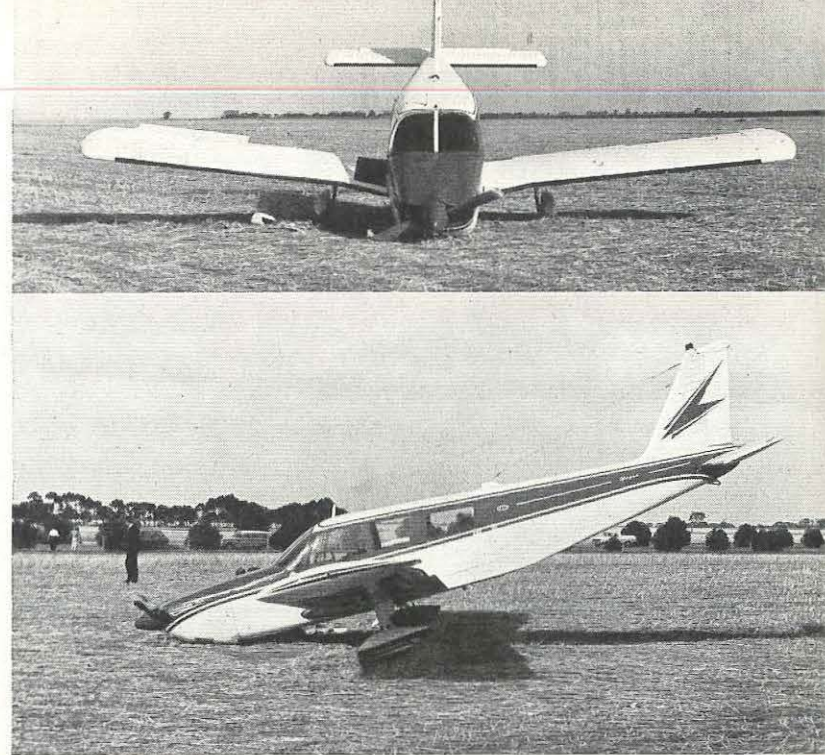
Gone Bush

Before setting out for an inland destination in Western Australia, the pilot of this Comanche had been informed that the strip to which he was proceeding was 2,500 feet long. En route, he computed that in the existing conditions his aircraft would require a landing run of 2,100 feet.

The strip length, when measured, proved to be only 1,850 feet long. The pilot said that his approach to land had been "normal" but it is evident that he made no attempt to plan or carry out a type of approach that would have assisted him to stop the aircraft in the length available.
