No. 56

MAY 1968

AVIATION SAFETY DIGEST

DEPARTMENT OF CIVIL AVIATION AUSTRALIA

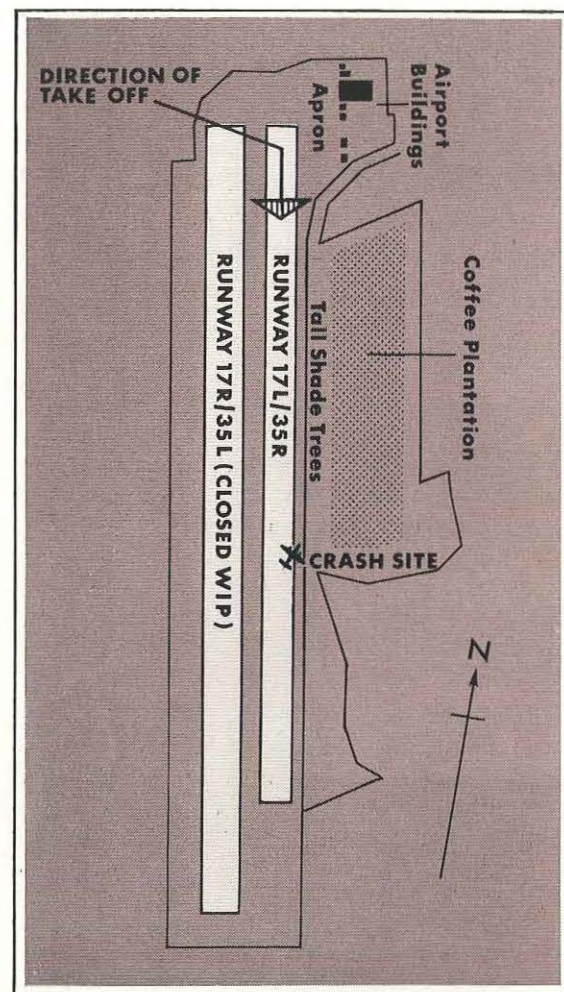
Diagram of Goroka Airport showing direction of take-off and position of wreckage.

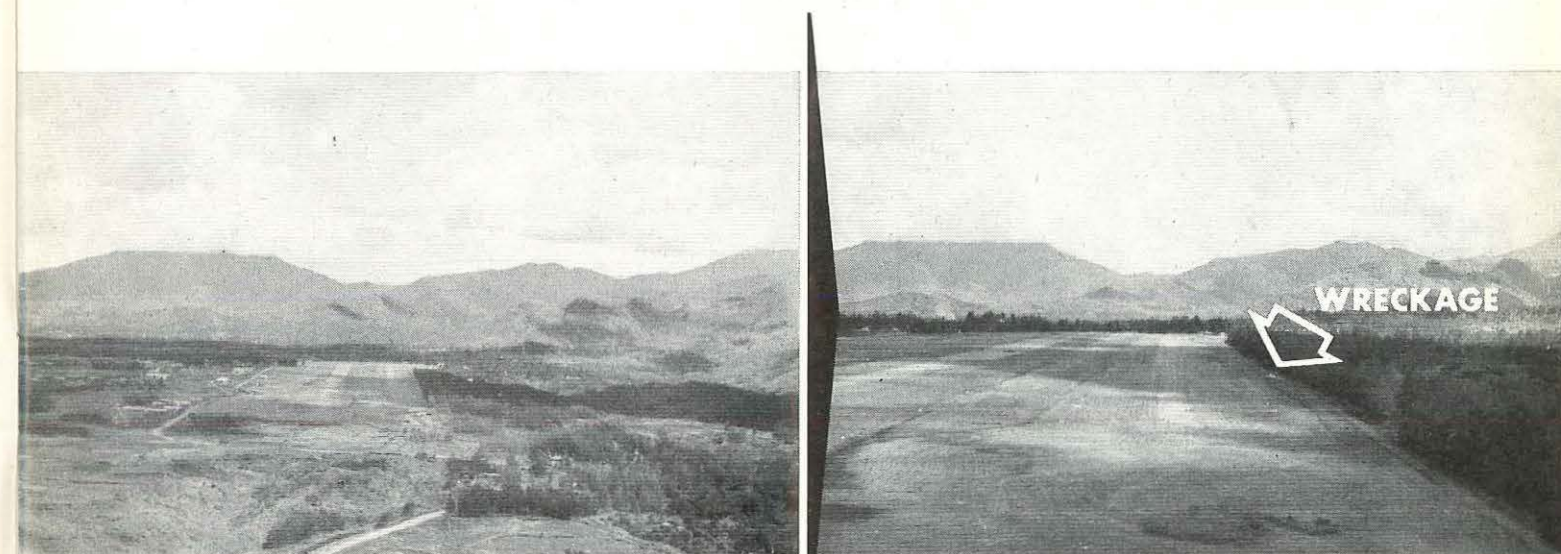
Goroka Airport as seen on the approach to Runway 35R (Reciprocal to aircraft's take-off path). The position of the wreckage is indicated.

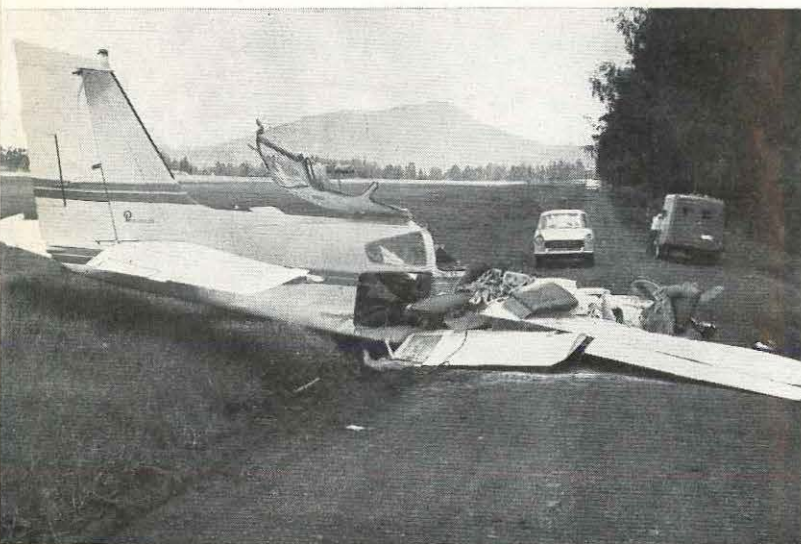
The damage sustained by the aircraft confirmed that it had struck the ground in a steep diving attitude of about 60 degrees to the ground. The point of impact was 3670 feet from the commencement of the take-off run and 120 feet to the left of the runway centre line. The wind was calm at the time and the visibility was unlimited, and the weather conditions had obviously played no part in causing the accident.

The Wreckage by the side of the runway looking back in the direction of take-off.

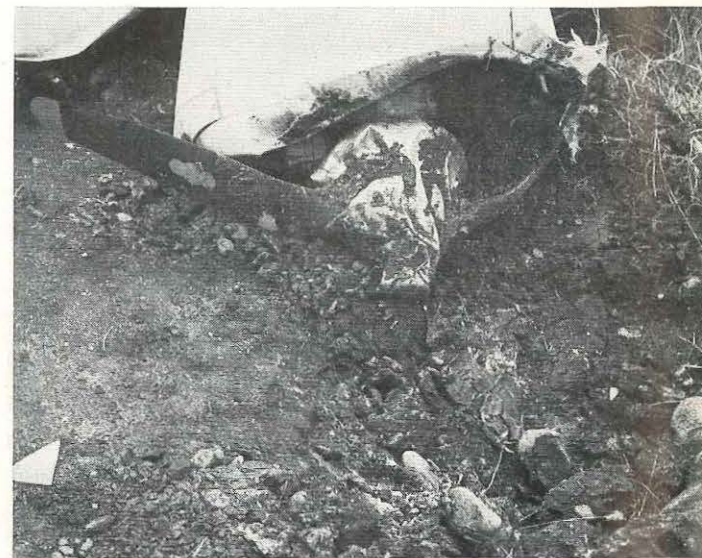
The damage to the propellers indicated that the engines were delivering little, if any, power at the time of impact. A detailed examination of the engines showed that they were nevertheless capable of normal operation at this time and there was no evidence that the fuel system had been mismanaged. This appeared to confirm the evidence of eye witnesses that a change in power occurred at or near the top of the climb, and it was considered very unlikely that the aircraft could have achieved the flight path and height observed if any reduction or loss of power had occurred earlier.

The impact crater made by the port engine. The damage to the propeller clearly indicates that the engine was developing little, if any power at the moment of impact.

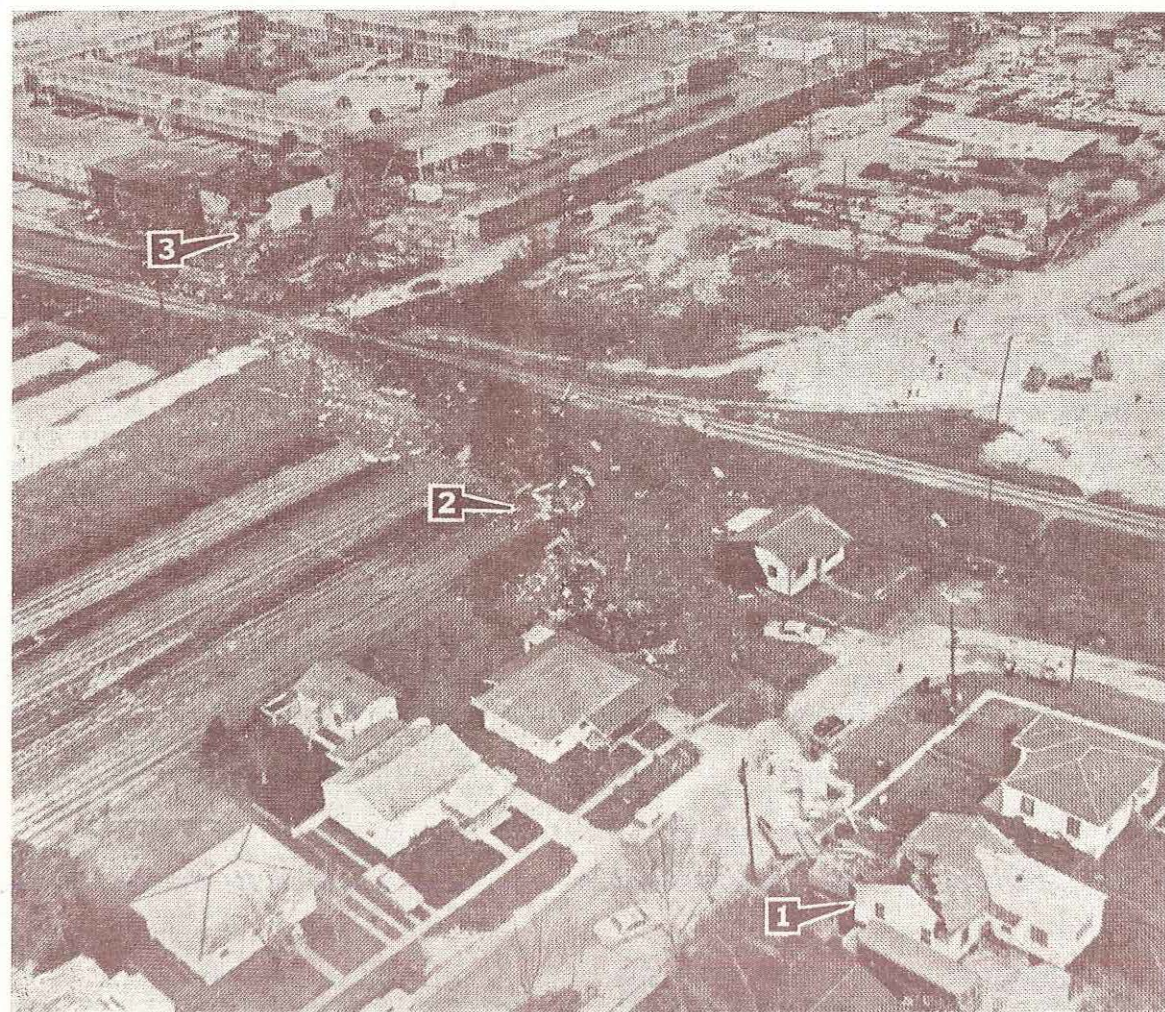
The trail of destruction left by the aircraft. The house (1) was struck immediately after the initial impact with a tree. The aircraft then struck the ground at (2) completely demolishing a second house. The wreckage finally came to rest against the motel (3). (Associated Press Photograph.)

The National Transportation Safety Board determined that the probable cause of the accident was improper supervision by the instructor and improper use of flight and power controls by both the instructor and the captain-trainee during the simulated two-engined out landing approach, which resulted in a loss of control.

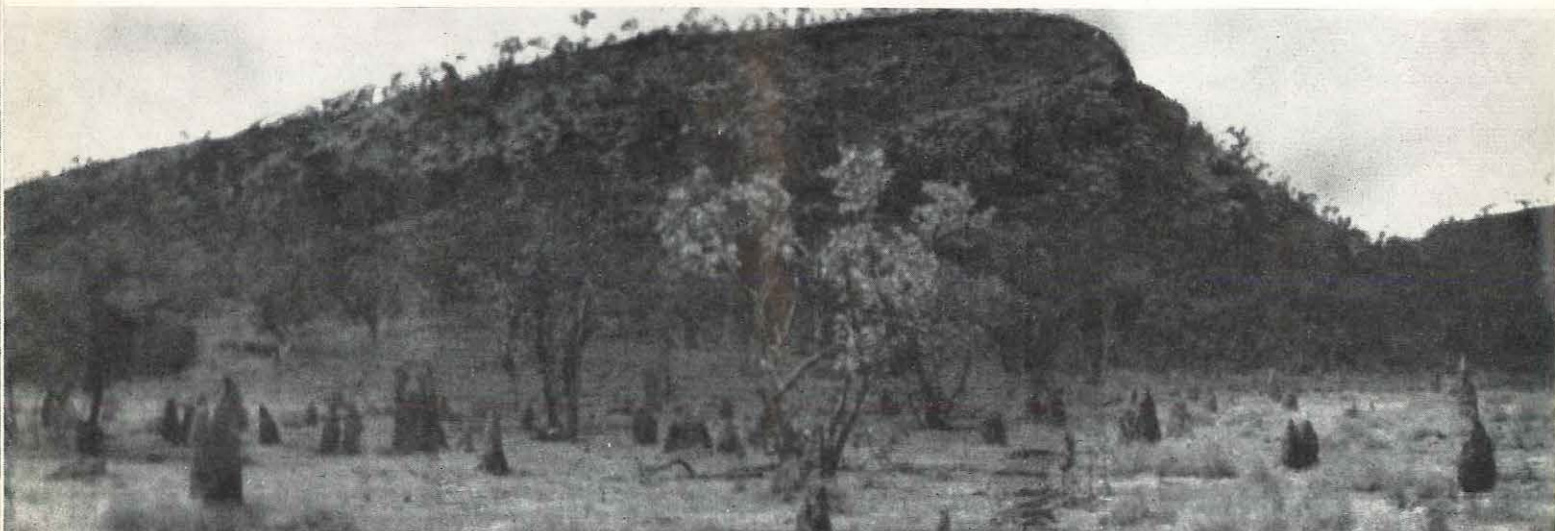
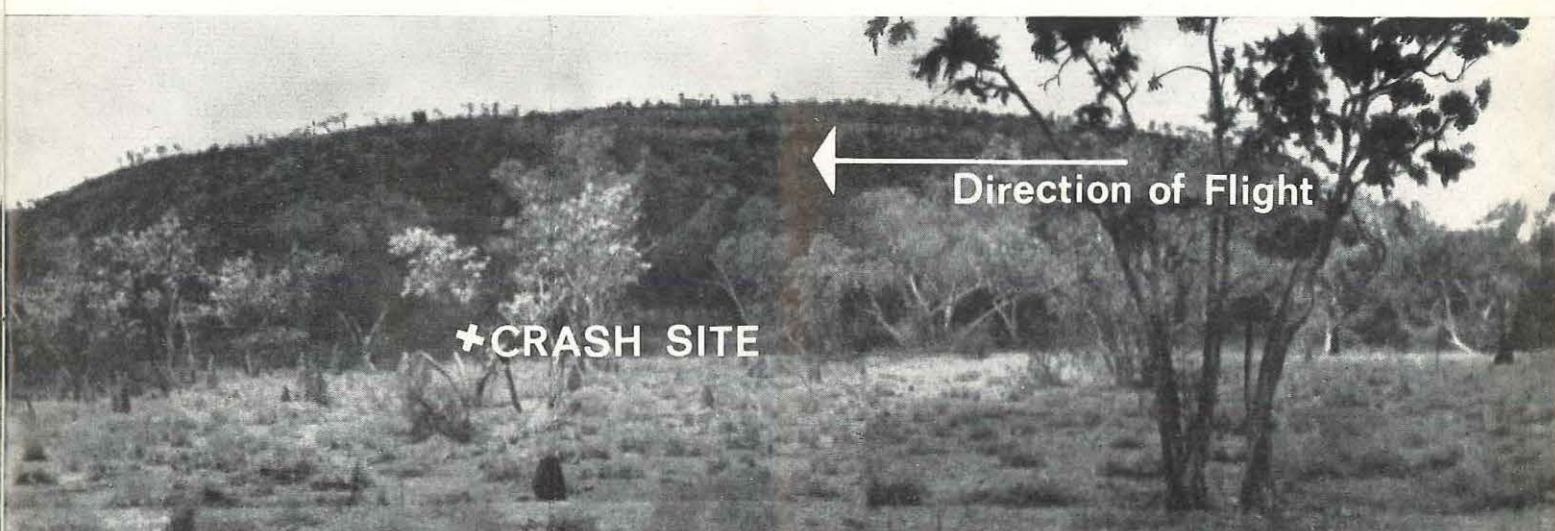
(Below) The escarpment to the north of the camp site which the aircraft was turning to avoid when it crashed. The photograph was taken a little to the south-west of the camp site.

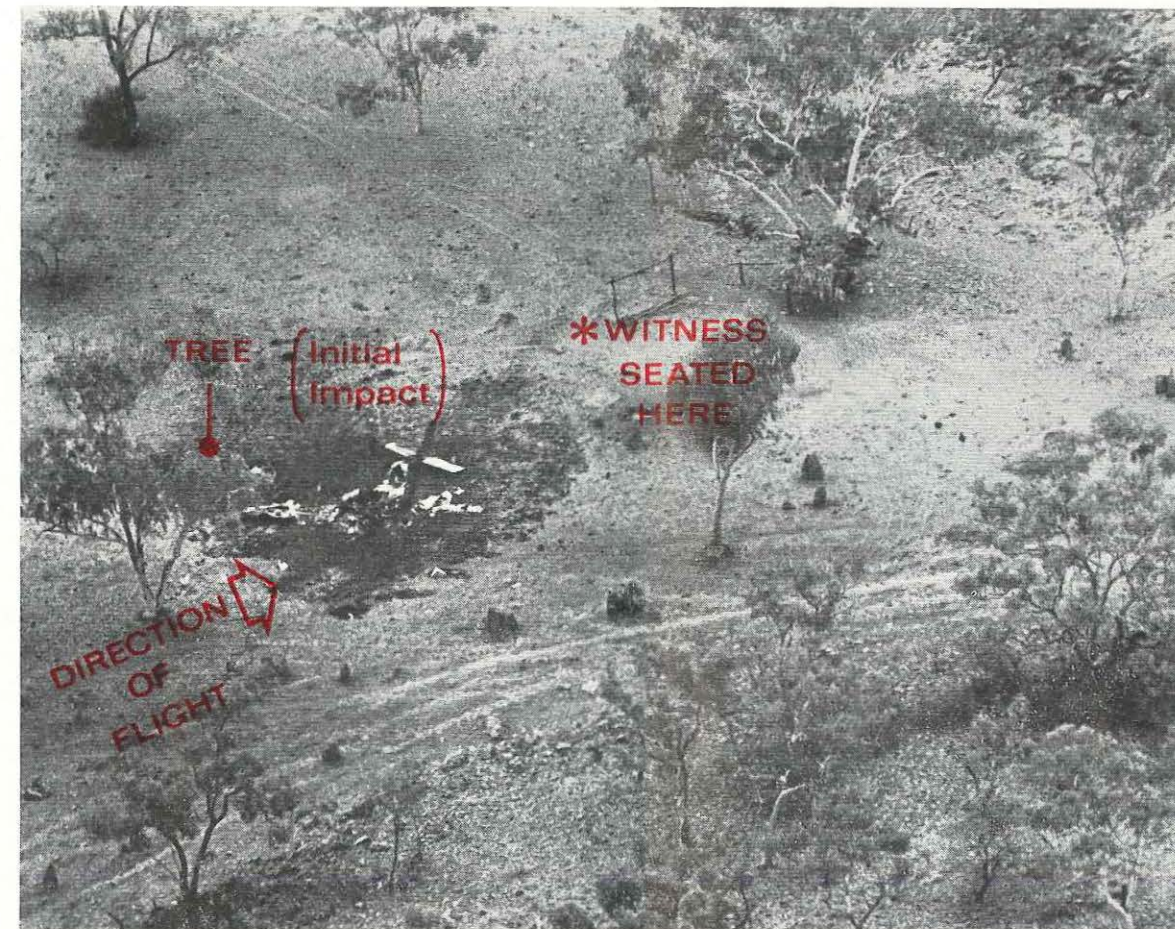
Examination of the wreckage confirmed that the engine was delivering substantial power at the moment of impact. It was established that the aircraft was intact when it struck the tree immediately before ground impact, and there was no evidence that any defect or malfunction in the aircraft had contributed to the accident. It was also established that the flaps were lowered about 15 degrees, that the undercarriage was retracted, and that the aircraft was loaded to its maximum weight at the time of the accident. A damaged watch found in the wreckage had stopped at 0649 hours.

The camp site and wreckage of the aircraft as seen from the air, looking south-west.

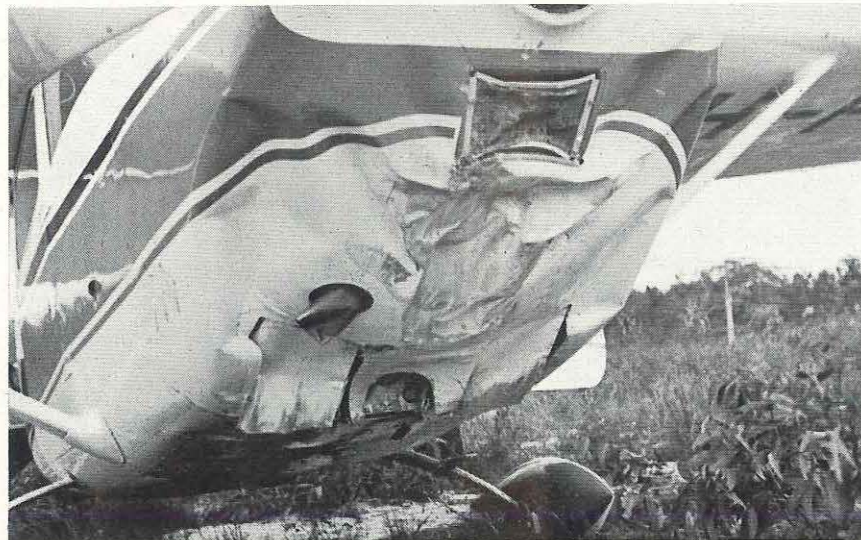
Damage to the air intake, exhaust system and the lower side of the engine compartment, where both the carburettor and fuel filter bowl are located, is clearly evident in this photograph.

Although the lower portion of the engine compartment was extensively damaged as shown in the photograph above, including breaking the carburettor off the intake manifold, no fire broke out and the aircraft was later repaired and re-

stored to service. The nose leg failure was attributed to damage sustained during a previous landing or take-off.

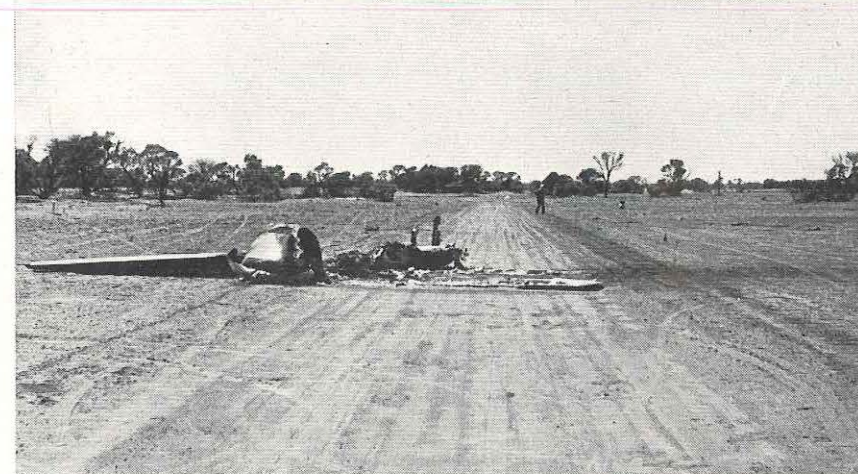
All that remained of the other Cessna 182 after the accident near Wilcannia. The pilot neglected to turn off the fuel when the nose leg collapsed.

The pilot then returned to the aircraft, turned off the magneto switches and began to examine the damage. He said as he was doing so, a sudden explosive "puff" of flame leapt out from in front of the engine compartment firewall on the lower starboard side. Fanned by the strong wind, which was blowing from the starboard side of the aircraft, the fire quickly spread. Soon afterwards, the starboard fuel tank exploded and the whole aircraft was engulfed in flame. It was completely burnt out within about 15 minutes.

It was found later that the pilot had not turned off the fuel. It was probable that when the nose leg failed, damage occurred to the fuel system in the vicinity of the carburettor or the fuel filter

It is very likely that, had this pilot adopted the same procedure as the pilot in the first accident, no fire would have broken out and the aircraft would not have been destroyed. Although, the occupants were out of the aircraft before the fire broke out, it is easy to see that in circumstances only a little different, occupants who might otherwise be uninjured could be trapped and incinerated. All because the pilot didn't remember to turn the fuel off when the aircraft ran into difficulties!

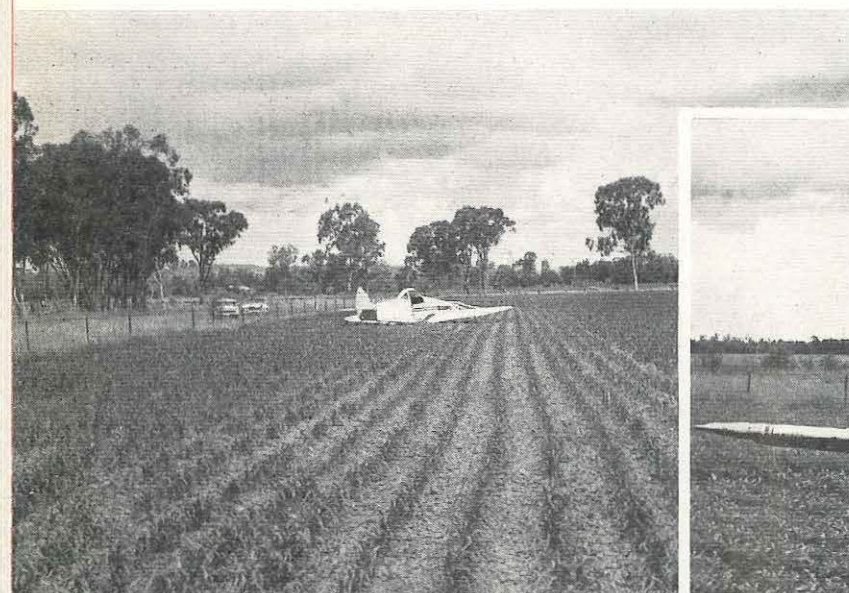
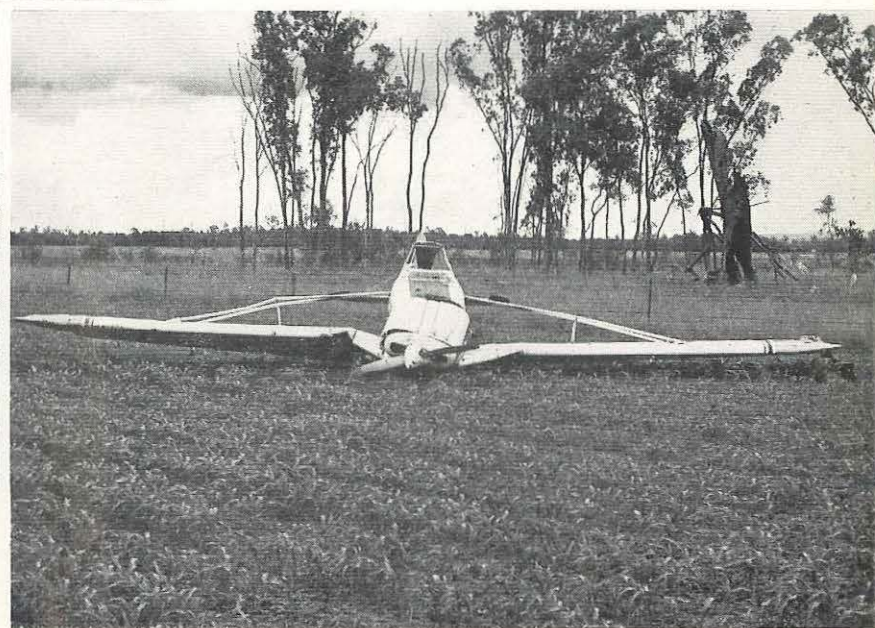
The pilot of the sorry looking Pawnee in the pictures above, was spraying a crop of cotton in a large level field in Queensland, making his spraying runs north-east, south-west, and parallel to a three wire power line which bounded the south-eastern side of the paddock.

momentarily reduced power to regain a level attitude. Retarded by the stretching power cable, the aircraft decelerated and began to sink rapidly. The pilot re-applied almost full power and pulled the control column back hard just before the aircraft struck the ground. It fell down heavily in a level attitude with almost no forward speed, collapsing the undercarriage and dislodging the engine mounting and wing root attachments, but the pilot, who was wearing a crash helmet, escaped with only minor injuries.

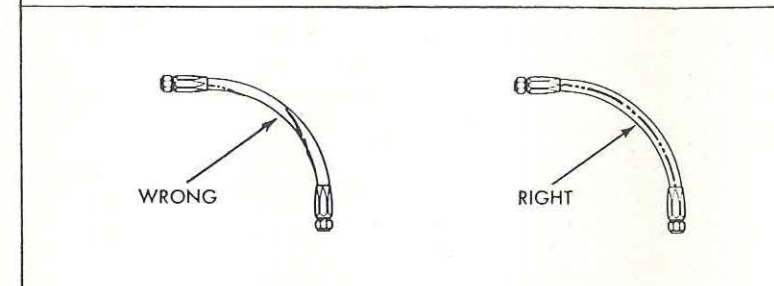
Fig. 2

Note the position of the linear stripe. Care must be taken to ensure that the hose is not twisted. High pressure applied to a twisted hose can loosen the gland nuts, or even cause the hose itself to fail.

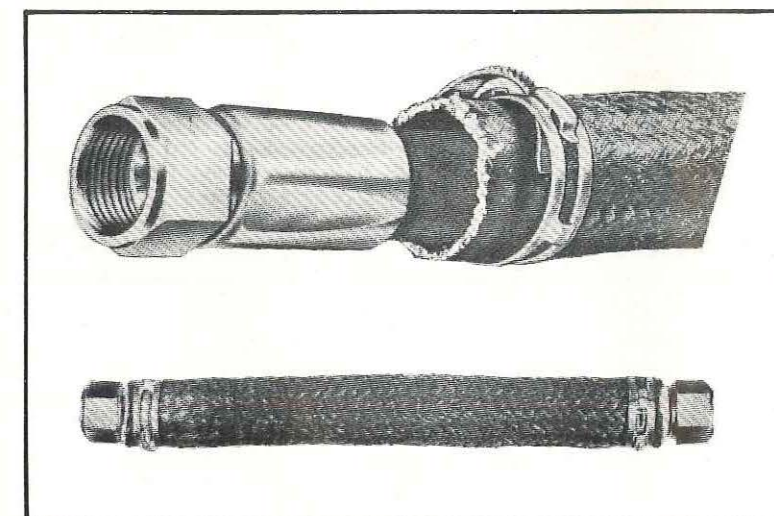
Fig. 4

A fire sleeve fitted to a flexible hose. Note how the sleeve may be pushed back after releasing the clamp, to enable the end socket to be gripped while installing the hose.

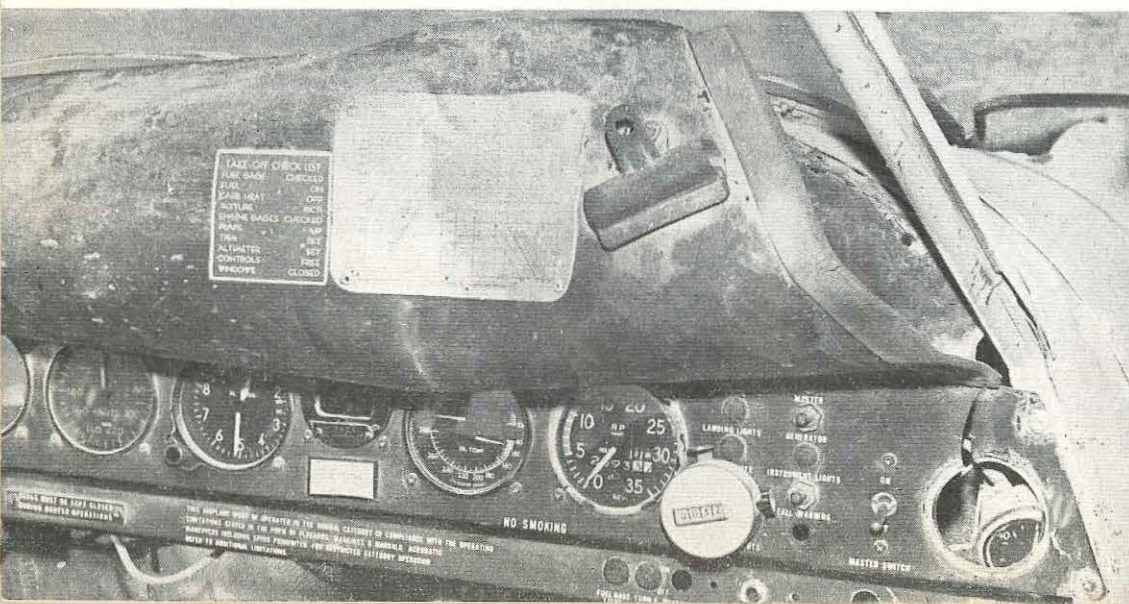
It is worth mentioning that the pilot's injuries in this case were mainly facial and were evidently caused by striking a bulldog clip (used to hold notes, sketch maps, etc.) which was screwed to the padded instrument panel coaming. (See Photograph). The placing of sharp objects in the cockpit, where they can cause injuries in the event of an accident is an obviously dangerous practice and completely nullifies any advantage gained by incorporating crash pads and other protective medium, in the design of the cockpit.

The instrument panel of the Pawnee, showing the bulldog clip attached to the crash pad.
