DEPARTMENT OF CIVIL AVIATION AUSTRALIA

**AVIATION
SAFETY
DIGEST**

No. 58 SEPTEMBER 1968

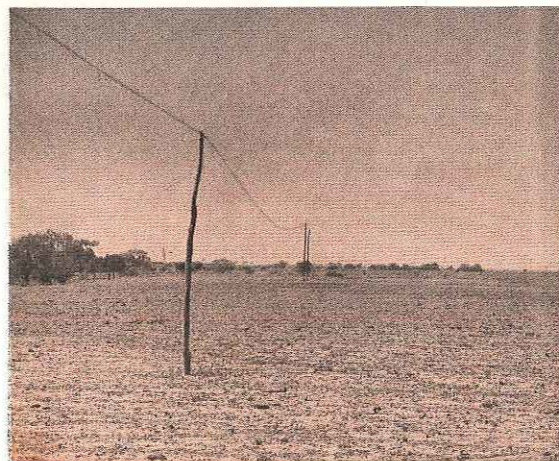
The telephone line 250 feet beyond the edge of the clay pan, under which the aircraft passed.

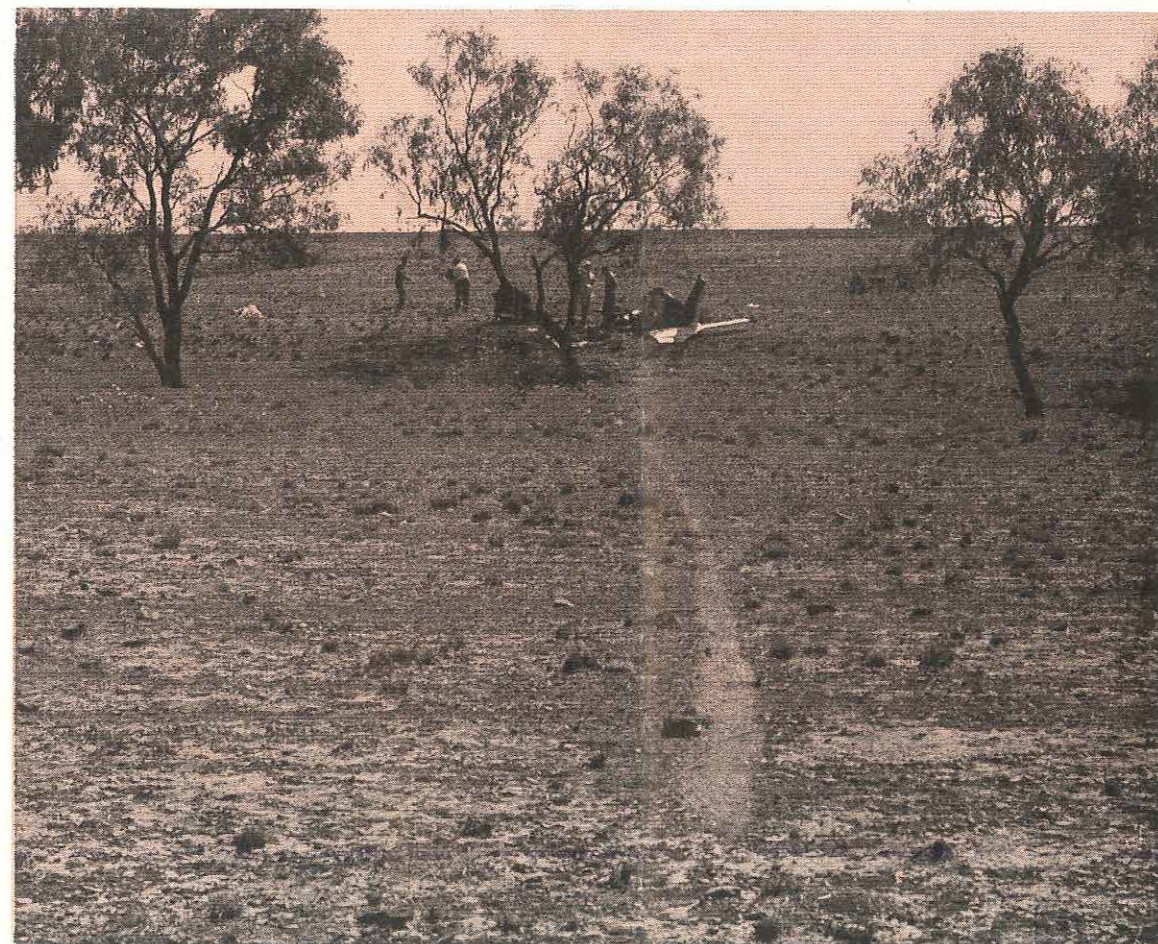
The burnt-out wreckage just beyond the line of trees in the creek bed. Note the ground mark made by the aircraft immediately before impact.

The cause of the accident was that the pilot attempted to take-off on a strip which was of insufficient length under the existing conditions.

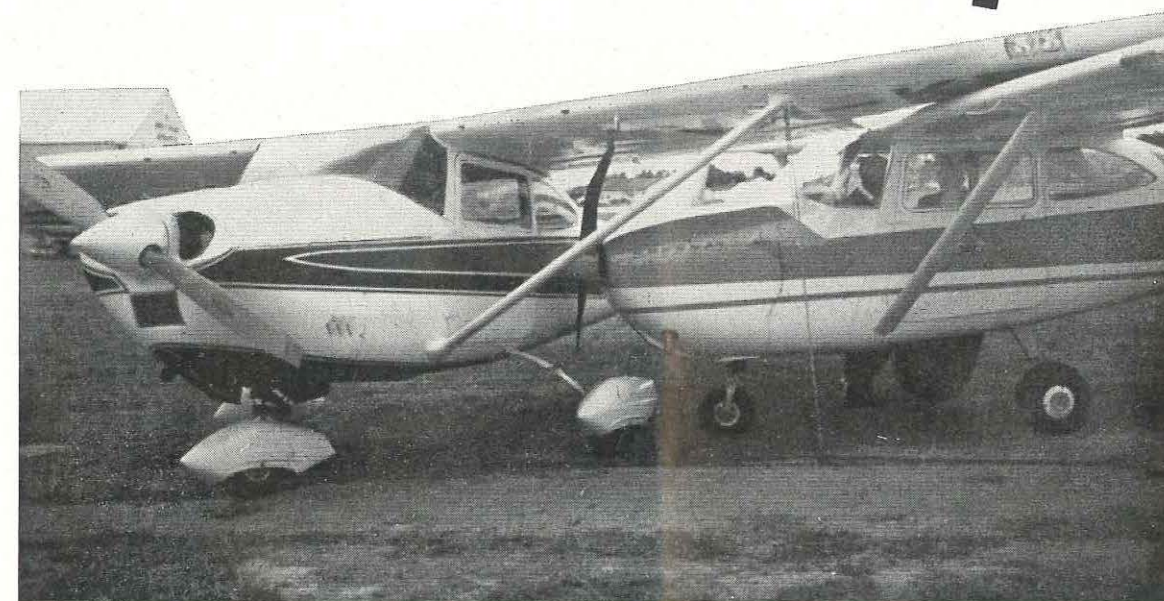
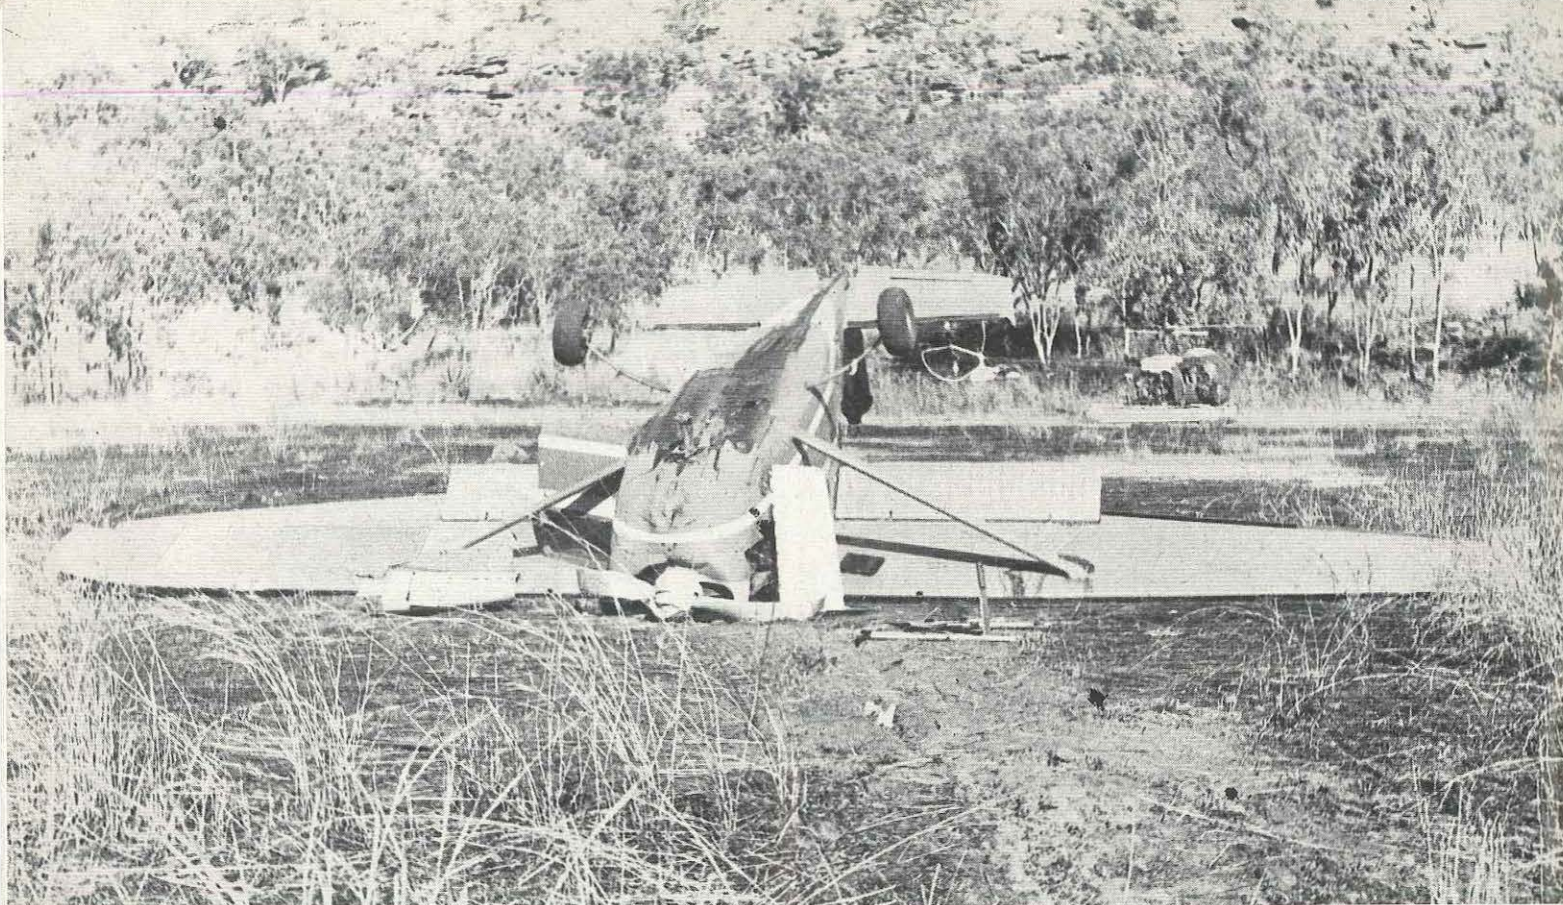
shown in the photographs, both the 182 and the 172 were damaged substantially.

The aircraft's brakes were subsequently tested, but could not be faulted, and the collision was attributed to the pilot's lack of care in manoeuvring his aircraft. The fact that the pilot, who was of small stature, had not adjusted the control seat when he entered the aircraft might have contributed to the incident. The seat was well back on its rails, and it is probable that from this position the pilot was unable to apply adequate braking.

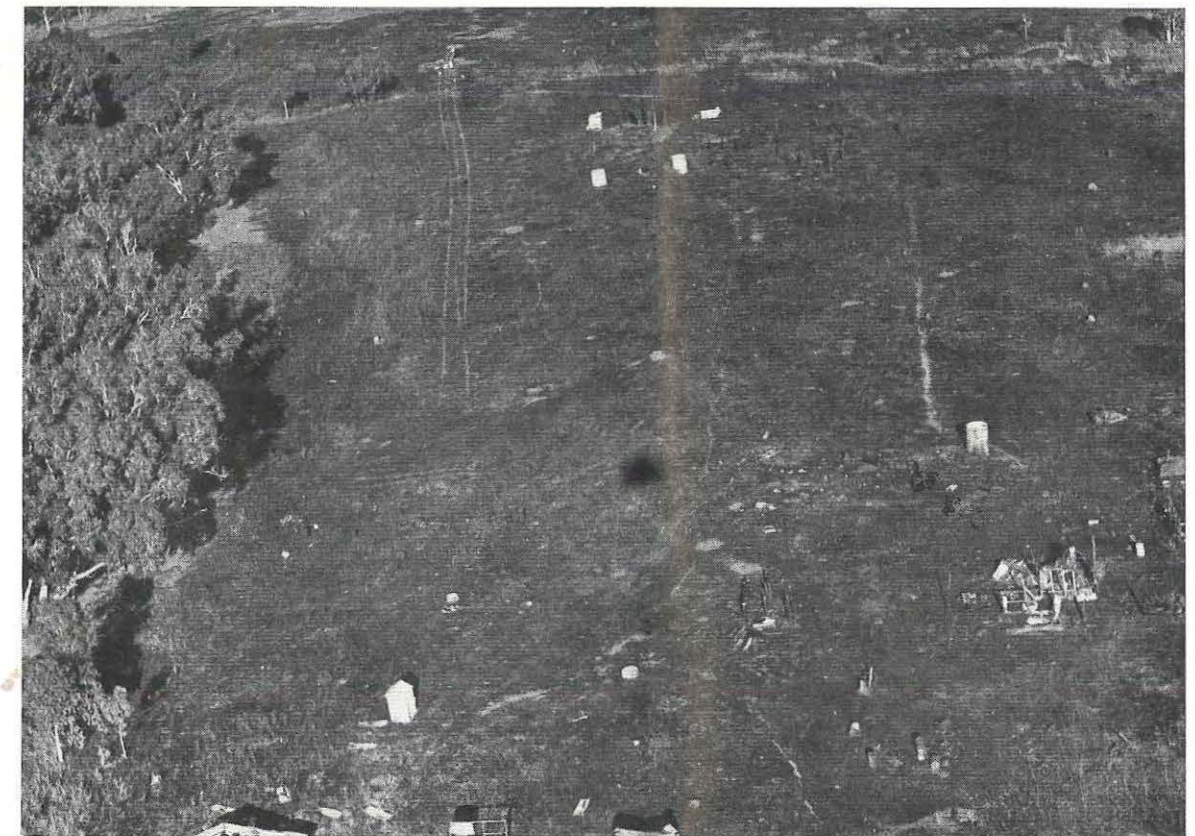
Below: Aerial view of the area on which the landing attempt was made. The aircraft's tracks can be seen across the fire-blackened surface.

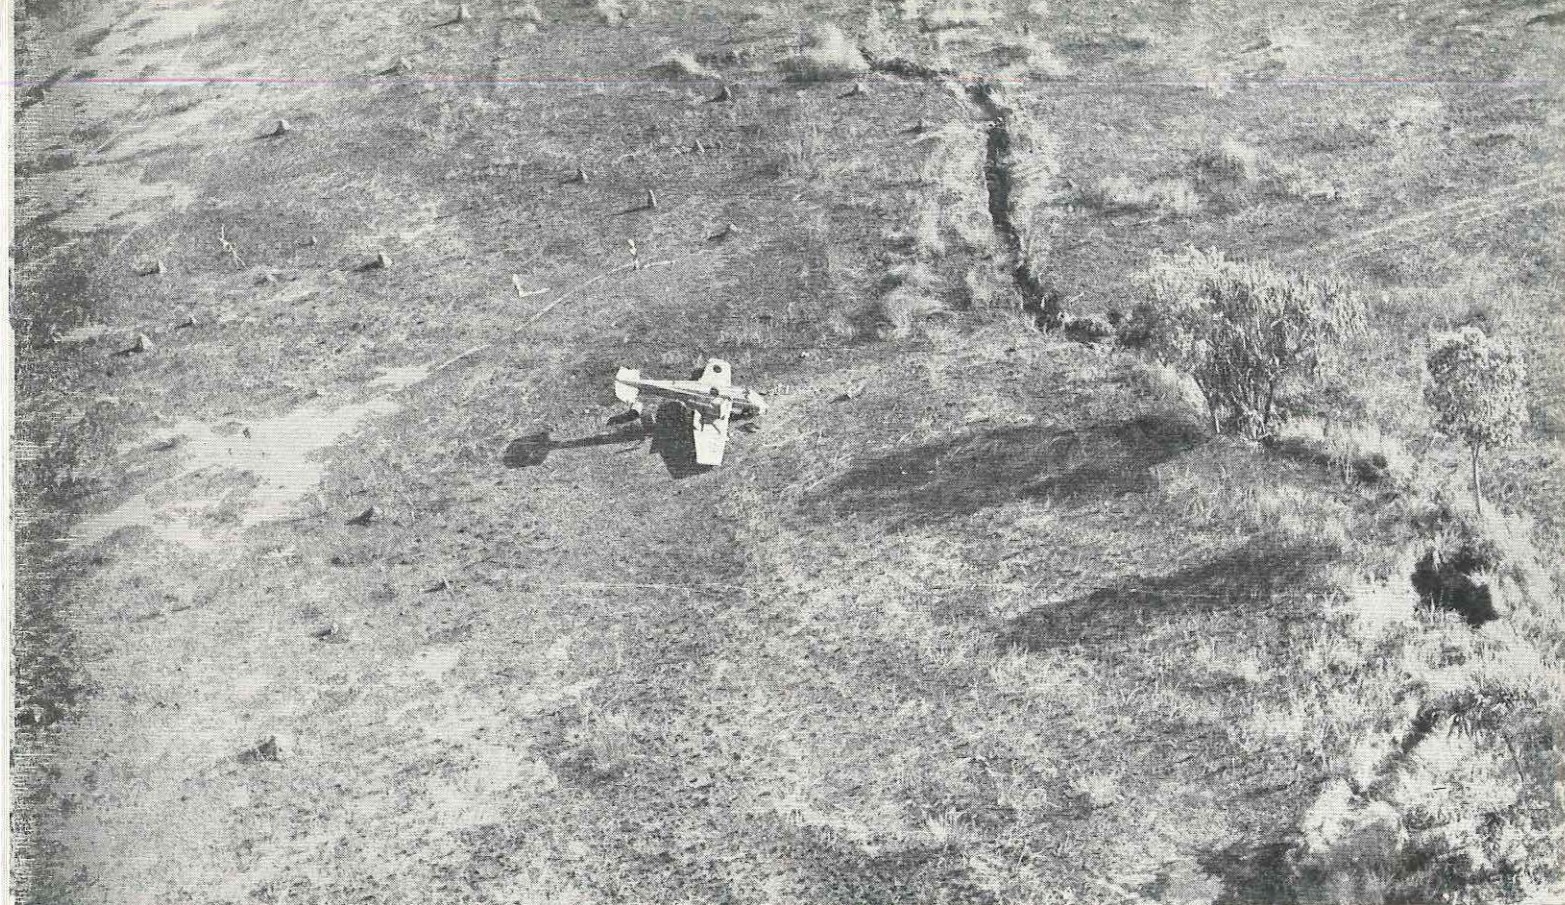
The easily-recognisable erosion gully seen from the air.

It is difficult to understand how the pilot failed to notice the erosion gully across the proposed landing path before he committed himself to landing on this grossly inadequate area. The pilot said afterwards that he did not see it because the whole area had been burnt black and the edges of the gully were hidden by tufts of grass. It is quite evident, however, that the pilot's inspection of the area from the air must have been very cursory, for, as the photographs on these pages show, the gully itself was clearly visible from overhead and from almost any angle

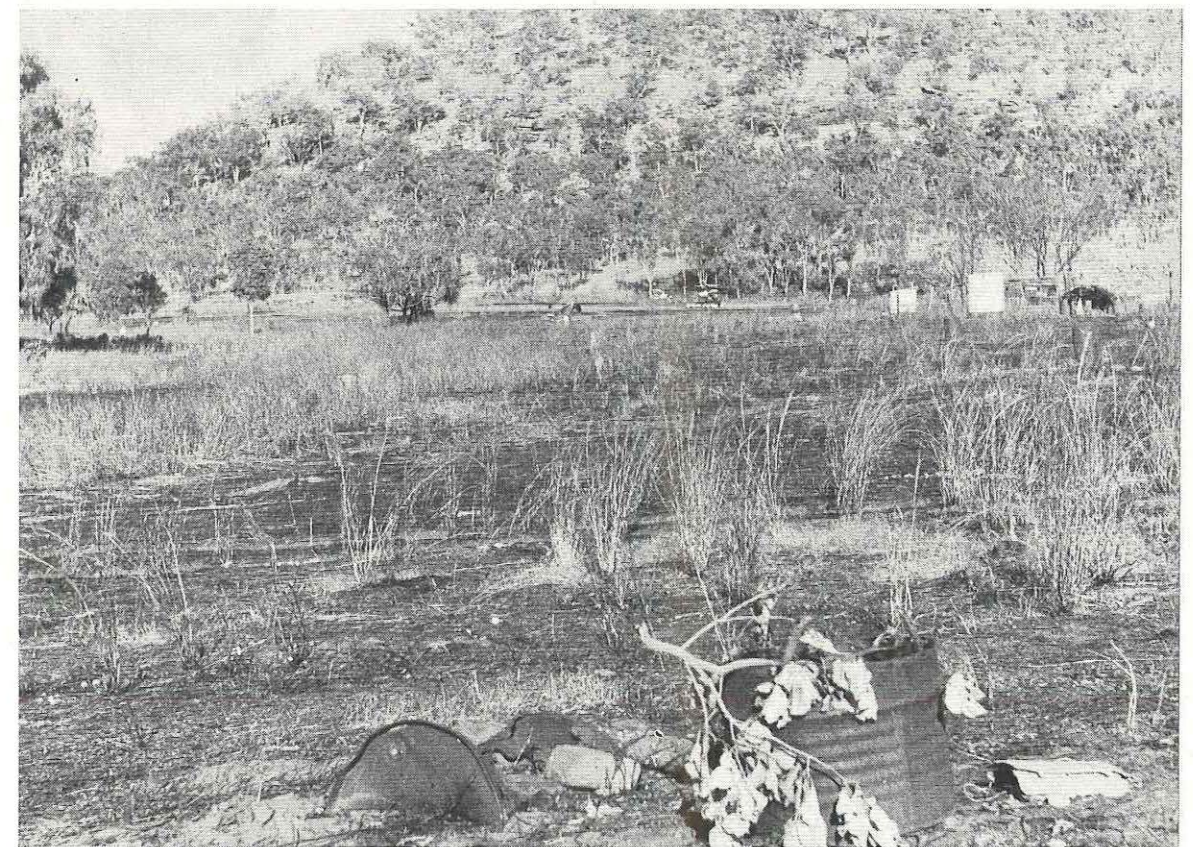
Inspection of the strip on which the pilot had attempted to land showed that it was grossly inadequate for the operation. Apart from the fact that the strip was unsuitable for normal category operations because of the hill at its south-western end, the effective operational length was very much less than that required. From the threshold marked by the drums to the erosion gully in which the aircraft crashed was only 600 feet. Obstructions on the approach end of the strip reduced the effective operational length even

further to only 550 feet. From the aircraft's Flight Manual it was determined that, with the load the aircraft was carrying in the prevailing conditions, an effective operational length of 1550 feet would have been required for the landing. Although the damage to the aircraft was repairable from a technical point of view, the area where the accident occurred was so inaccessible and remote that salvage of the aircraft was considered uneconomical.

View of landing path from "threshold" marked by drums. Note the steep hill beyond the end of the "strip".

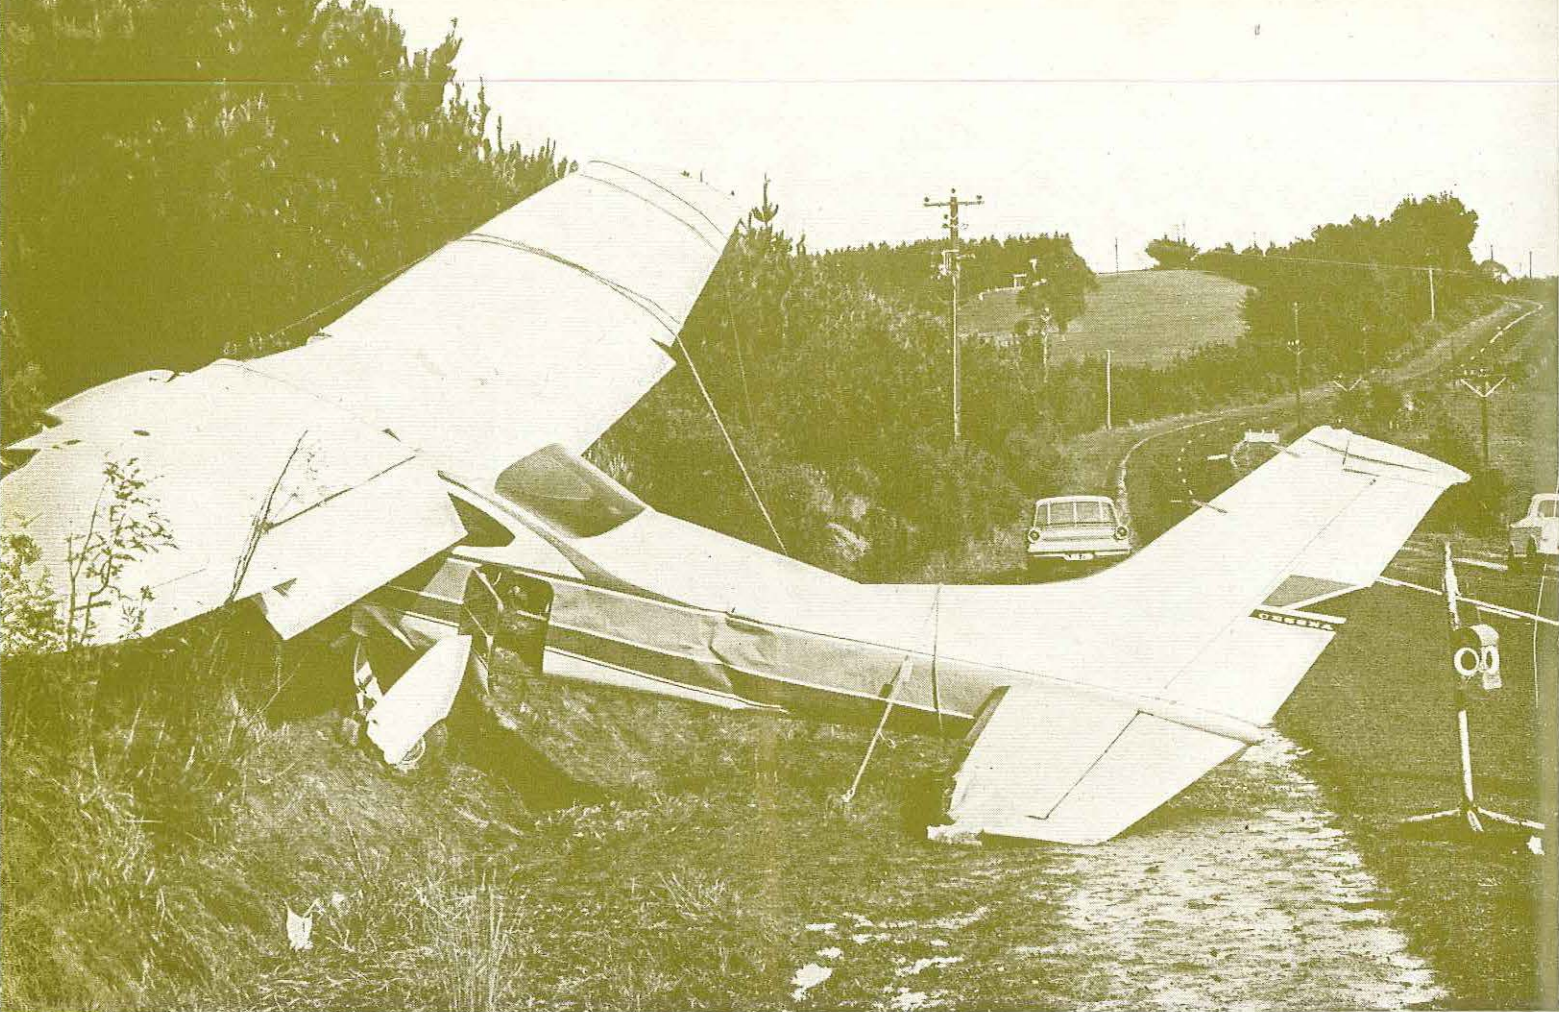
Left: The aircraft as it came to rest against the road embankment, badly damaged.

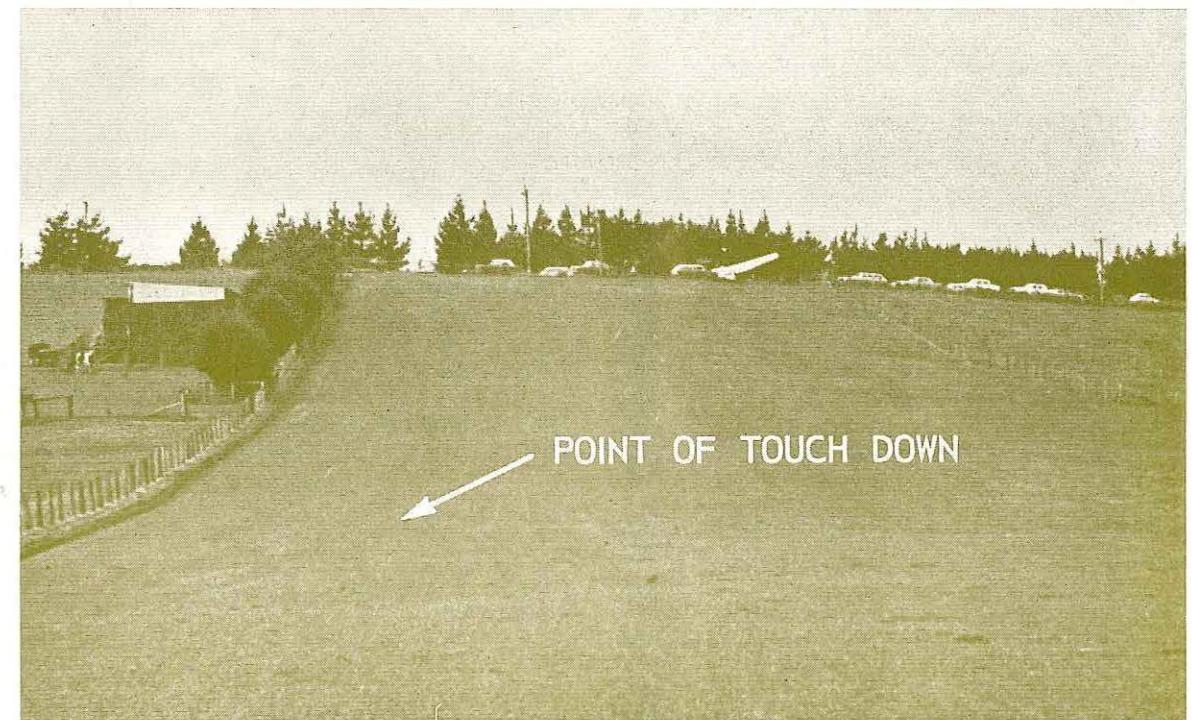
Below: Photograph looking up the strip in the direction of landing. The road and accident site can be seen in the background.

It was evident immediately the investigation of the accident began that the pilot's assessment of the wind strength was greatly in error and that this was a major factor in the accident. The pilot stated that he assessed the wind from the smoke of a nearby factory chimney and believed it to be about 10 knots. It was clear from the other evidence, however, including that of a private pilot who owns a property near the agricultural airstrip, that the actual wind strength was of the order of 30 knots. Inspection of the agricultural strip itself showed that it fell far short of the minimum strip requirements for normal category operations. Even for agricultural flying, because of the obstructions of the southern end, it was suitable only for "one-way" operations from the north. From fence to fence the overall length of the strip was only 1,550 feet, whereas the Flight Manual for the Cessna 182 shows that, even in nil wind conditions, a landing distance of 1,780 feet is required. The pilot had greatly over-estimated the gradient of the strip, and the effect this would have in assisting him to bring the aircraft to a stop and, with the 30-knot tail wind, there was absolutely no chance of completing a successful landing on the strip. Measurements showed that the aircraft, travelling at high speed because of the tail wind component, did not touch down initially until 900 feet beyond the threshold of the strip, leaving only 600 feet for the landing roll.

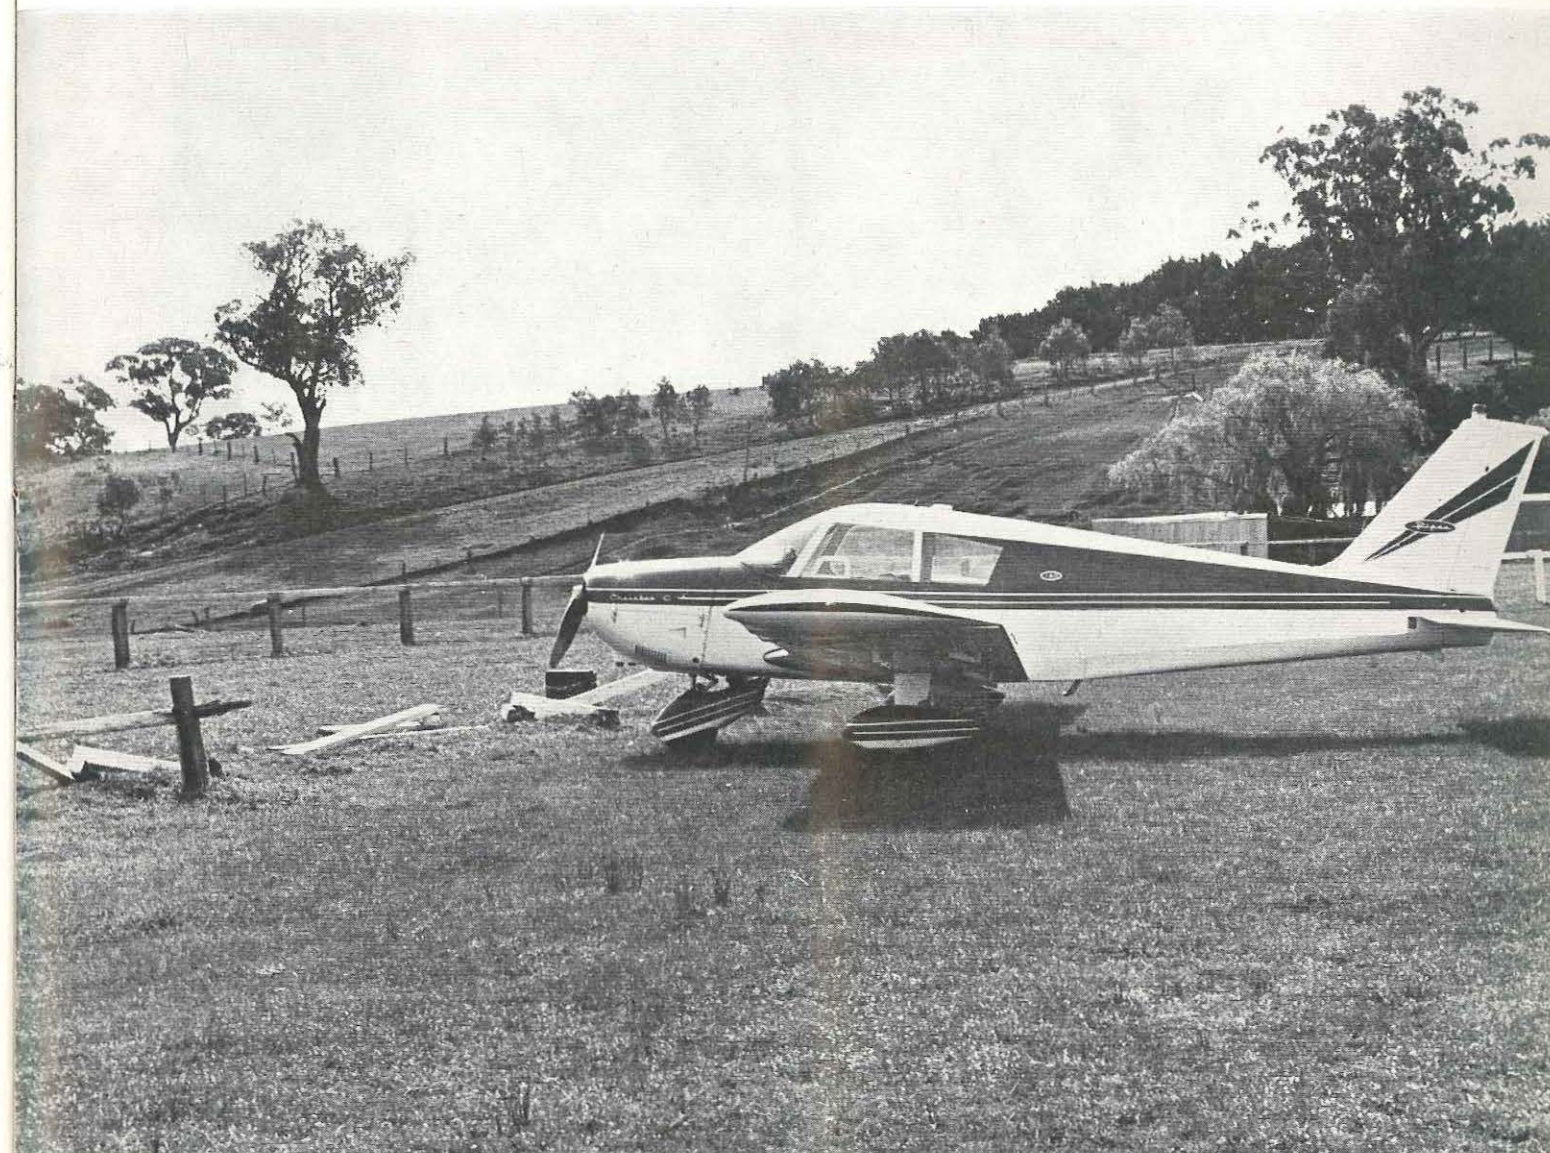
At the conclusion of a cross-country flight from South Australia the pilot of the Cherokee 180 shown in the picture made a landing on the racecourse of a town in western Victoria, where he had been told "there was plenty of room for the Cherokee 180." The landing was uneventful and the pilot disembarked two passengers and took off again. After flying to another nearby town and picking up a third passenger the pilot returned to the racecourse and prepared to land again. During the aircraft's absence, however, a light shower of rain had fallen which had made the grass surface greasy. The pilot made a

normal approach to land and after touching down applied the brakes. On the wet grass this had little effect and the pilot was unable to prevent the aircraft running into a wooden fence at the up-wind end of the landing area.

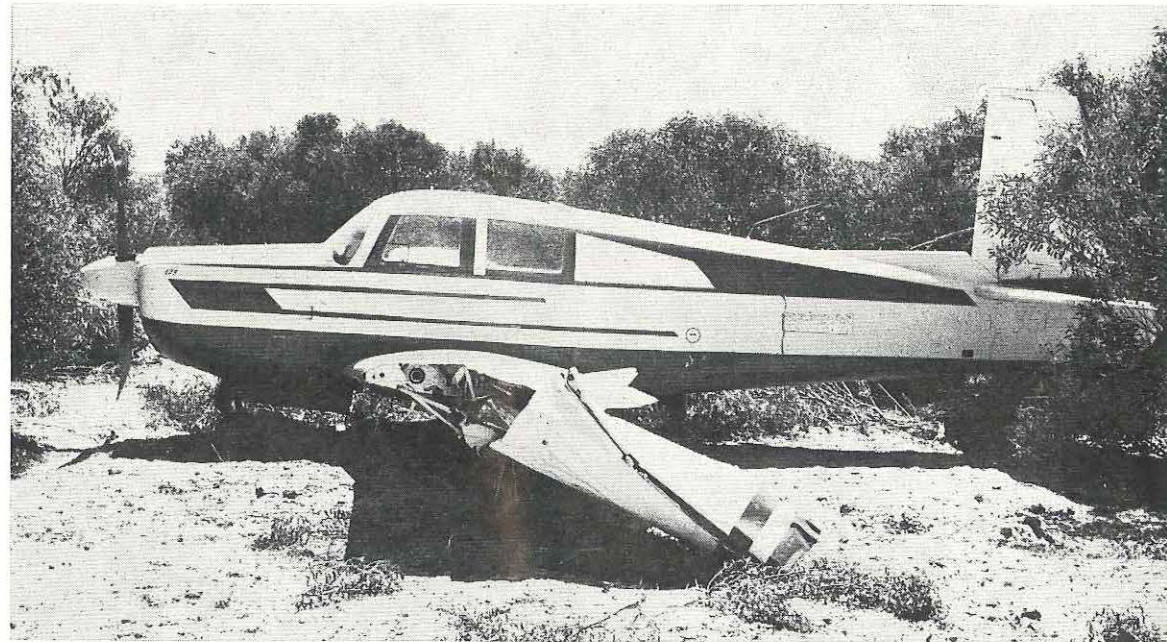
The pilot of this Mooney M20 attempted to take off fully loaded from a paddock in which the effective operational length of the run he had chosen was 1,800 feet. After using the length of the paddock without becoming airborne, the pilot attempted to lift the aircraft over the fence at the up-wind end of the paddock. The aircraft struck the fence with the undercarriage, the port wing dropped, then the starboard wing struck a bush and the aircraft slewed

to a stop badly damaged. The occupants escaped without injury. The pilot had not consulted the take-off performance chart in the aircraft's Flight Manual, which would have shown him that in the prevailing conditions an effective operational length of 2,200 feet on short, dry grass was required. In any case, because the paddock was covered in long weeds, it is very doubtful whether the area would have met the requirements of an authorised landing area.

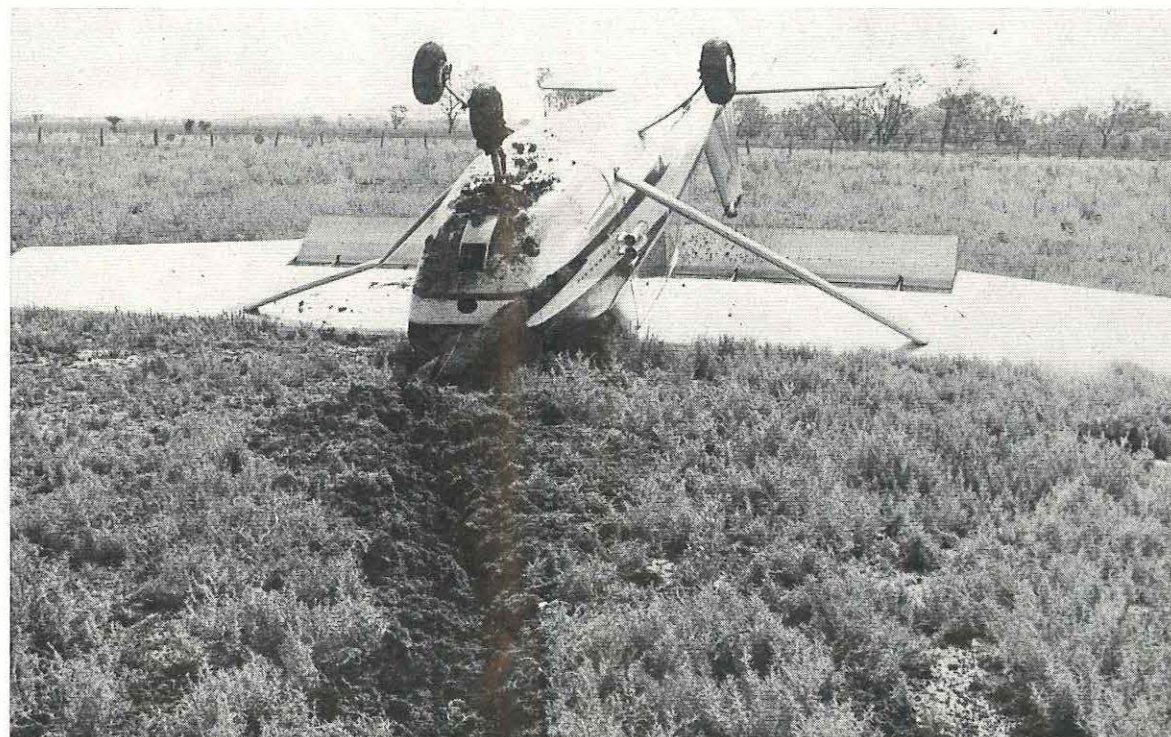
As the take-off run progressed the pilot realised that the aircraft's acceleration was being retarded by the softness of the surface and he became doubtful that the aircraft would become airborne before reaching the end of the strip. He closed the throttle, then applied the brakes lightly, but the nose wheel gradually sank deeper into the rain-softened surface of the strip and the aircraft nosed over on to its back, coming to rest just inside the up-wind end of the strip.

The overturned 172 as it came to rest near the end of the rain-soaked strip. The softness of the surface can be gauged from the depth of the furrow made by the nose-strut.

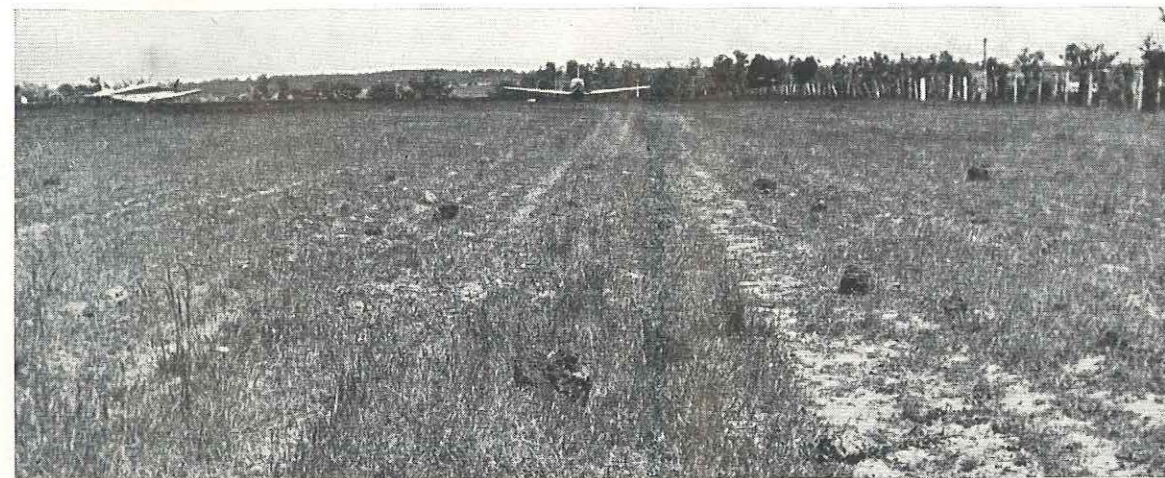
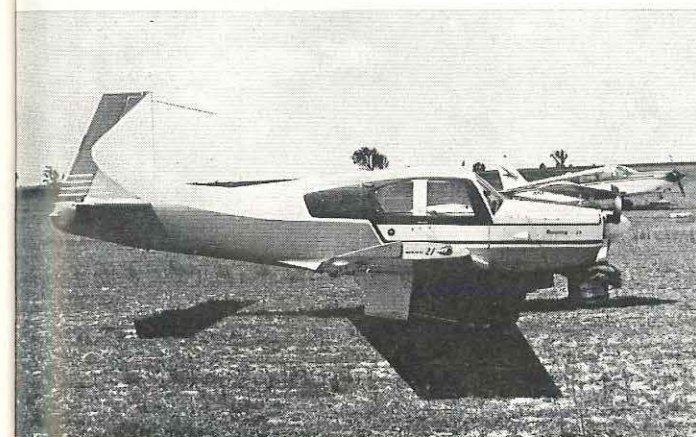
In the course of a cross-country flight from Armidale, New South Wales, to Dalby, Queensland, the pilot of this Mooney planned to land at the township of Deepwater, in the New England Ranges. Arriving over the airstrip at Deepwater, the pilot made a circuit to inspect its condition and carried out a normal approach to land, turning on to final at about 500 feet. The pilot made a normal touchdown on a mown area, but during the landing run the undercarriage struck some scattered rocks. The nose wheel strut collapsed, and the propeller was damaged.

It was found that the pilot had landed on an area alongside the airstrip and not on the strip itself. The area on which the aircraft landed had been mown more recently than the strip itself and this misled the pilot into believing the mown section was the airstrip. The airstrip itself was marked with white painted motor tyres, and, although it was heavily grassed, these markers were clearly visible from the air. It was obvious that the pilot had not taken sufficient care during his inspection of the area before landing. Had he taken the trouble to properly identify the boundaries of the airstrip before beginning his approach the accident would not have occurred.

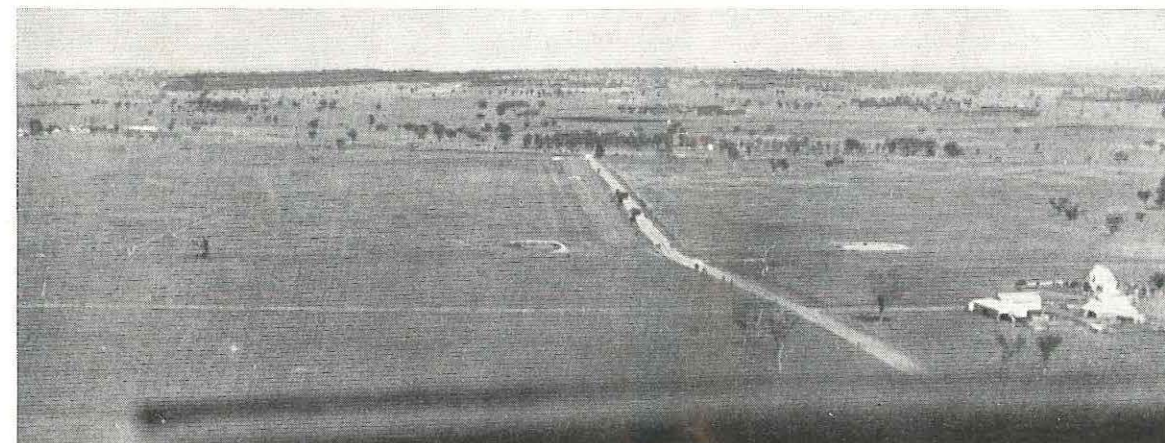
Below: The mown area on which the aircraft landed, as seen on the approach. The strip itself is immediately to the left.

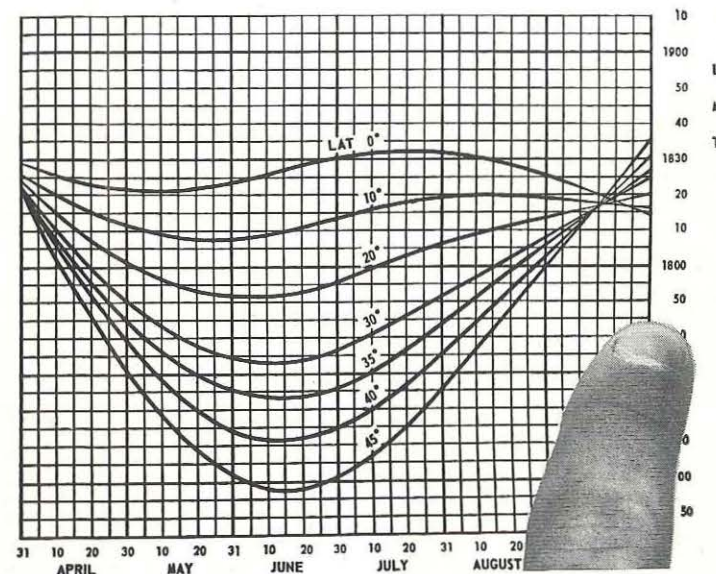
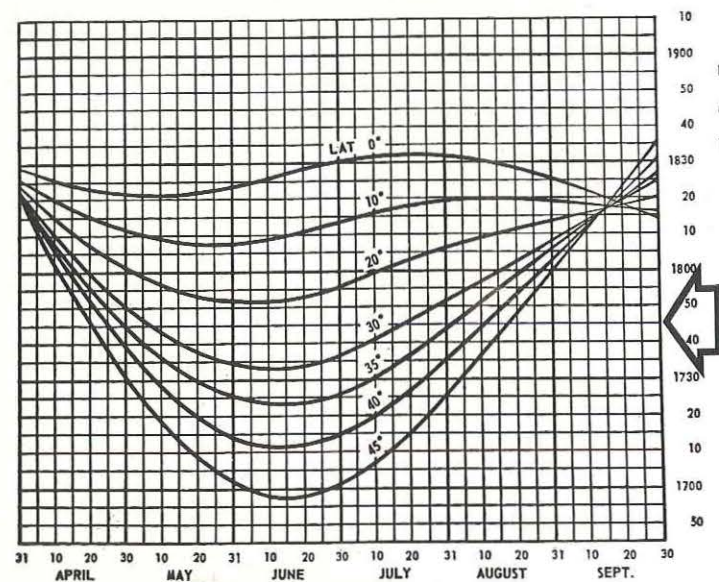
When reading across from the daylight and darkness curves to the local mean time scale at the margin of the graphs, it is possible to associate the reading with the hour numerals above the reading, rather than the applicable hour figures below the reading. In this way the graphs can be misinterpreted by one hour. The error is especially likely when running a finger from the curves across to the time scale. As shown in the photographs, the finger then covers the hour numerals applicable to the position on the scale as determined from the curves.

The reading shown in the top picture could be interpreted as 1845 hours. As is clear from the lower picture, the true reading is 1745 hours.

We appreciate our reader's interest in bringing this matter to the Department's attention, and action is being taken to eliminate the difficulty in the next reprinting of the daylight and darkness graphs.
