DEPARTMENT OF CIVIL AVIATION AUSTRALIA

AVIATION SAFETY DIGEST

No. 59 NOVEMBER 1968

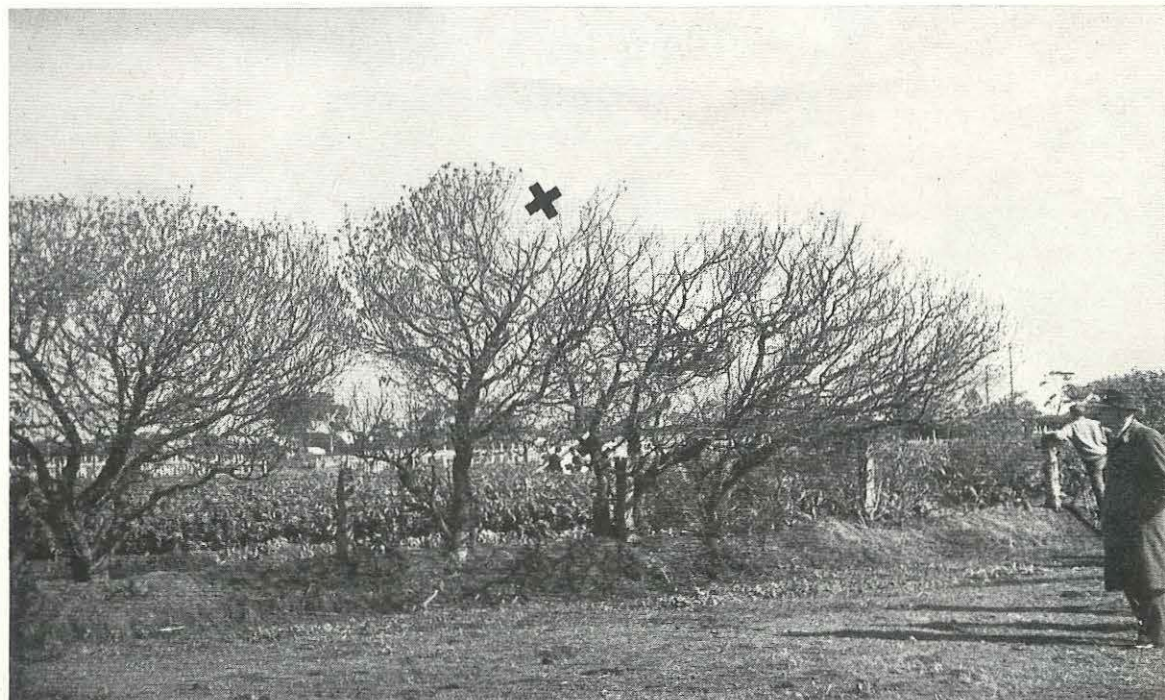
The line of trees over which the pilot attempted to lift the aircraft. The cross indicates where the port wing struck an upper branch.

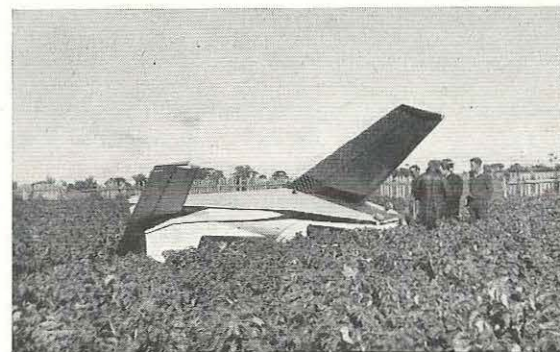
The aircraft upside down in the market garden, looking in the direction of flight.

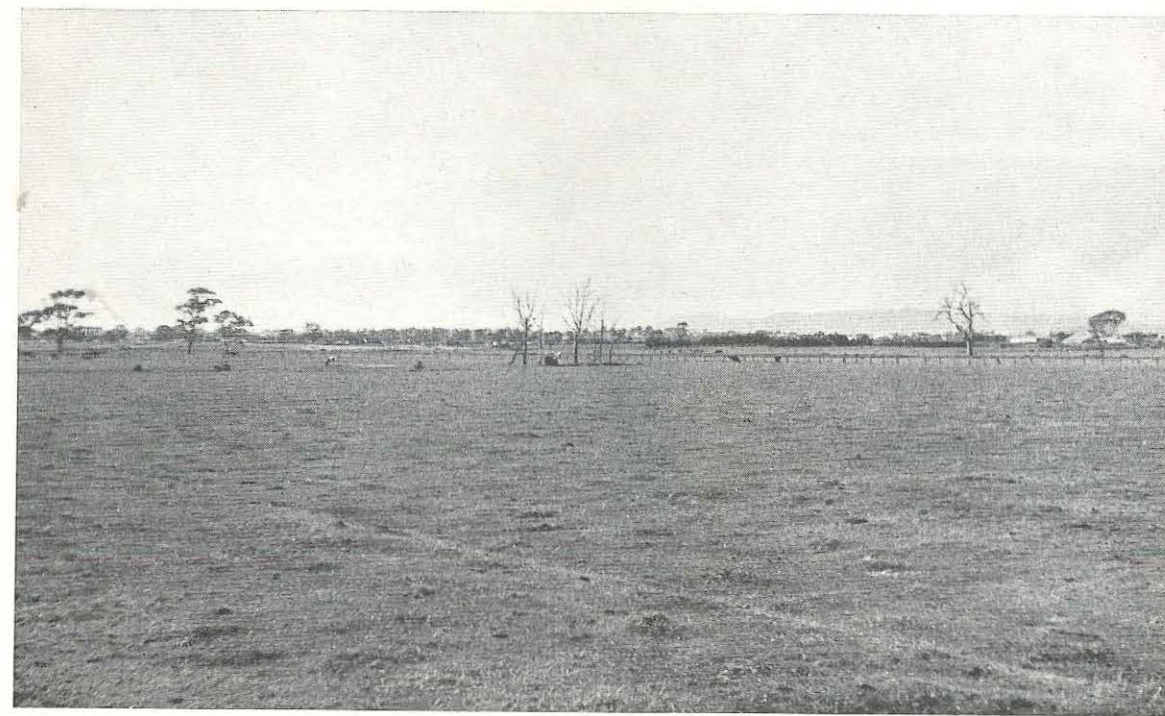
The paddock in which the pilot attempted to land, looking back in the direction of approach.

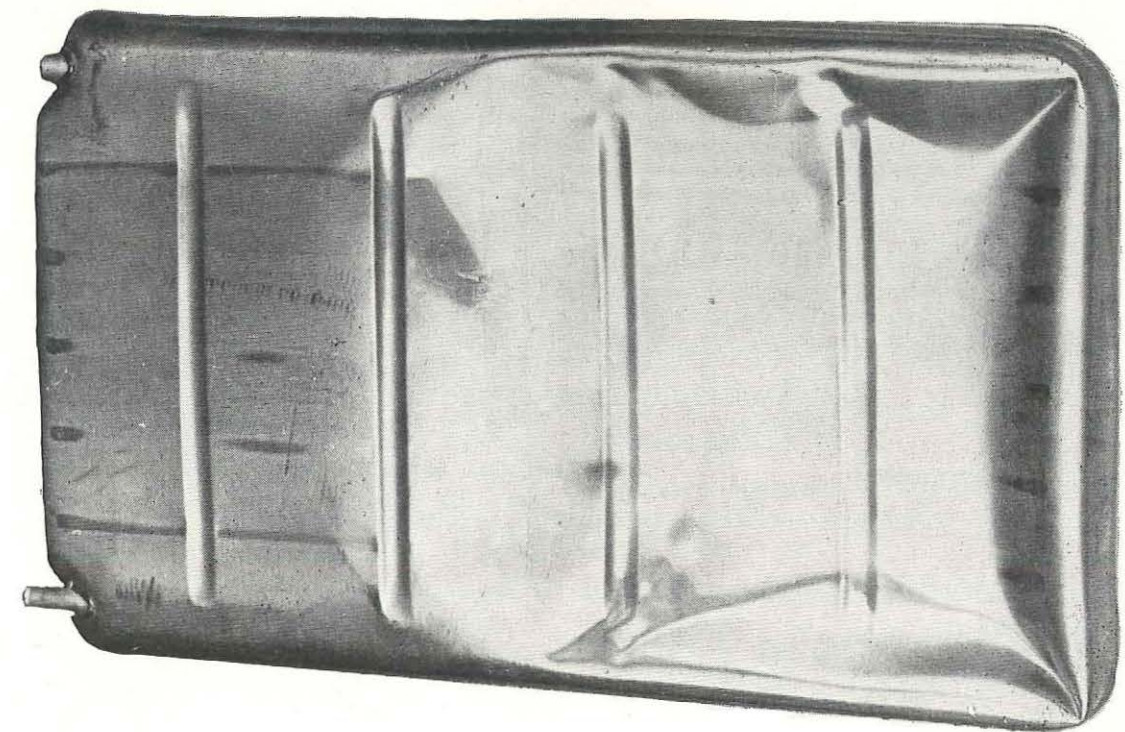
One of the two inter-connected starboard fuel tanks, showing the degree of collapse.

tinued to draw from the tanks.* The reduction in the capacity of the tanks resulting from the collapse, was very much greater than the quantity of fuel that the rear engine could have consumed during the short period of operation on the flight on which the accident occurred. It was evident that the tank venting system had become blocked some time before the flight on which the accident occurred and led to the collapse of the tanks, and that on this last flight, the rear engine had failed as a result of fuel starvation. A close examination of the rear engine fuel lines was made to determine whether on this occasion, any blockage or contamination might have been responsible for the fuel starvation, but no such evidence was found.

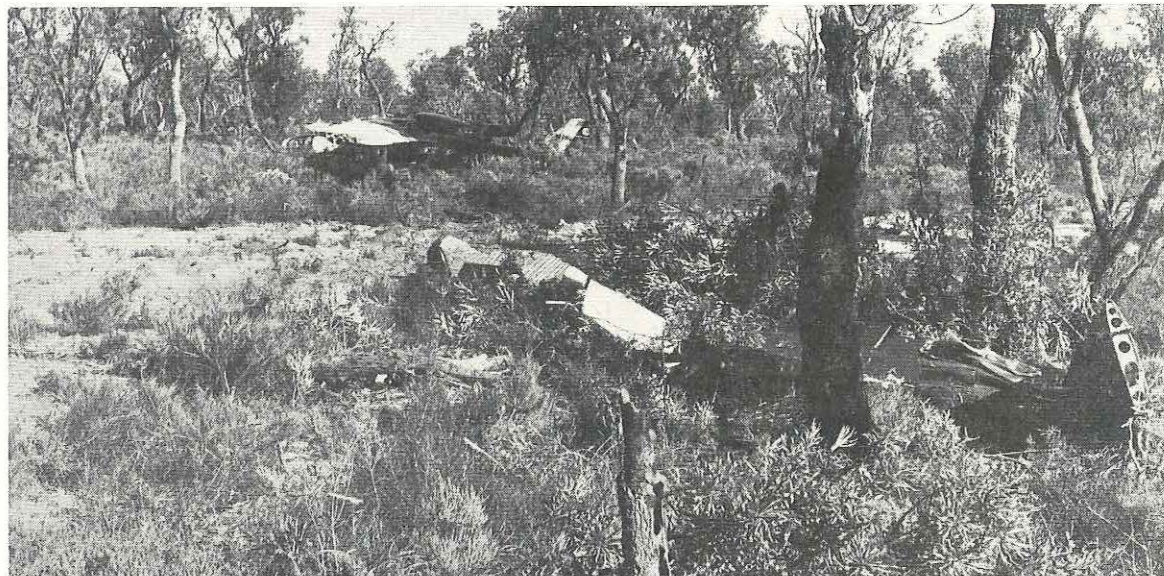
A section of the swathe which the descending aircraft cut through the trees and scrub. The wreckage of the tailplane is at the base of the broken off tree in the foreground.

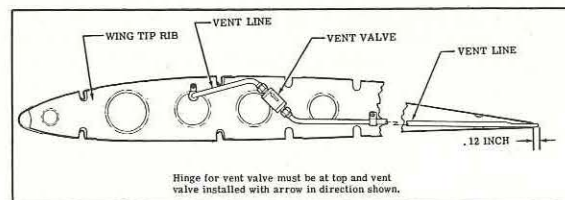
The vent valve for the starboard fuel tanks, situated in the starboard wing tip, was next inspected and was found to be installed correctly. (See diagram on this page). The vent valve assembly itself was then dismantled and examined and

Diagram showing fuel tank vent arrangement inside the fibre glass wing tip.

it was found that the hinged plate which forms the valve was firmly stuck to the body of the valve. In this type of valve, the valve plate is hinged at the top, so that when the valve assembly is correctly mounted, the weight of the plate causes it to close. The plate is sealed against the body of the valve by a rubber 'O' ring attached to the valve plate, which contacts a flat face on the body of the valve. It was evident that the valve plate had been stuck in the closed position for some time. During much of this time the fuel tanks had, no doubt, been venting through the small by-pass bleed holes in the body of the valve. However, because the bleed holes are very small in diameter, they could easily become blocked by foreign matter. Such a blockage had no doubt occurred, and been responsible for the collapse of the fuel tanks on an earlier flight, and on the aircraft's last flight, had resulted in fuel starvation of the rear engine. Although the bleed holes were clear when examined after the accident, it was likely that the blockage had been forced out when the starboard wing collapsed (see photographs) allowing the fuel in the tanks to impose a considerable head of pressure on the valve at the wing tip. Fuel was actually escaping from the valve by-pass holes when the aircraft was first examined after the crash.

Although the stuck condition of the starboard tank vent valve was not the cause of this accident, the emergency from which it developed would not have occurred if the valve had been functioning properly. The case therefore provides a warning to operators of all aircraft to ensure that vent lines and valves are thoroughly checked for operation and freedom from obstructions at the prescribed inspection intervals.

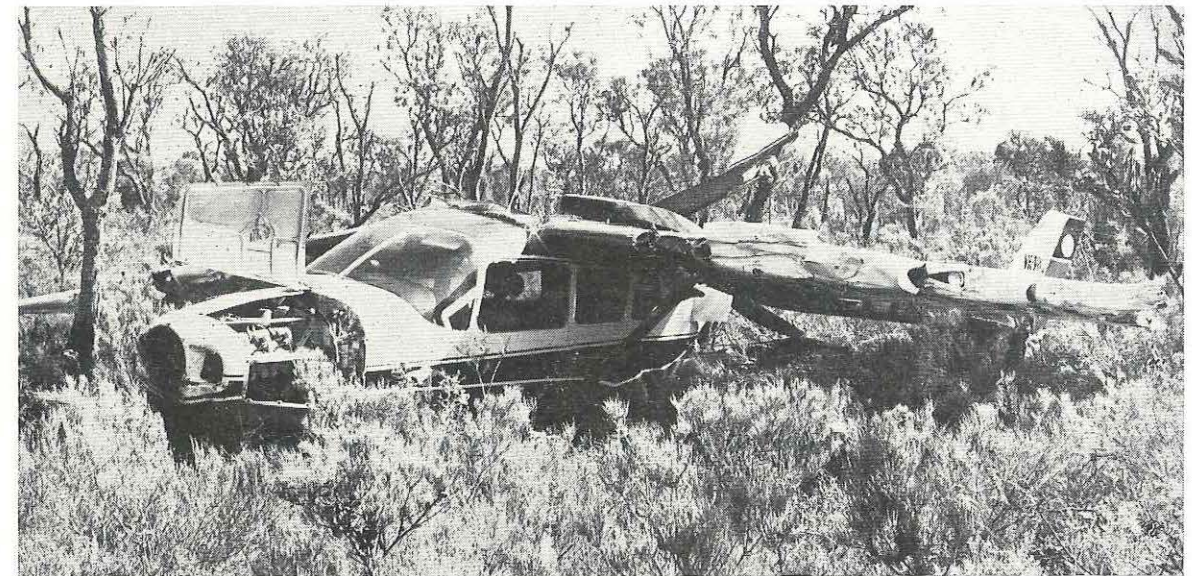
The wrecked aircraft as it came to rest. Note the position of the starboard wing.

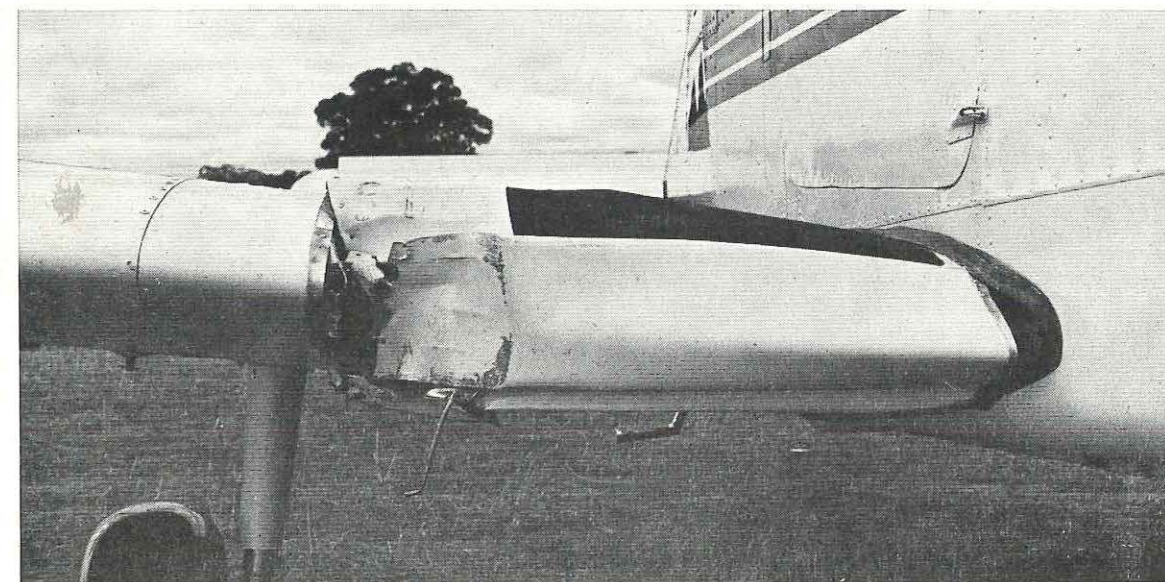
Damage to the leading edge of the wing resulting from the collision with the windsock pole.

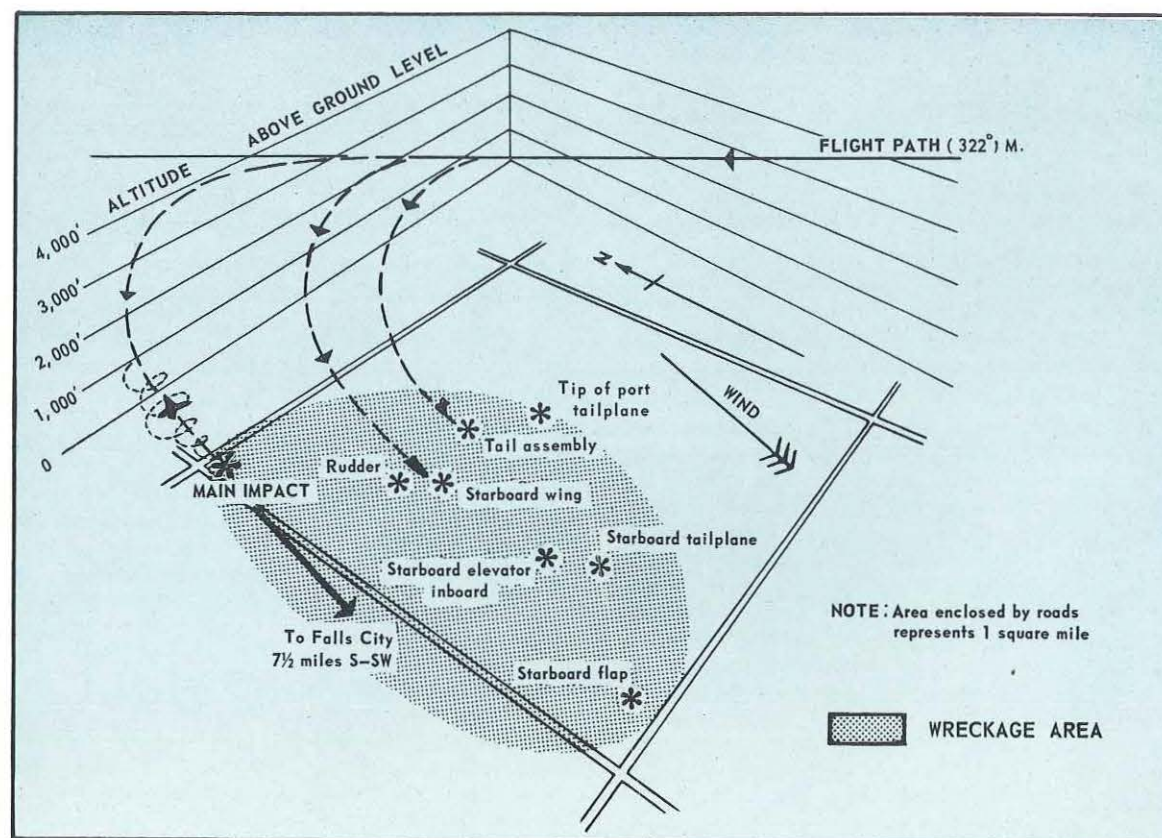
An analysis of the likely trajectories of the various pieces of wreckage was carried out to attempt to determine the sequence of the in-flight break-up of the aircraft. As a result, it was concluded that the break-up had occurred in a very short period of time, probably of the order of two seconds, and that the tail assembly probably separated before the starboard wing. The study also

Three dimensional diagram illustrating distribution of wreckage and trajectories of major sections of aircraft after the in-flight break-up.

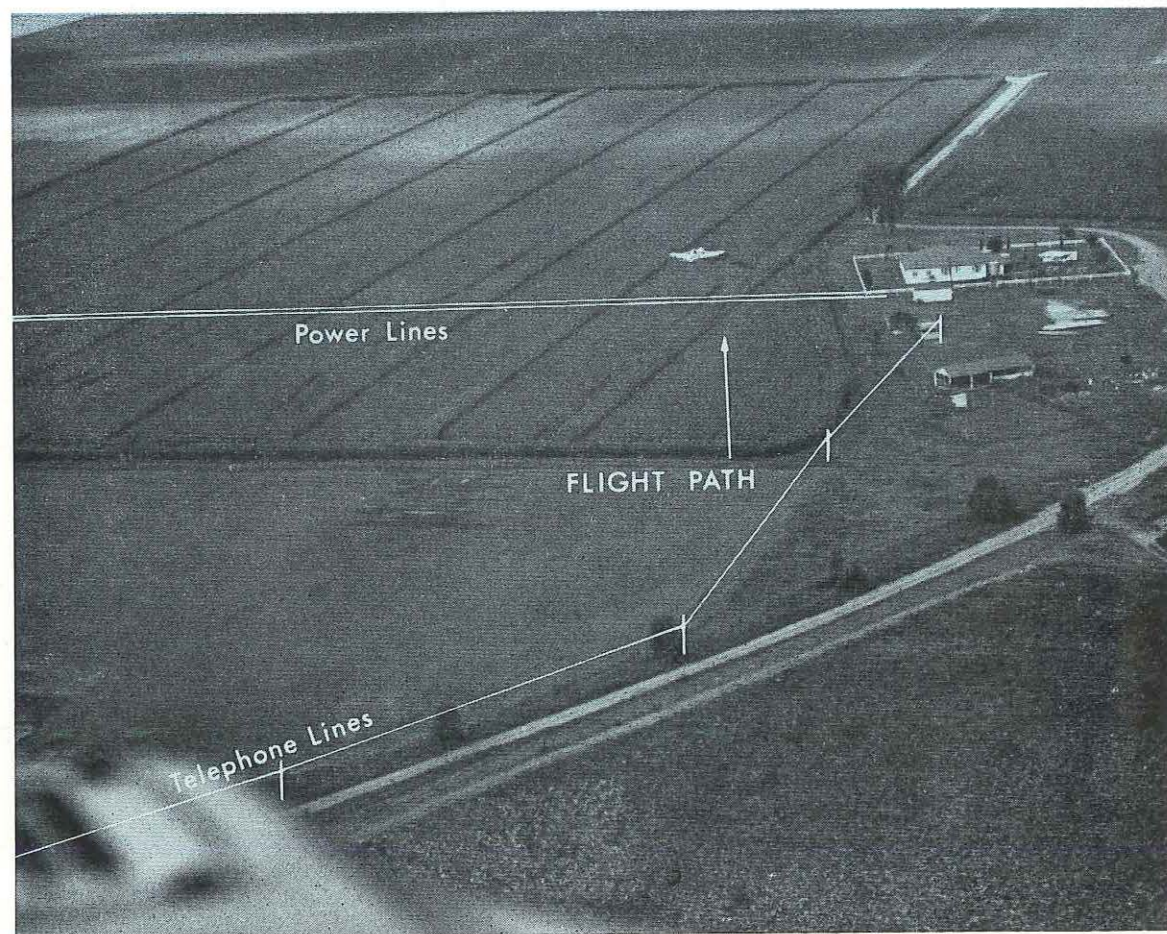
Aerial view looking in direction of final run. The flight path intersects the row of Sudan grass immediately beneath the power line.

power line and the row of Sudan grass, this particular section of the paddock was not suitable for the type of spraying operation proposed by the pilot. As the photograph on this page shows, it should have been apparent to the pilot that a spraying run in the only direction available would place the aircraft in the very situation which on his earlier runs he had been at pains to avoid.

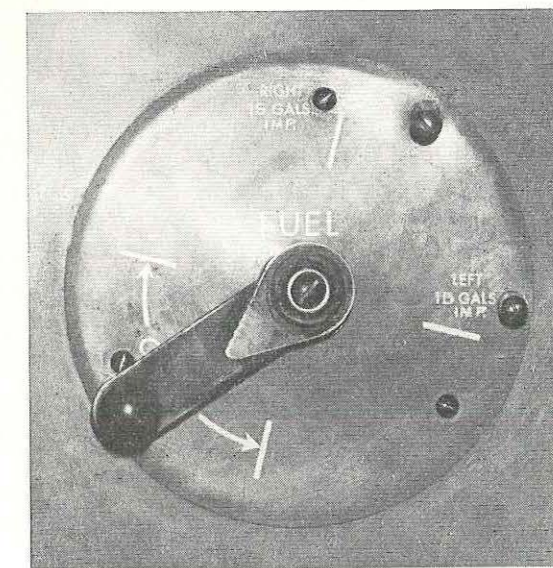
The Piper Tripacer fuel selector. The selector is in the 'Off' position in the photograph.

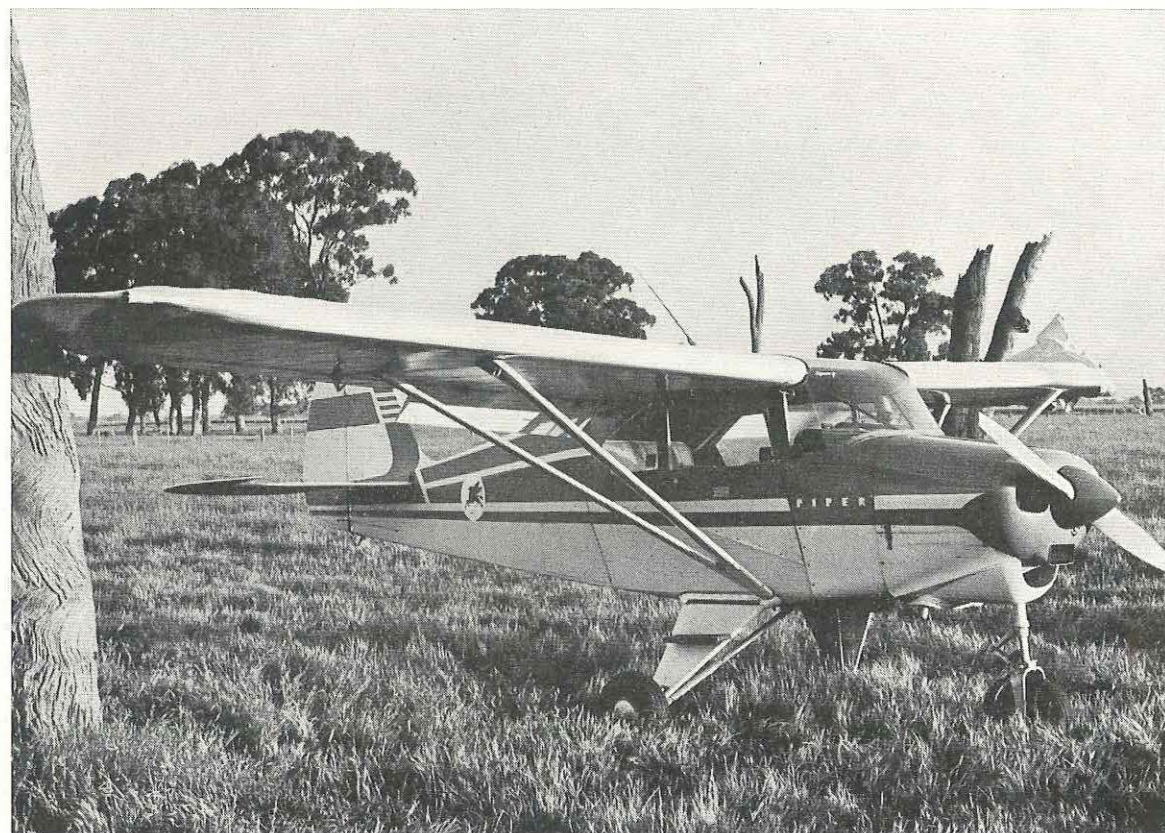
The aircraft as it skidded to a halt after the port wing had struck a tree. The starboard wing is almost brushing a second tree.

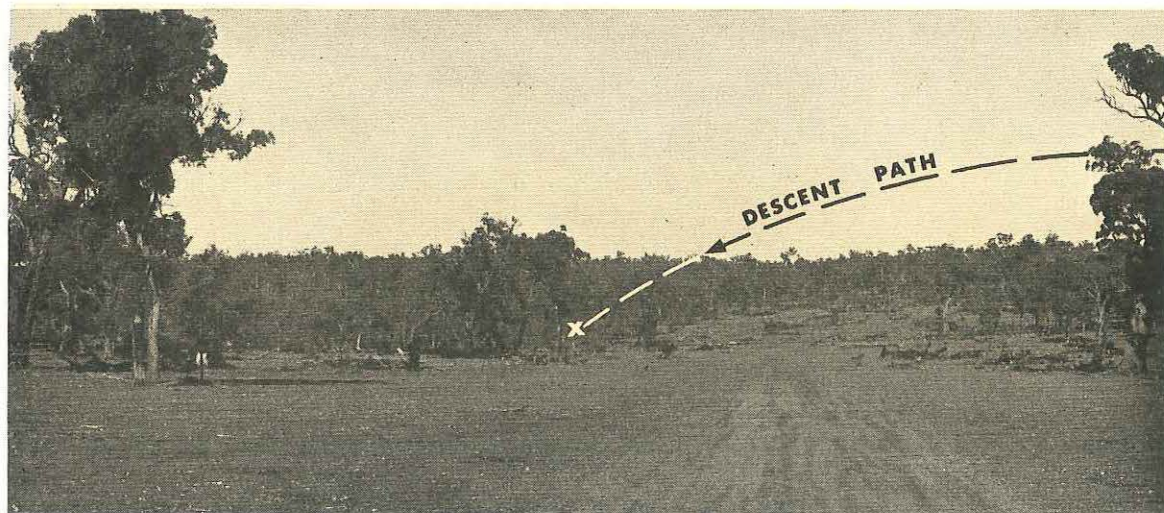
ABOVE: View from up-wind end of strip, looking back in direction of aircraft's approach. Blinded by sun as he was turning on to final, the pilot was unable to prevent the aircraft colliding with trees at the side of the strip.

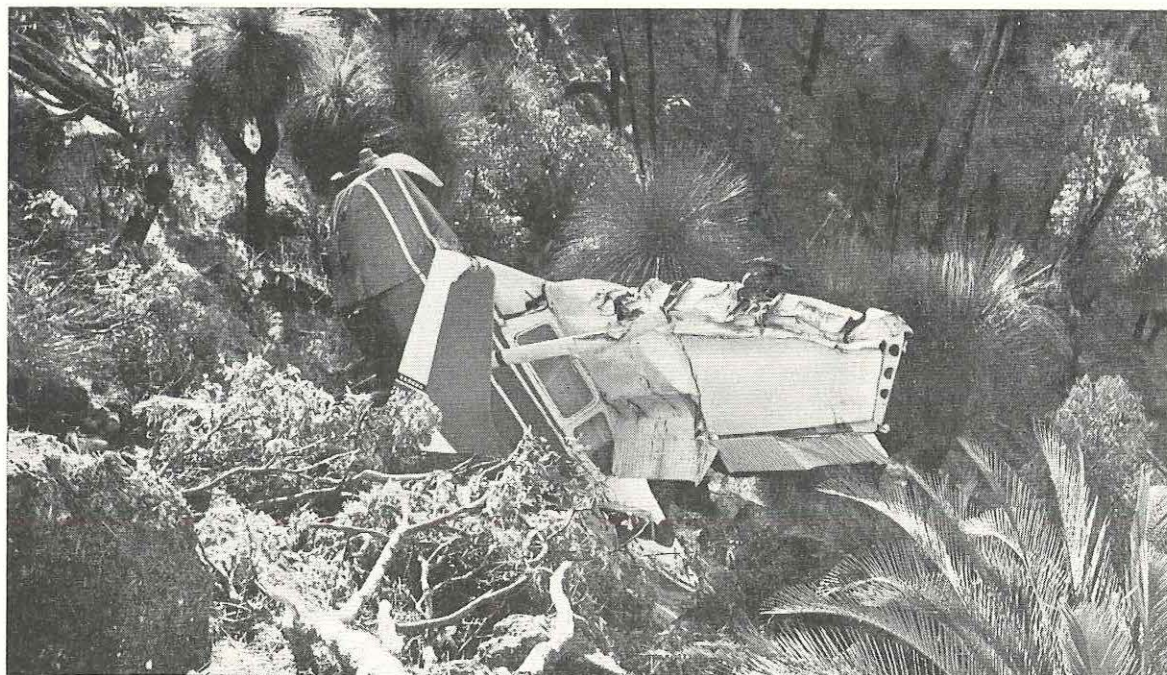
BELOW: The jack-knifed wreckage lying on the rock-strewn slope below the edge of the plateau.
