# AVIATION SAFETY DIGEST

No. 61 MARCH, 1969  
DEPARTMENT OF CIVIL AVIATION, AUSTRALIA

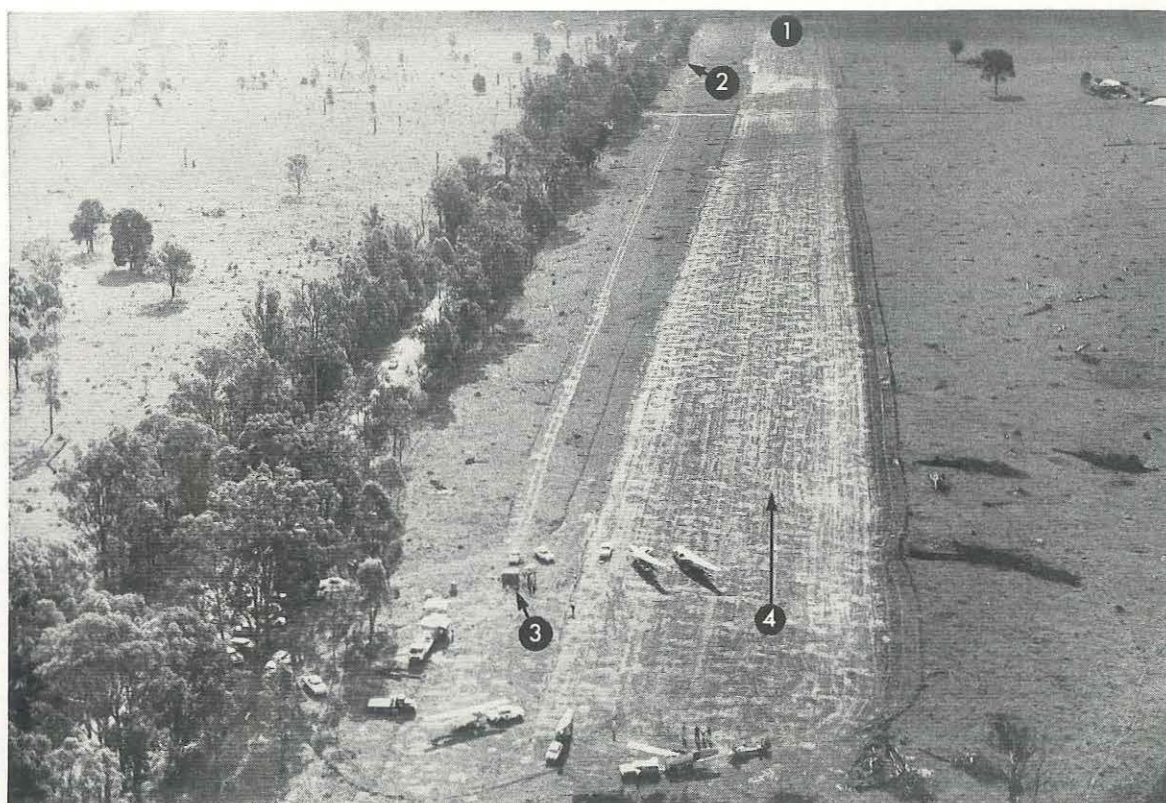
Aerial view of glider strip from over eastern end looking west, showing (1) position of winch, (2) accident site, (3) duty pilot's tent, (4) take-off path of glider.

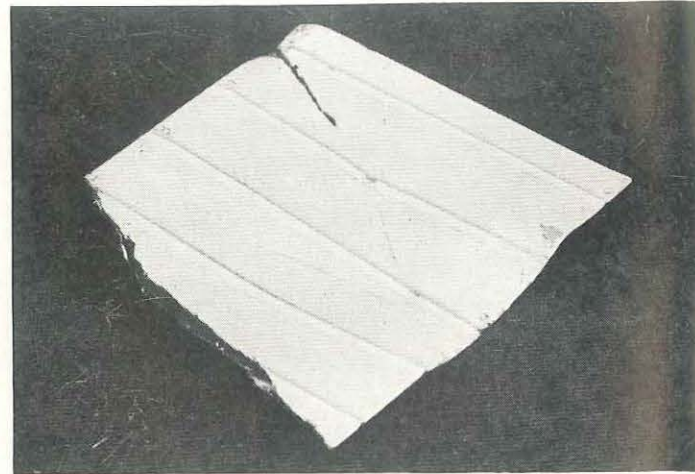
*Section of aircraft's starboard aileron which fell from the aircraft after being severed by the cable.*

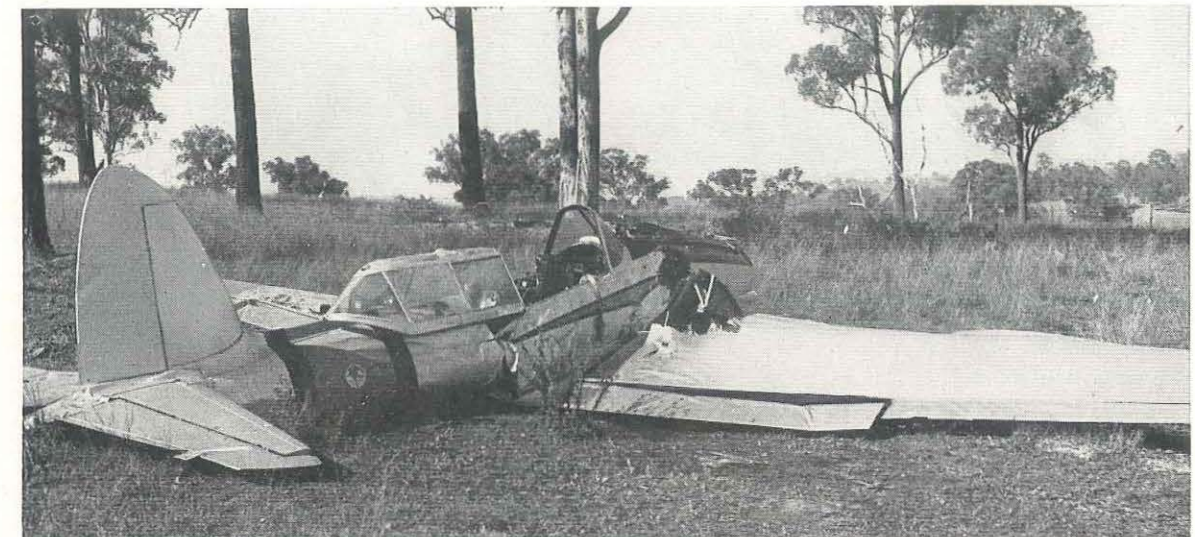
*The wreckage as it came to rest. The mode of impact is clearly evident from the damage sustained by the aircraft.*

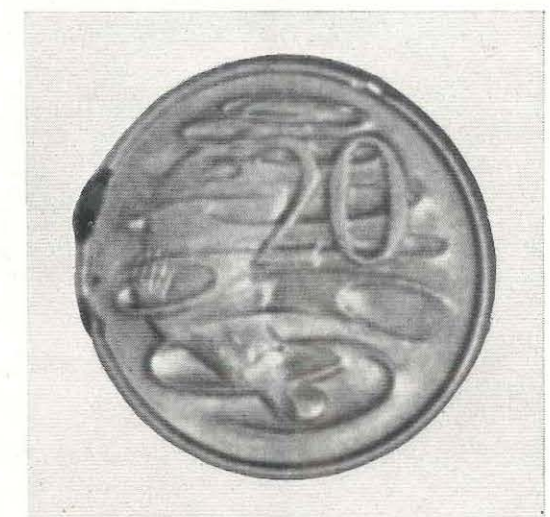
*The mutilated coin found in the fuselage during the investigation.*

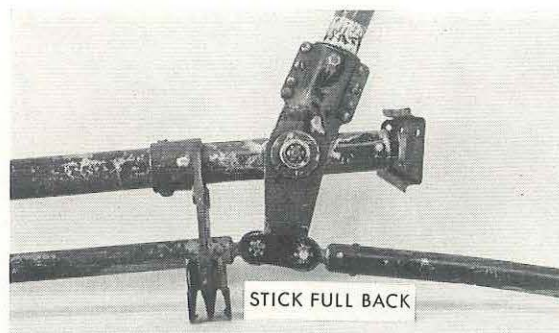
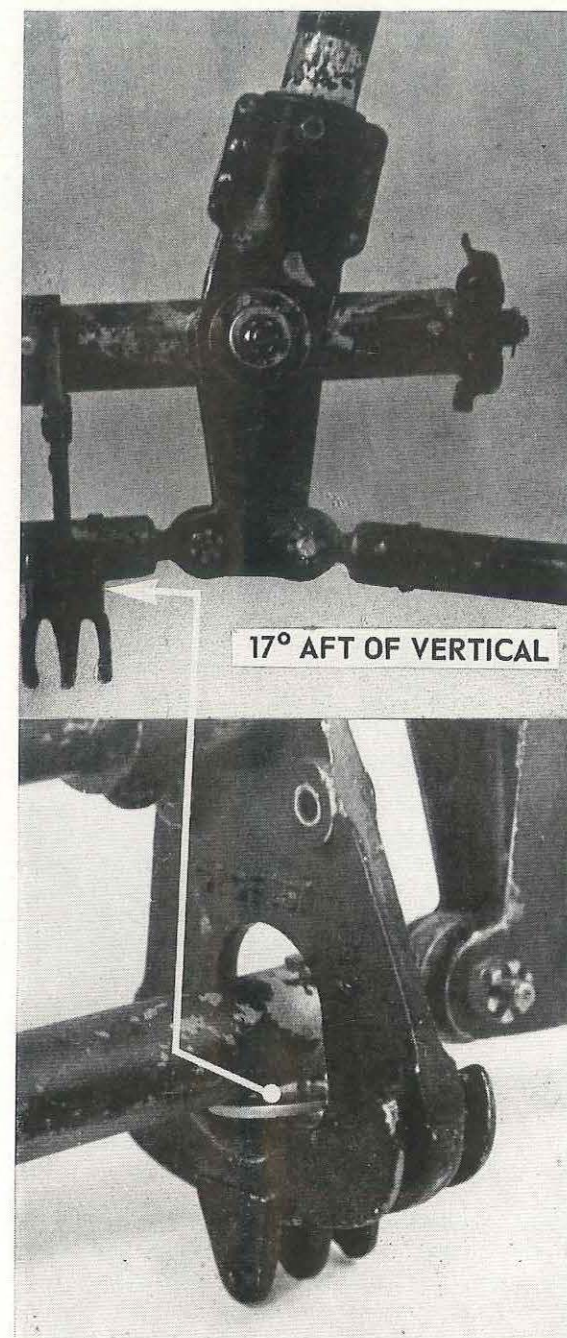
Left: The elevator control linkage removed from the aircraft showing the rear cockpit control column in the fully rearward position.

Below: Photographs showing the location in which the coin could prevent further forward movement of the control column from the 17 degree aft position.

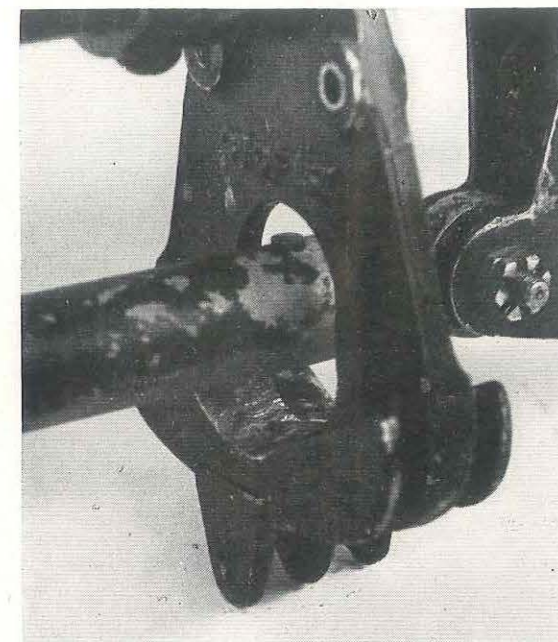
Marks on the saddle forging apparently caused by the jammed coin. The marks shown in the picture were found to match those on the coin.

objects entering the control linkage area. The boots should be in good condition and should fit snugly around the control column. When one control column is removed from an aircraft for single pilot operations, the boot should be closed over the open socket to prevent the entry of foreign matter through the socket itself.

It is also important that aircraft be thoroughly checked for forgotten tools and other loose material after any maintenance work has been performed. Pilots and L.A.M.E.'s should have no need to be reminded of this, yet random checks still reveal items of equipment, surplus nuts and bolts, etc., that have been left lying in aircraft. Aircraft owners, operators and pilots can assist in overcoming this continuing problem by drawing any such instances to the attention of maintenance personnel, and for the safety of their own well being, by checking for themselves that no tools or other equipment remain when work in their aircraft has been completed.

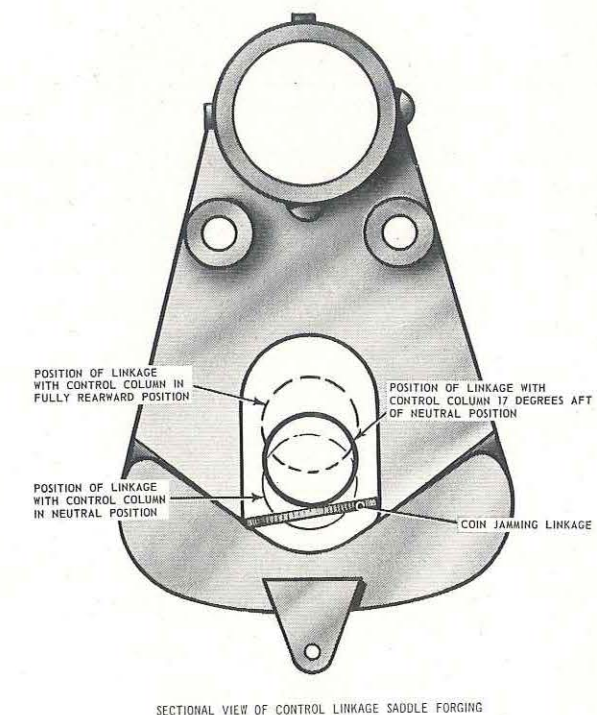
Sectional view of control linkage saddle forging, showing relationship of coin and control linkage tube, with control column in different positions.

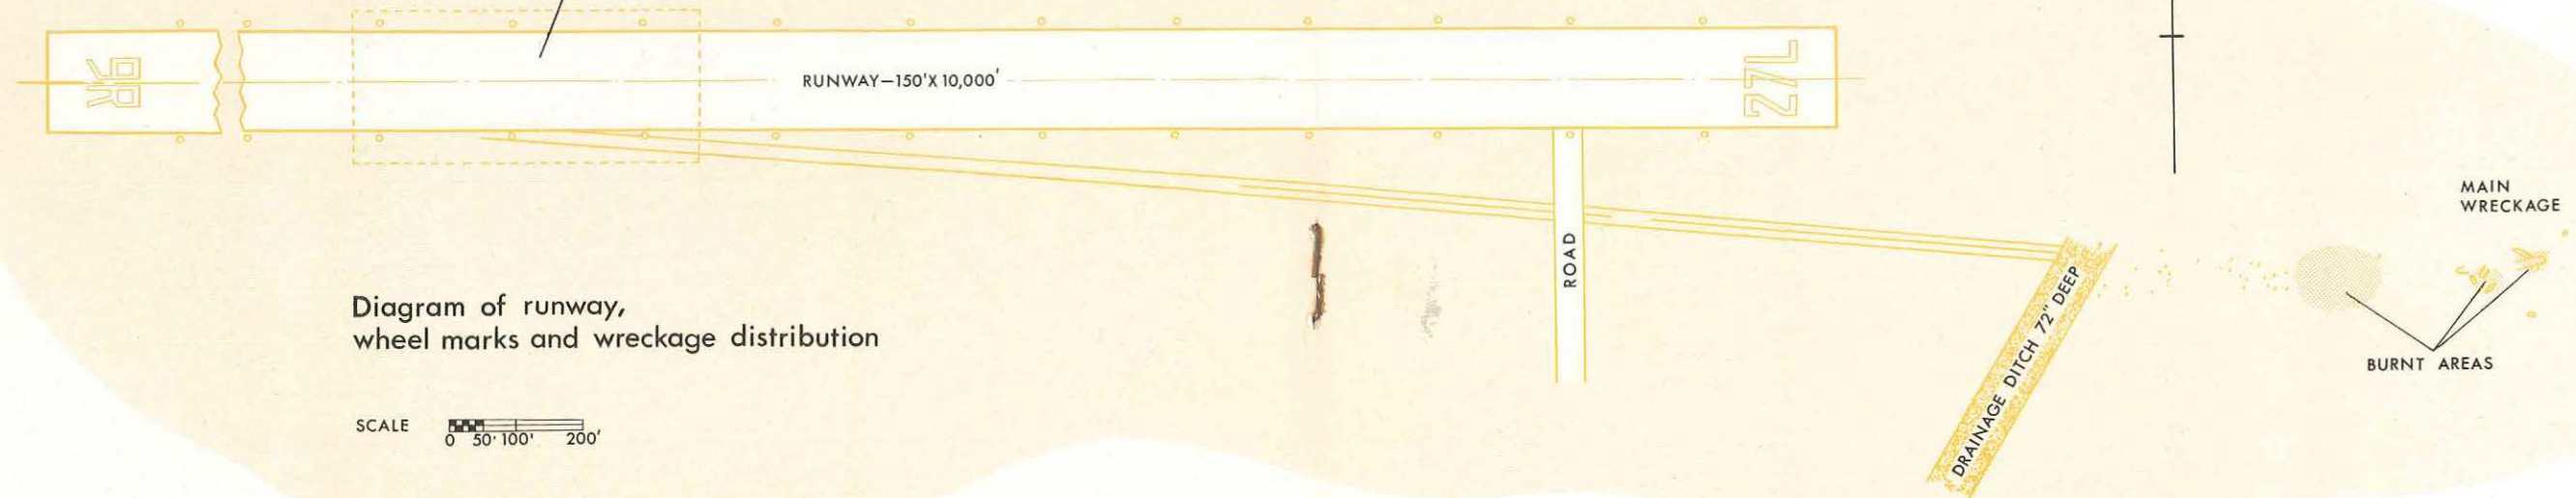
Diagram of runway, wheel marks and wreckage distribution

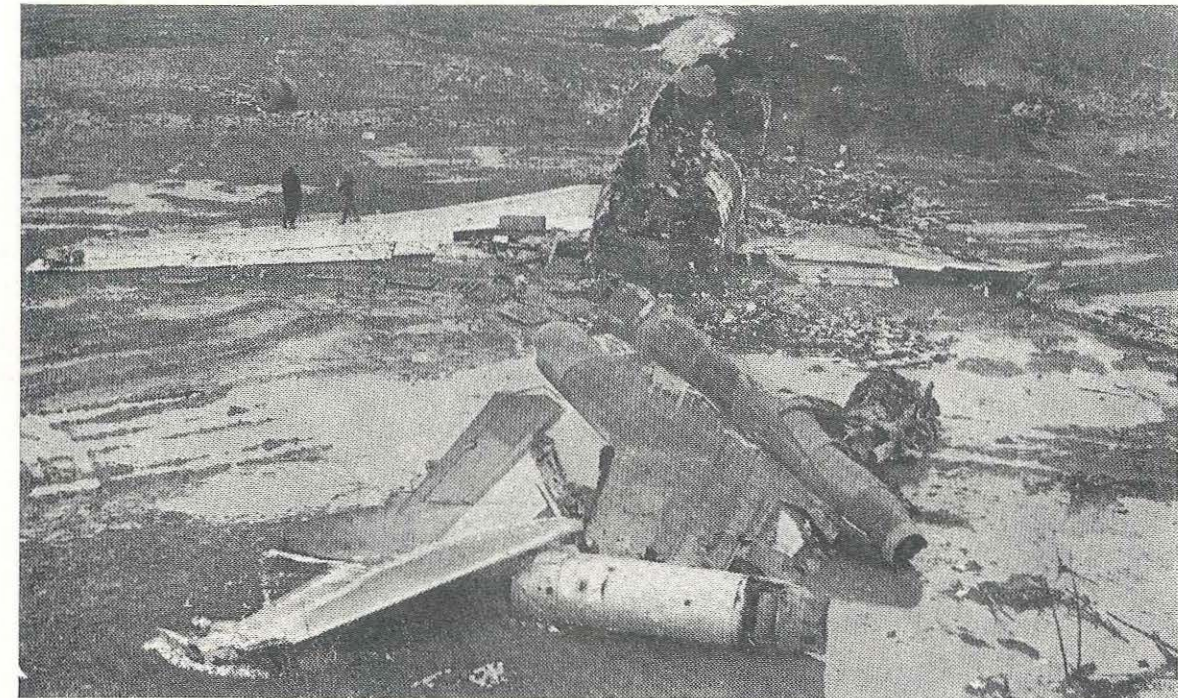
*View of the wreckage showing the burnt-out fuselage and detached tail section.*

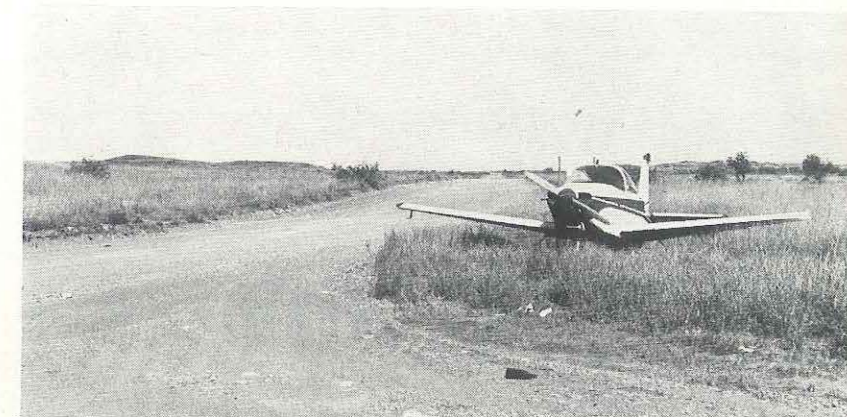
The pilot said afterwards that he believed the accident was the result of his anxiety to clear the roadway as soon as possible, in that he had attempted to taxi too fast which, with the tailwind component, caused the aircraft to swing.

*Right: The aircraft where it came next after striking the signpost. The section of road on which the aircraft landed can be seen in the distance.*

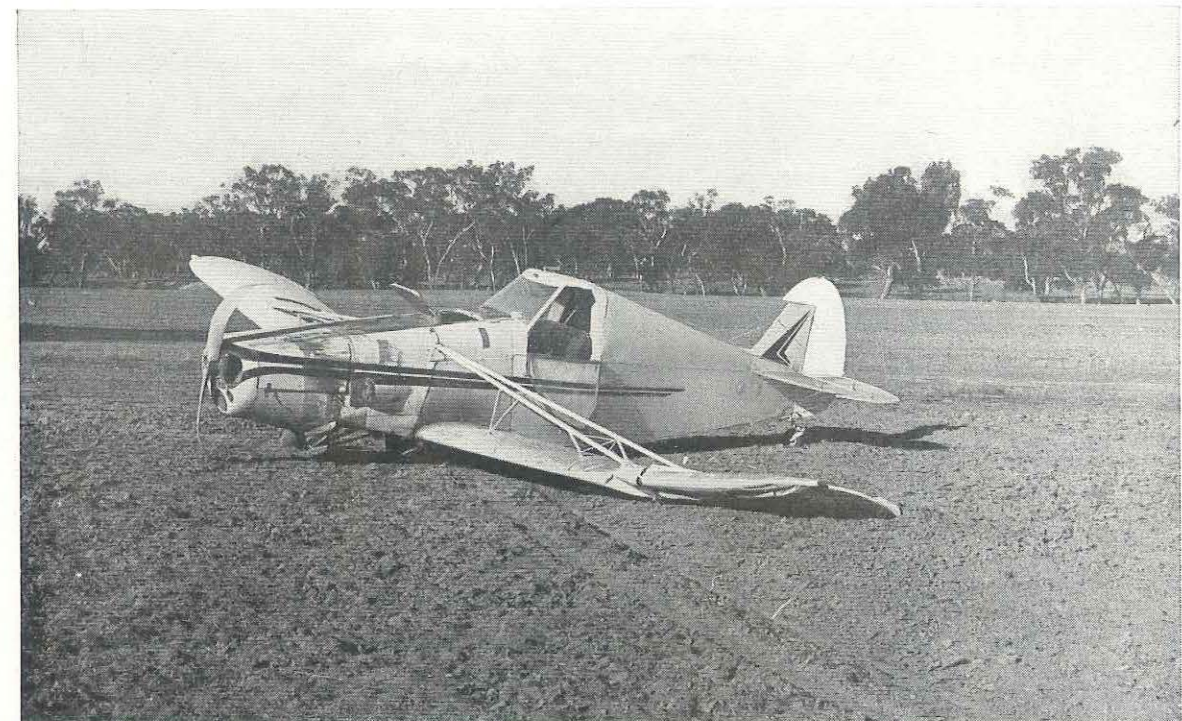
It seems certain that, on seeing the obviously shallow fog when he arrived over the strip, the pilot believed the visibility was adequate because he could see the ground through it, from overhead. He thus became another victim of the old snare of "slant visibility", which has been responsible for approach accidents almost from the earliest days of aviation. The fact that it is possible to see the ground vertically through a few feet of fog is no measure whatever of the likely visibility in the direction of approach, and along the proposed landing path.

*The degree of damage inflicted on the aircraft is clearly evident in this picture, taken looking back in the direction of approach.*

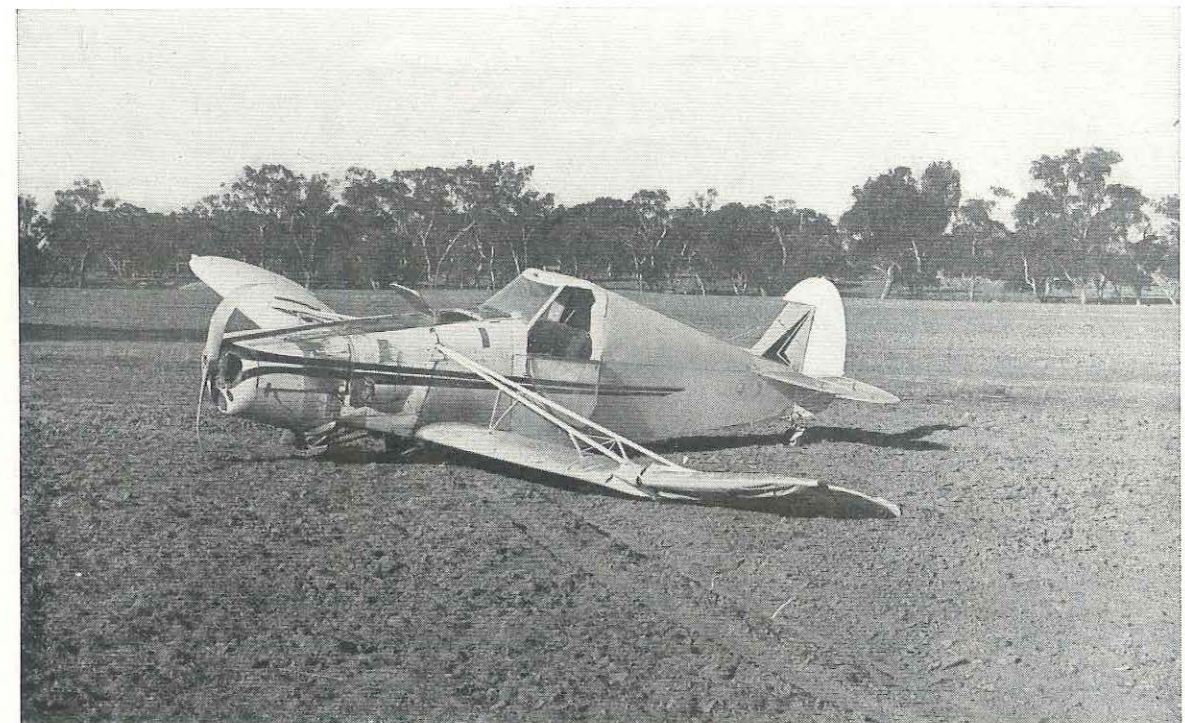
*The degree of damage inflicted on the aircraft is clearly evident in this picture, taken looking back in the direction of approach.*

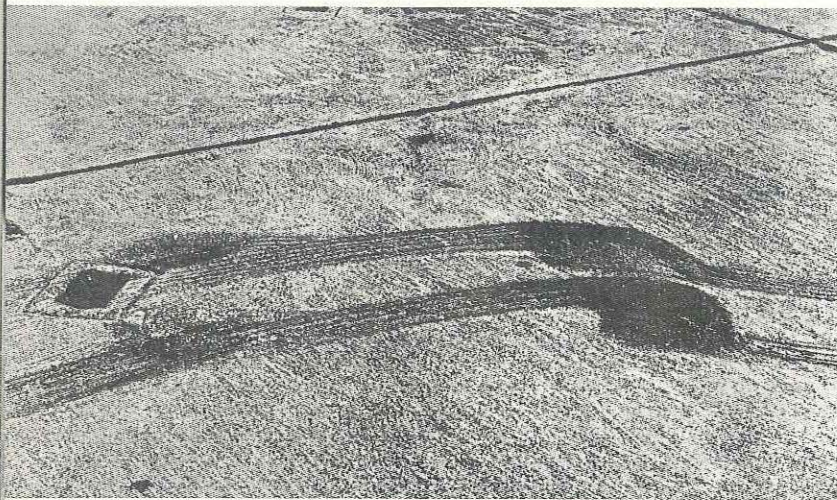
Take a look at the illustration. The black marks you can see were made by an aircraft being moved by a tractor in such a manner that the rear wheels of the bogie were "screwed" into the concrete before skidding sideways and the turn continuing.

The heat generated by the "screwing" action melted the rubber of the tyre at its contact area and molten rubber was evident on the concrete over approximately 39 feet of the turn.
