No. 62 MAY 1969

AVIATION SAFETY DIGEST

DEPARTMENT OF CIVIL AVIATION AUSTRALIA

FATAL OUT- LANDING

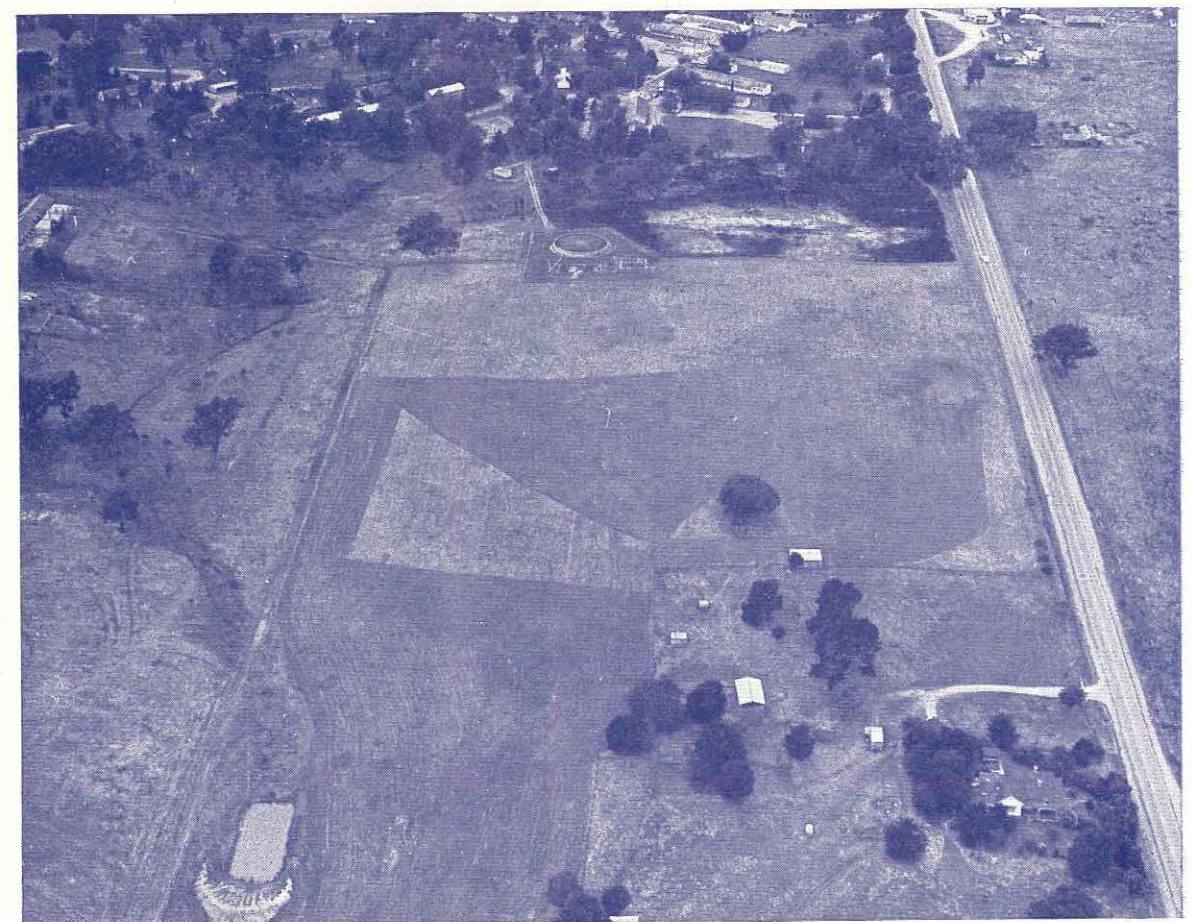
Below: The paddock in which the pilot attempted to land. The direction of the glider's approach was towards the camera, over the buildings in the background. The tree that the glider struck is near the centre of the picture.

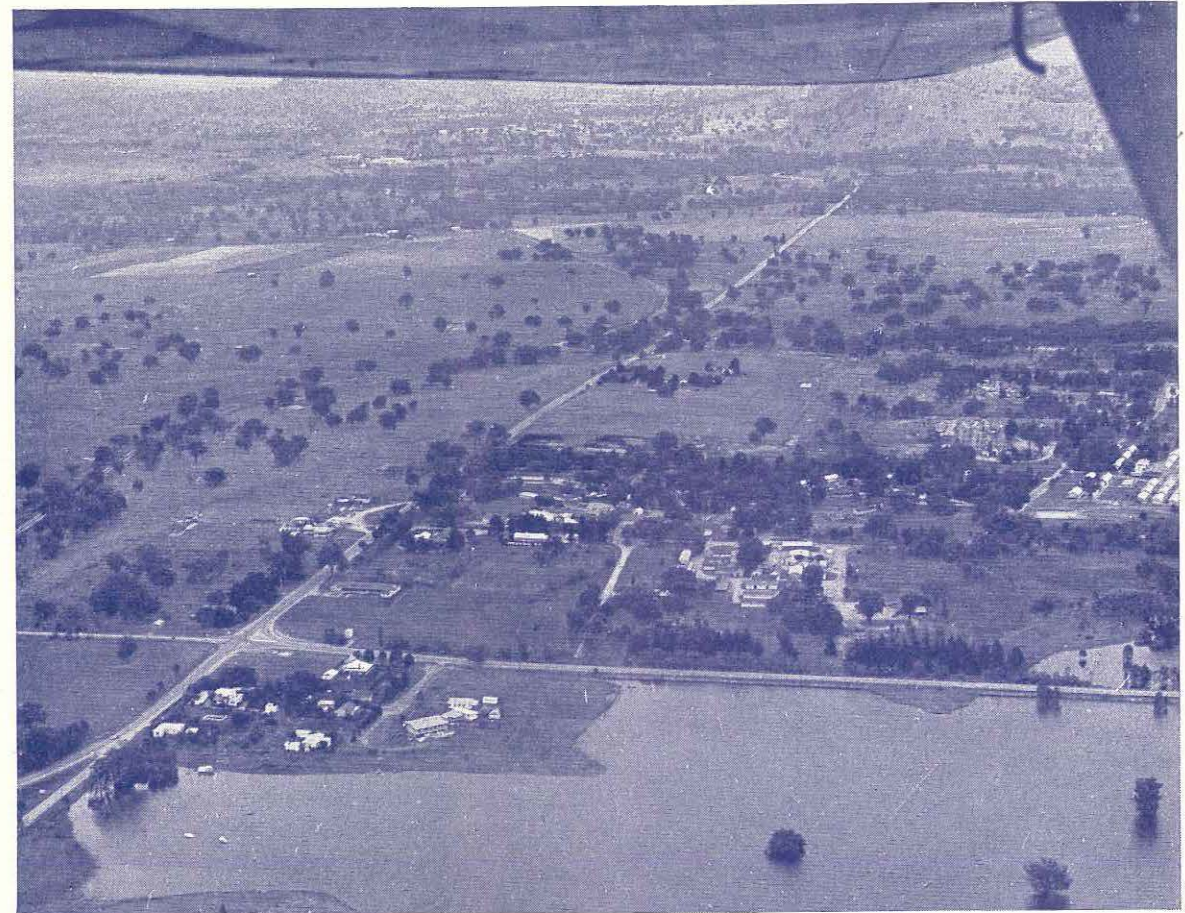
General view of the area in which the pilot was forced to land. The paddock the pilot chose can be seen in the centre of the picture immediately to the right of the road. The photograph is taken looking in the approximate direction of the glider's final approach.

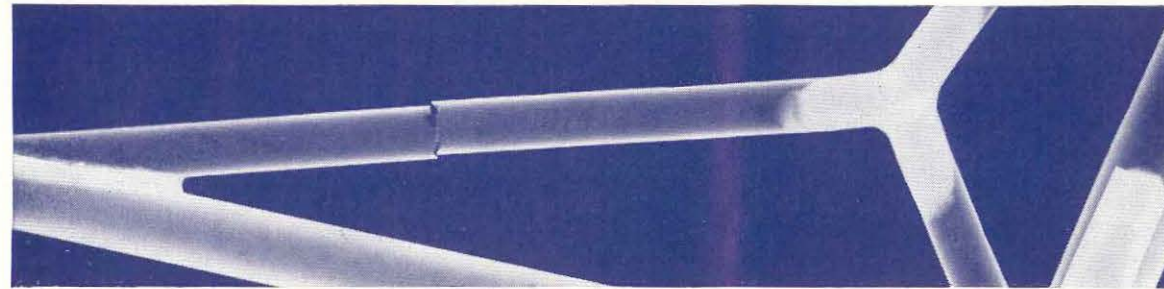
the X-ray film was developed, the photograph showed that the bracing tube was fractured at a point within the section covered by the tape (see title illustration). The broken section was cut out and examined to determine the cause of failure.

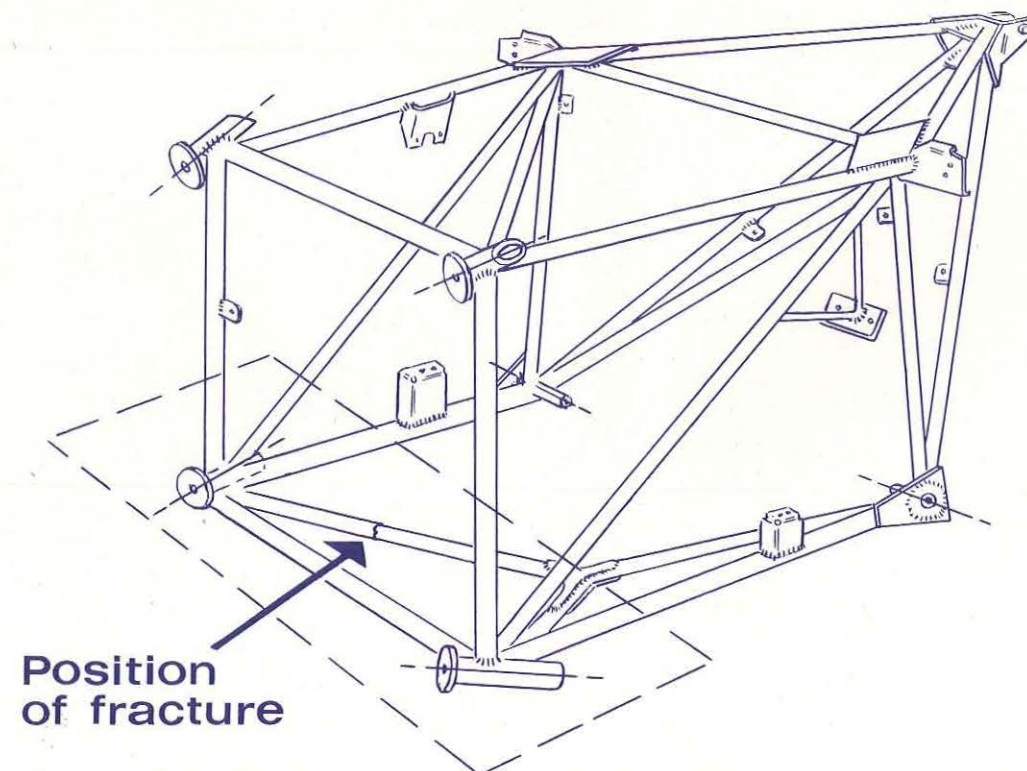
RECENTLY, while a routine X-ray inspection was being performed on the engine mounting structure of a certain light twin-engine aircraft for the purpose of determining whether or not corrosion was present on the internal surfaces of the welded tubular structure, it was noticed that about three inches of the diagonal bracing tube in the bottom panel was wrapped with friction tape. The area with which the inspection was concerned is shown within the dotted lines of Figure 1. When

Fig. 1. Three-dimensional drawing of engine mounting, showing position of fracture.

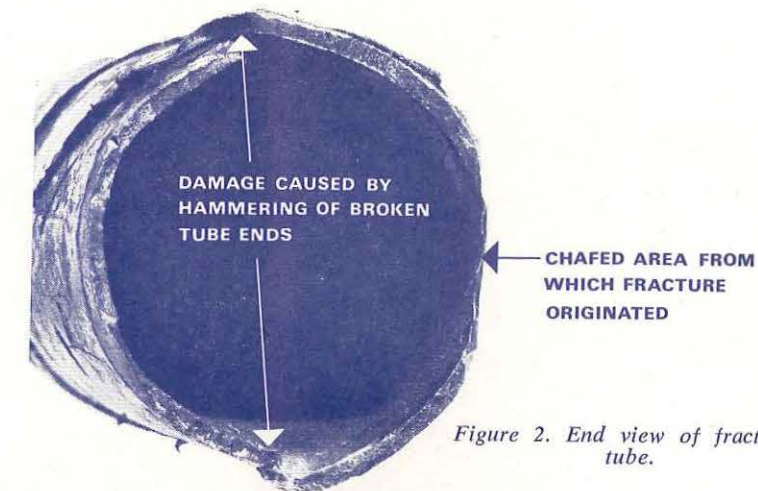
It was found that the tube had been very badly chafed by a flexible pipe line resting against it, without the pipe having been properly supported or the tube protected against damage. Figure 2 shows the extent to which the chafing had reduced

Figure 2. End view of fractured tube.

the thickness of the tube wall before it failed as a result of fatigue. It was evident from the indentations shown in Figure 3 that the aircraft had been flown for some considerable time after the fracture had occurred. The indentations were caused by the hammering of the broken ends of the tube and their extent gives a clear indication of the degree of distortion that occurred in the engine mount after the bracing tube broke.

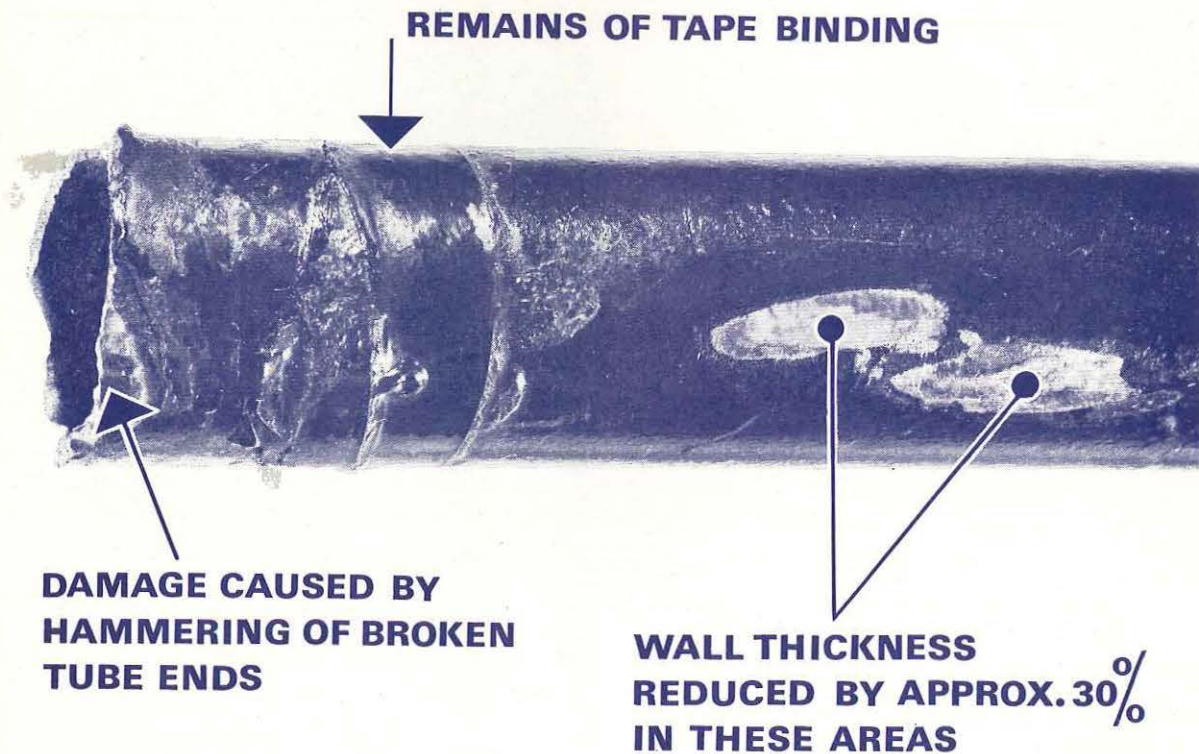
Figure 3. Side view of fractured tube.

It is evident from the presence of the tape binding on the tube that someone had seen the chafed area and had applied the tape to prevent further damage. Whilst this may have been done in good faith, the person concerned was actually covering up a serious defect, because the damage had obviously progressed to the extent that a repair was necessary even at that early stage.

Figure 3 shows what the chafed area probably looked like when the tape was applied. This is believed to be so because, at the time that the X-ray inspection was performed, the tape had not been penetrated. Two other chafed areas can also be seen, both of which had reduced the thickness of the tube wall by about 30 per cent. In all probability, these two areas would have become starting points for failures similar to the one that actually occurred.

be protected against the chafing by the use of tape binding, such precautions are not really effective unless the fuel line or similar item is secured to the structure in such a way that relative movement between the two items is prevented. Under no circumstances however, should tape binding be applied to components or structure in which damage is already evident. The circumstances which caused the failure under discussion reflect a very low standard of technical competence, firstly in continuing to accept an installation which allowed the chafing to occur, and secondly in obscuring a defect of such a serious nature.

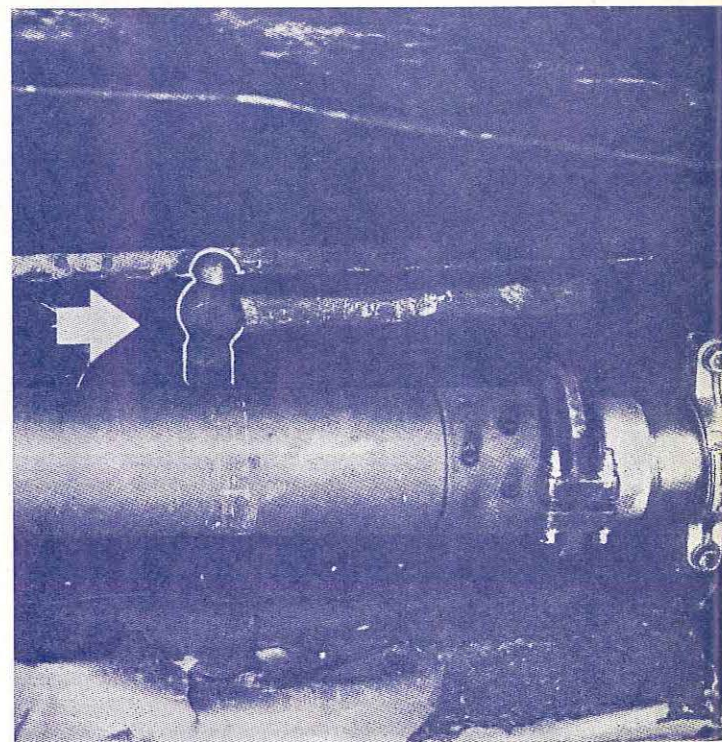
It was found that the tail rotor drive shaft had failed in flight. The failure was caused by an engineer's hammer which had been left inside the tail rotor shaft cover (see photograph), in the course of a daily inspection. The inspection had been carried out at night in the open with only the aid of a torch.

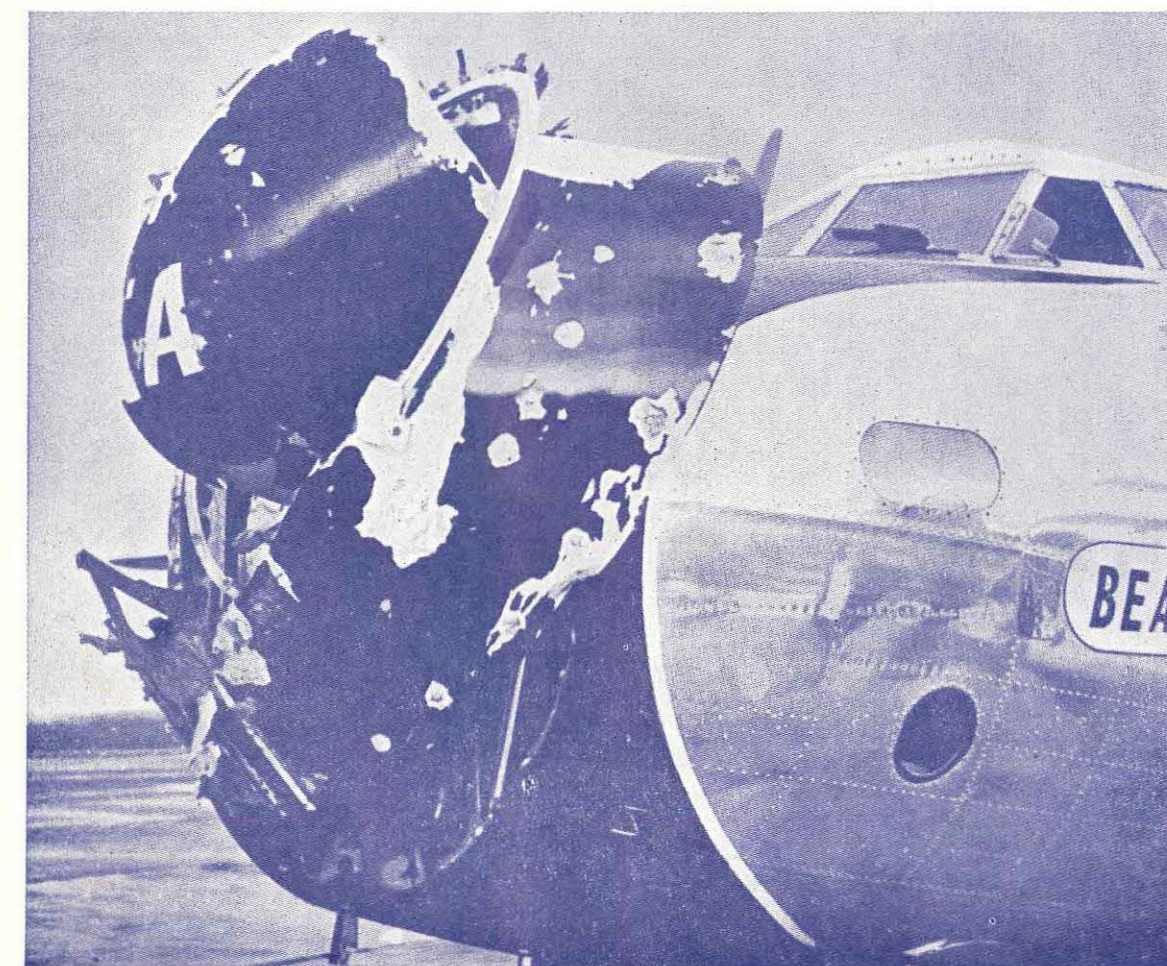
The nose of an Ambassador aircraft, of wooden construction, was so damaged and displaced by a lightning strike, that the view through the wind-screen was obstructed. The aircraft however, was landed safely, by the second pilot who was able to see through the direct vision window. Such mat-

Damage caused to an Ambassador aircraft by a lightning strike on the nose cone.

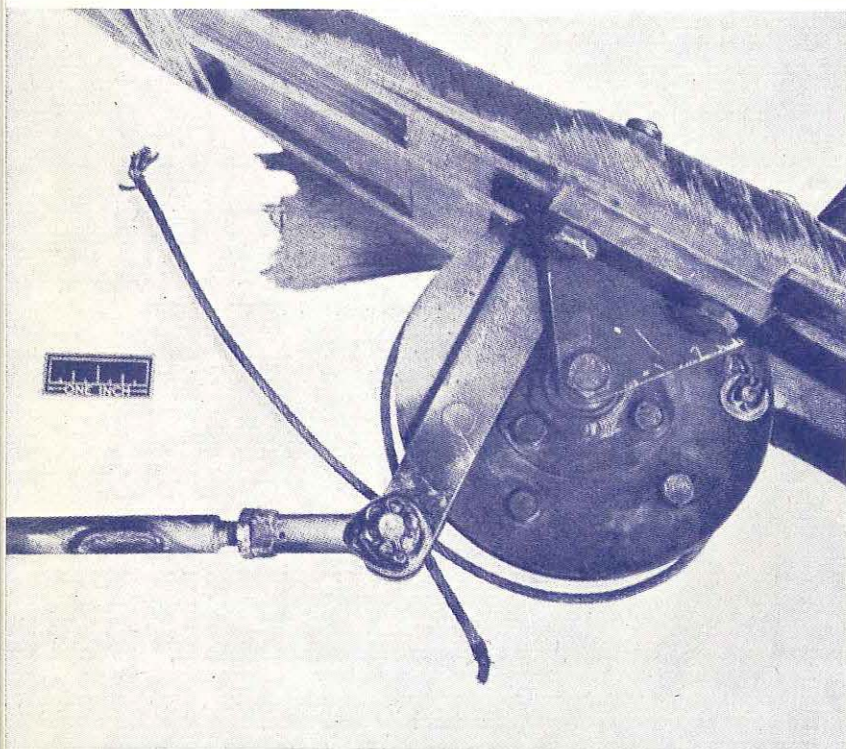
Effect of lightning strike currents flowing through the aileron cables of a glider of wooden construction.
