No. 64 SEPTEMBER 1969

AVIATION SAFETY DIGEST

No. 64 SEPTEMBER, 1969
DEPARTMENT OF CIVIL AVIATION, AUSTRALIA

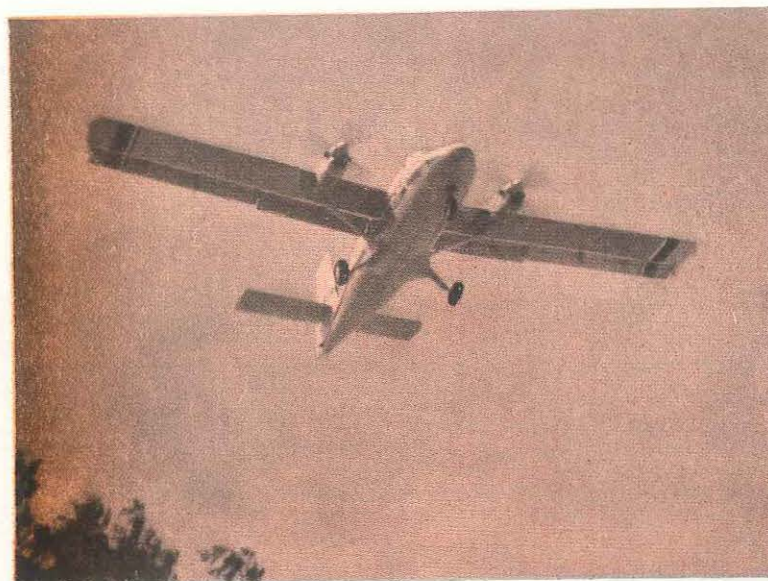
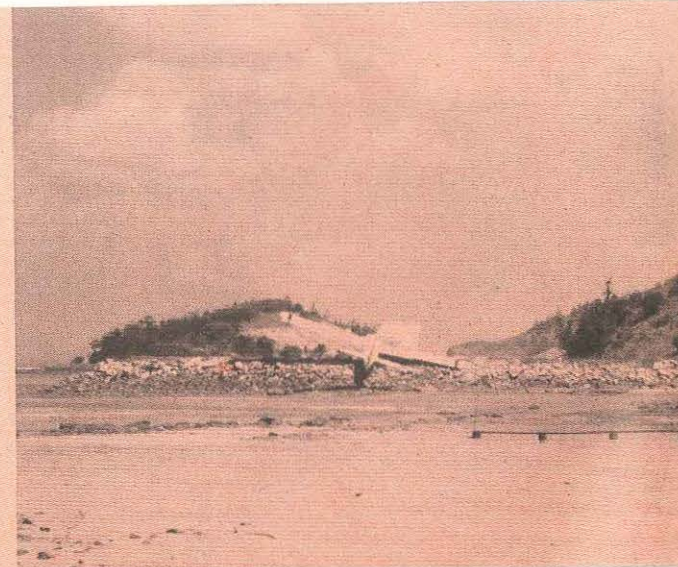
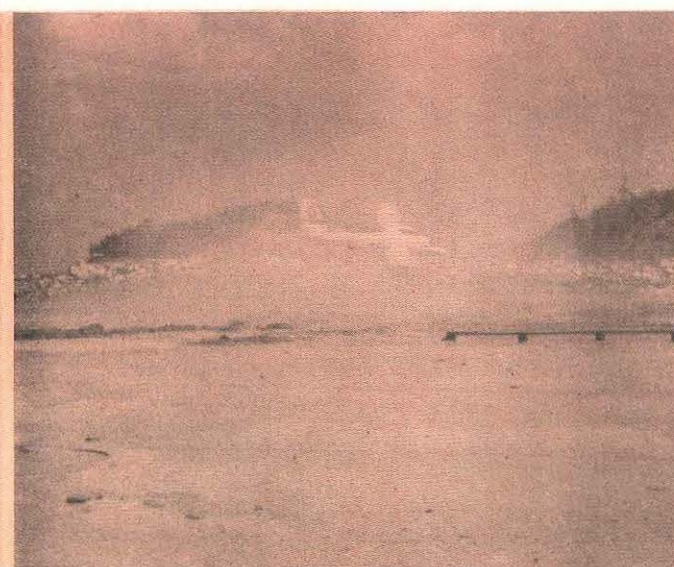
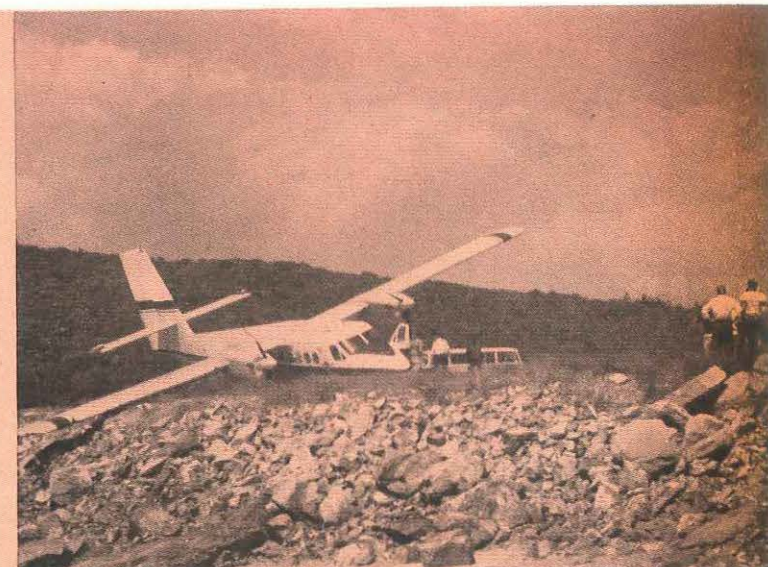
This sequence of pictures, showing the accident as it actually happened, were taken by an amateur photographer who was on the beach over which the aircraft approached to land. The photographer's position for the first three pictures was some 650 feet north-west of the threshold of the strip. The tide was out at the time the pictures were taken. At high tide the low lying area in pictures 2 and 3 is flooded. (1) Aircraft, apparently operating normally, passes over photographer on final approach

to land. (2) Aircraft loses height short of strip and in wing-down attitude strikes rock retaining wall with undercarriage and starboard wing tip. Note the dust beginning to rise. (3) Aircraft bounces up on to reclaimed area, slews to right and comes to rest in a cloud of dust. (4) Passengers evacuating aircraft after it had slithered to a stop. Strip is to the right in this picture. The starboard wing is overhanging the rock retaining wall against which the aircraft impacted.

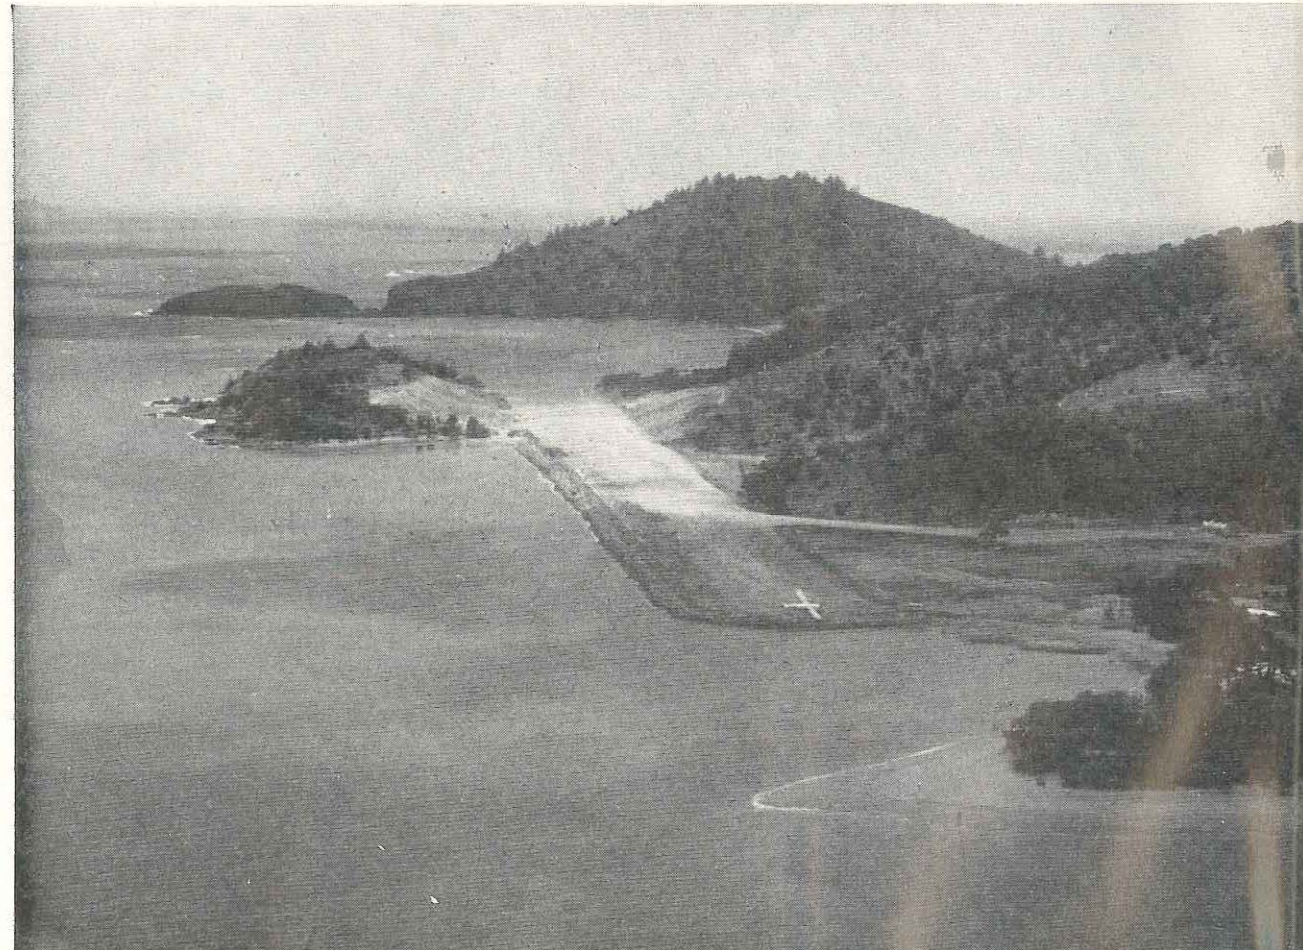
Aerial view of strip looking south-east, taken when tide was in. The taxiway leading to the terminal area can be seen running off to the right of the strip. The sequence of pictures on the previous pages were taken from the far side of the sand-spit in the foreground.

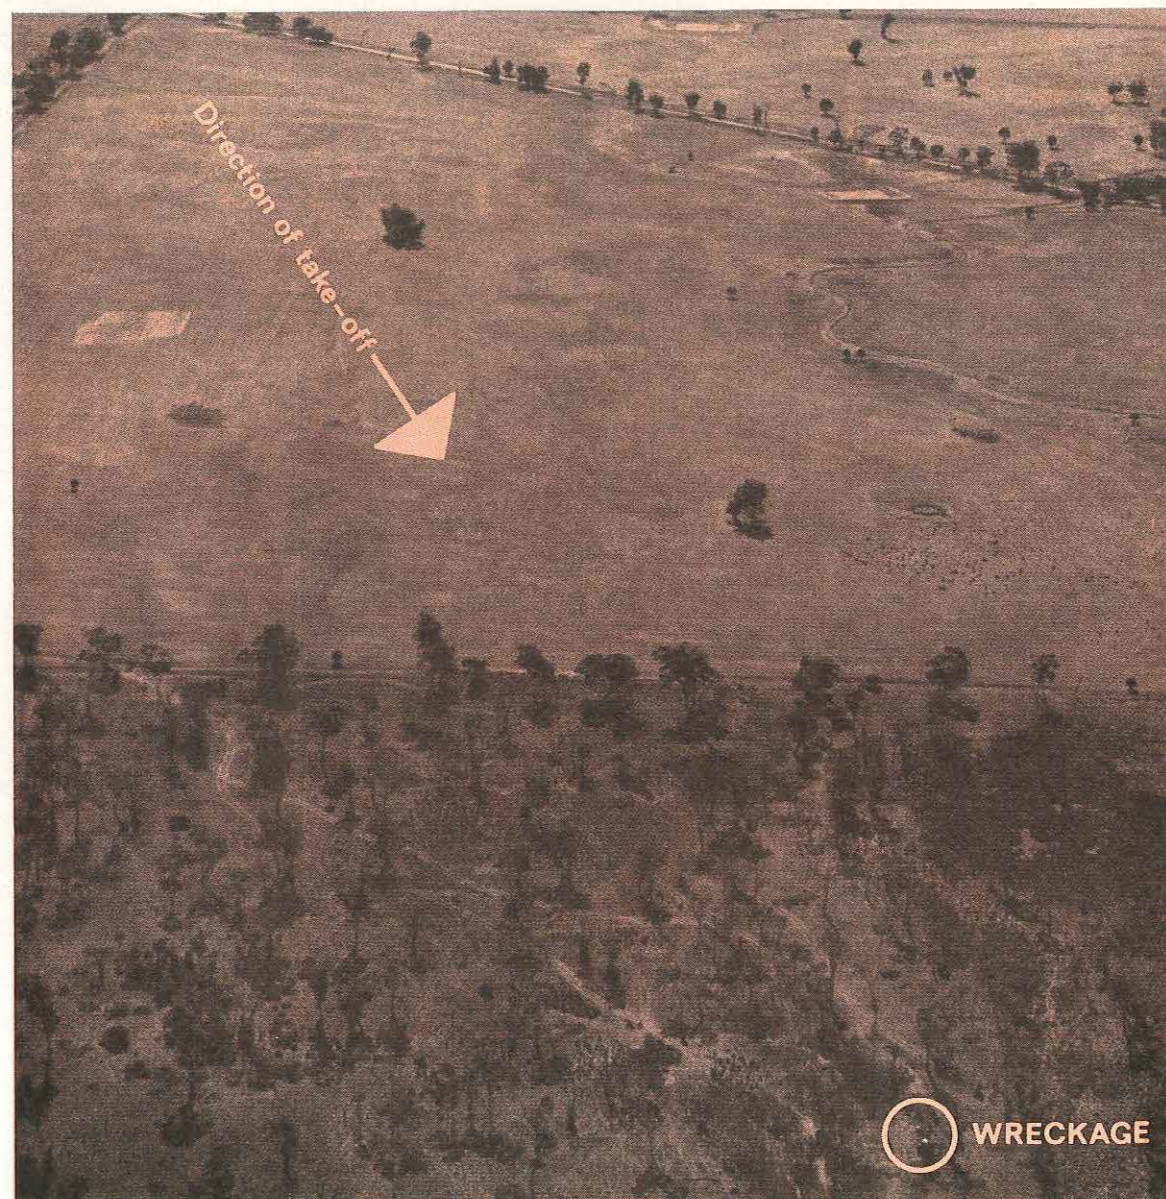
Aerial view of paddock and accident site, looking west.

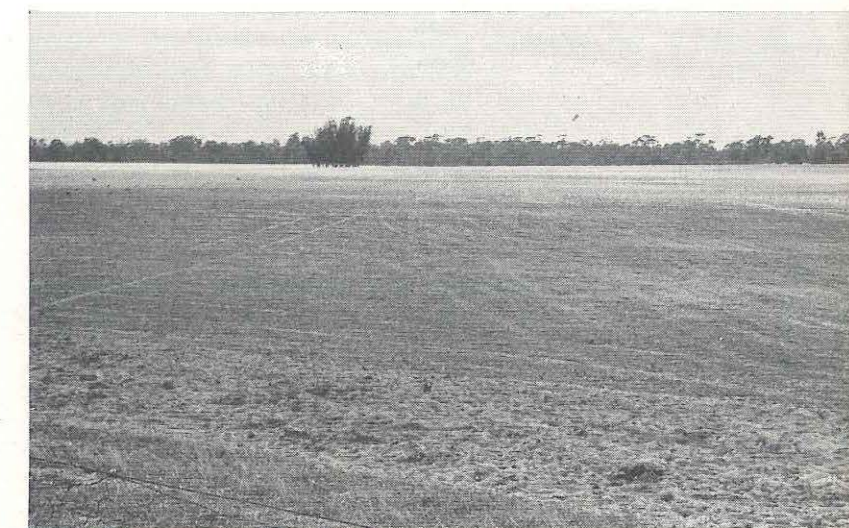
View of take-off path taken from fence near commencement of run.

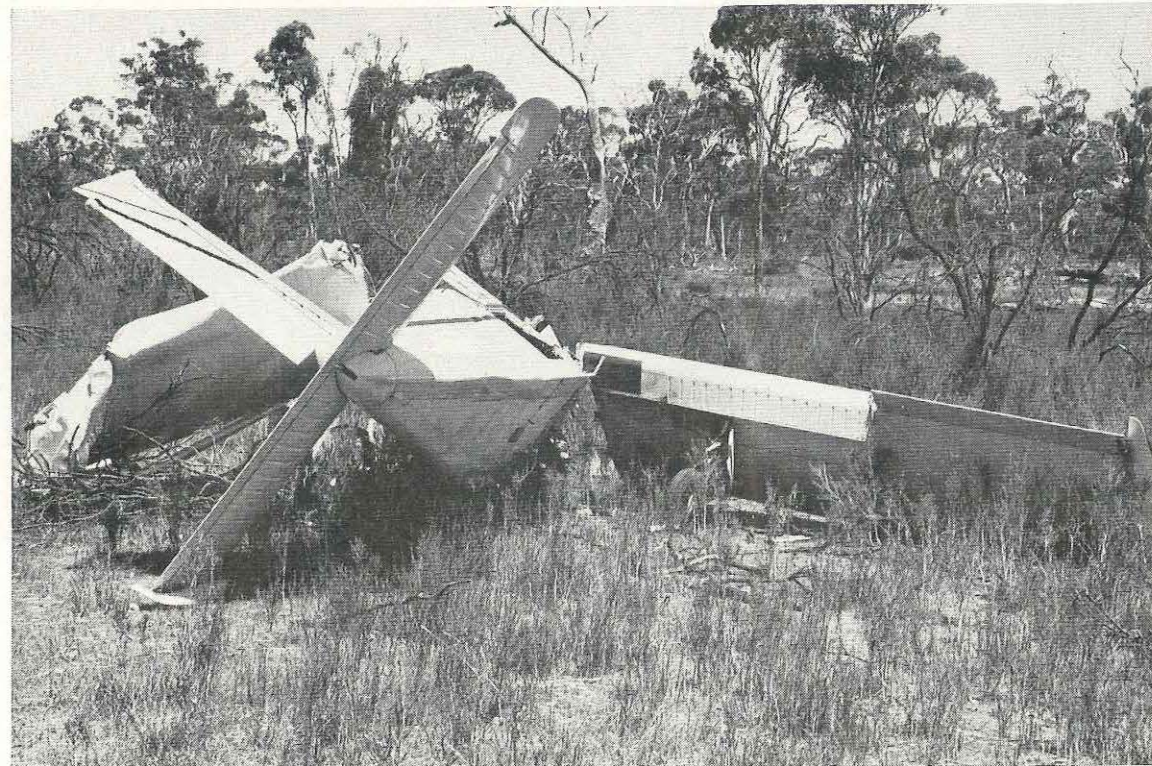
The wreckage as it came to rest. The flap position was the result of impact forces.

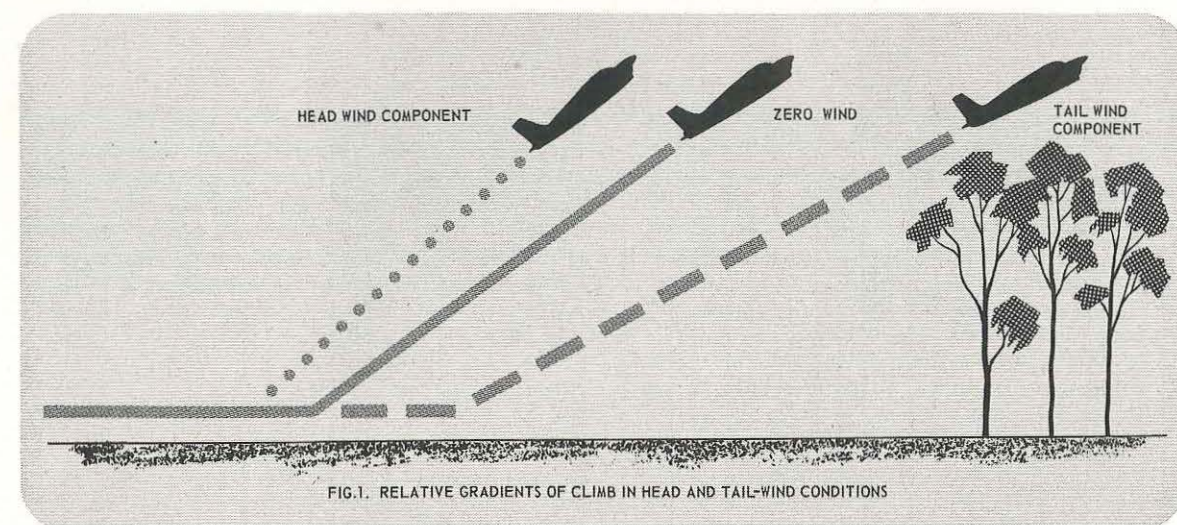
FIG.1. RELATIVE GRADIENTS OF CLIMB IN HEAD AND TAIL-WIND CONDITIONS

Just the opposite occurs during a take-off in tail-wind conditions, in that the increased ground speed results in a longer distance being taken to reach the same height. The actual gradient of climb in this case will be somewhat less than the figure achieved in still-air. If the gross weight for take-off has already been limited by the aircraft's performance chart to meet the 6% still-air climb gradient requirement, or if the aircraft just achieves this figure at an unrestricted weight, then in the more adverse tail-wind situation, the margin above the 5% obstacle-free gradient from the end of the strip will be reduced. If the tail-wind component is strong enough, the aircraft may even descend relative to the required obstacle-free gradient. These variations in climb gradient are shown in Fig. 1.

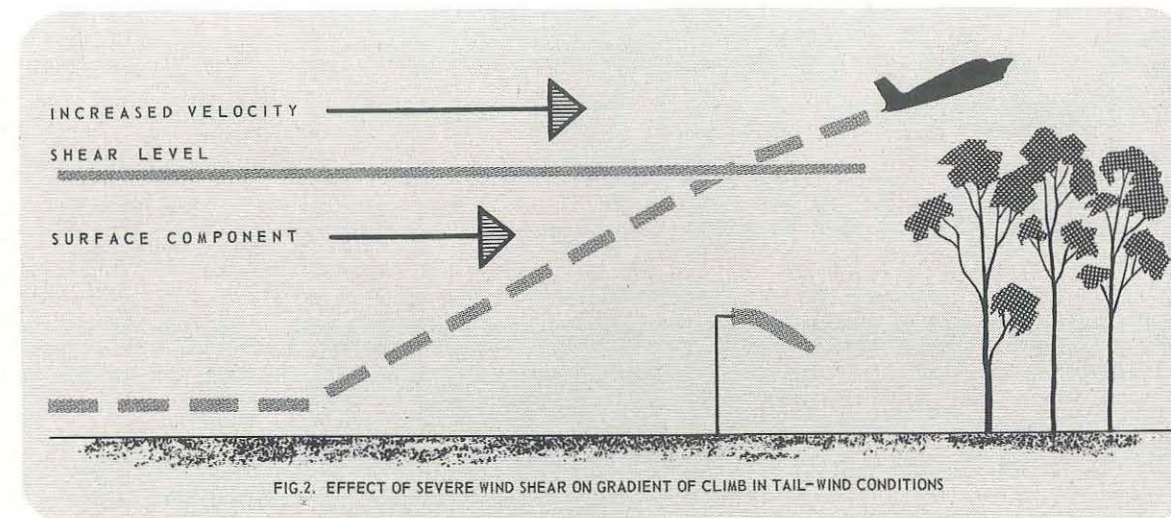
FIG.2. EFFECT OF SEVERE WIND SHEAR ON GRADIENT OF CLIMB IN TAIL-WIND CONDITIONS

tail-wind component increases and with it, the distance to reach a given height; i.e., there is progressive reduction in climb gradient as height is gained. This situation is illustrated in Figure 2.

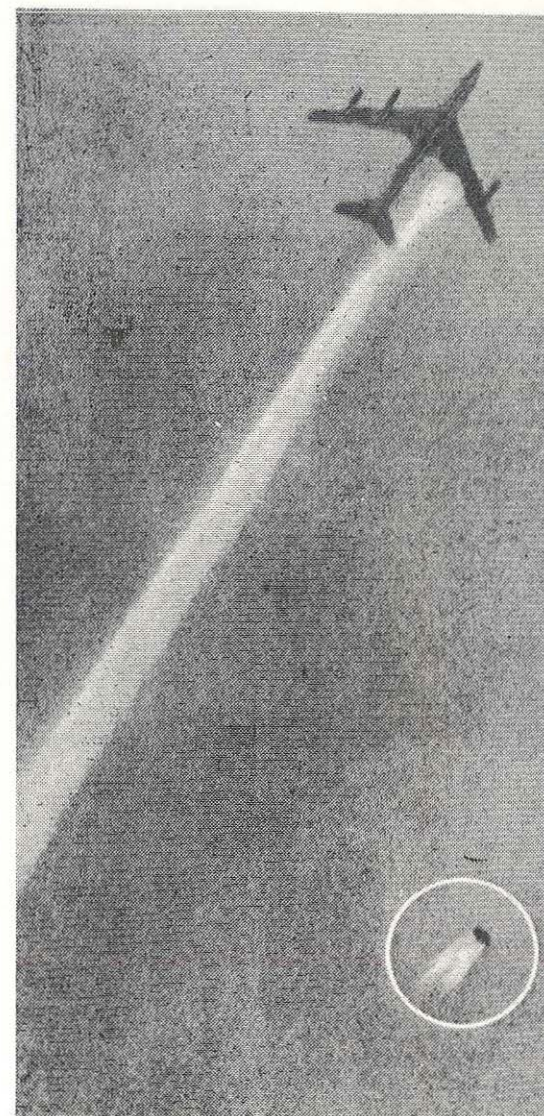
A minute and a half after the start of the fire, the No. 2 engine, with part of its mounting pylon, fell from the aircraft. The flight crew were unaware of this, but knew that the fire was still burning.

Taken by an on-the-spot photographer, this picture shows the No. 2 engine falling from the burning port wing as the aircraft was returning to land.

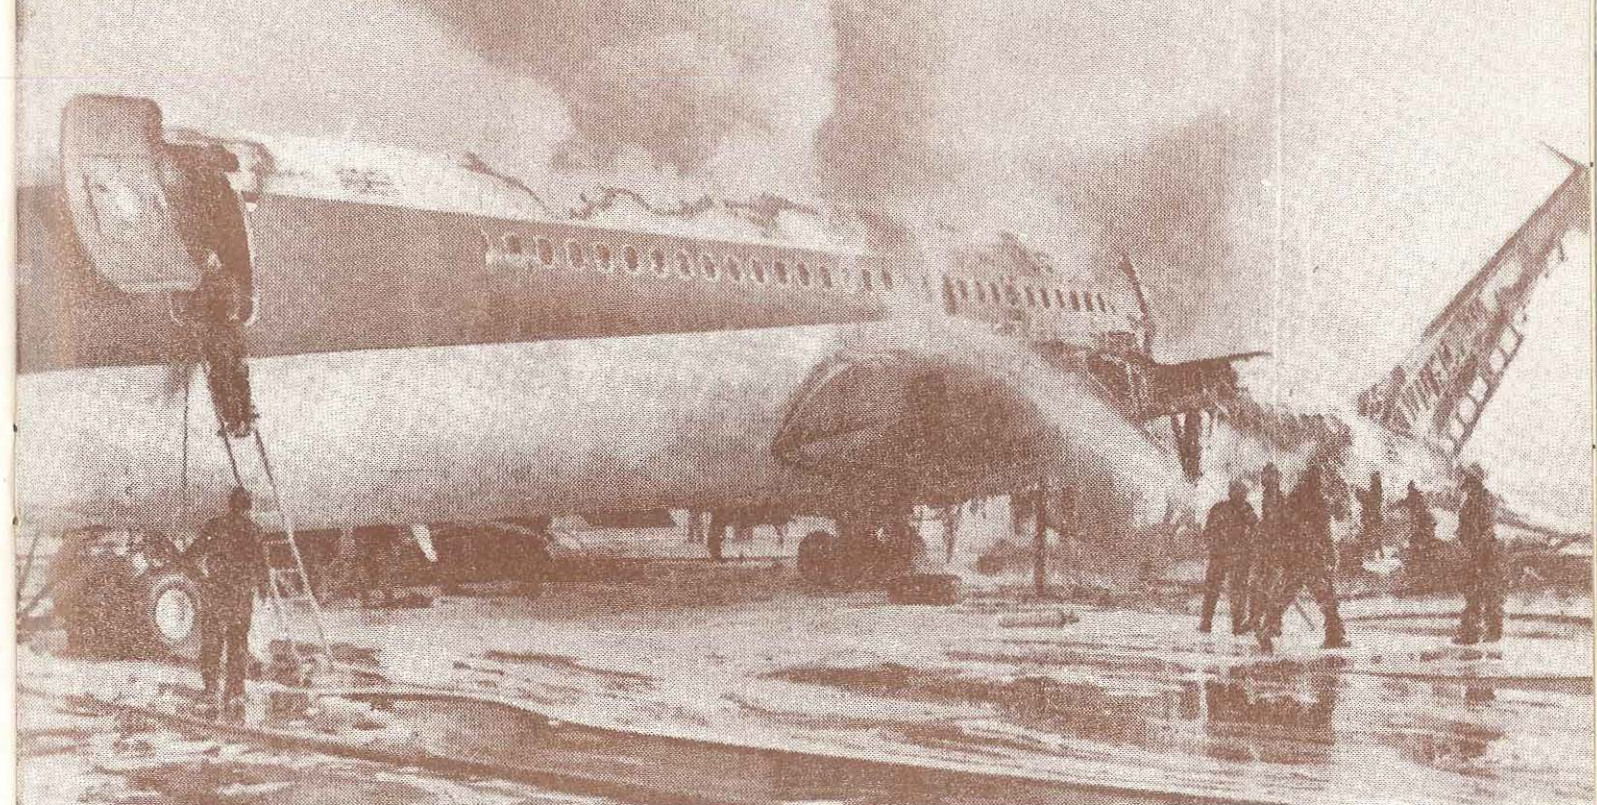
Firemen subduing the fire in the fuselage. Most of the survivors escaped from the aircraft before the fuselage was breached.

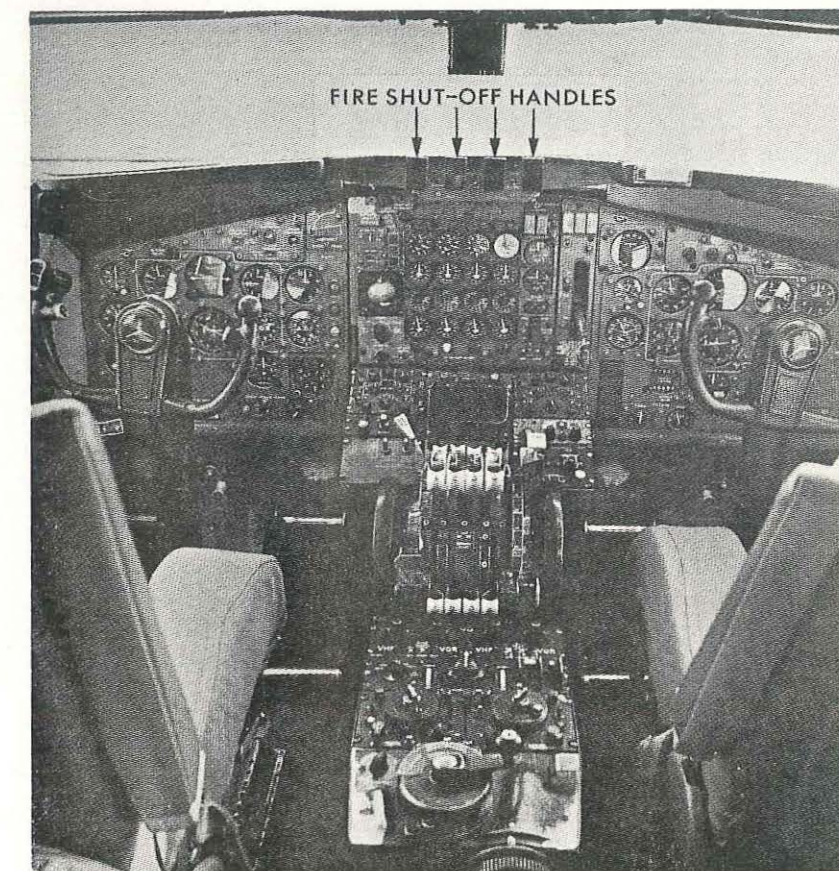
Pilot's instrument panel in the Boeing 707, showing position of fire shut-off handles.

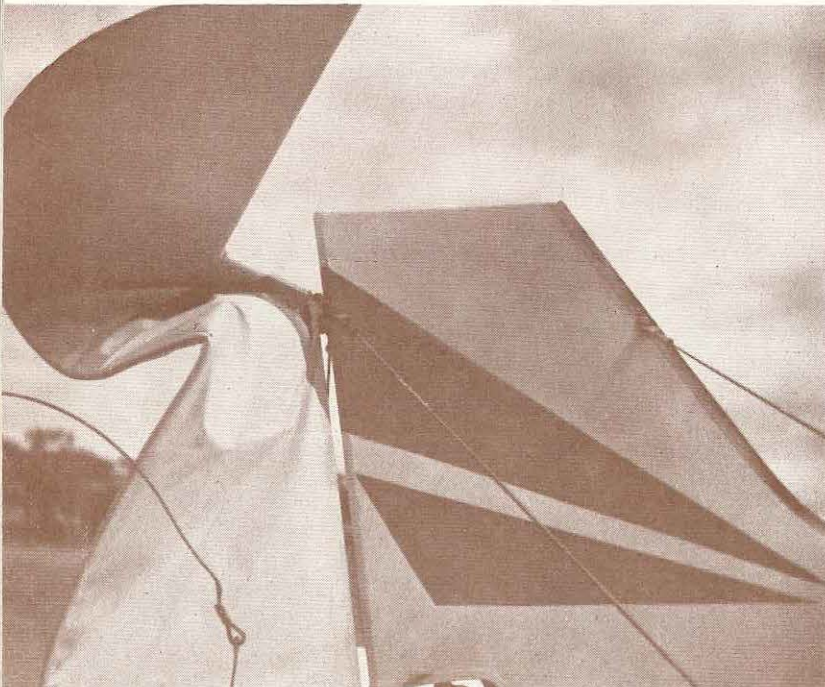
Above: The Pawnee's rudder after its encounter with the power line. Despite the severe distortion, the aircraft remained under control.

IN northern New South Wales, a Pawnee was spraying a field of cotton, making passes beneath a long span, single wire power line which crossed the area. All went well until the pilot worked his way to about the middle of the power line span, where the sag in the wire reached its lowest point.

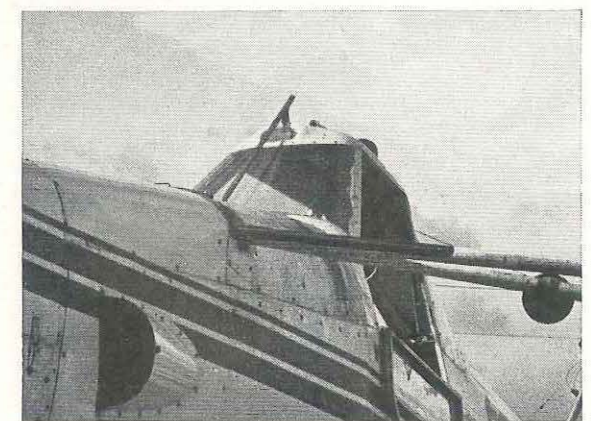
Above: Wire cutter as fitted to the windscreen of later model Pawnee aircraft.

The same philosophy of "good insurance" could also be applied to the fitting of wire-cutters to the windscreens of Pawnee Aircraft. This safety device was also introduced well after production had begun, and, as in the case of the anti-sag deflectors, there are a number of aircraft flying in Australia without them.

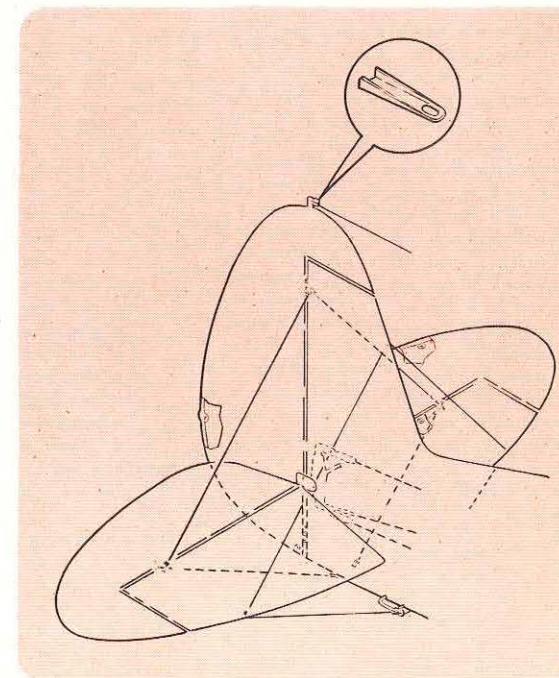
Left: Position of anti-sag deflector fitted to deflector cable on top of rudder of some Pawnee aircraft. Such a fitting might have prevented the damage shown on page 22.

equipment. It is apparent that the deflector had been removed at some time during the aircraft's life, possibly to renew the deflector cable, and for some reason was not replaced. If this was so, the person responsible could have had no appreciation whatever of the importance of such devices to the safety of agricultural aircraft.

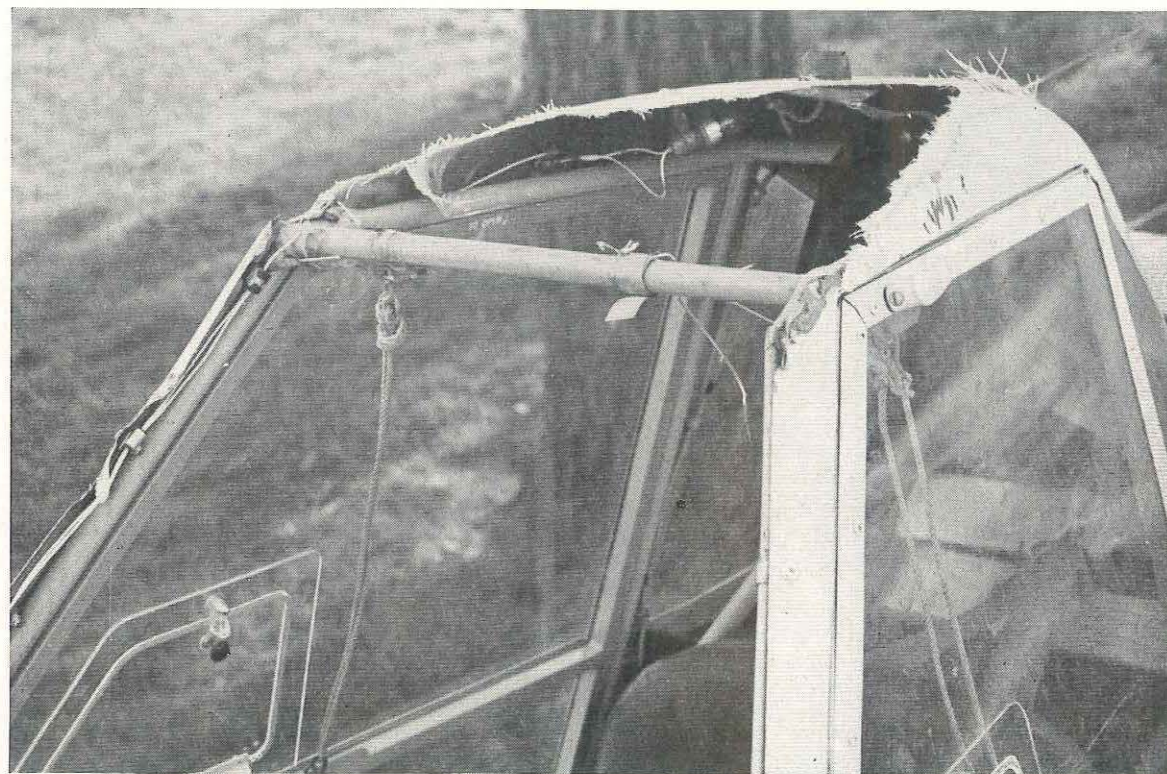
The windscreen and cockpit roof were torn off this Pawnee when it struck overhead wires while spraying in Queensland. The windscreen was not fitted with a wire cutter.

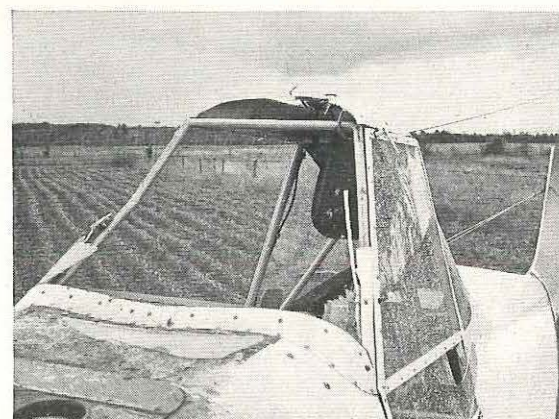
Another example, also from Queensland, of a wire strike shattering the windscreen of a Pawnee. A windscreen wire cutter of the type shown on the previous page would probably have prevented this damage.

The photographs taken of two different accidents on this page show what a wire strike can do to the windscreen of an aircraft. There is little doubt that the serious degree of damage, and risk of injury to the pilot, that occurred in each case, could have been avoided if these aircraft had been fitted with windscreen wire cutters. In this case again there is little installation problem and the cost is not great — certainly insignificant in comparison with the damage shown in the pictures!
