No. 66 JANUARY 1970

# AVIATION SAFETY DIGEST

DEPARTMENT OF CIVIL AVIATION AUSTRALIA

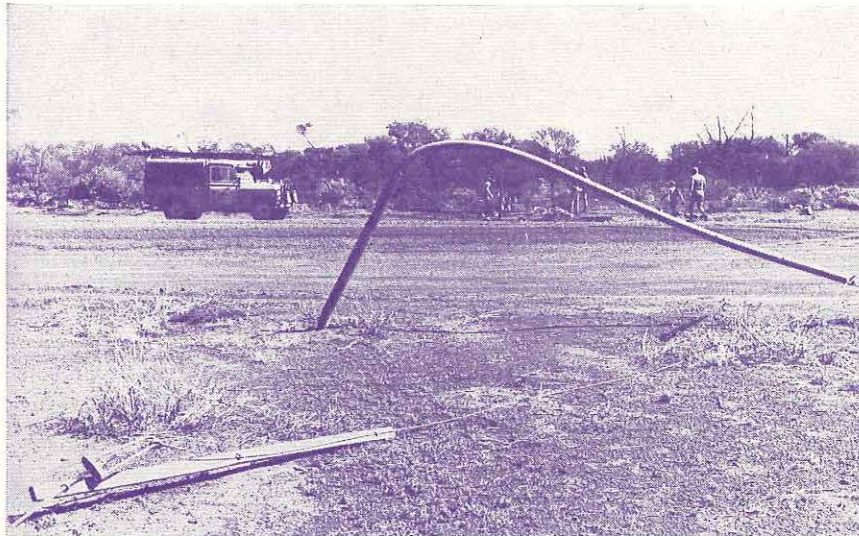
*The anchor point for the stay wire, pulled to the ground after the helicopter had struck the wire above the road. The telegraph pole which the stay wire was supporting was on the opposite side of the road where the group of men are standing.*

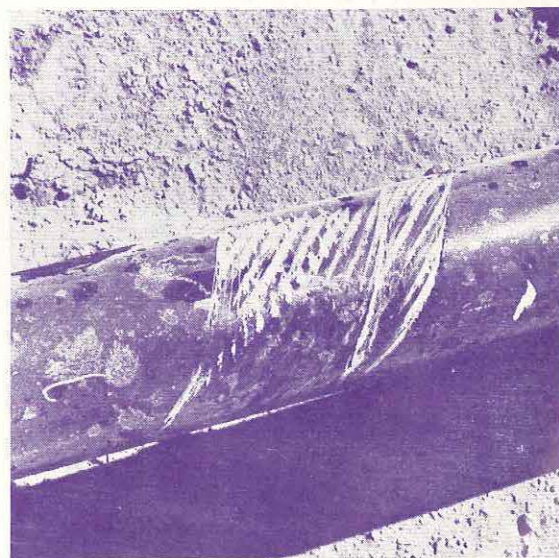
*Cable strike marks found on the starboard skid of the helicopter. Similar marks were also evident on the port skid.*

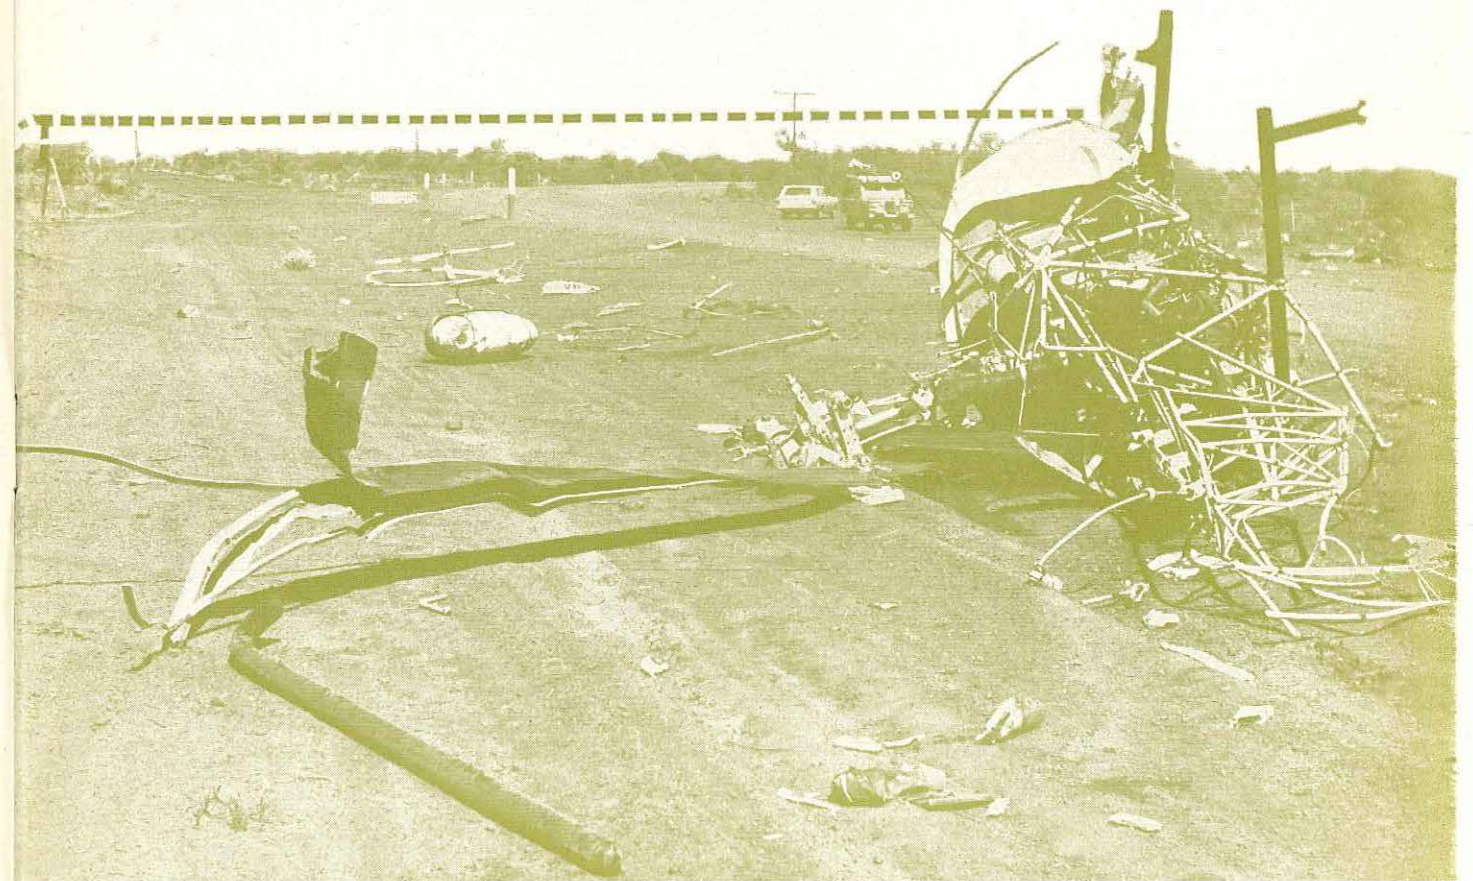
Although the cause of the accident has been attributed to operating the helicopter at an unsafe height, it is also apparent that the planning of the operation was a contributing factor. The refueling stops were planned on the basis of making the flight in nil wind conditions and made no allowance for possible head winds, yet the pilots were aware, from this experience on the previous leg, that the winds were adverse.

*General view of the wreckage with the position of the stay wire indicated by the heavy dotted line. The damaged anchor point shown on the opposite page can be seen at the extreme left. The picture was taken looking back in the direction of the helicopter's approach.*

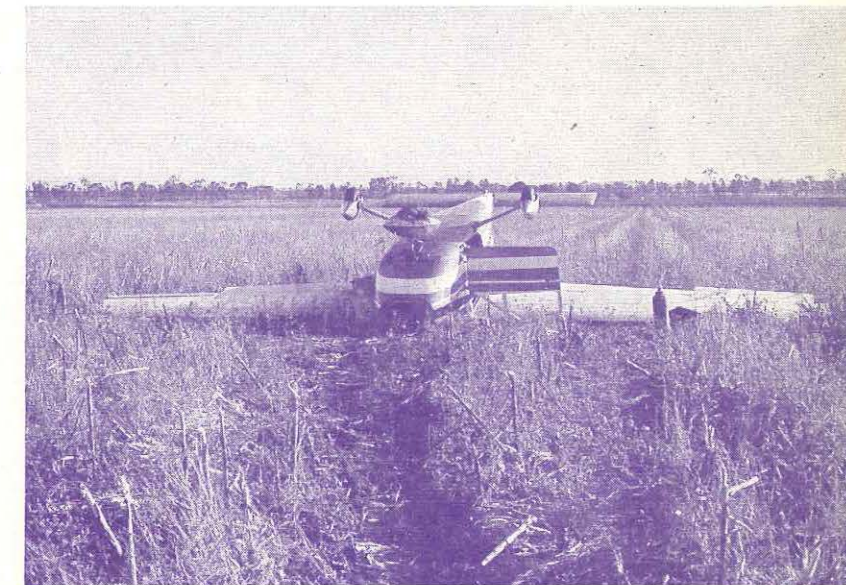
*The ridge of earth which forced the nose wheel off-centre. The path of the deflected nose wheel through the soft soil is clearly evident.*

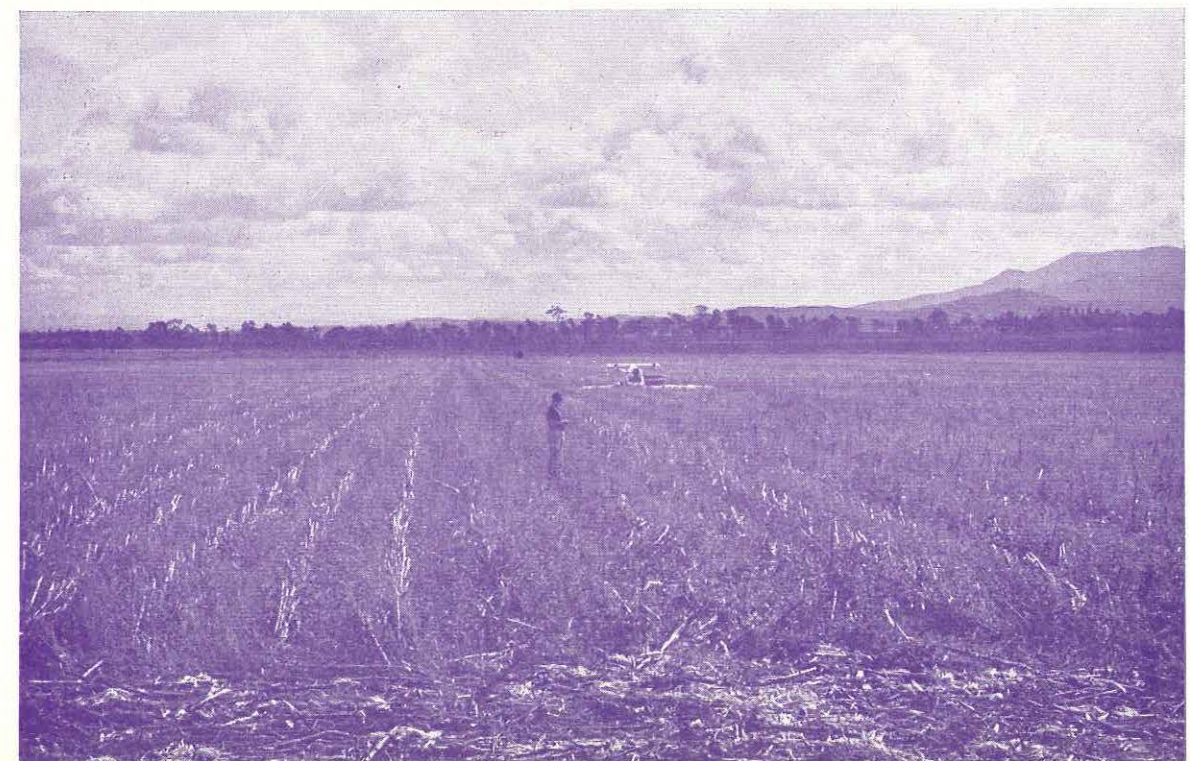
*The accident site looking in the direction of landing. The man in the foreground is standing at the aircraft's touch-down point.*

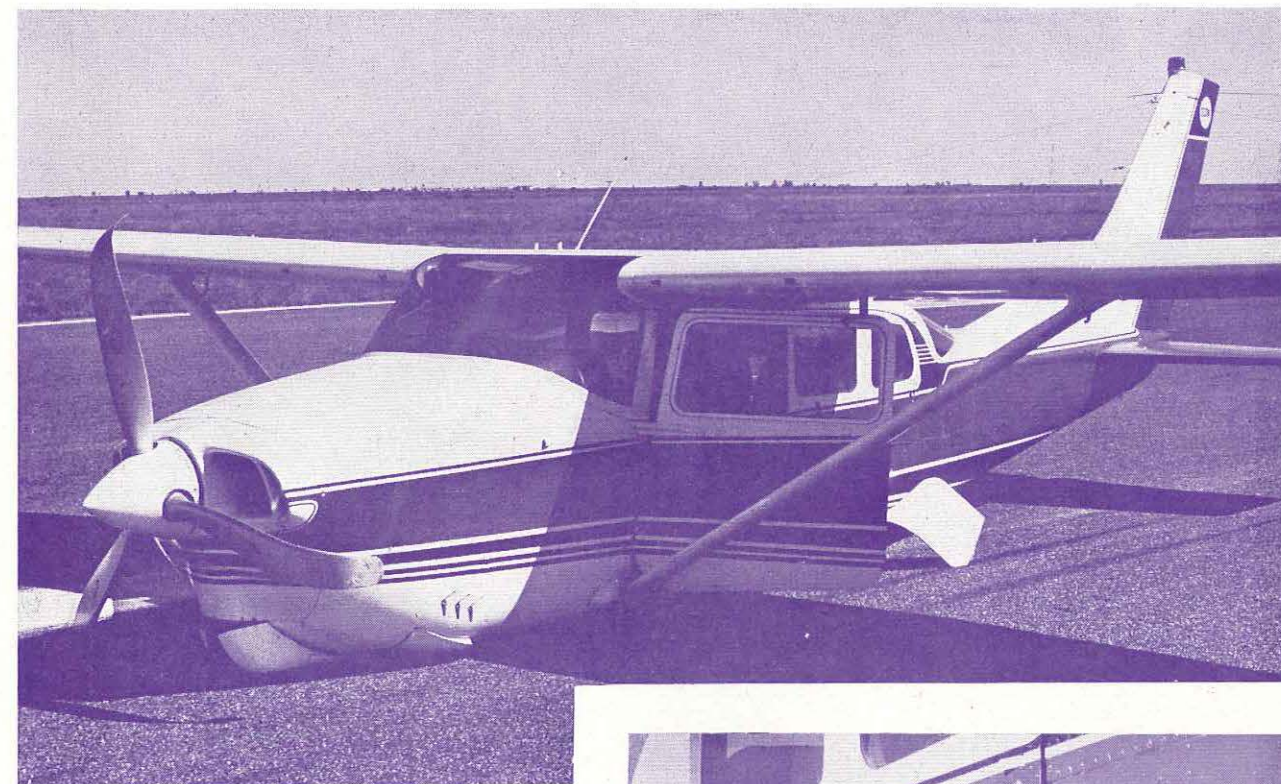
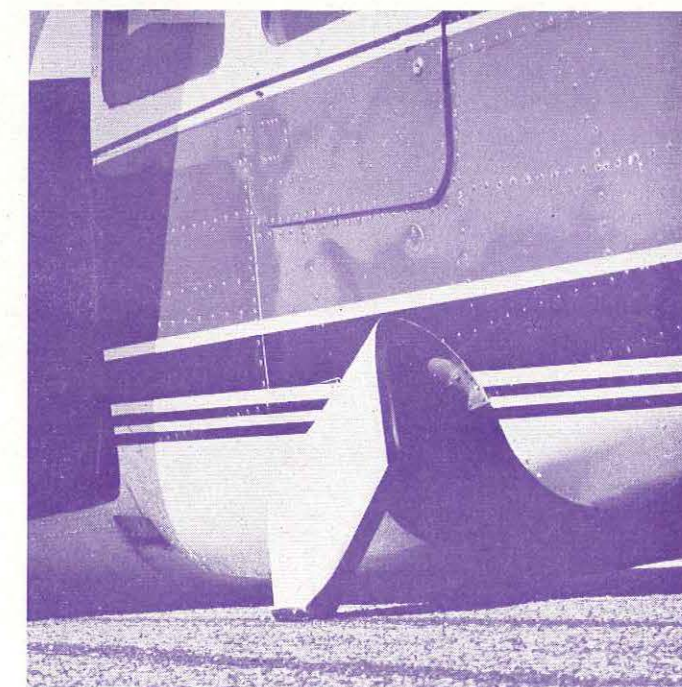
Examination of the aircraft after the accident showed that the oil level in the hydraulic system reservoir was low and that, although the undercarriage doors had begun to open when the undercarriage was selected down, there was insufficient fluid in the system to complete the extension cycle. The reason for the low oil level was a slow leak from a gland in the nose leg uplock ram. The emergency extension system was nevertheless fully operational and there would have been nothing to prevent the pilot pumping the undercarriage down manually.

*These pictures show clearly that the undercarriage extension cycle had begun before the aircraft landed. The nose wheel doors are half open and the port main undercarriage door is fully open. Insufficient fluid in the hydraulic system prevented completion of the cycle.*

demonstration of a fact that has been proclaimed many times in the past—both in the Digest and elsewhere. **Rigid adherence to established cockpit checks is the only sure way to prevent accidents of this sort!**

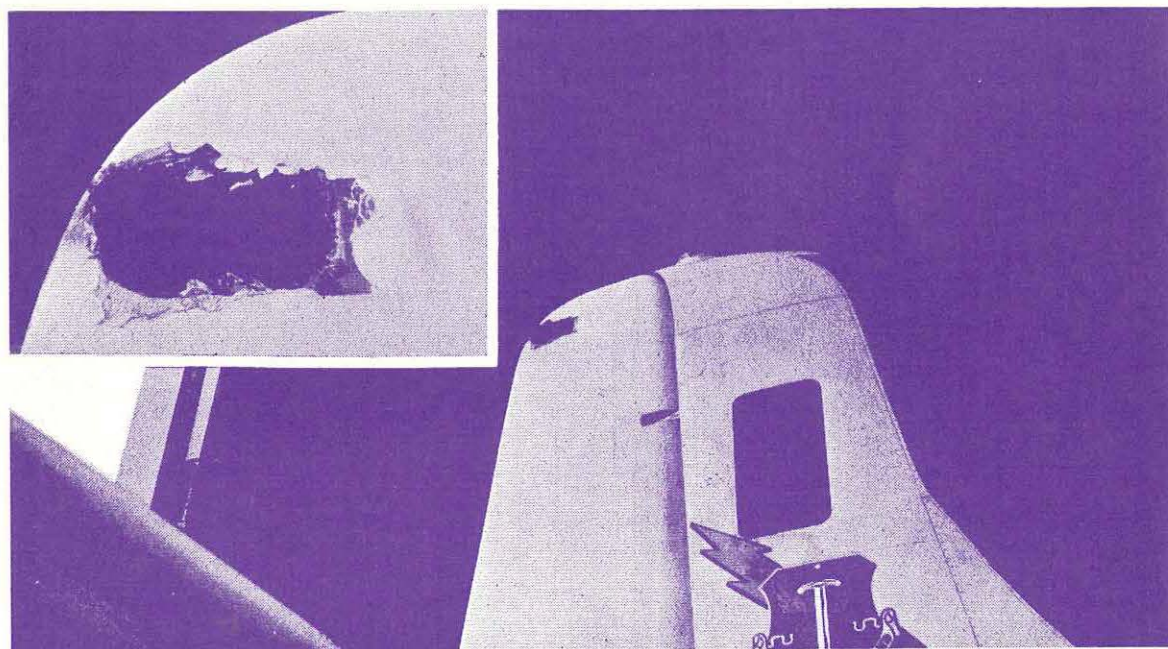
THE hole in the fibreglass-fabric covered rudder of the C-118 was the size of a volley ball. The pilot, who was unaware of the damage until he stepped down from the aircraft at the completion of what had appeared to be a routine flight, could hardly believe his eyes. There had been no blinding flash, booming jolt, tingling limbs, spinning compasses or other time-honoured indications of a lightning strike. Nevertheless, there was the hole in the rudder, and the only explanation for it was "a bolt from the blue."

While driving between two sizeable bright spots on the airborne radar, winking about ten miles apart, the aircraft had encountered a flurry of light snow flakes, light turbulence, and precipitation static on VHF. The snow changed to light ice crystals and lightning had flashed several times, seemingly well clear of the aircraft, as the flight continued without incident. Sheer luck determined that the lightning bolt which passed through the rudder did not damage the operating mechanism.
