No. 68 MAY 1970

AVIATION SAFETY DIGEST

DEPARTMENT OF CIVIL AVIATION AUSTRALIA

Contents

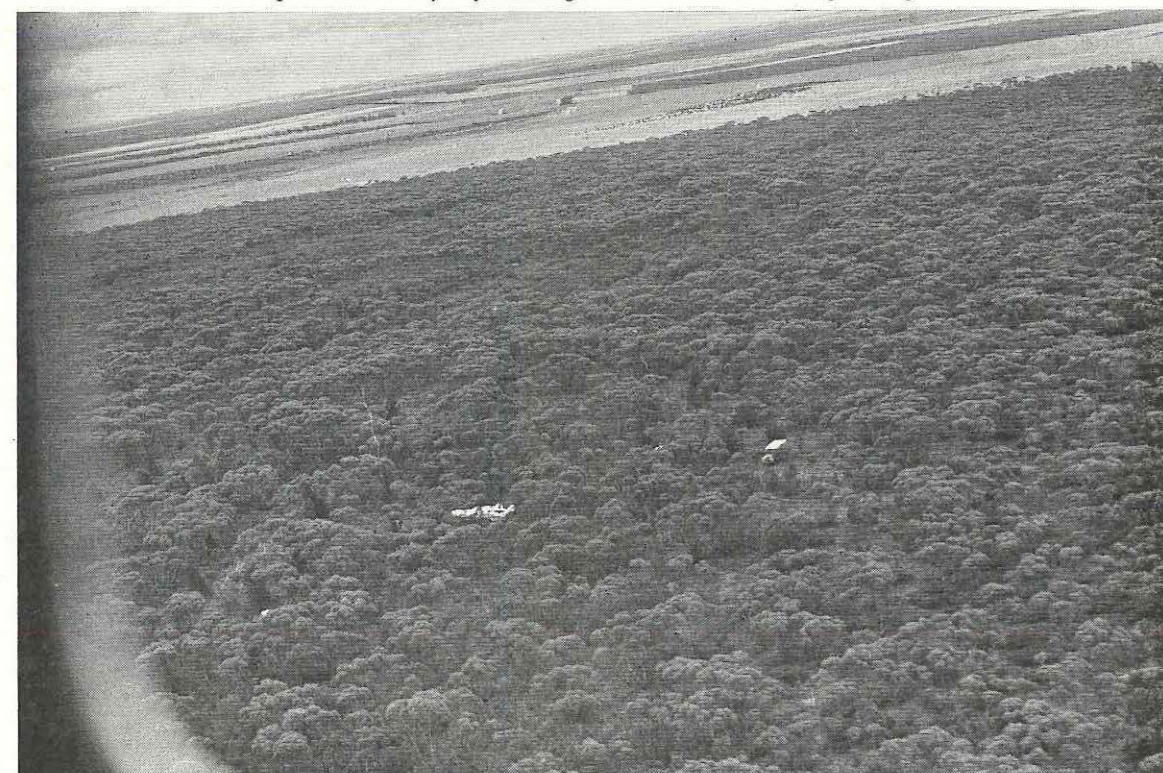
Aerial view of accident site looking back in direction from which aircraft had come. Note the complete absence of any wreckage trail in the surrounding undergrowth.

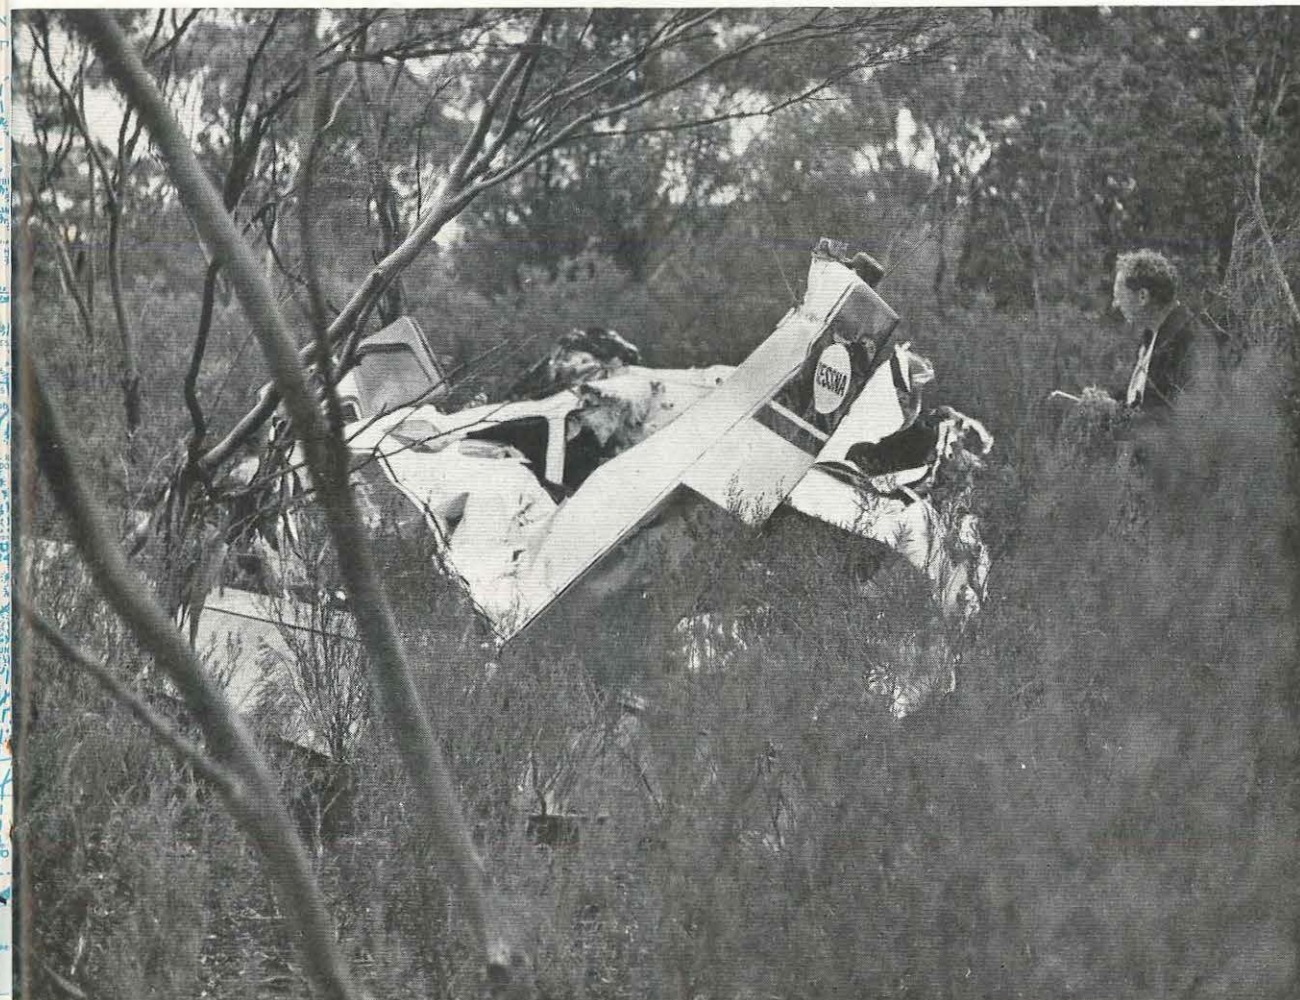
The wreckage as it was found. The lack of damage to the surrounding undergrowth clearly indicates that the aircraft struck the ground in a near-vertical descent.

to the cause of the accident. Damaged watches recovered during the examination indicated that the accident had occurred a few minutes after 1500 hours.

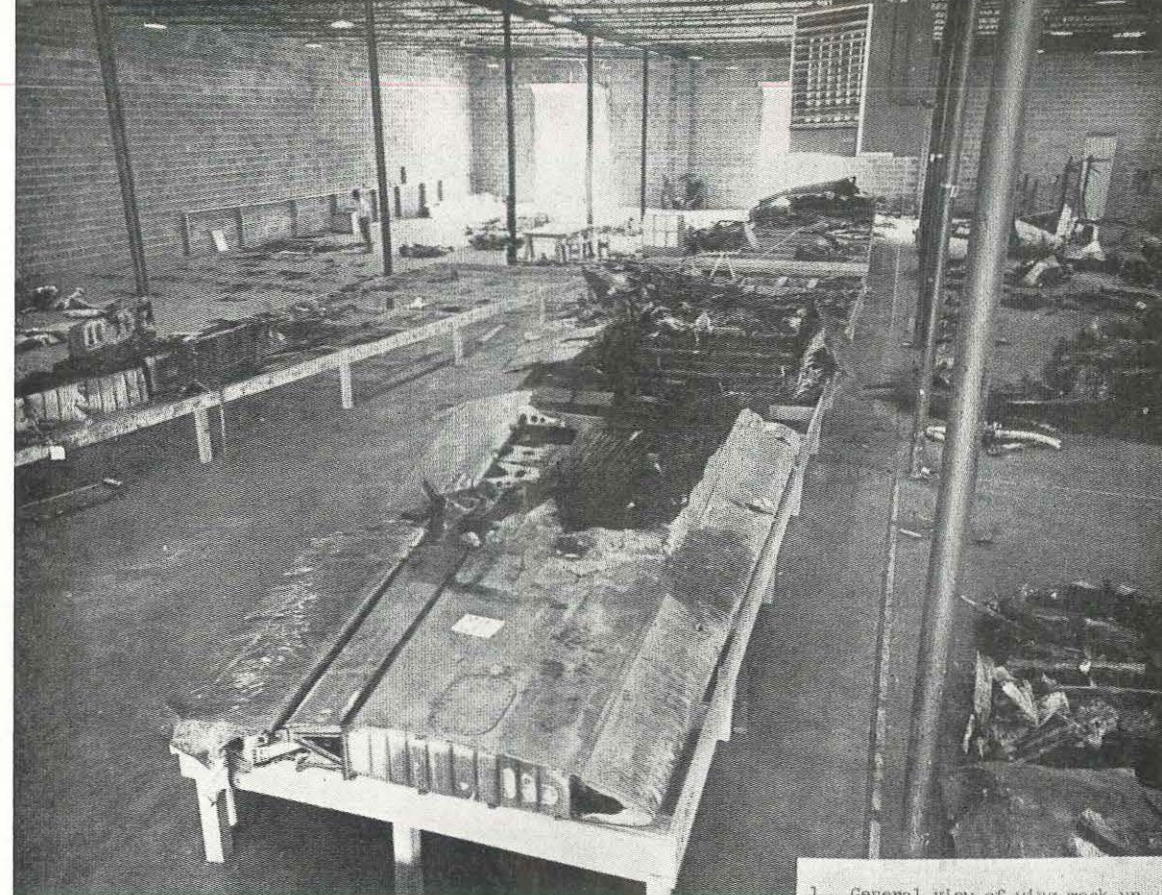
The wreckage of the Electra's wing being "reconstructed" during the investigation.

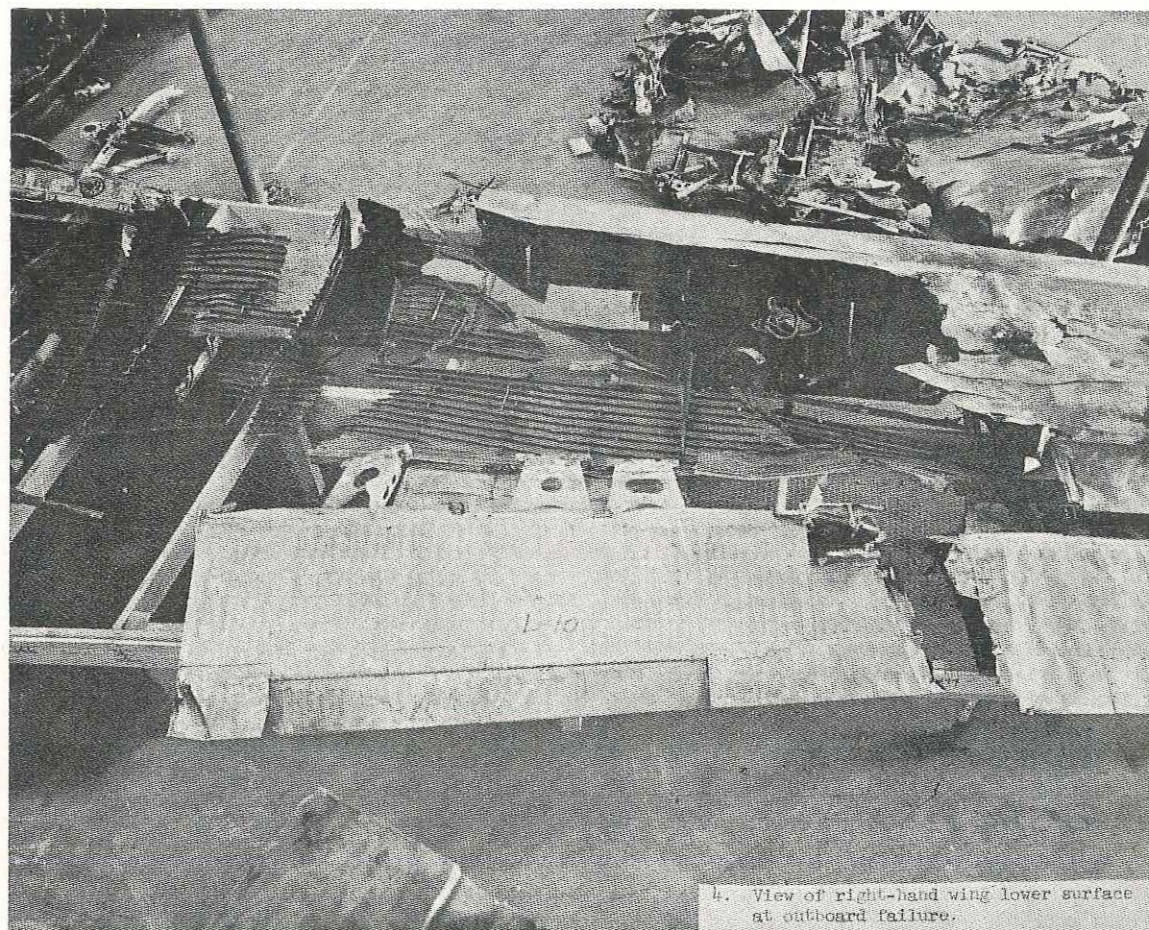
4. View of right-hand wing lower surface at outboard failure.

The underside of the "reconstructed" starboard wing showing the position of the outboard failure.

During the attempted recovery from this spiral, the inboard section of the starboard wing was subjected to positive bending and torsional moments in excess of its ultimate strength. Because of the effect of the rolling moment created by the pilot's attempt to level the wings, the port wing was not subjected to loads as high as those imposed on the starboard wing. The evidence indicates that the wing failed, with the wingtip and wing leading edge moving upwards, and with the wingtip moving aft. The initial failure occurred in the section of the wing which is usually critical for compressive stress in the positive, high angle of attack, loading condition. Such a loading condition normally occurs in a pull-out from a dive.

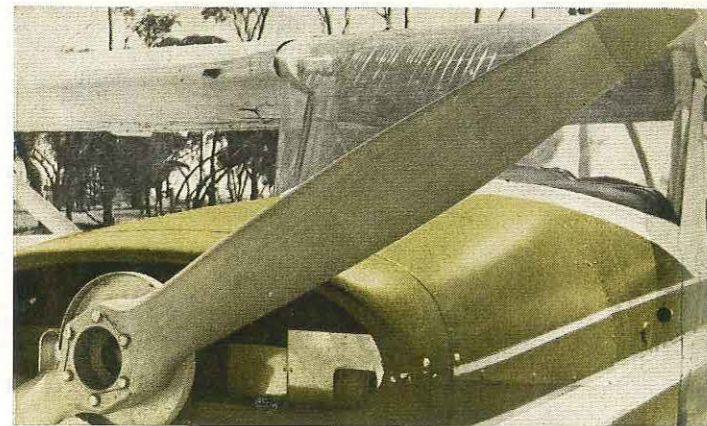
Marks left by the wire on propeller and windscreen. The leading edge of the starboard wing was also damaged.

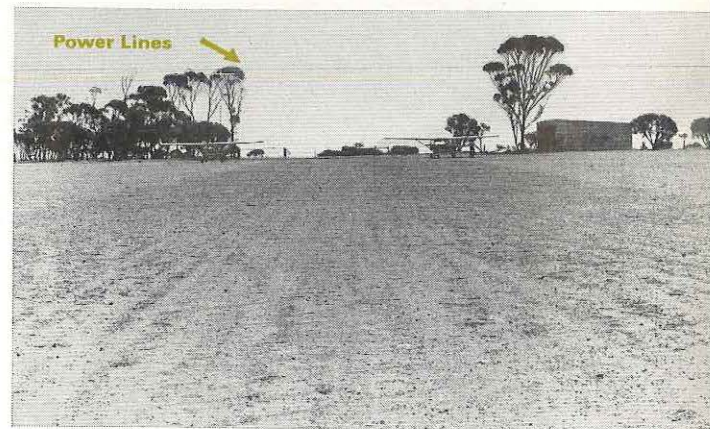
View from point of touch-down, looking back towards approach path. The power line struck by the aircraft is indicated.

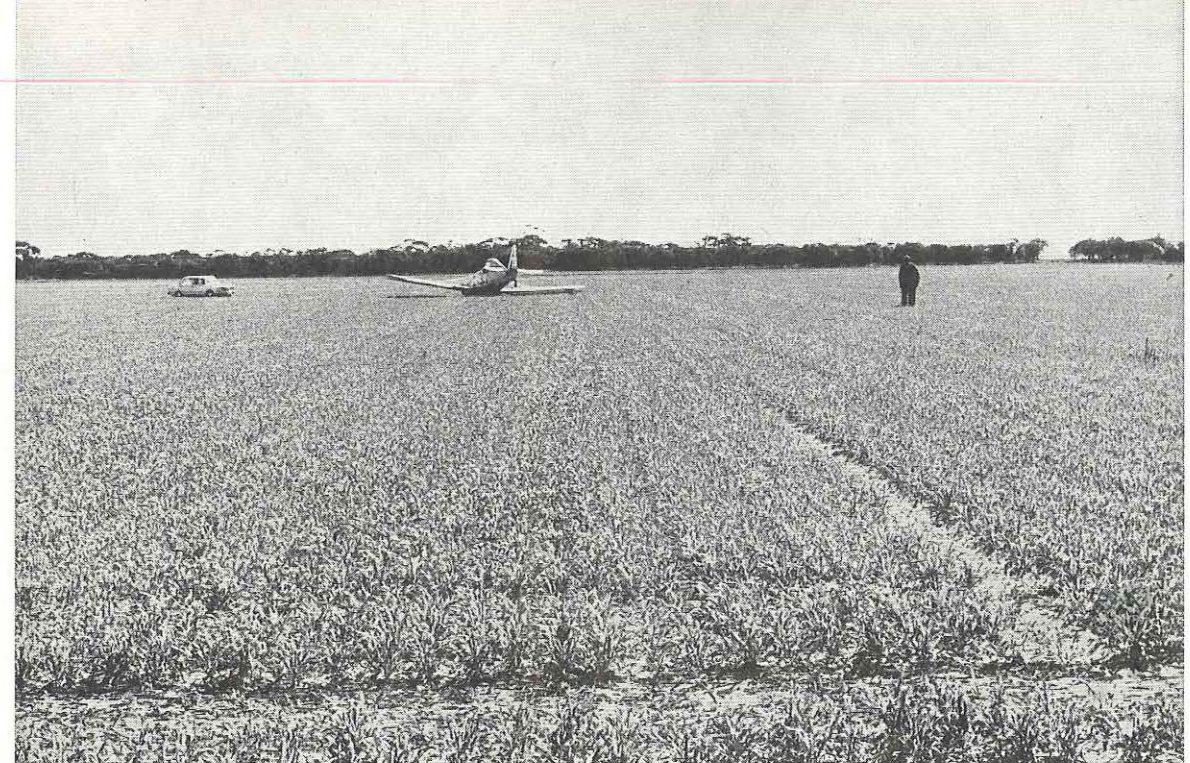
View looking in direction of flight from point at which Callair's tail wheel became hooked on the wire.

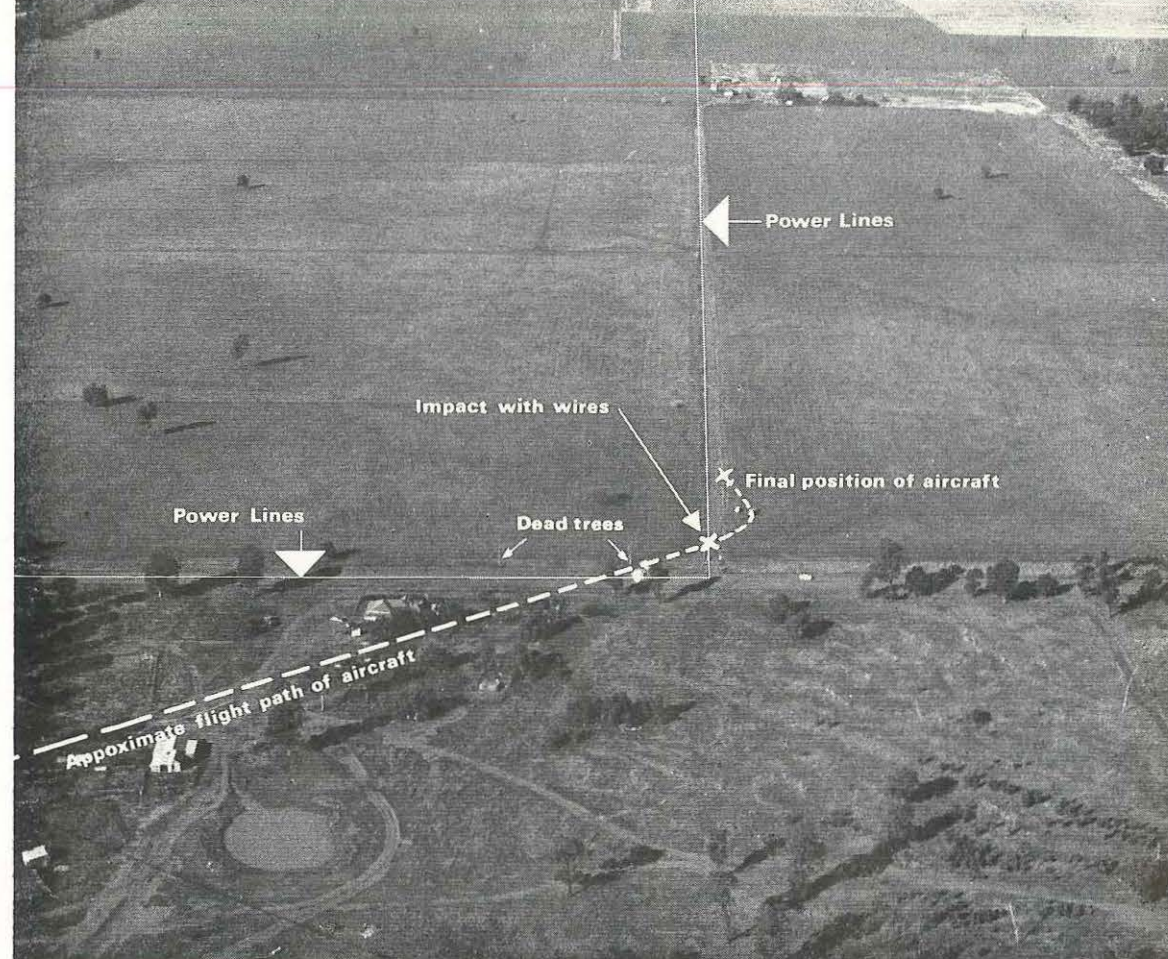
Above: Aerial view of paddock chosen for forced landing practice, showing aircraft's approach path and location of power line.

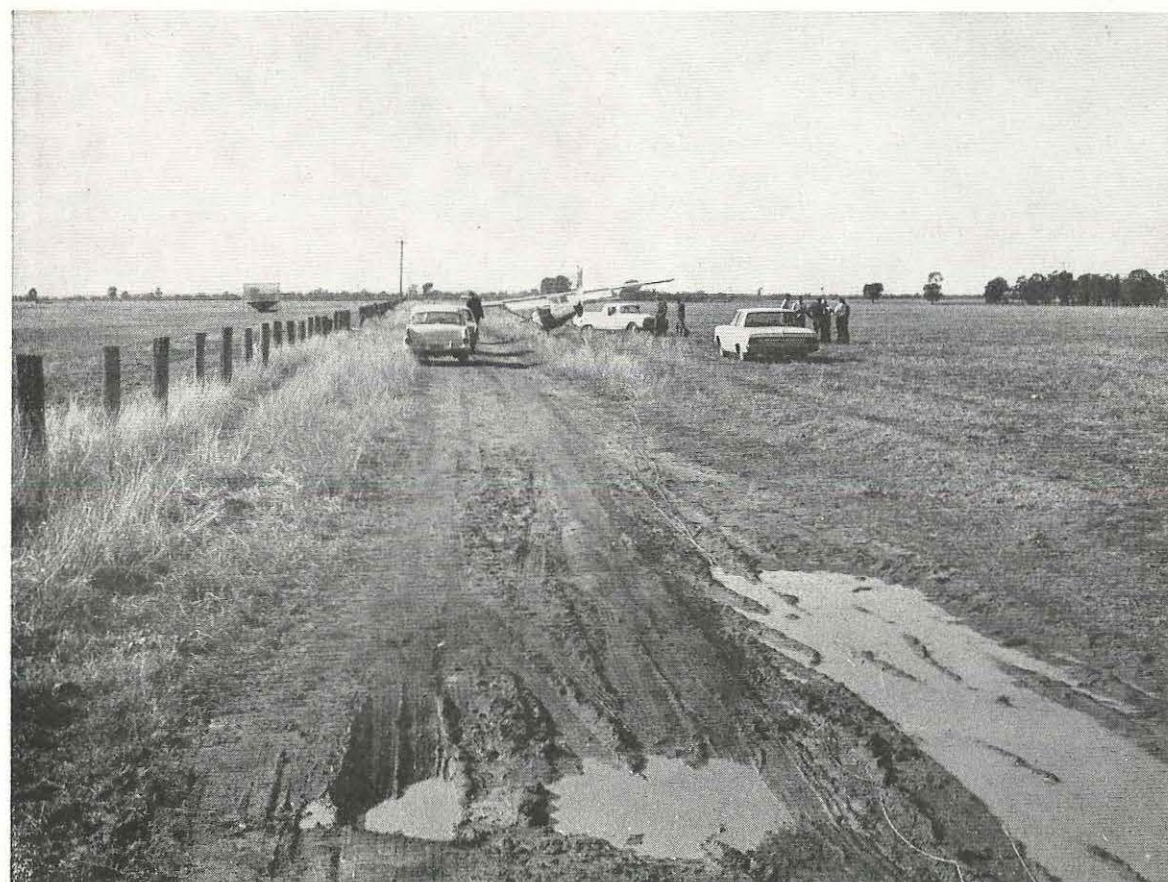
Below: The accident site in the paddock. The overhead wires above the fence at left were those struck by the aircraft.

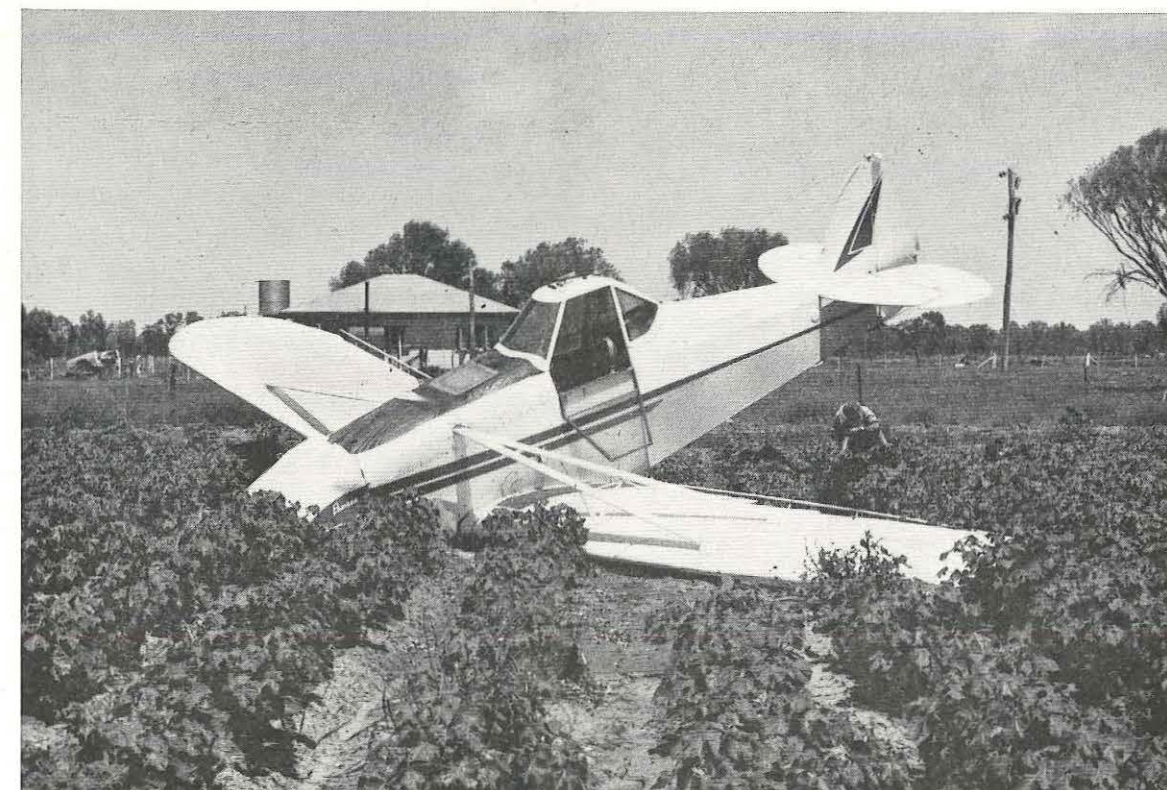
The privately-owned Pawnee as it came to rest after flying into the second power line. Portion of the line can be seen in the background.

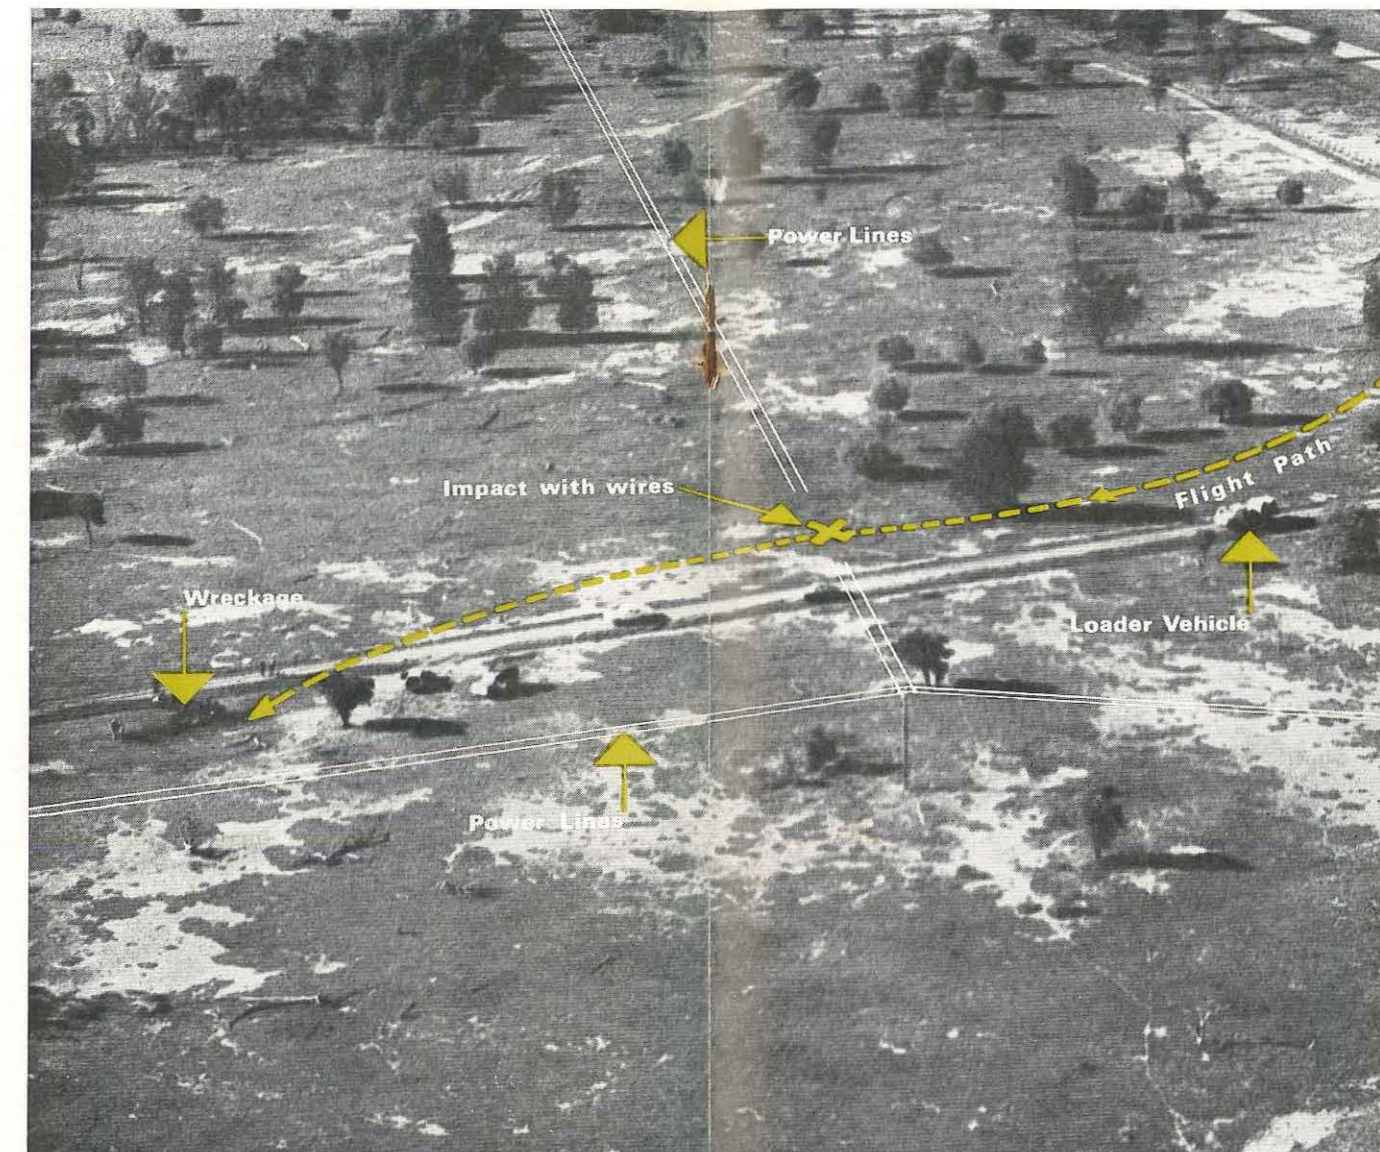
(5) The wreckage in the picture is that of an agricultural Pawnee that had just been flown to a property in western N.S.W. to begin the day's work. The pilot landed normally on the property's agricultural strip at the end of the ferry flight but, finding that his loader-driver had not arrived with

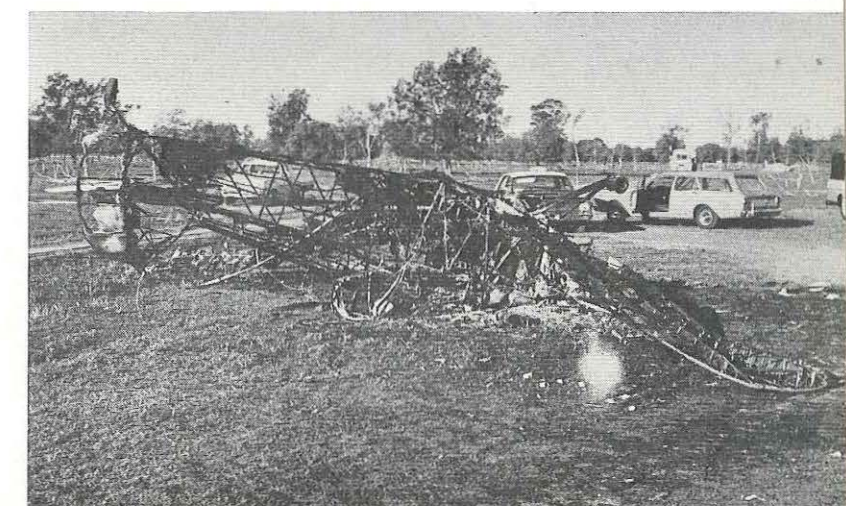
Above: View of burnt-out wreckage, looking in direction from which the Pawnee approached. The gates of the property through which the loader vehicle had just passed can be seen in the background.

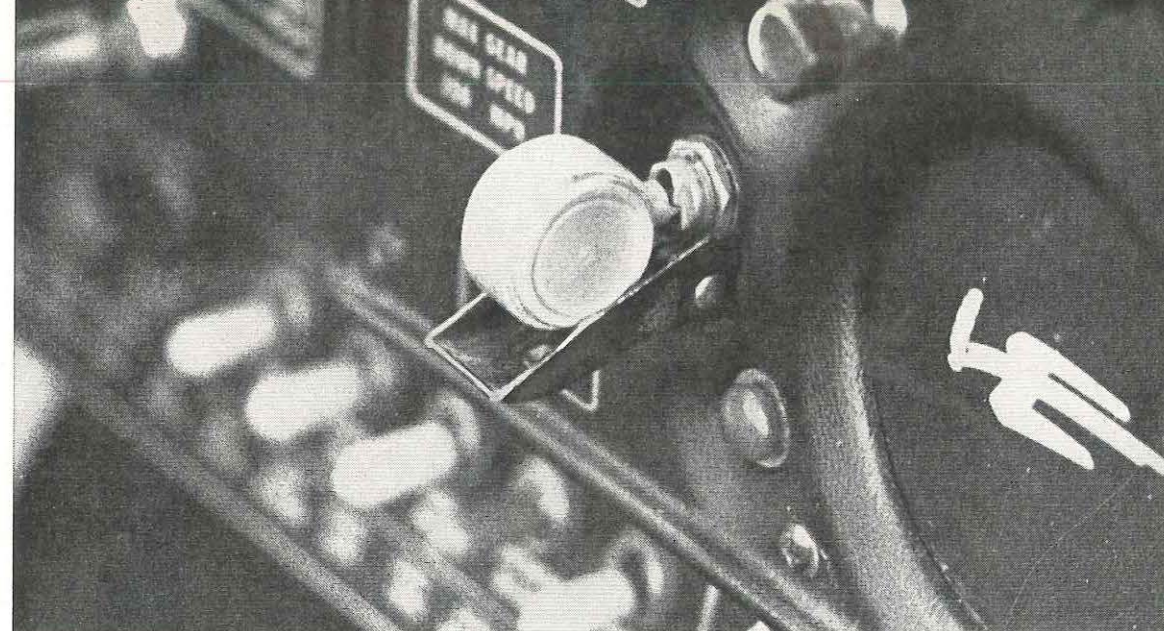
Above: The undercarriage switch still in the neutral position after the aircraft had come to rest.

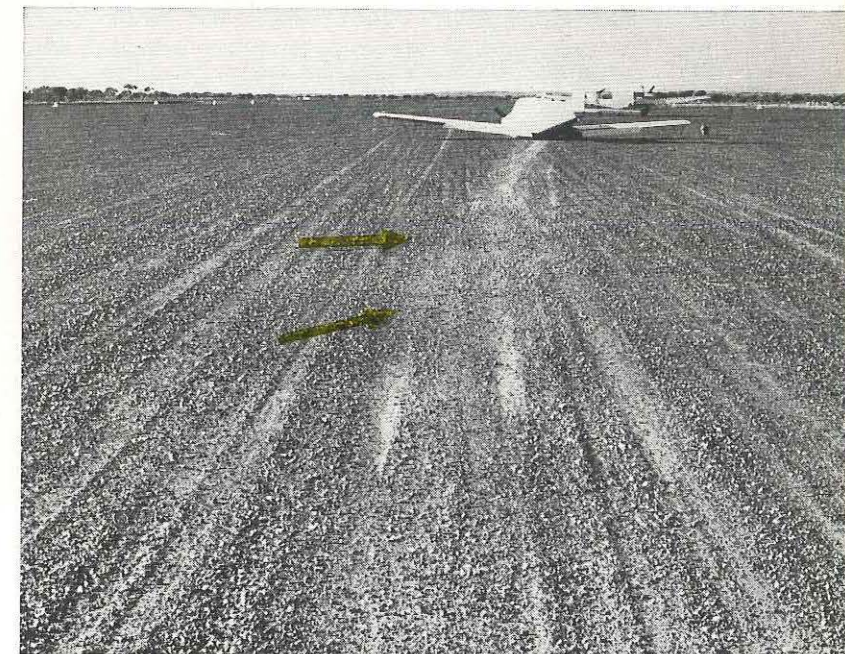
Below: Marks left on the runway show that the undercarriage was fully retracted at touch-down. The arrows indicate propeller slash marks.

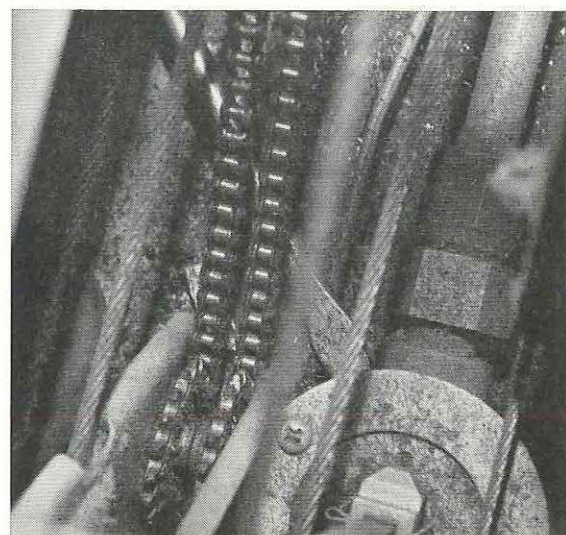
Figure 1

Although neither screwdriver was actually fouling controls when discovered, their position was such that they could easily have been caught in the control linkage. The larger screwdriver, some 12 inches in length, was found beneath the cockpit flooring. With its blade tucked beneath the fuel selector valve, it was lying diagonally below the
