DEPARTMENT OF CIVIL AVIATION AUSTRALIA

# AVIATION SAFETY DIGEST

No. 69 JULY 1970

## FATAL SEQUEL to loss of propeller blade

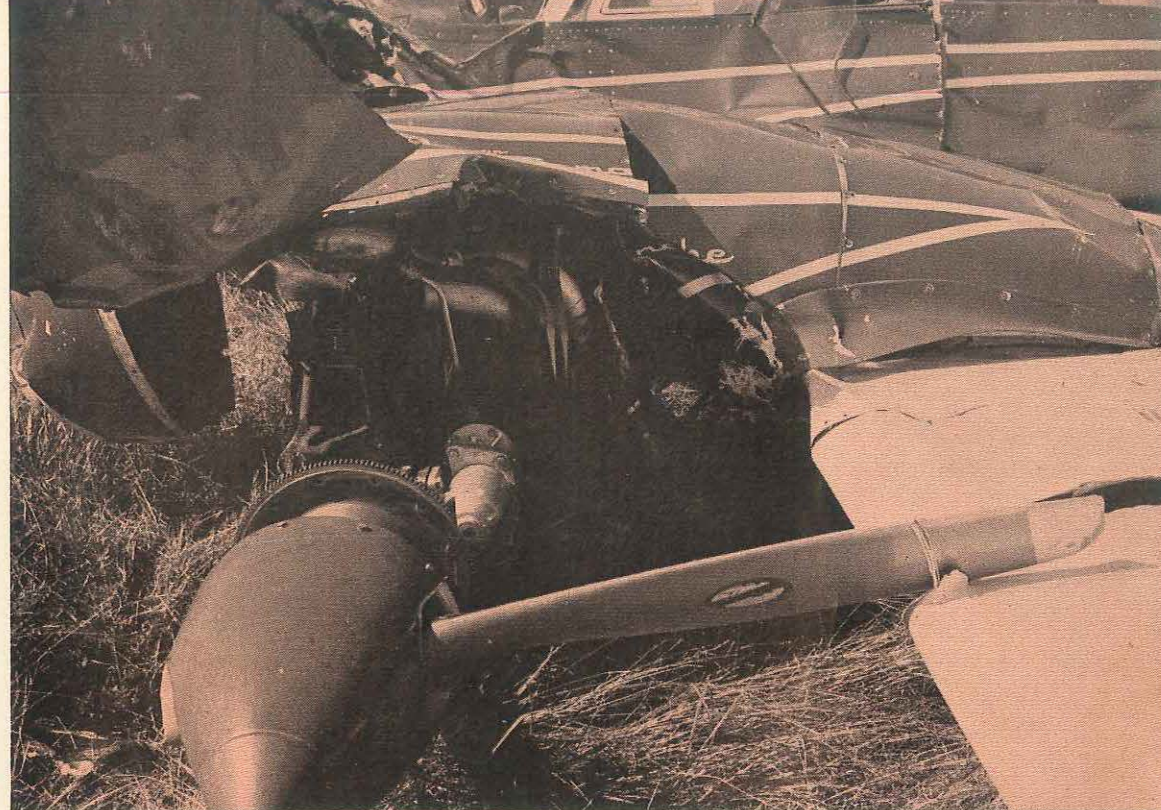
Above: The port engine, partially dislodged from its mountings, as it was found at the accident site. The intact propeller blade has cut through the upper and lower wing leading edge skins almost back to the main spar.

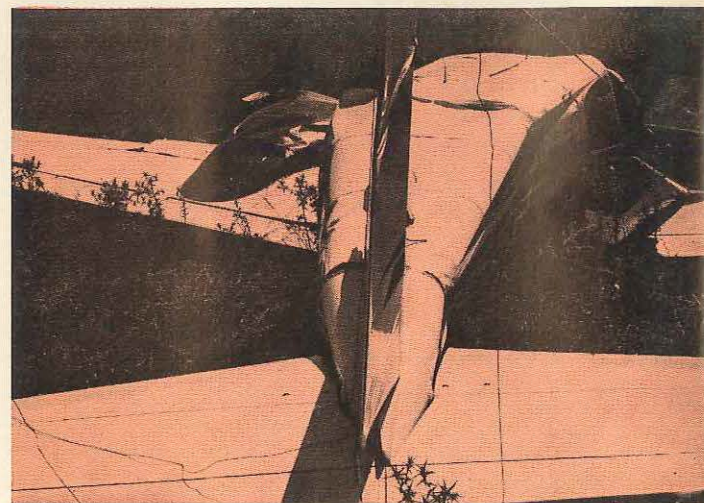
Right: Rear view of the wreckage as it came to rest. Distortion of the fuselage and impact marks indicated that the aircraft struck the ground in a fully-developed flat spin to the left.

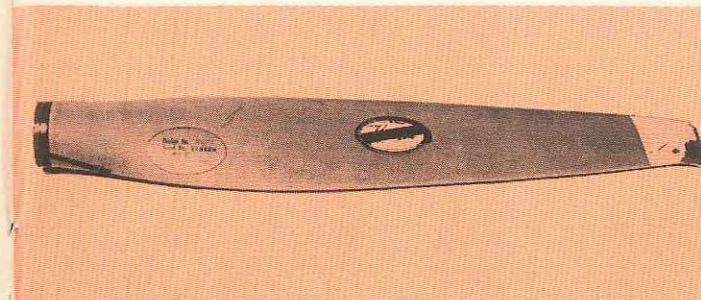
Intact blade of the port side propeller after removal from the wreckage for examination.

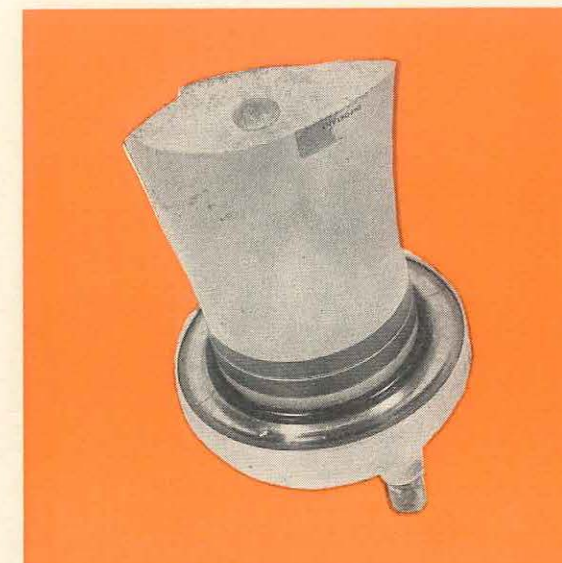
It was clear from the wreckage examination that one blade of the port propeller had failed in flight, close to its root end. The failure had resulted from normal operating loads applied to the blade after its strength had been greatly reduced by a fatigue crack extending over approximately 75 per cent of the cross sectional area of the blade-root. A strip examination of both engines and propellers disclosed no defect which would have prevented them from operating normally or have resulted in any unusual vibration, and the history of the failed propeller contained no record of any previous damage.

The failed propeller blade, with end of lead "wool" balance weight visible in the centre of the fracture surface. Fatigue cracks which led to the ultimate failure of the blade originated in corrosion pits in the walls of the balance weight hole.

remaining root end by the Aeronautical Research Laboratories in Melbourne disclosed that the fatigue crack ultimately responsible for the failure had initiated internally at a corrosion pit in the bore of the balance weight hole, the sides of which were badly corroded. Corrosion products were found in the balance weight hole of the failed blade and on the lead "wool" balance weight itself. Although the hole had been closed by a tight fitting plug, it was evident that water had been present in the hole for a long period. The material from which the failed blade was made met the appropriate specifications and no casting defects were found in it.

As a result of this accident, an Airworthiness Directive\* was issued by the Department requiring certain propellers of this type to be dismantled and the blades inspected for signs of corrosion in the balance weight hole. Any blade in which evidence of corrosion is found within the lower inch and a half of the balance weight hole is to be retired immediately. To date four such propeller blades have been found to be affected by corrosion in this way and have been withdrawn from service.

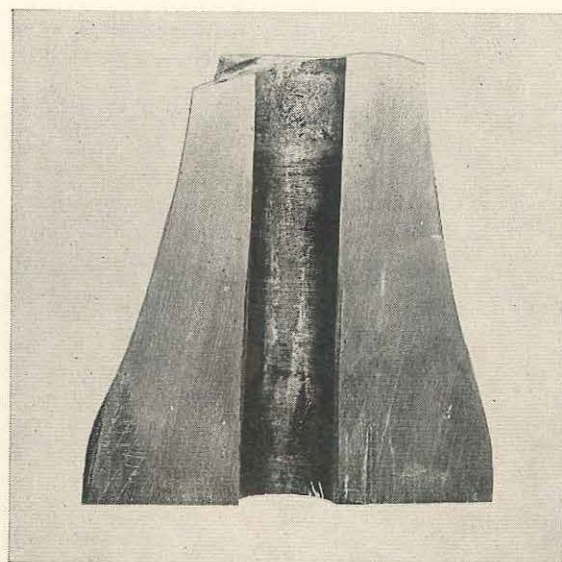
Longitudinal section through the balance weight hole of the failed blade. Note the white streaks of corrosion product and the dark coloured, corroded sides of the hole.

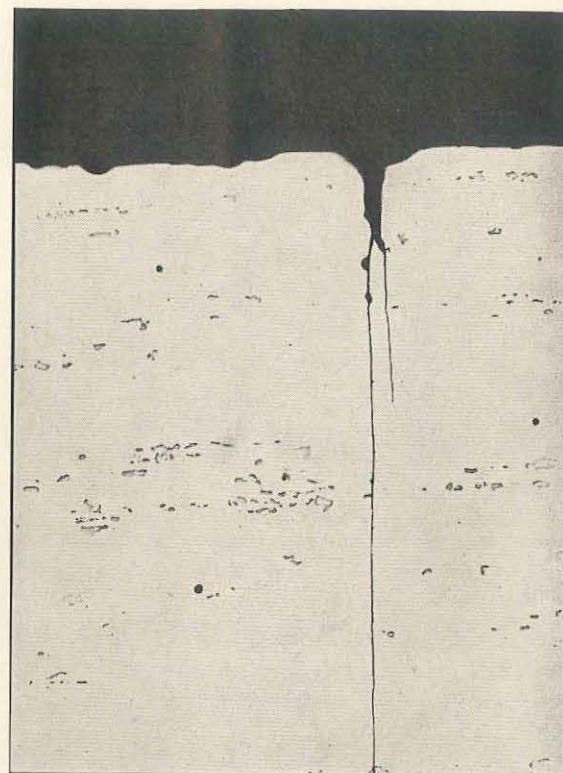
Another section through the balance weight hole and fracture surface, magnified 200 times, showing a large crack and corrosion pits in the walls of the hole.

From the overall investigation, the sequence of events that led to the accident thus emerged. At some time during the history of the propeller, moisture evidently became trapped in the balance weight hole of one blade. Corrosion developed as a result, causing pitting of the surface of the balance weight hole. From one such corrosion pit a fatigue crack developed which ultimately progressed to the point where the blade failed under normal operating loads. The resulting out-of-balance condition of the propeller dislodged the engine from its mountings and the pilot was unable to maintain effective control of the aircraft.

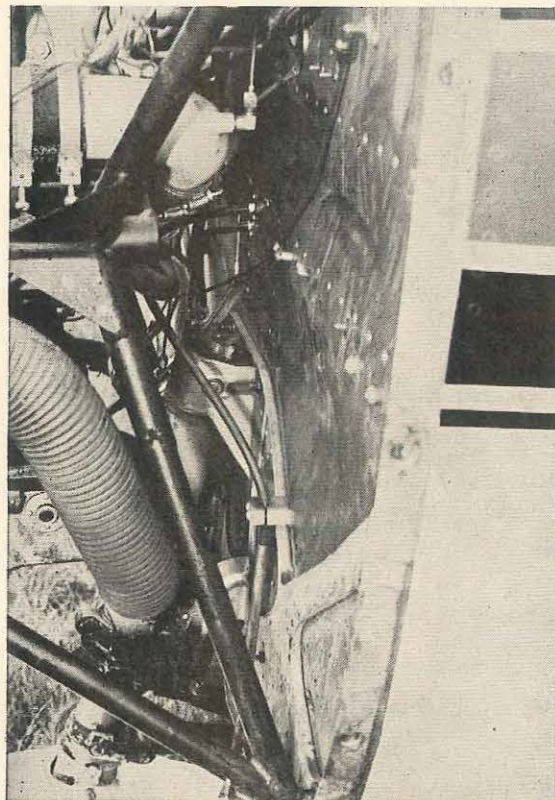
*Deformation of the firewall, caused by the nose wheel striking a rock during take-off, is clearly visible with the engine cowlings removed.*

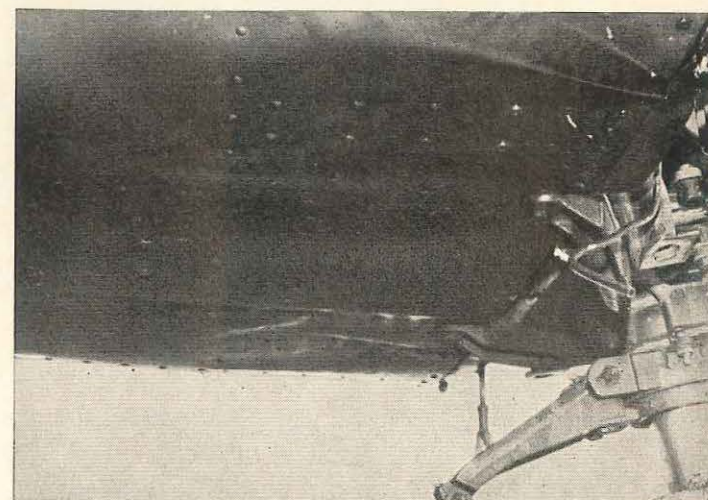
*Buckling of the lower fuselage skin immediately aft of the nosewheel strut.*

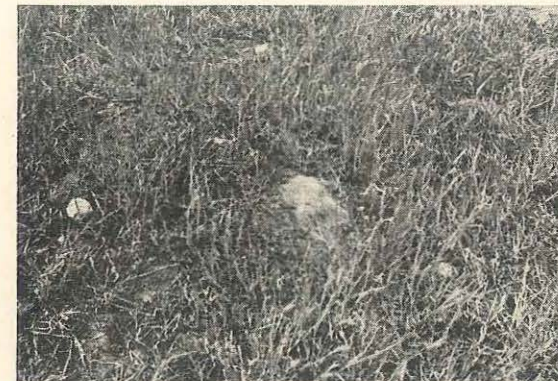
*Long grass in the paddock from which the aircraft was operating almost obscures the rock struck by the nose wheel.*

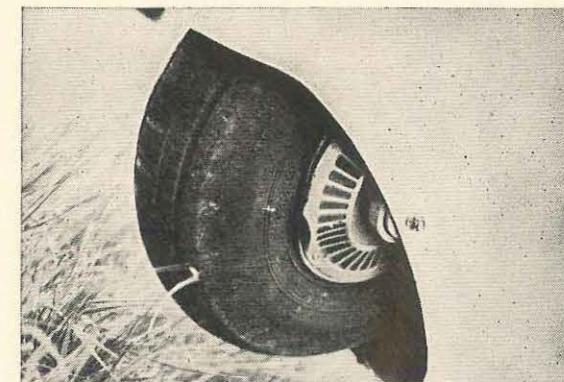
*The nose wheel raised clear of the ground to show the damaged rim.*

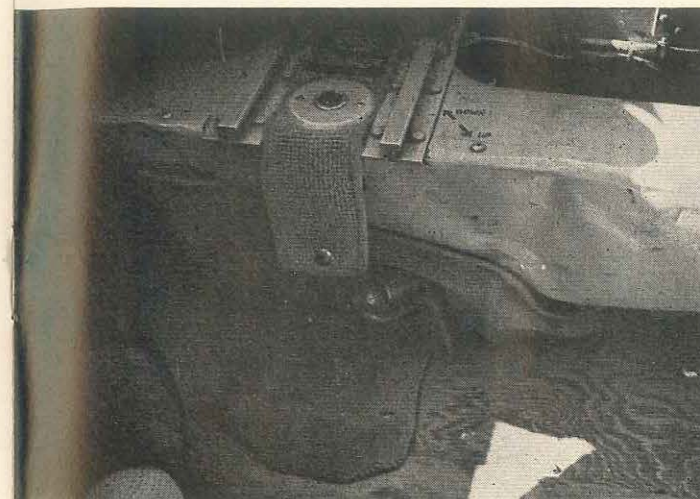
*Above: The emergency undercarriage extension handle in the stowed position. To prevent accidental engagement, the operator of this aircraft normally bound the handle to the shank of the mechanism with a strip of masking tape.*

Correct stowage of the hand crank with the standard protective cover in place not only reduces the chances of interference, but minimises the possibility of wheels-up accidents of this type. —

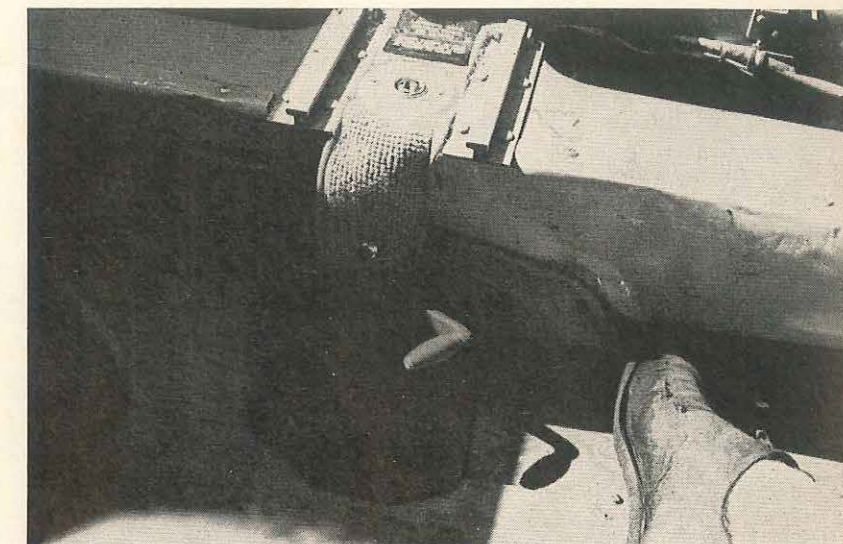
*Above Right: The extension handle in the engaged position.*

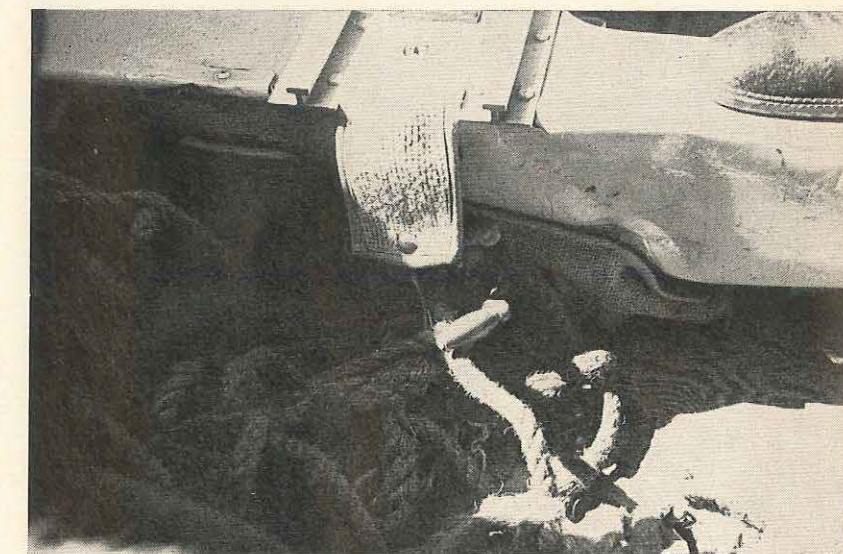
*Lower Right: This picture shows the pile of rope and cargo net lying across the extension handle. When the undercarriage was selected down, the rotating handle became tangled in the netting and prevented the undercarriage from fully extending.*

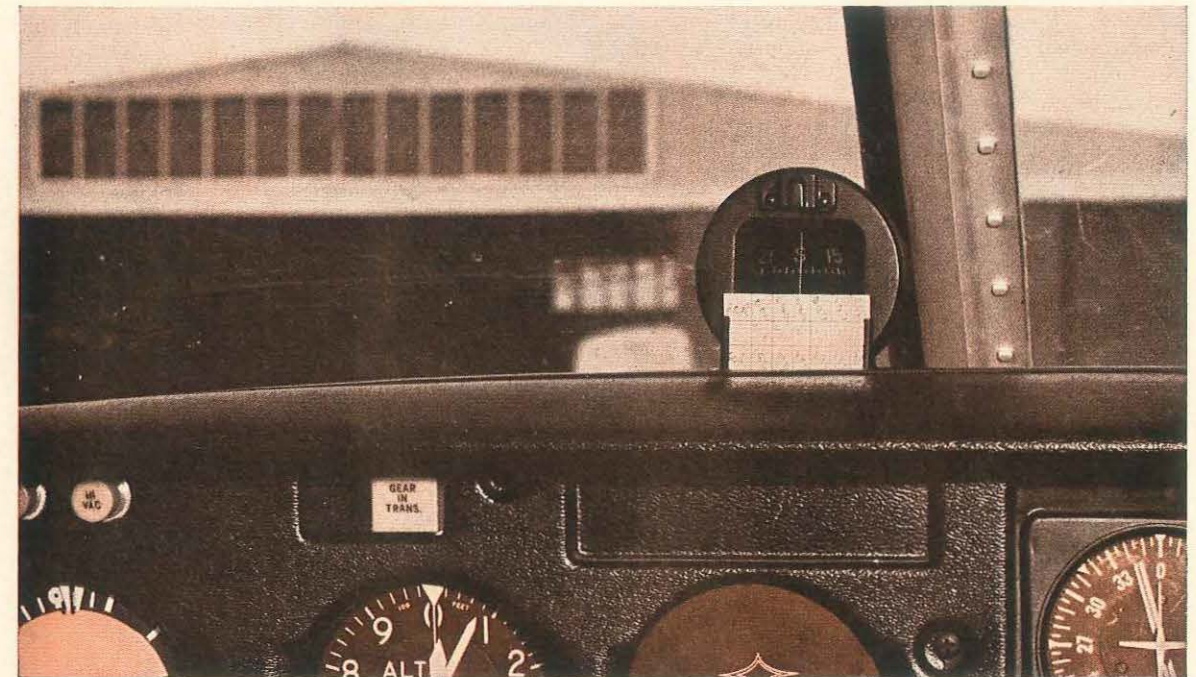
*Above: The magnetic compass of the Cherokee Arrow correctly reads 180 degrees.*

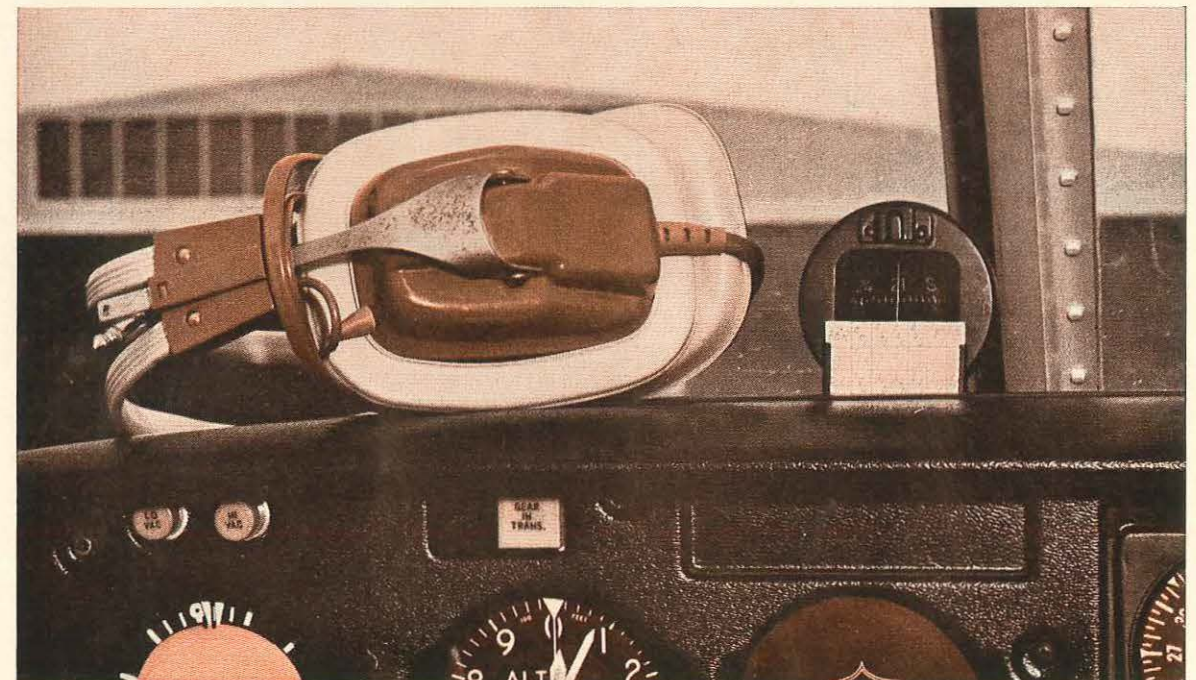
*Below: With the aircraft in the same position, an error of 30 degrees has been induced in the compass reading by placing headphones on the instrument panel coaming.*

The area above the instrument panel in a light aeroplane seems an obvious place to put articles during flight because it is so ready to hand. But as this and other incidents have shown, the consequences of utilising this space can have startling results. As our earlier article pointed out, it may be prudent to declare this area "out of bounds to all articles"!
