No. 70 SEPTEMBER 1970

AVIATION SAFETY DIGEST

DEPARTMENT OF CIVIL AVIATION AUSTRALIA

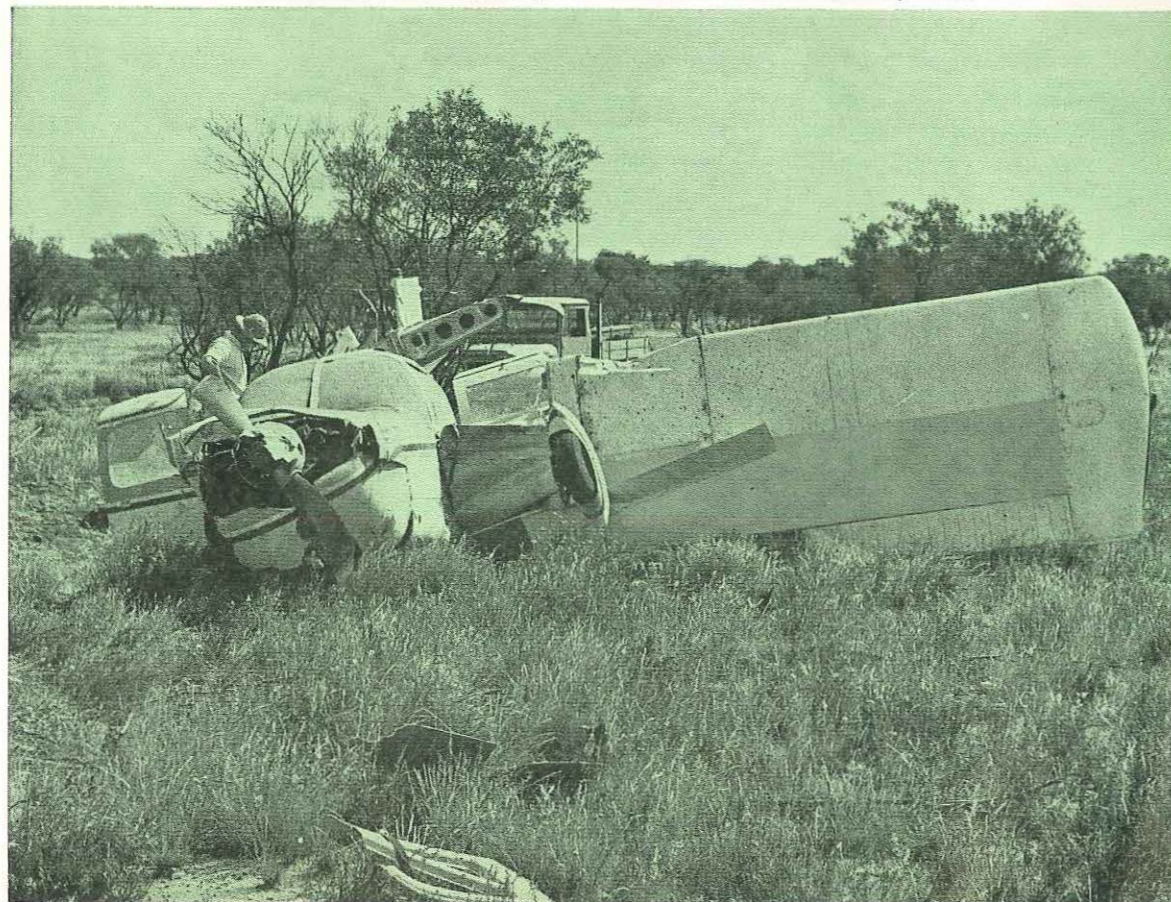
The aircraft as it came to rest alongside the Hermannsburg-Alice Springs road. Although both wings were torn bodily from the fuselage the cabin area remained relatively intact.

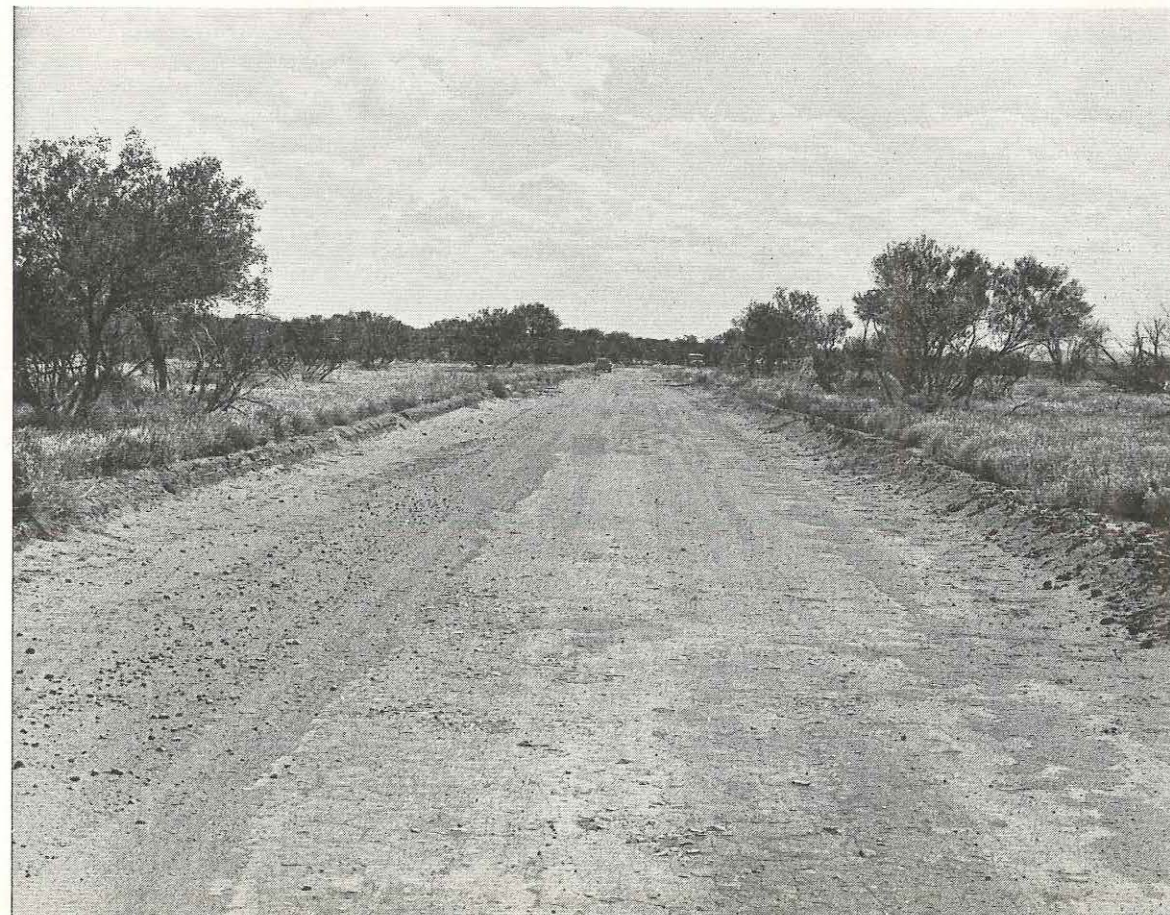
The section of the road on which the aircraft landed, looking in the direction used. The wreckage, hidden by trees, lies immediately to the right of the parked vehicles in the distance.

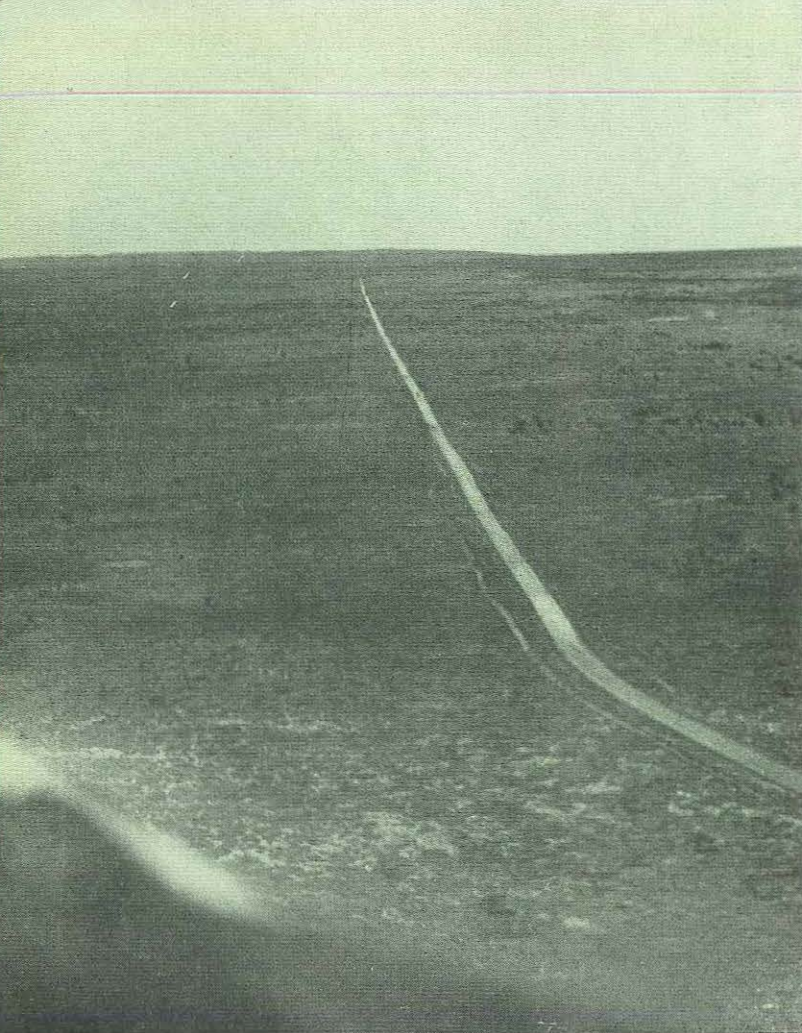
The clearly defined gravel road, as it would have appeared to the pilot soon after leaving Hermannsburg.

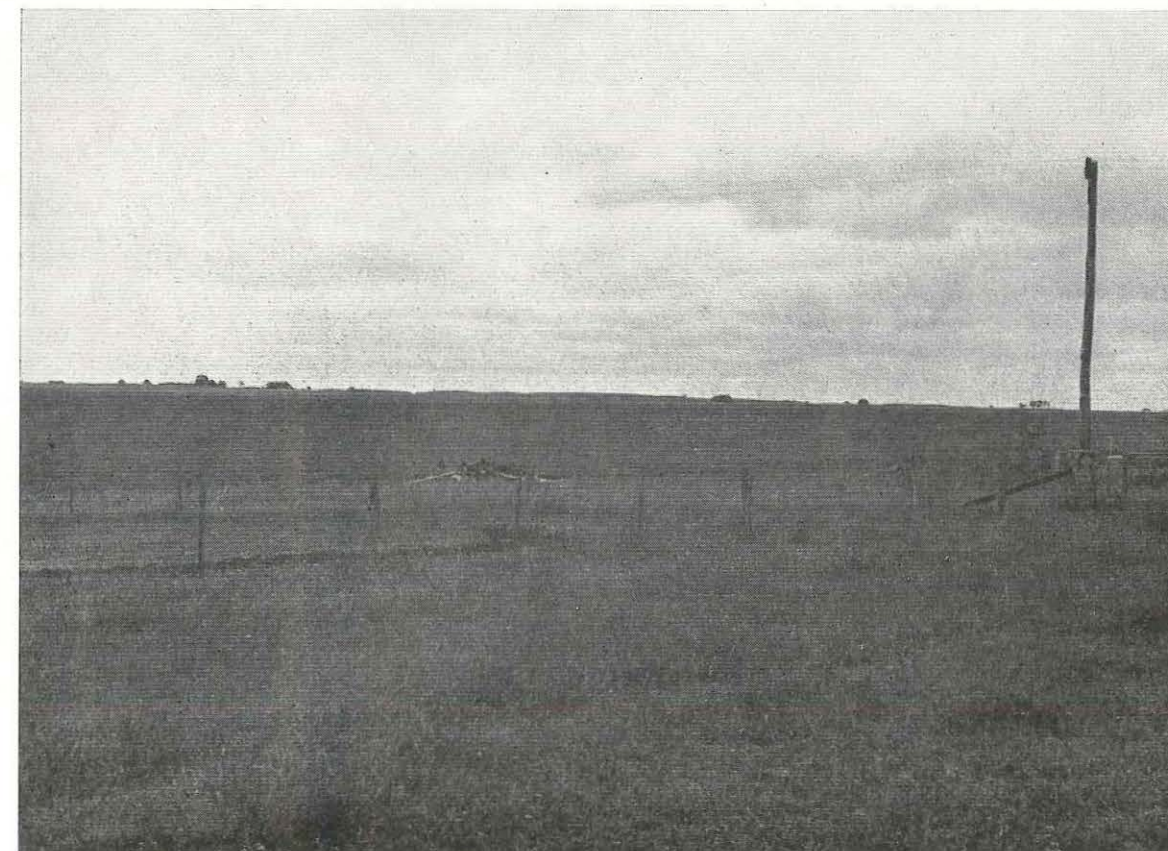
The evidence of an eye witness who saw the crash from the verandah of a farmhouse half a mile south-west of the accident site indicated that the aircraft maintained a steady flight path up to the moment it struck the wires, and it was apparent that the pilot had made no attempt to climb to a safe height while returning to the landing strip for the last time. In the circumstances, the cause of the accident can only be ascribed to the fact that the pilot flew the aircraft at an unnecessarily low height.

General view of accident site looking in the landing direction, with the two wire power line struck by the aircraft in the foreground. The wreckage can be seen a short distance beyond the fence. The strip from which the aircraft was working is in the middle distance, slightly to the left of the pole.

- By flying the aircraft in such a manner that the chances of striking an unseen hazard are no greater than absolutely necessary.
- By maintaining a high standard of vigilance throughout the whole operation.
- By marking the positions of wires in some manner that is clearly recognisable to the pilot.

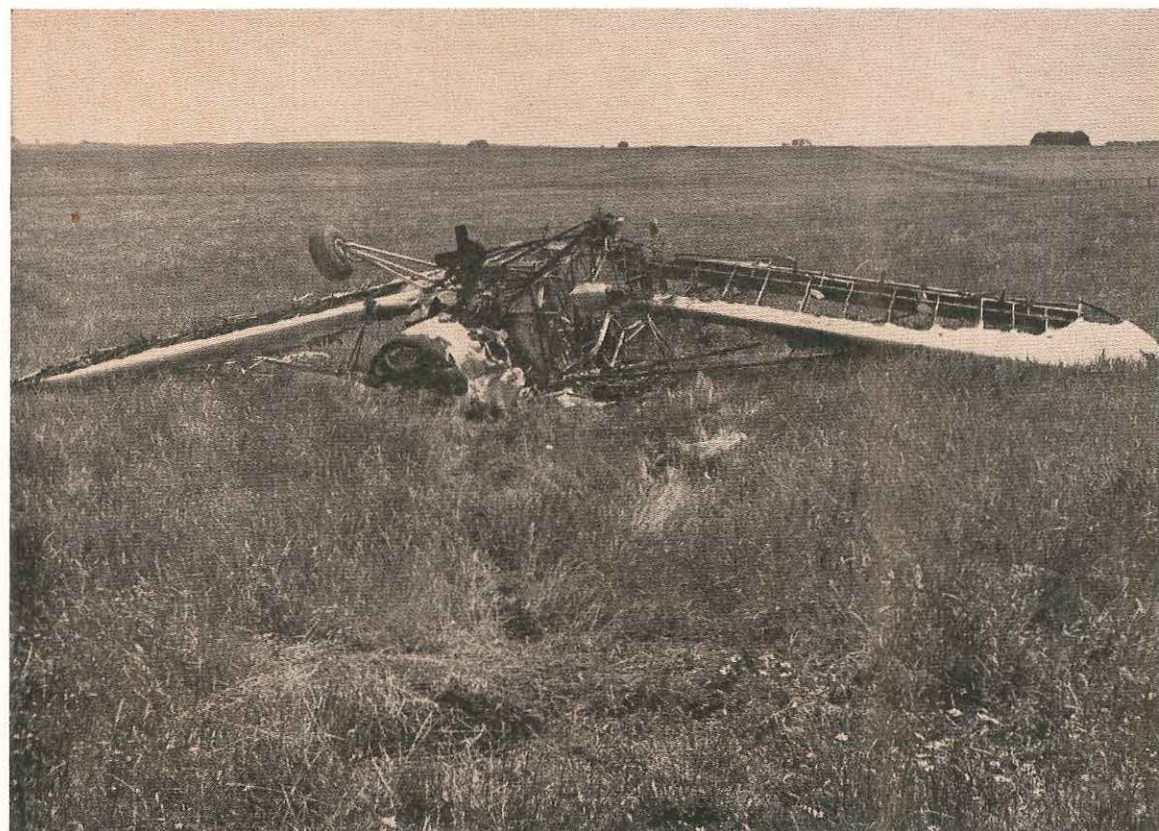
Above: The burnt-out wreckage, looking in the direction of flight. The landing strip can be seen on the rising ground directly behind the aircraft. The point of initial impact is in the foreground, indicated by the circle of grass cut by the propeller.

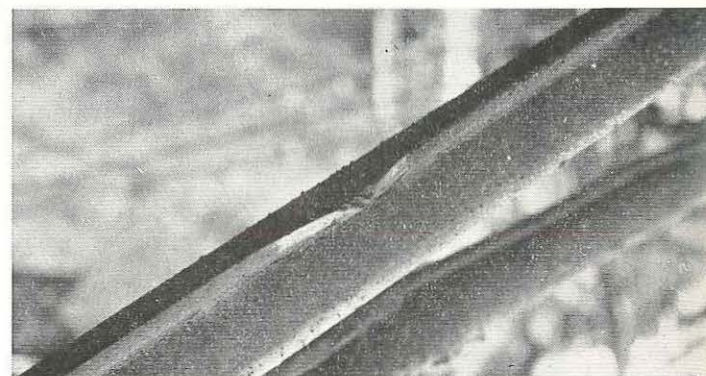
Below: Impact marks of the power line on the port undercarriage leg. Similar markings were also found on the starboard leg.

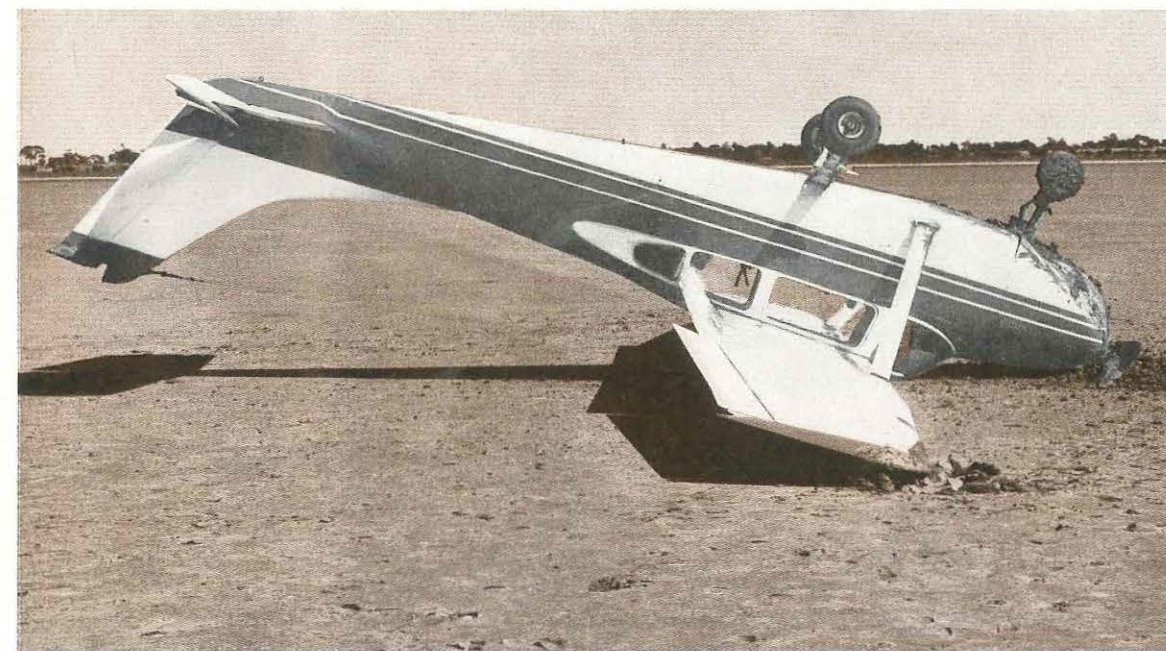
The cause of the accident was that the pilot attempted to land the aircraft on an unsuitable surface.

This series of pictures graphically illustrates the treacherous nature of the surface of the clay pan and the drastic effect it had on the aircraft's landing roll. Marks on the smooth crust clearly indicate the aircraft's touchdown point, port landing wheel first.

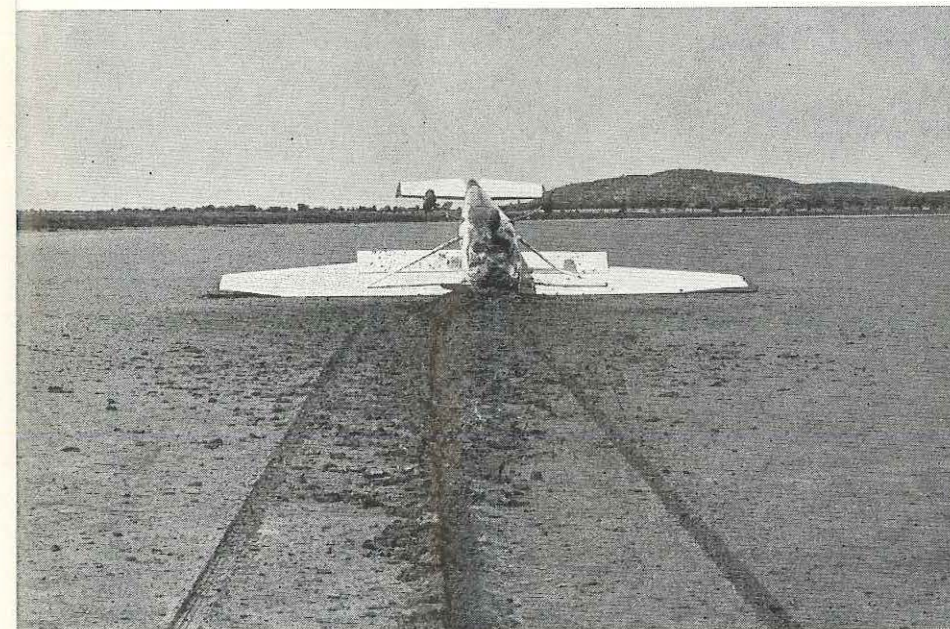
As the aircraft slowed, the nose wheel penetrated the thin, apparently dry crust, and rapidly sank into the thick mud beneath.

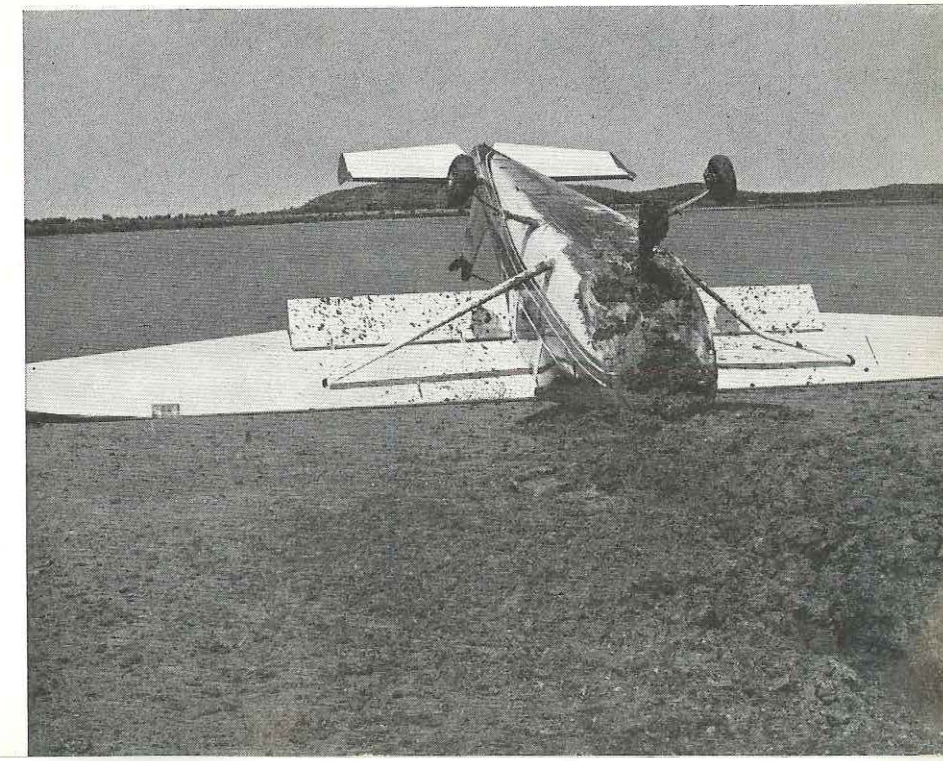
The aircraft as it came to rest, looking in the landing direction. Note the depth to which the nose leg penetrated into the mud before the aircraft finally fell over on to its back.

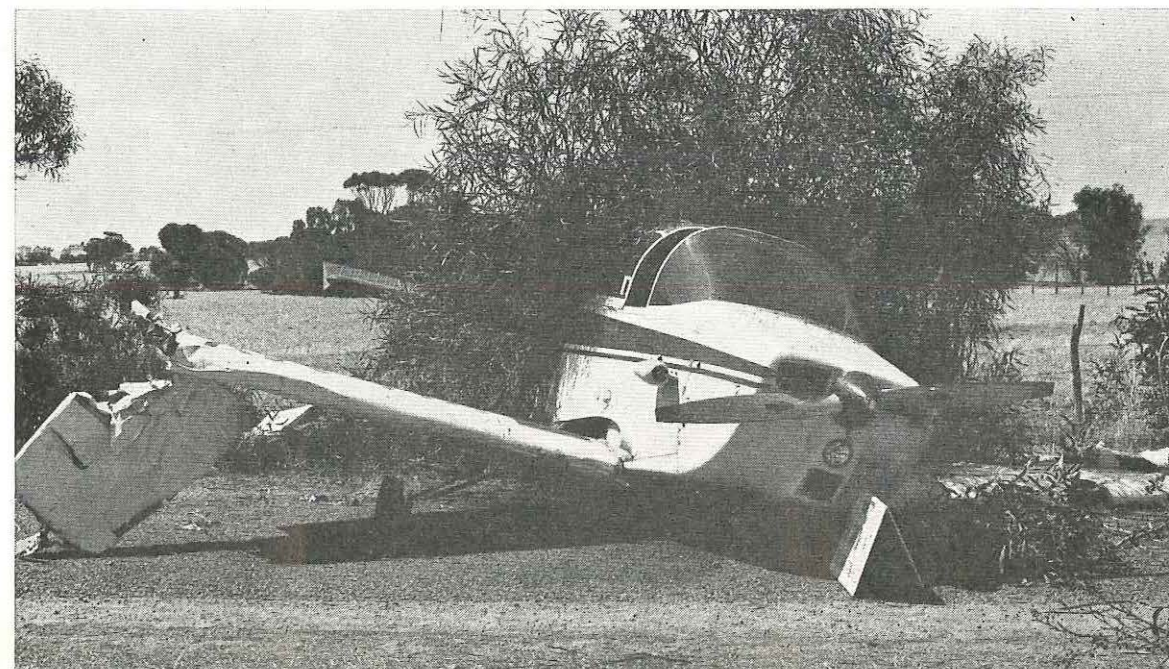
View of the wrecked aircraft with the paddock in which the pilot was forced to land visible in the background. Although both mainplanes were dislodged in the accident, the engine and propeller were undamaged.

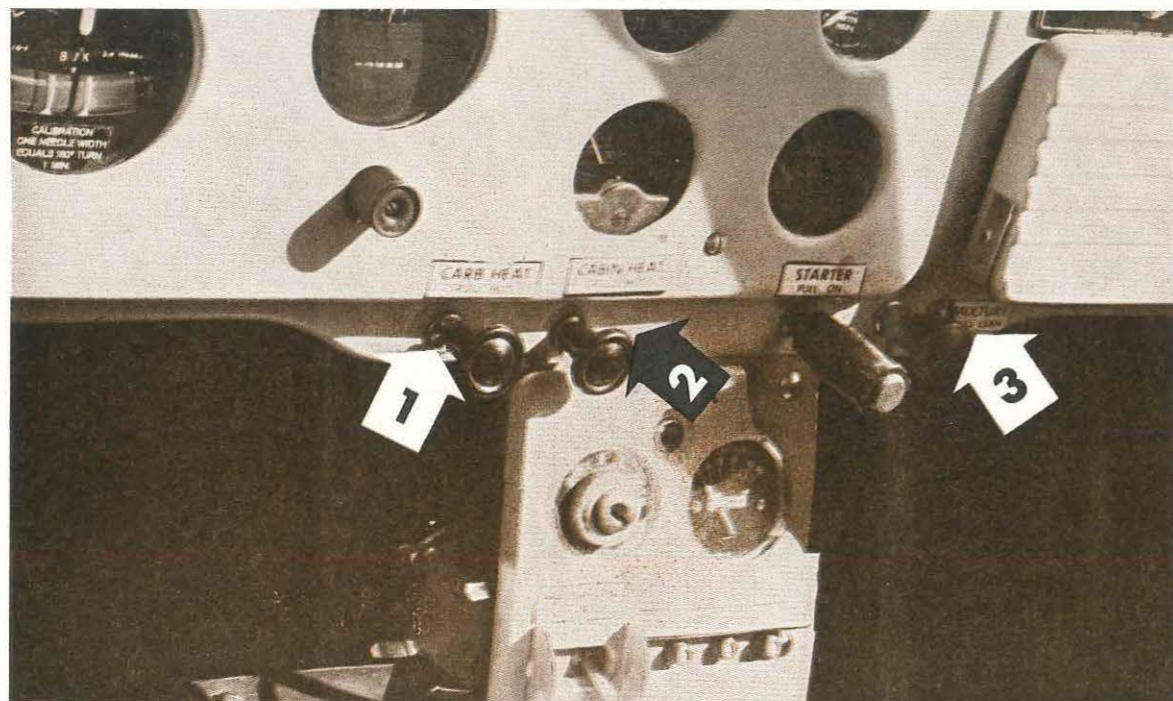
feature are the placards gummed to the bottom of the instrument panel immediately above the respective knobs. An inexperienced pilot taking a hasty glance at the instrument panel could easily confuse the two black knobs and apply cabin heat instead of carburettor heat.

Close-up of the Airtourer's instrument panel, showing relative positions of (1) cabin heat control, (2) carburettor heat control and (3) mixture control.

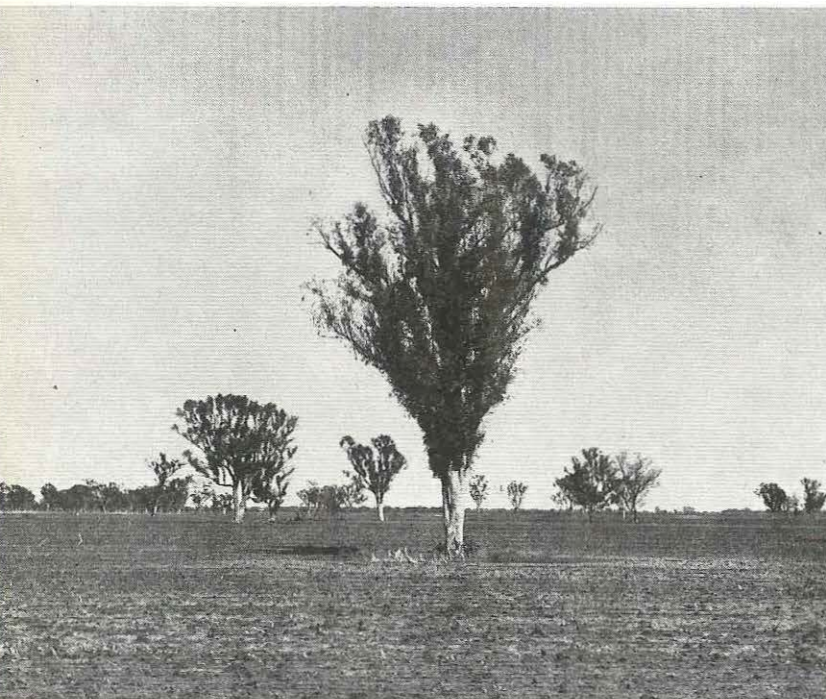
Above: The tree over which the aircraft approached for its final spraying run, as seen from the edge of the crop. The proximity of the tree to the edge of the crop necessitated a steep descent.

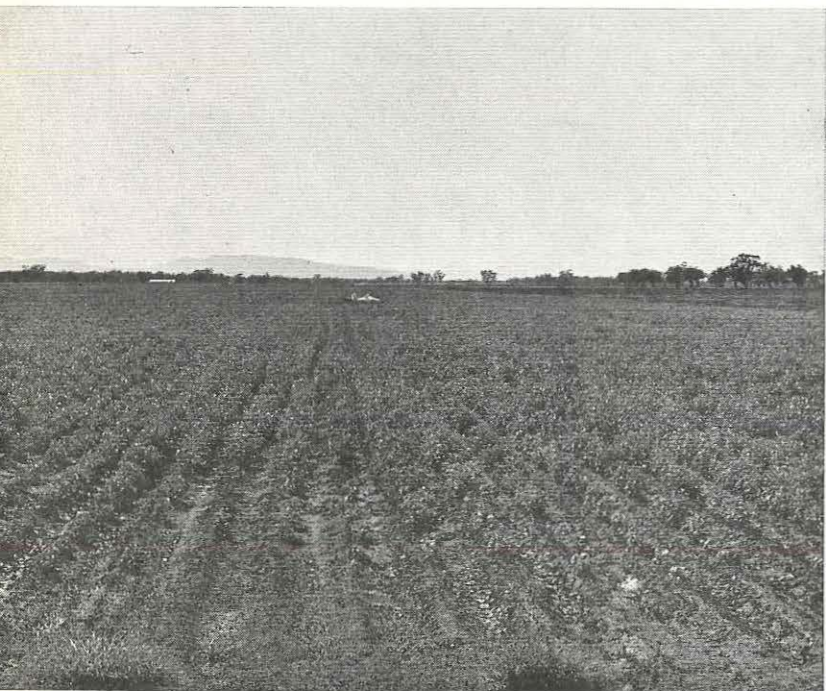
Below: View from beginning of the run on which the wheels entered the crop. The aircraft can be seen in the distance where it came to rest.

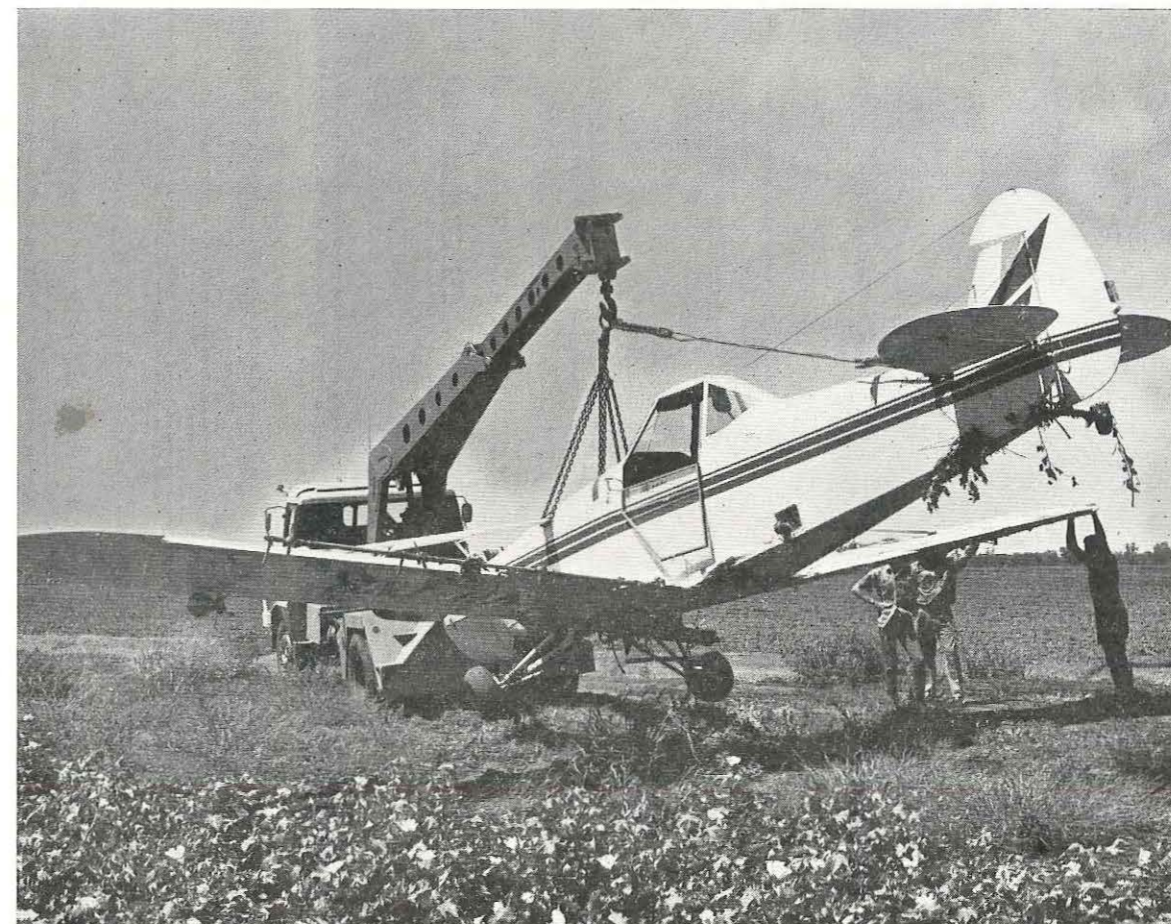
Damage to the undercarriage and the lower section of the fuselage is evident as the aircraft is lifted clear of the crop.

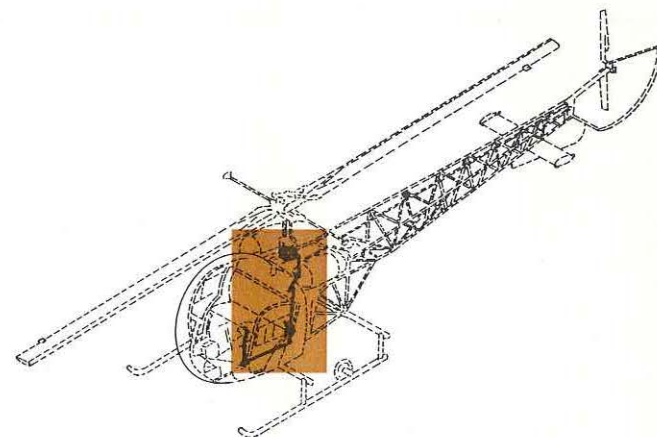
Further examination then revealed that the push-pull control rod connecting the lever to the cyclic control power cylinder had been installed some time previously in the reverse sense. It was evident that stresses imposed on the torque tube lever by this incorrect installation had, over a period of time, been responsible for its failure.

lever. But if the rod is installed in an inverted position, the space between the ears of the torque tube lever fork is not wide enough to accommodate the fixed end of the tube and fouling occurs as the lever travels upwards. This has the effect of transferring the point of maximum bending from the design point at the axis of the torque tube, towards the centre of the lever.

In this case the helicopter concerned was a service aircraft and the circumstances of the accident are not, strictly speaking, a matter for the Department of Civil Aviation. But it is mentioned in the Digest to emphasise yet again the paramount importance of properly conducting duplicate inspections after any adjustment, repair, or replacement of parts in the primary control system of any aircraft. Instructions detailing the procedure for these duplicate inspections will be found in Airworthiness Directive DCA/GEN/26.

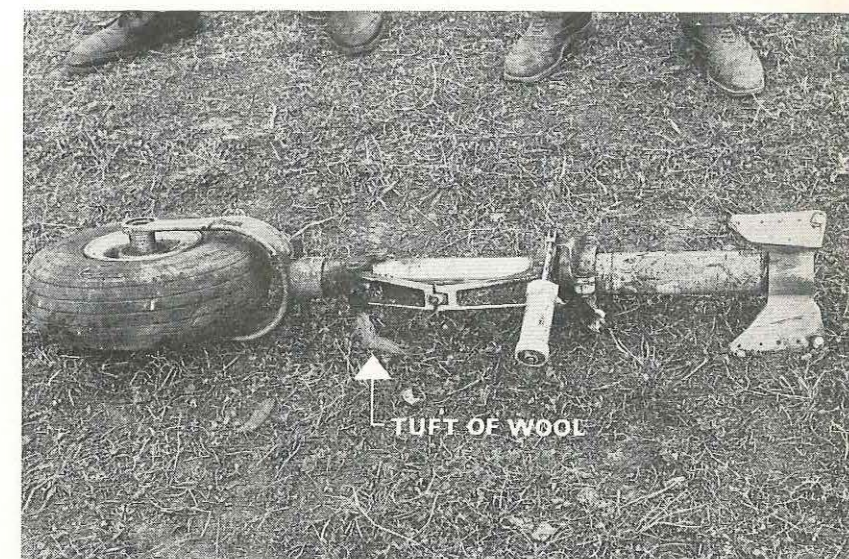
Above: The complete nose wheel leg, torn from its mountings when the aircraft struck a sheep, as it was found in the paddock. A tuft of wool is still adhering to one of the torque link bolts.

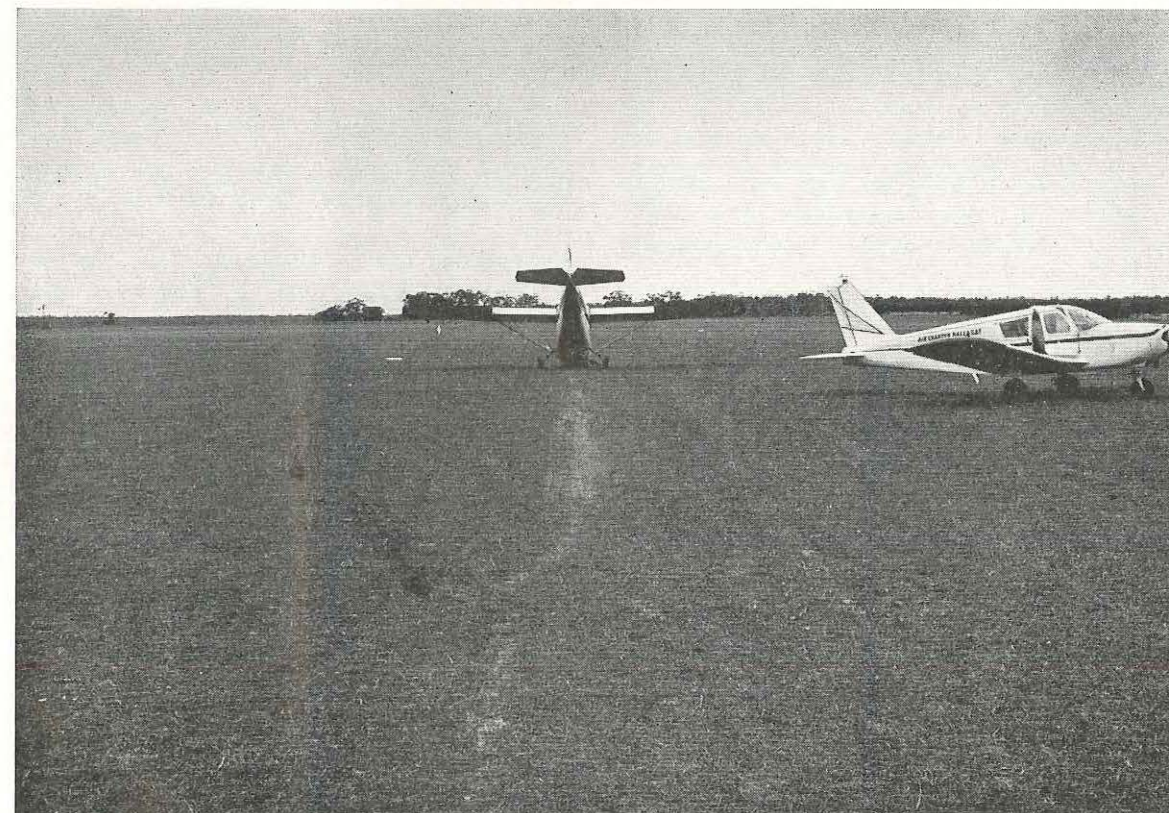
Below: The damaged aircraft, as it came to rest on the strip looking in the landing direction. Ground marks left by the underside of the engine cowl as the aircraft slid to a halt, can be seen in the foreground.
