AVIATION SAFETY DIGEST

Number 77 January 1972

DEPARTMENT OF CIVIL AVIATION AUSTRALIA

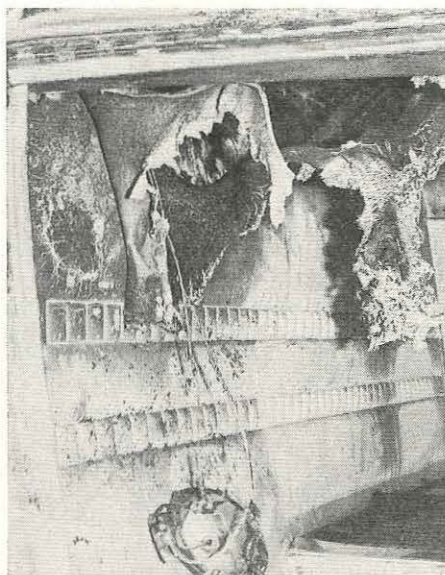
The luggage locker lamp, which is normally attached to the locker roof lining immediately inside the door, was found hanging by its wiring with the integral switch still in the "on" position. The lamp assembly had clearly fallen from its mounting when the lining was burnt away. The insulation on the wires leading to the lamp had been burnt away within the locker itself but was un-

The lamp assembly itself in the locker was badly charred and its unprotected bulb was covered with burnt remnants of plastic foam. Normally in this type of aircraft, the bulb in the luggage locker is protected by a translucent plastic lens, but there was no evidence that a lens had been attached to the lamp assembly at the time of the fire. Thus any soft material packed tightly into the upper section of the locker, could come directly into contact with the bulb itself.

Opposite page left: Burnt-out interior of forward luggage compartment with lamp hanging by damaged wiring.

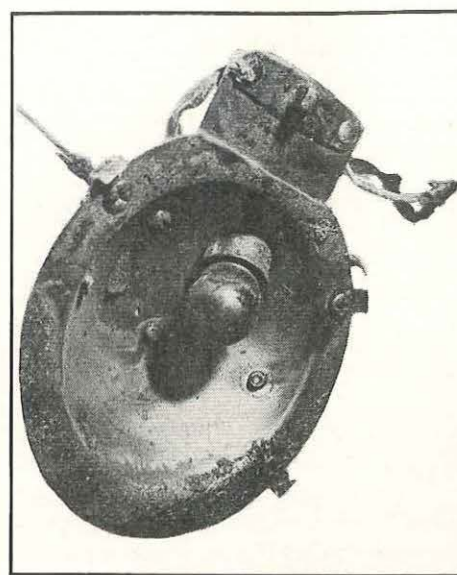
Right: Close up of lamp with fragments of burnt plastic foam still adhering to bulb.

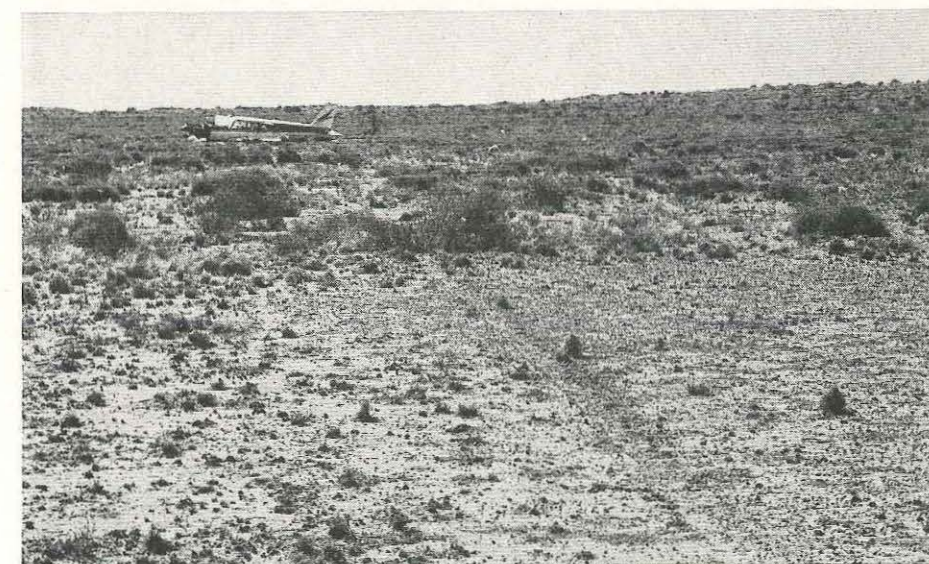
Centre: Wheel marks left by the aircraft on the surface of the clay pan. The rougher ground beyond is clearly evident.

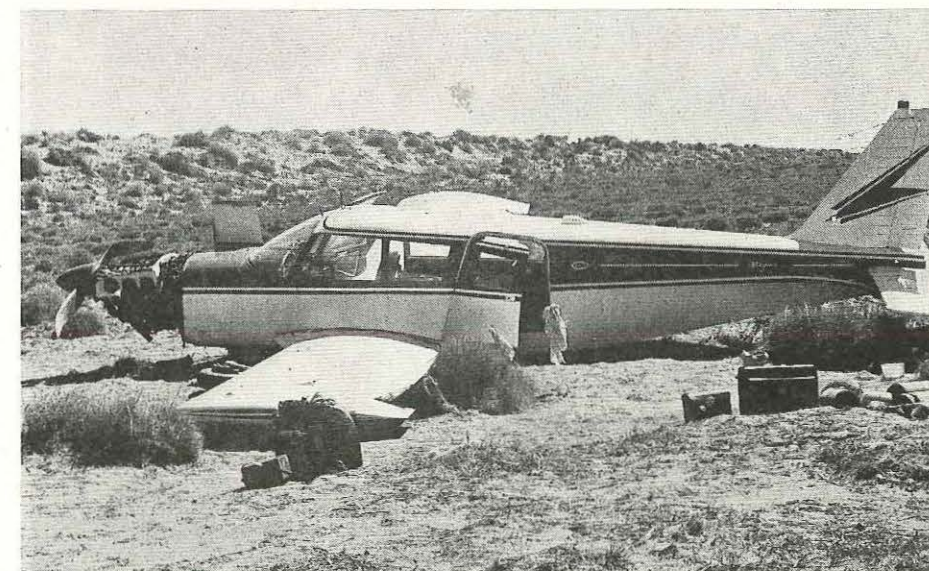
Bottom: The damaged aircraft as it came to rest. The engine cowlings were removed after the accident.

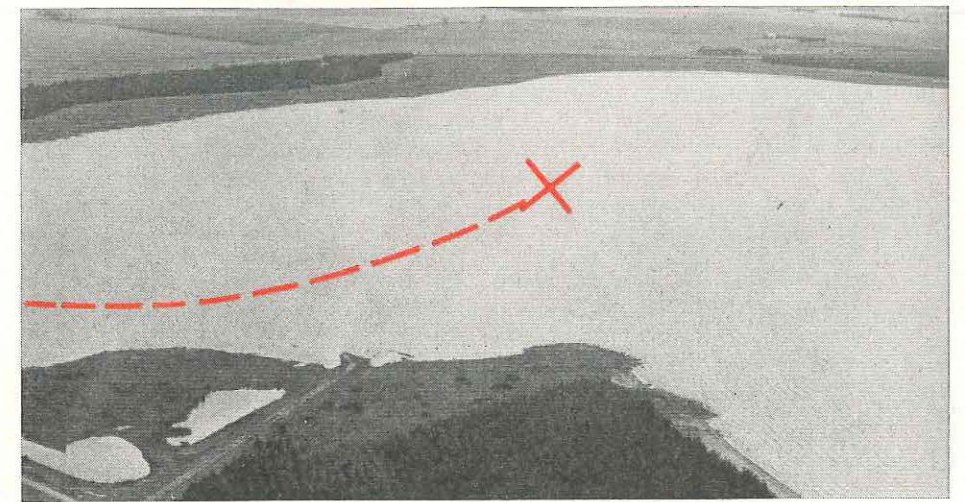
View looking south-west over Lake Wurdiboluc showing approximate final flight path and point of impact with water.

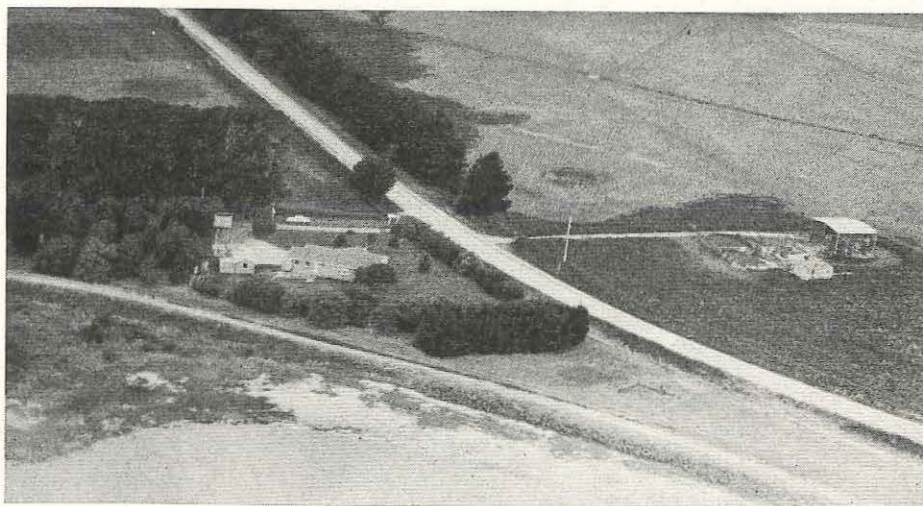
View looking in the direction in which the aircraft was flying shortly before the accident. The tall trees which the aircraft turned to avoid can be seen on the left.

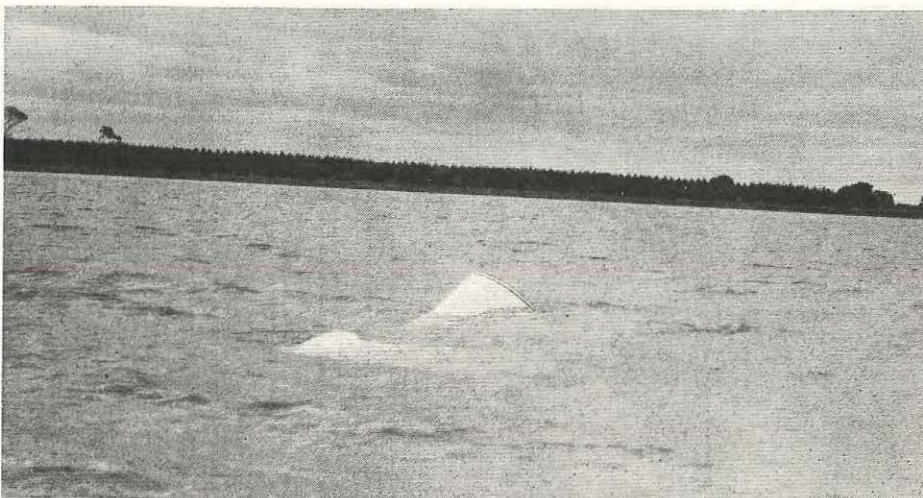
The only portions of the aircraft which remained visible above the surface of the lake after the accident were the starboard wing and cabin roof. The survivors clung to the wreckage while awaiting rescue.

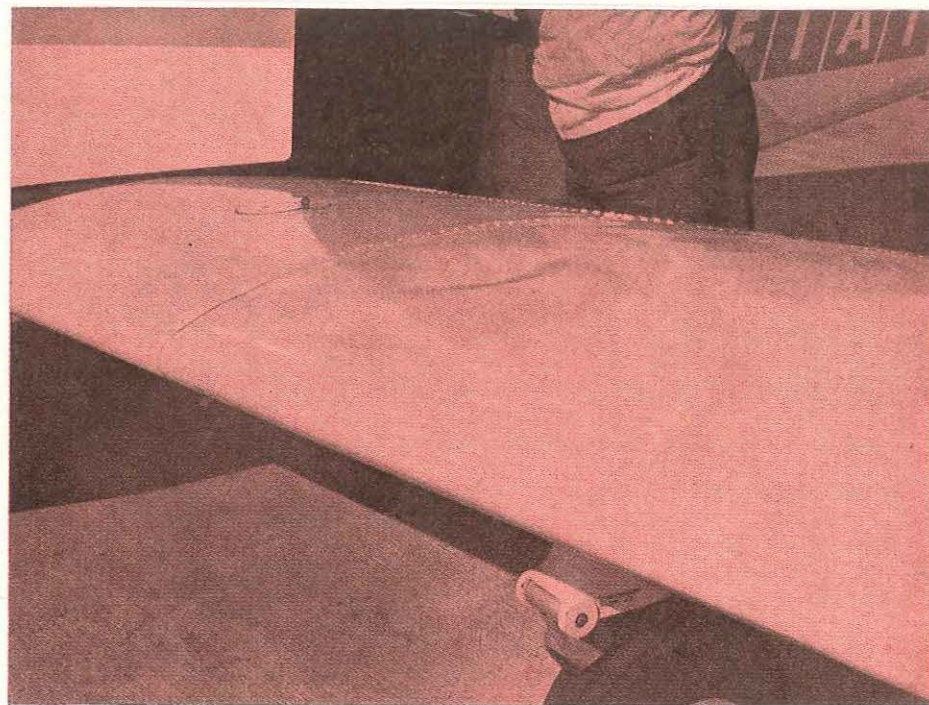
Severe buckling of the upper surface of the Musketeer's port wing just outboard of the fuel tank conveys some idea of the excessive in-flight loads to which the aircraft was subjected.

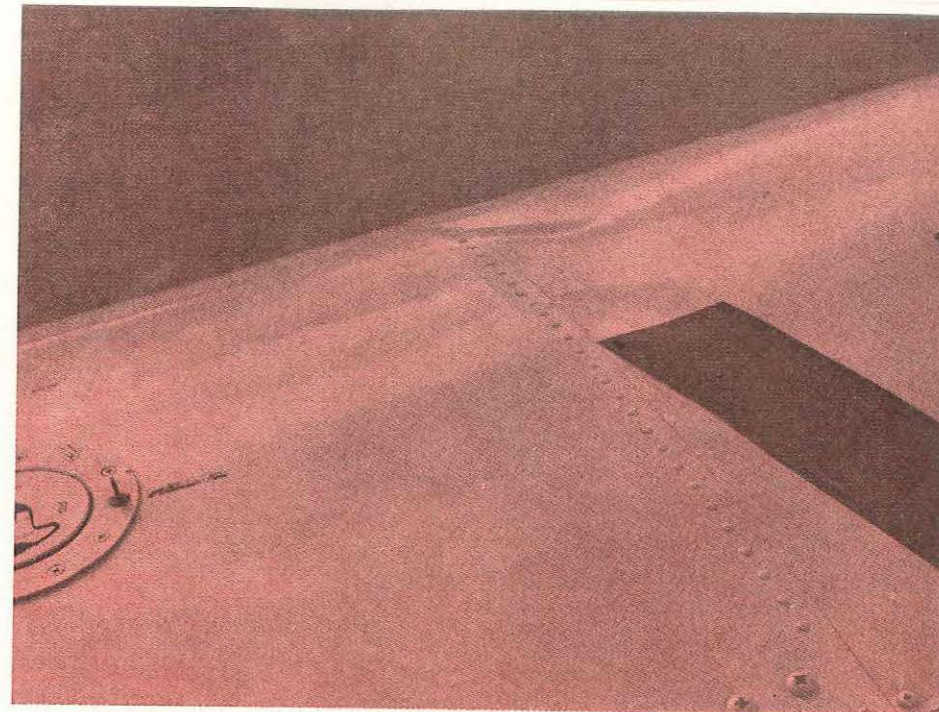
Similar damage was sustained by the starboard wing as a result of the loss of control in cloud.

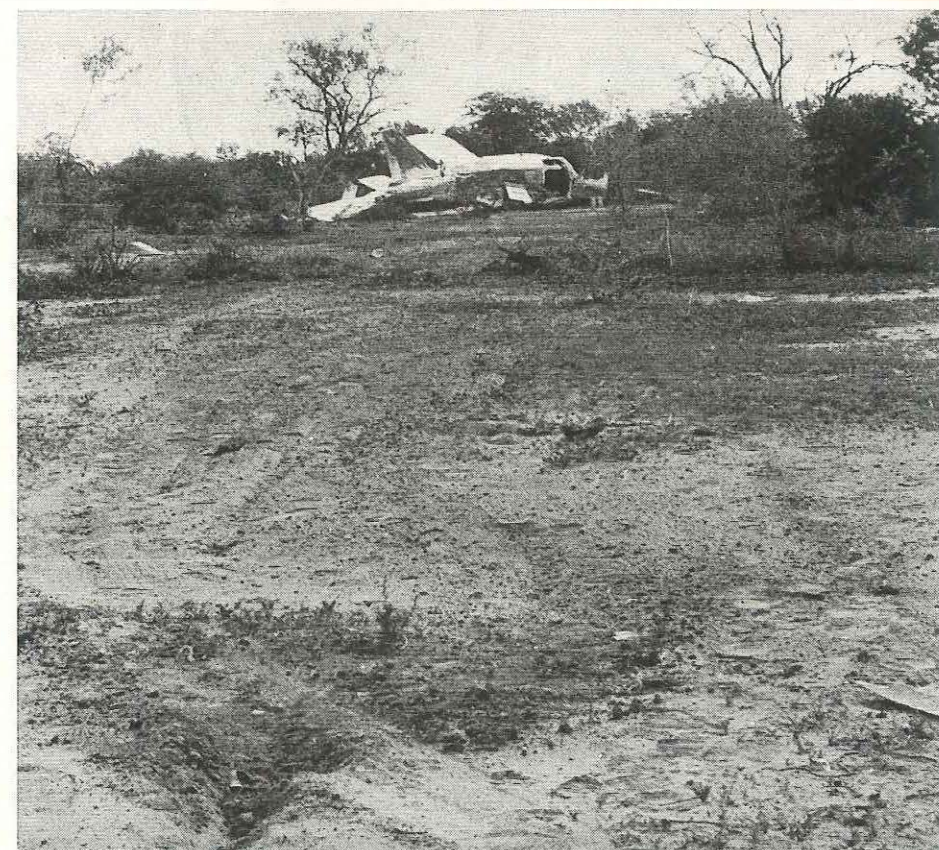
View of wreckage looking in direction of impact. The force with which the aircraft struck the ground can be gauged from the depth of the initial impact marks in the foreground.

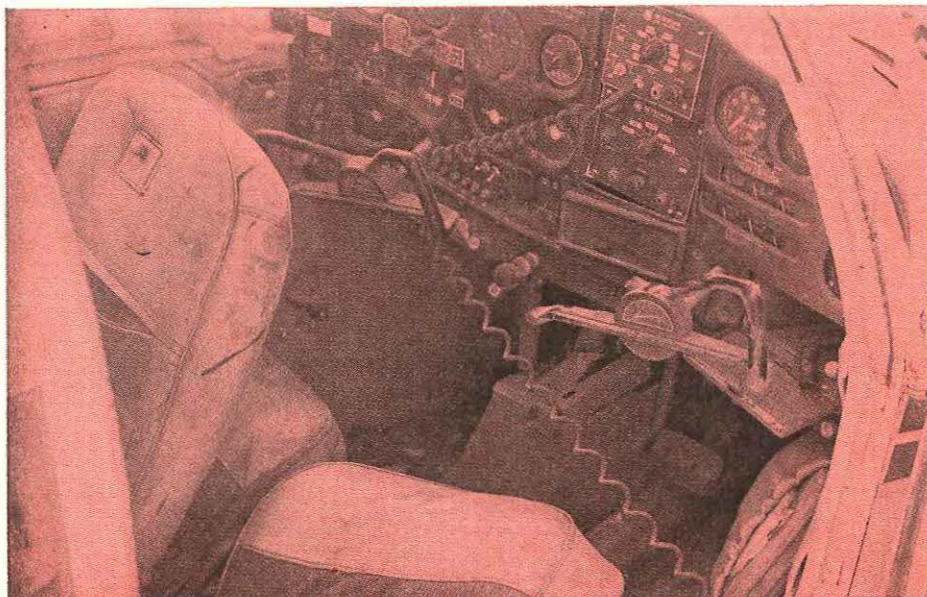
The interior of the aircraft after the accident. Considering the extent of the damage, it is surprising that the consequences were not more severe.

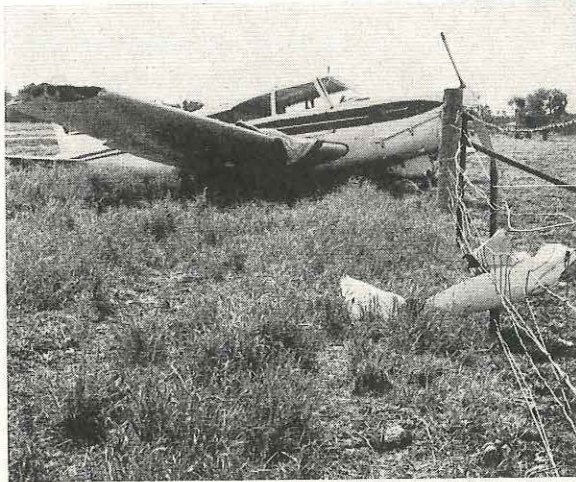
Arriving over a station property airstrip in fine weather, the pilot of this lightly laden Comanche flew a normal left hand circuit and approached to land into a very light northerly breeze. The pilot's planning of the circuit resulted in a somewhat flatter than usual final approach path, with some power applied. The pilot knew there was a fence short of the strip threshold, but believed the aircraft would clear it without difficulty.

As the aircraft passed over the fence with the pilot looking well down the strip, the starboard wheel struck a tubular steel fence panel, forcing it rearwards. As the aircraft touched down 500 feet further on, it slewed to the right, ran off the strip and came to rest entangled in the eastern boundary fence.

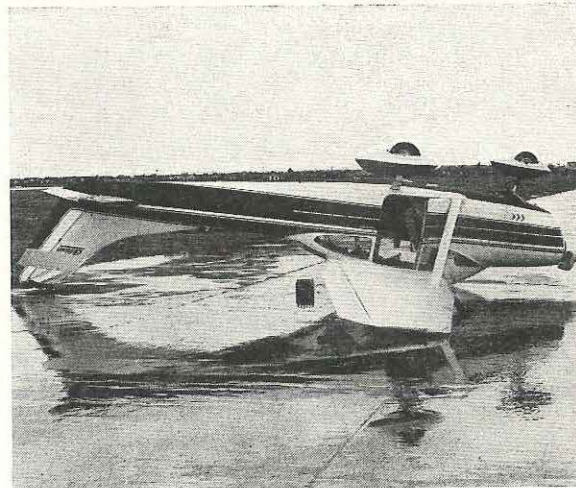
Although the pilot of this Cessna 182 had been advised, as he was approaching Essendon, that the surface wind was 25 knots and gusting to 40 knots, he decided to continue for a landing. He expected to have some difficulty in taxi-ing without wing tip assistance, but thought the normal cross-wind taxi-ing technique would handle the situation.

After a successful landing into wind, the pilot turned the aircraft to the left on to a taxiway. But when he attempted to turn into wind again on to the next taxiway to the right, a strong gust lifted the starboard wing tip, and the aircraft pitched nose down and to the left until it was resting on its port wing tip. The pilot stopped the engine and climbed out intending to hold down the tail, but before he could do so the aircraft was blown over on its back.

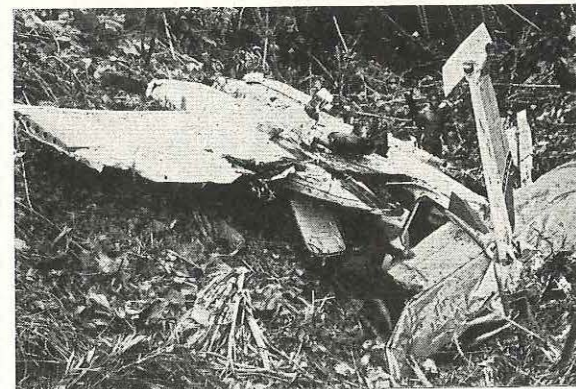
Following an uneventful charter flight from Talasea, New Britain, to Bali airstrip, Unea Island, New Guinea, the pilot of a Cessna 310J experienced braking difficulties during the landing run because of the long wet grass, then found that he was unable to taxi off the strip until a build up of grass and mud was removed from in front of the mainwheels. These difficulties were overcome, but during the four and a half hours that the aircraft remained on the ground at Bali, continuous rain fell. This worsened the condition of the already soft strip, and three large pools of water formed on the northernmost 550 feet of its 2,600 feet length.

After striking the ground 20 feet beyond the threshold, the aircraft skidded, then cartwheeled 300 feet before coming to rest inverted in a deep gully. One passenger suffered fatal injuries and the aircraft was destroyed.

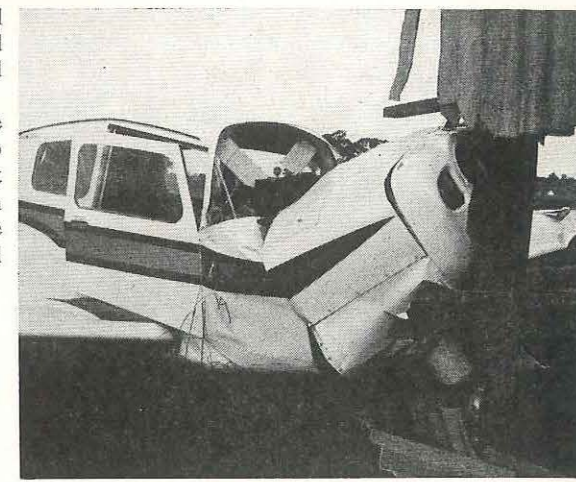
Returning to Shepparton aerodrome at the conclusion of a brief local flight, the relatively inexperienced pilot-in-command of this Musketeer found that the 10 knot crosswind he had experienced on take-off had increased to 15-20 knots, and a good deal of drift was obvious on final approach.

The aircraft touched down starboard wheel first, still drifting to the right, and shortly afterwards began to weathercock into wind. Unable to control the swing, the pilot applied power to go around, but the aircraft ran off the runway and flight strip, heading towards a hangar 300 feet from the edge of the strip. It could not become airborne in the distance available and struck a steel joist at the corner of the building. The pilot sustained serious injuries and the aircraft was damaged beyond economical repair.

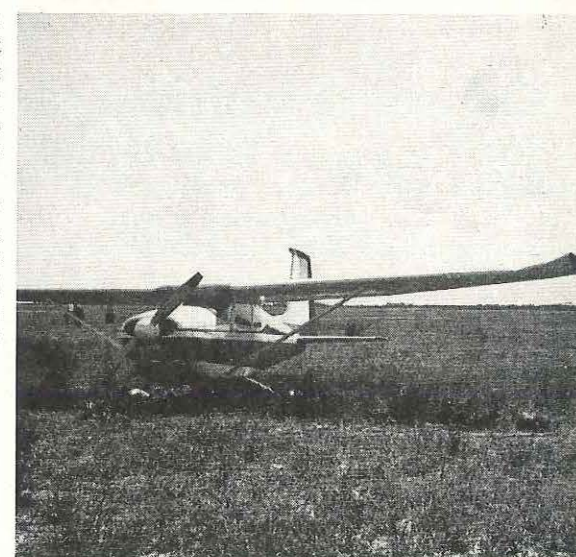
Although he was unable to contact the property owner at his destination for a strip report before departing, the pilot of this Cessna 182 knew that no rain had fallen in the area during the past two weeks and began the flight believing he would be able to assess the condition of the strip from the air before landing. The pilot's aerial inspection after arriving over the strip revealed nothing unusual, but the strip, which was sited within a large paddock, was only sparingly marked with white painted motor tyres.

Patches of long grass obscured the pilot's view of the markers after touchdown and, in the belief that he was keeping the aircraft aligned with the marked strip, the pilot veered the aircraft slightly to the left of the landing direction. Towards the end of the landing run and when almost 70 feet to the left of the centre of the strip, the undercarriage sank into an isolated patch of soft, moist, black soil and the port wing and propeller struck the ground.

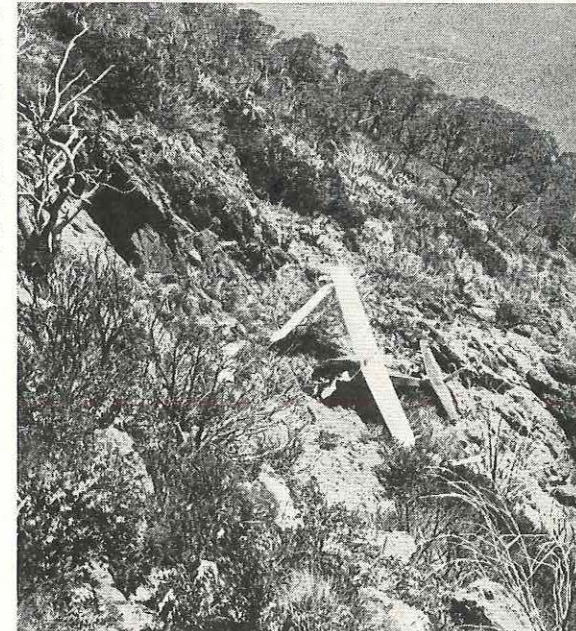
After rigging an improvised launching catapult which relied on the elasticity of a bungee assembly of motor tubes, and the acceleration of a four-wheel drive vehicle, an attempt was made to launch an ES57 'Kingfisher' glider from a level clearing on the crest of the steep-sided Big Talbingo Mountain, N.S.W.

The launching device had not been tested, nor had the operating technique been practised, and the glider was catapulted over the edge of the cliff at a speed insufficient to sustain flight. The left wing dropped, and the glider entered an incipient spin, spiralling to the left, until it struck the rocky cliff face below. The pilot was seriously injured and the glider severely damaged.

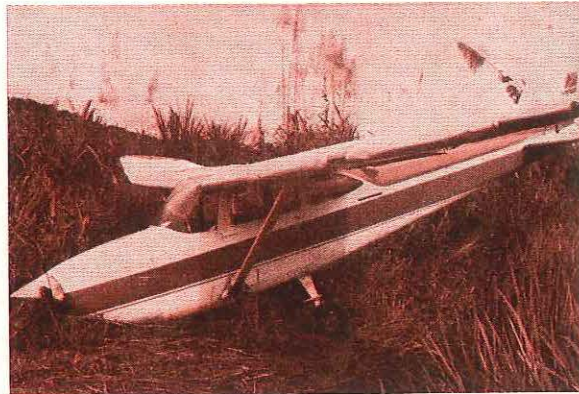
After landing at the "one-way" mission airstrip at Mai, New Guinea for the purpose of familiarising another pilot with the aerodrome, the pilot of this Cessna 172 did not take into consideration the poor surface condition of the 1,350 foot long strip, nor did he consult the performance charts before attempting to take-off in downwind conditions of five knots, gusting to 15 knots.

Acceleration was initially slow because of grass cuttings on a recently mown section of the strip but was then normal until the aircraft encountered a wet patch some 400 feet further on. But even when the aircraft encountered further soft patches, which slowed its acceleration again, the pilot persisted with the take-off. The aircraft had still not left the ground when, still under full power, it over-ran the strip into long kunai grass. The pilot-in-command closed the throttle, the observer pilot turned off the fuel, and the aircraft swung violently to the left and stopped, substantially damaged.

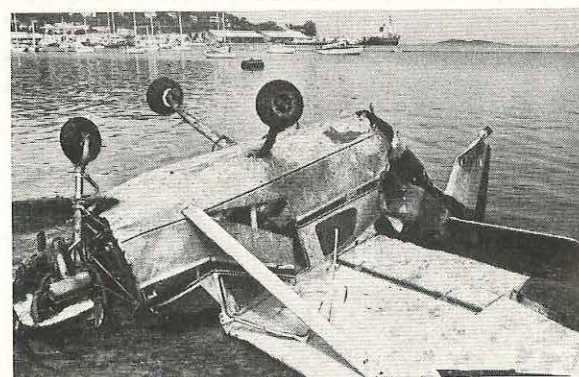
Shortly after setting out from Port Moresby on a private search for a missing yacht, the pilot of this Cessna 150 was advised by radio that the vessel had been located, but he decided to remain aloft and do some private flying in the Port Moresby harbour area. After flying at various heights below 500 feet for about fifty minutes, he applied power to climb and return to the airport. Instead of responding to the throttle the engine lost power at a height and position from which a suitable landing area could not be reached, and the pilot was forced to ditch the aircraft in the harbour.

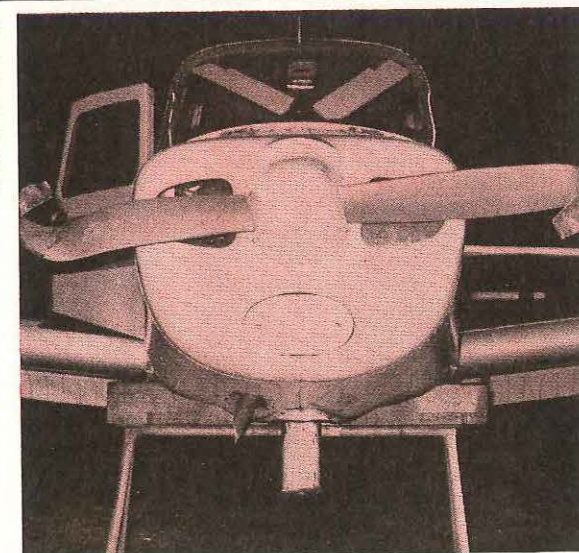
During a period of solo training at Jandakot, Western Australia, the pilot of this Beechcraft Musketeer commenced an approach for a touch-and-go, short-field type landing. As he began to round out however, the main wheels struck the ground heavily and the aircraft pitched forward on to the nosewheel with sufficient force to fracture the nosewheel fork attachment leg lugs. Following the loss of the nose fork and wheel, the propeller contacted the ground and the aircraft slid for 200 feet before coming to rest on the mainwheels and nose leg housing.

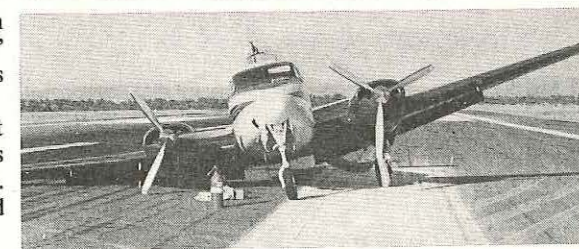
Unaware that a clevis pin had become dislodged from the starboard main undercarriage torque tube assembly, the pilot of this Beechcraft 'Queenair' lowered the undercarriage for a landing at Rottnest Island, W.A. but was unable to get the starboard main landing gear to lock down.

The aircraft returned to Perth, where an air-to-air inspection showed that although the starboard undercarriage leg was almost fully extended, it was remaining stationary during the pilot's attempts to cycle the undercarriage. The aircraft was landed at Perth, but the starboard undercarriage collapsed at the end of the landing run.

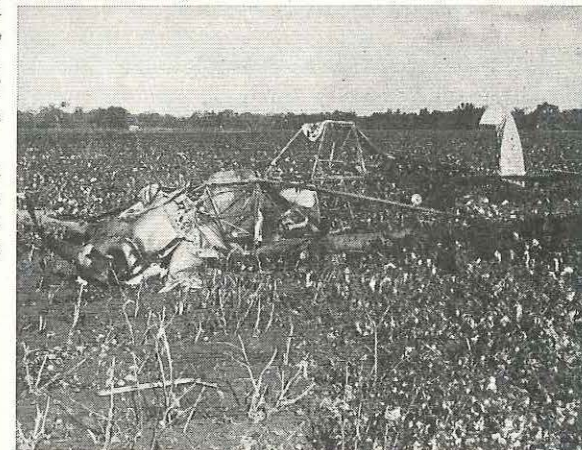
Night spraying of a cotton crop near Wee Waa, N.S.W., had proceeded without incident until the pilot of this Piper Pawnee commenced a steep climbing turn to the right to proceed to the next area, a mile and a half away. As the aircraft rolled out of the turn, he felt a momentary restriction of the aileron controls and switched on the cockpit lighting for a few seconds to search for loose objects.

Satisfied that all was clear, the pilot switched the lights off again, but at that moment the aircraft struck the ground in a steep nose down attitude while banked slightly to port. The undercarriage collapsed and fire broke out immediately. The pilot, who was otherwise uninjured, suffered serious burns while escaping from the aircraft.

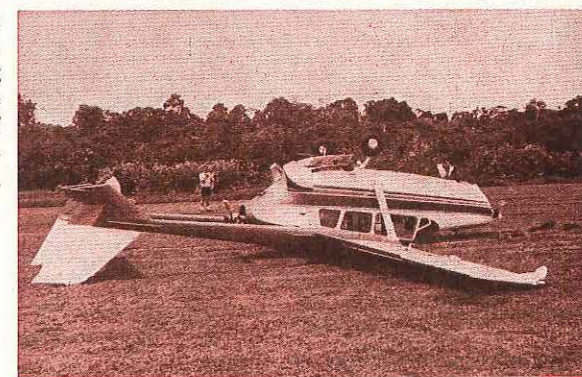
Although an inspection had showed that this Cessna 337 had sustained no damage as a result of a heavy landing at Karimui, P.N.G., the pilot abandoned the subsequent take-off because of a 'hammering' noise coming from the nose undercarriage area, which he believed to be abnormal. The pilot applied the brakes, but the aircraft did not stop within the confines of the strip, and after passing through the threshold markers on to an unserviceable area, the nosewheel dug into the soft surface and the aircraft overturned.

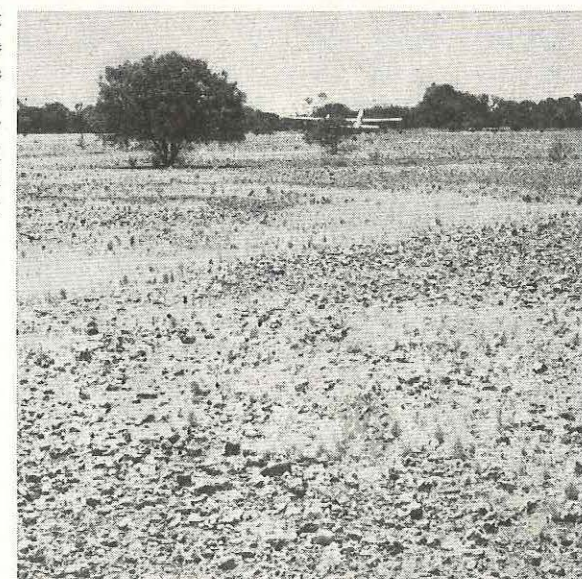
Three hours after departing Meekatharra for a charter flight to Mount Newman, W.A., the pilot of this Cessna 172H saw that he would be unable to reach his destination because of an intervening duststorm. Unaware that two suitable airstrips lay close to his return track, he attempted to return to Meekatharra. When only five miles north of Meekatharra, after being airborne for almost six hours, the engine failed from fuel exhaustion and the pilot was committed to a forced landing on stony, scrub-covered ground. The aircraft was substantially damaged but none of the four occupants was injured.

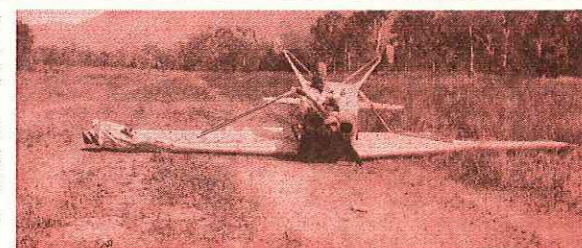
An early morning inspection from the air of the unfenced and partially completed landing area on the pilot's own property near Proserpine, Queensland, gave no indication of any obstructions or wandering stock, but showed the pilot that there was no wind.

The subsequent landing was quite normal until the Tri-pacer's wheels were firmly on the ground, when a kangaroo bounded across the landing path from the adjacent scrub. It was struck by the nosewheel, which was damaged and slowly collapsed rearward. The aircraft fell on to its nose, skidded for 148 feet, and overturned.
