AVIATION
SAFETY
DIGEST

Page
Aztec Disappears In Storm	2
It’s Not Worth The Risk	6
There Are No Second Chances	10
We Can All Be Professionals	14
Starting With a Bang!	16
Not as Planned	18
Air Safety Symposium	21
Crosswind Landings	22
Without Comment!!	26
In Brief	27

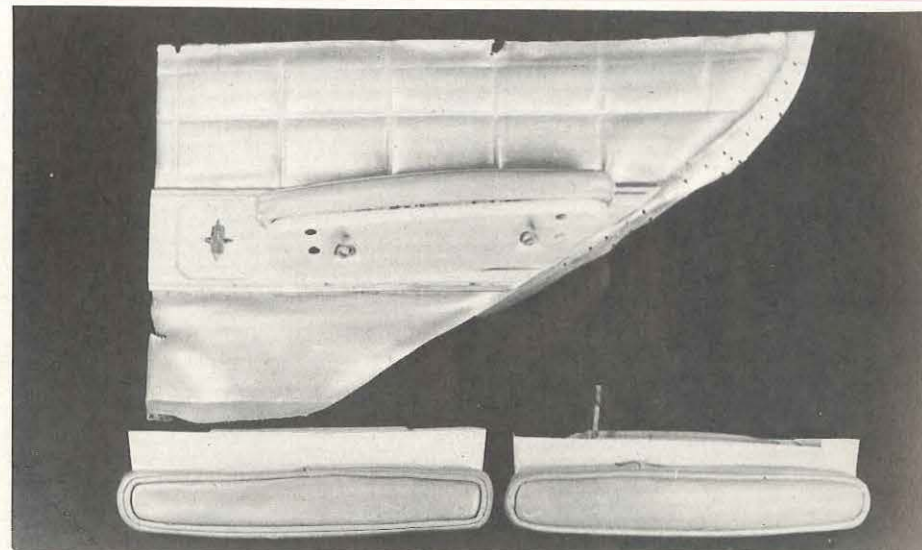
Cabin fittings from the missing Aztec found washed up on the shores of the western arm of Shark Bay.

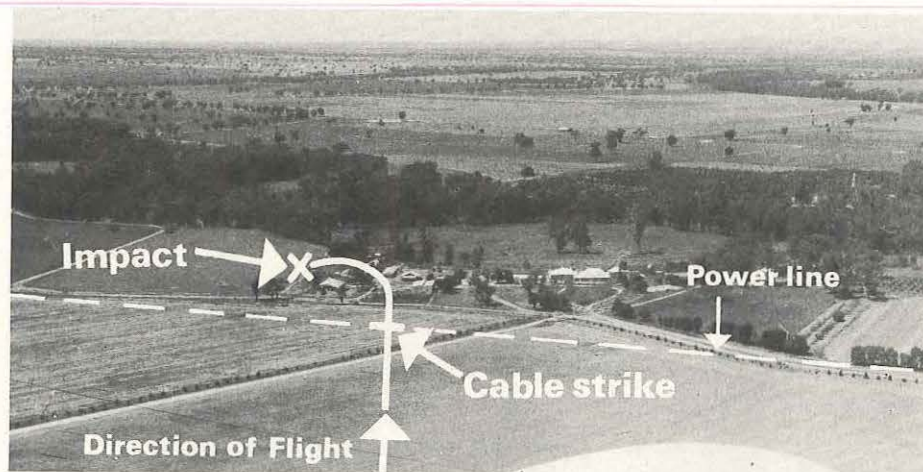
Aerial view of homestead buildings showing position of power line, final flight path and crash site.

Examination of the almost completely burnt-out wreckage and the overall area in which the accident occurred, showed that the power line struck by the aircraft ran east-west and comprised three heavy gauge cables, carried on poles 28 feet high and 475 feet apart. Each cable consisted of three strands of 14 gauge steel wire. All three cables had been broken at the pole next but one to the collision point on the eastern side of the flight path, approximately 700 feet away. To the west of the point struck by the aircraft, two of the cables had been torn from their insulators on seven supporting poles, over a total distance of 4,800 feet. One of these cables had become inextricably entangled on the aircraft structure. It had looped around the port wing,

under the engine against the carburettor, back over the starboard wing, and finally around the rudder and port side of the stabilator. The tension of the cable had pulled the carburettor rearwards, breaking it from its mounting flange. The landing lamp, mounted near the carburettor air intake, had also been broken by the cable, and pieces of glass had been ingested into the engine. At the tail of the aircraft, the cable had cut deeply into the stabilator from its trailing edge, and jammed the rudder hard to port.

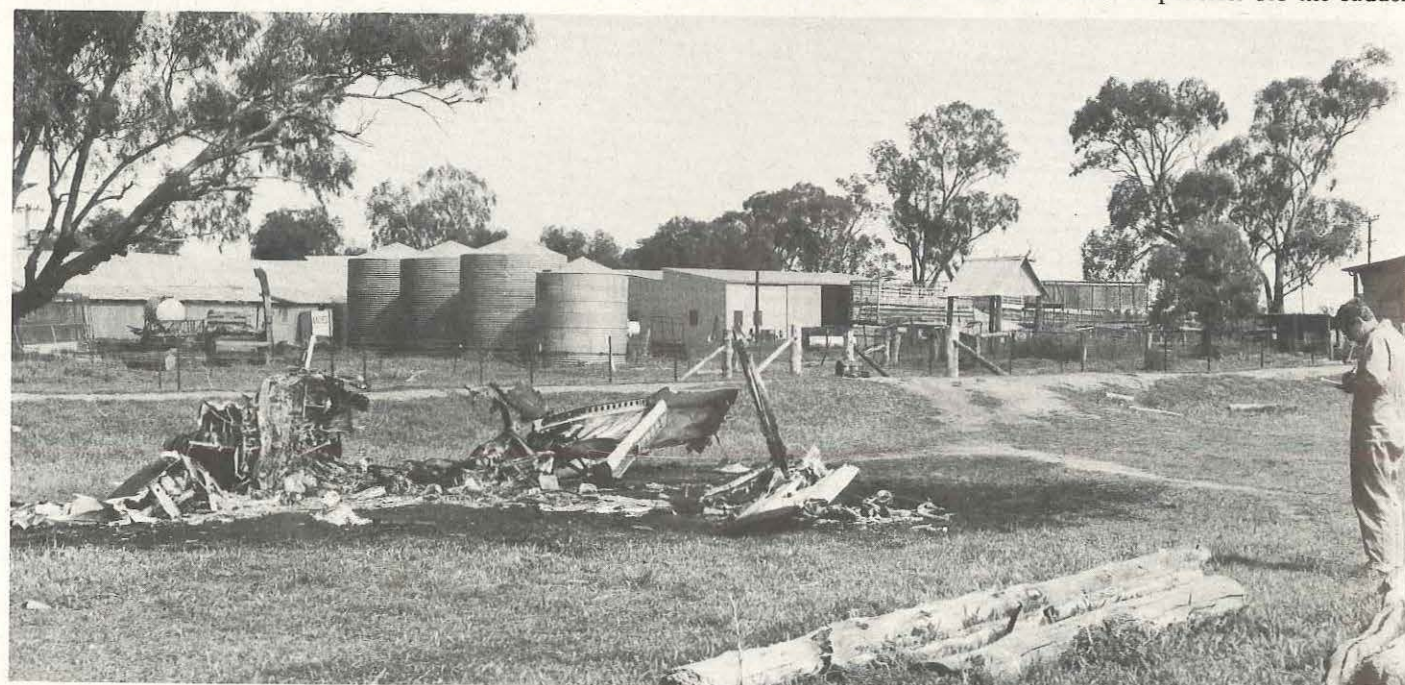
Left: View from crash site looking back in direction of aircraft's approach. The workshop beside which the men were working is in the centre of the picture.

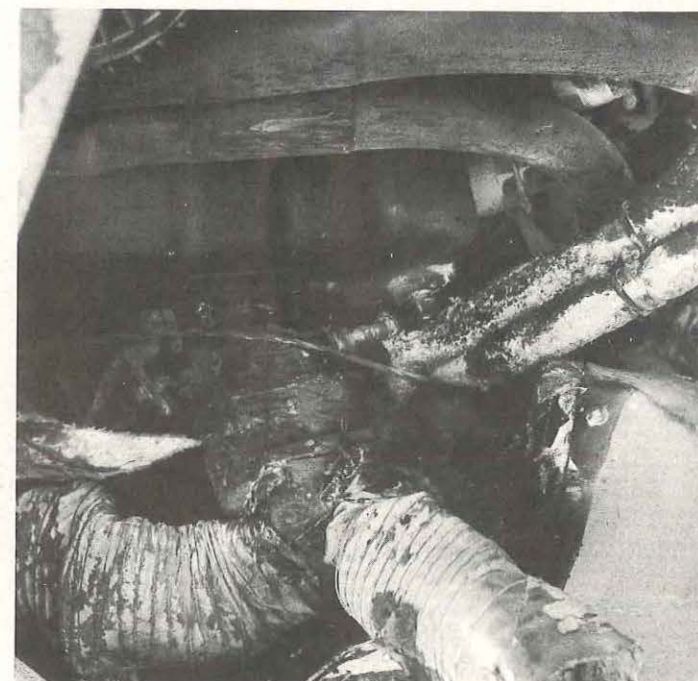
Right: View of underside of engine showing carburettor broken away from mounting flange by tension of power cable.

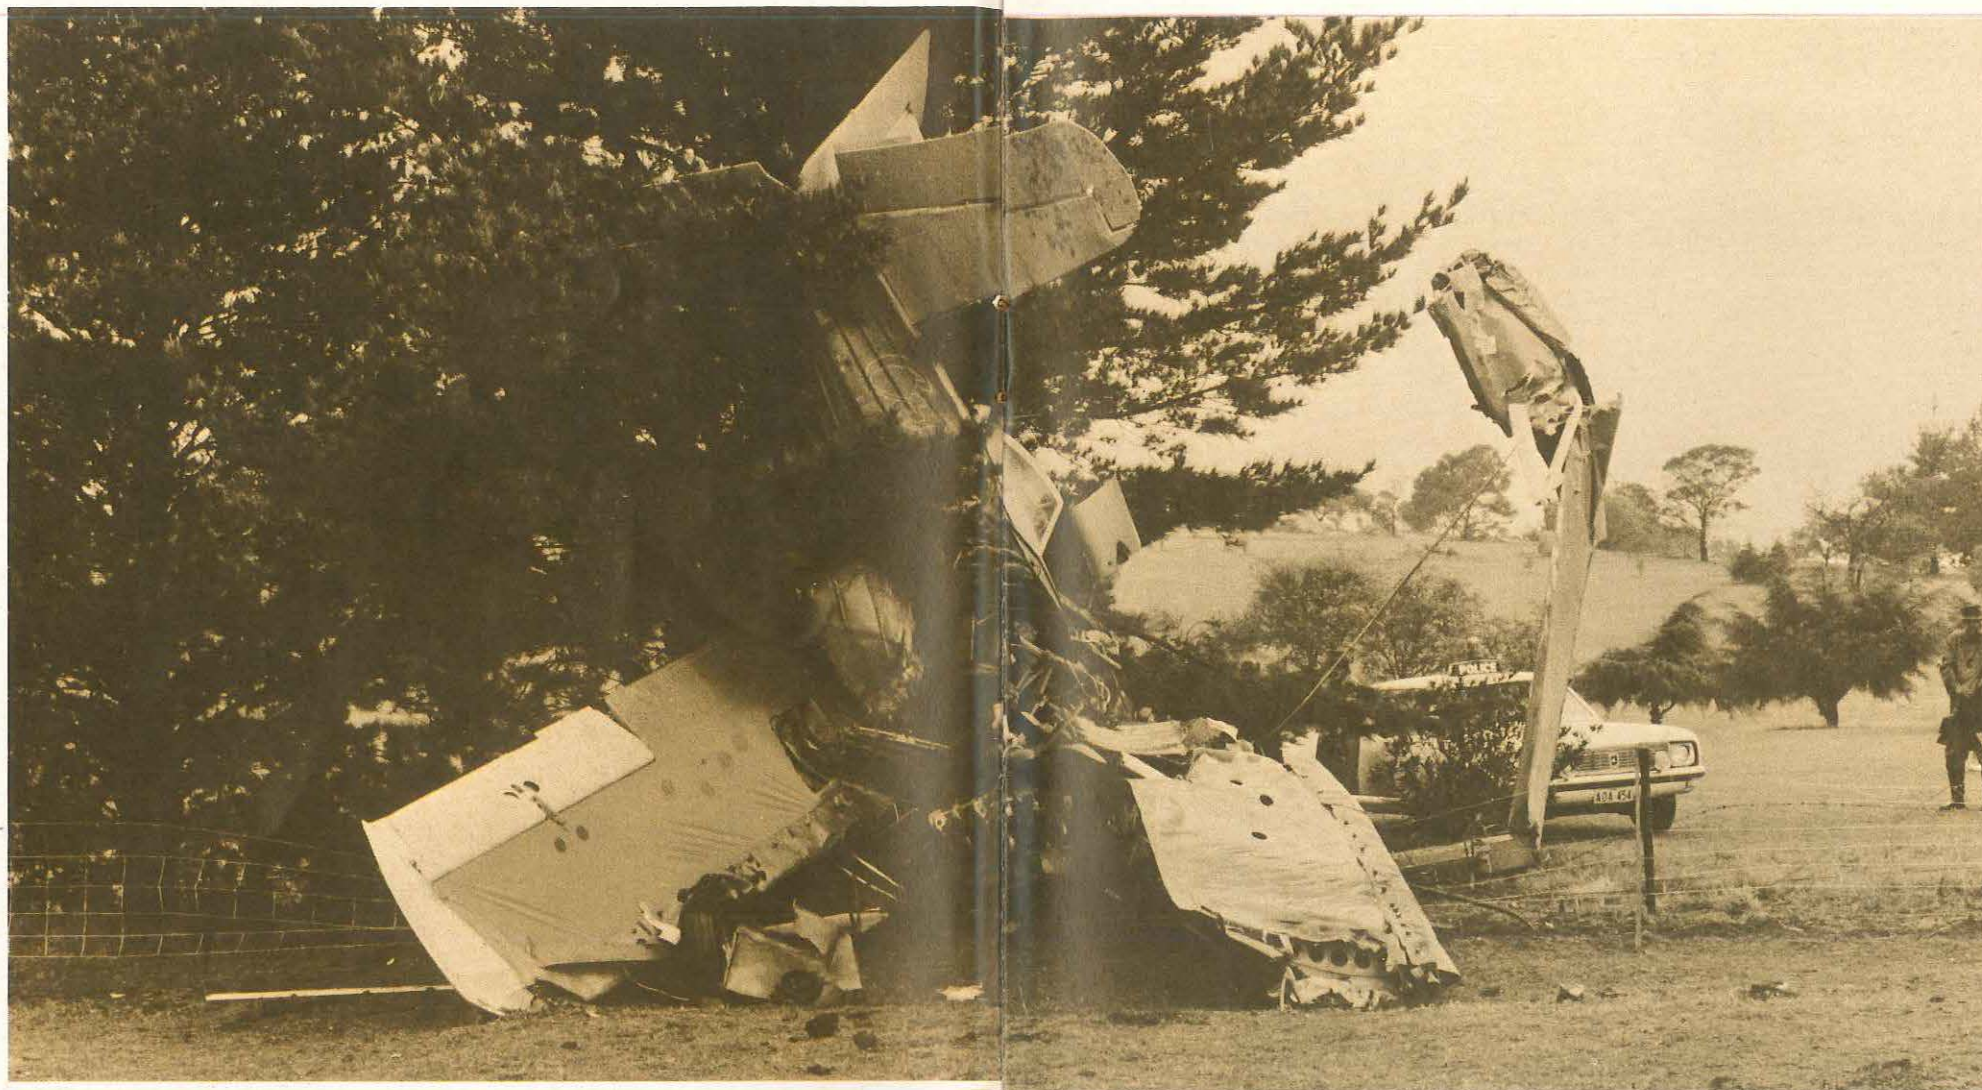
Wreckage of the Grumman Agcat as it came to rest on the golf course boundary after diving into the ground out of control.

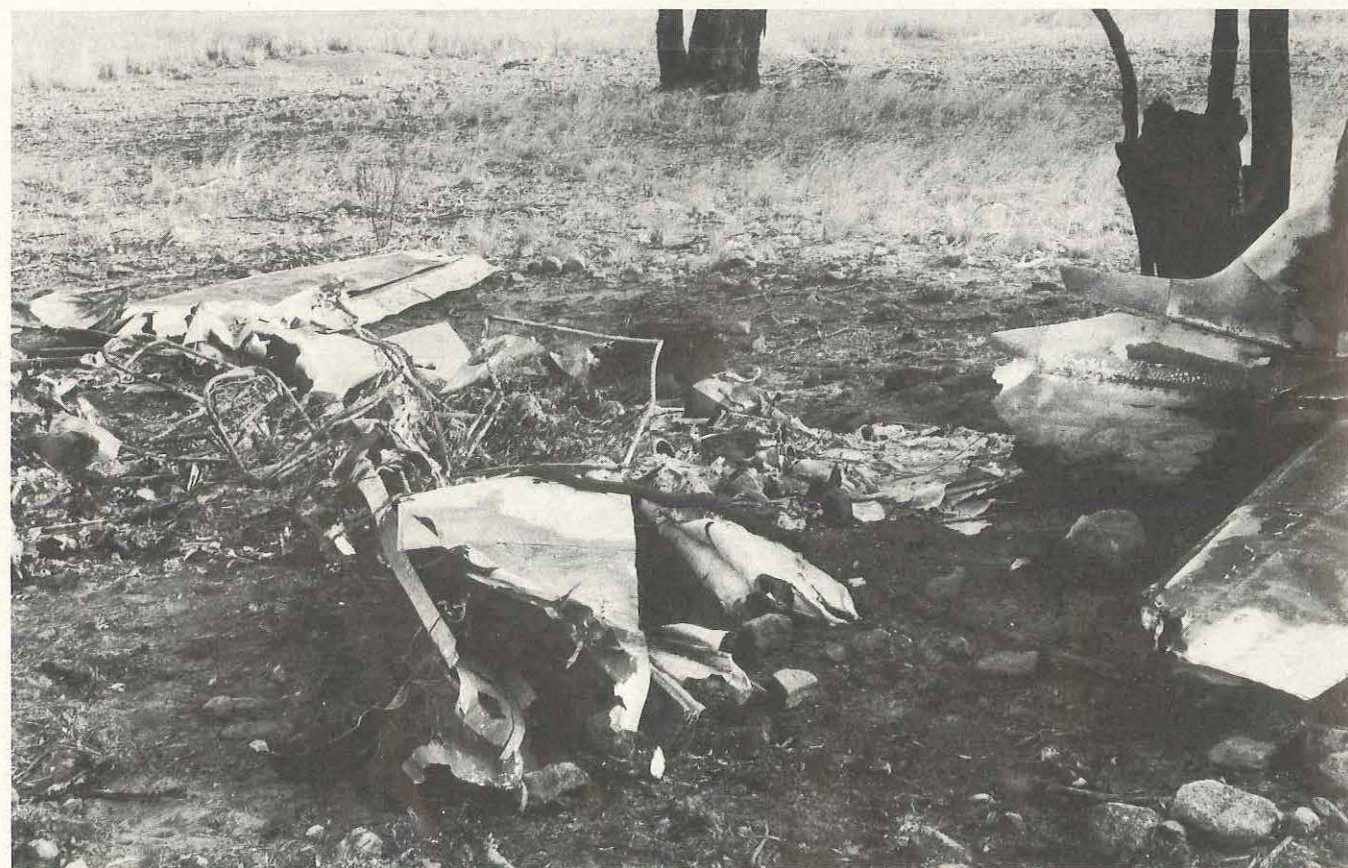
Left: All that remained of the Comanche after the crash and ensuing fire. A few seconds disregard for the fundamentals of flying safety was all that was necessary to reduce a fully serviceable aeroplane to this almost unrecognisable aggregation of charred and twisted wreckage.

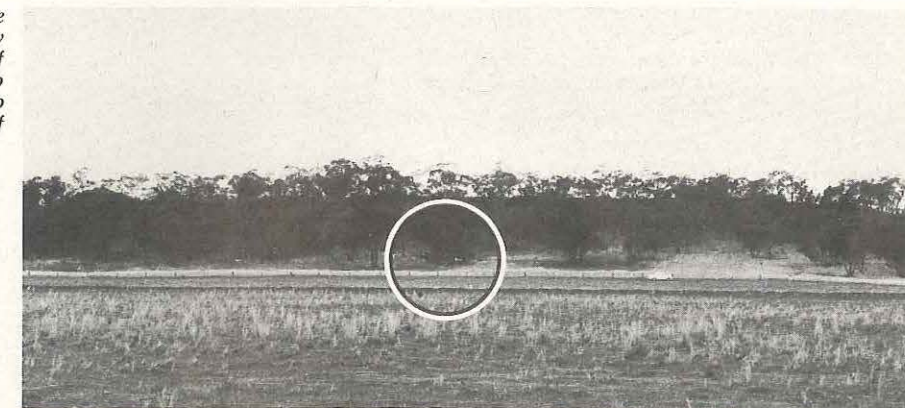
Top: General view of accident site looking in direction of flight. The wreckage can be seen in the centre of the picture at the base of the low, timbered ridge.

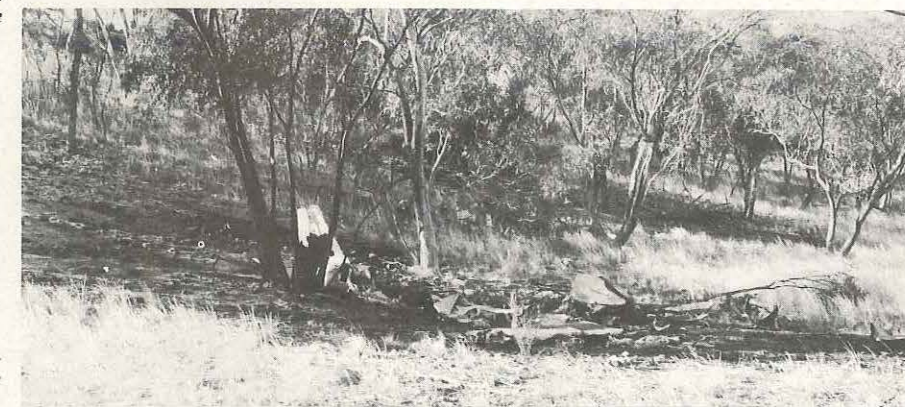
Bottom: Close-up of the accident site showing the burnt-out wreckage amongst the trees at the base of the ridge.

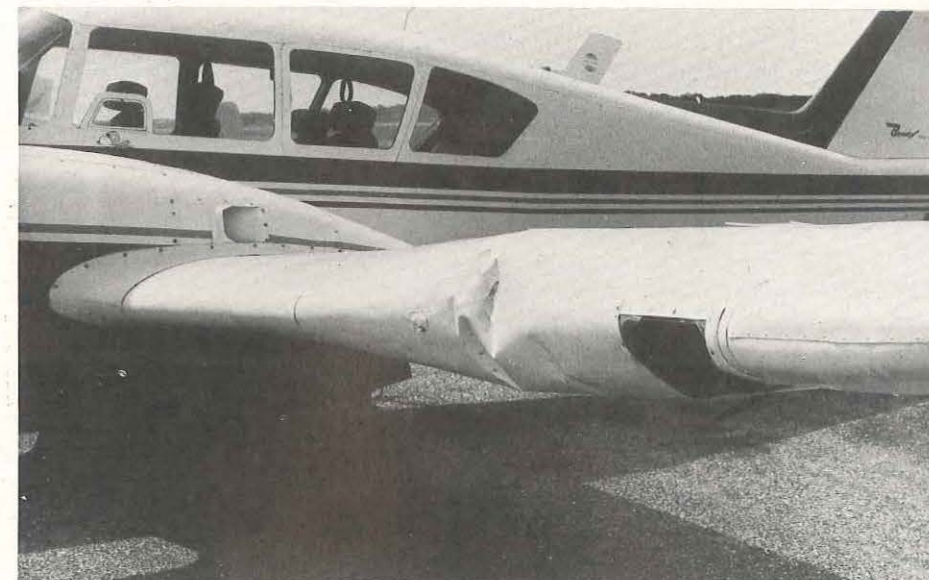
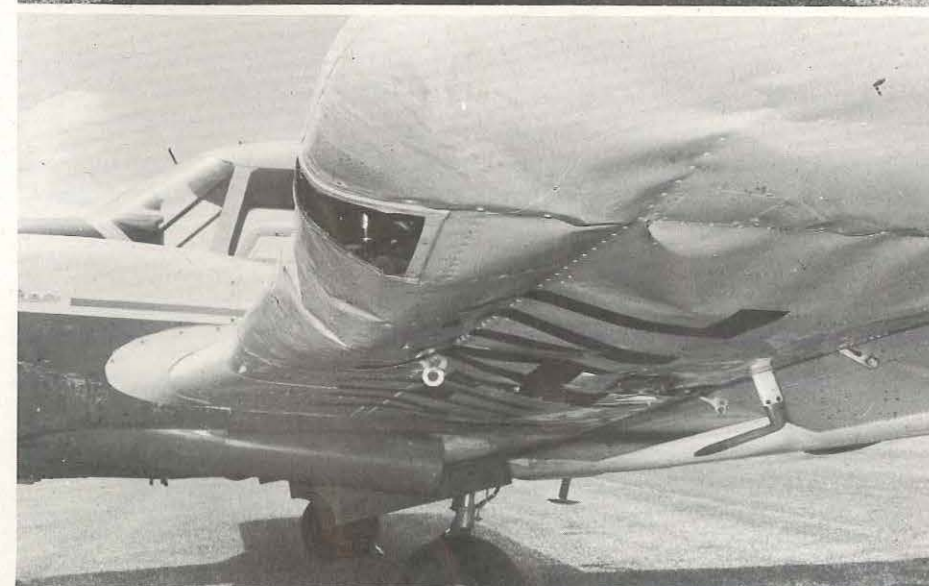
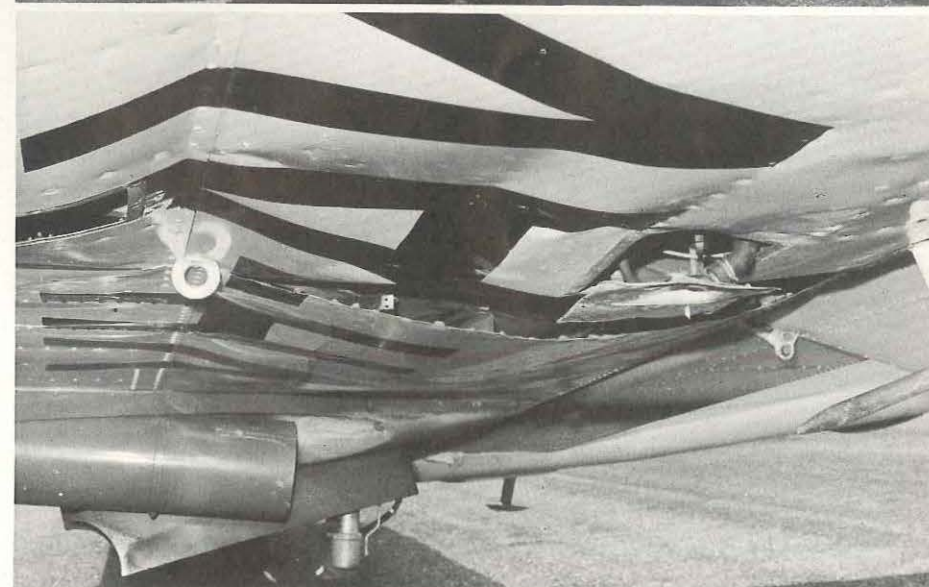
The damaged wing in the photographs on the opposite page belong to a Piper Aztec that was damaged by an internal explosion while the port engine was being started. Luckily no one was hurt, but as the pictures show very well, the damage was substantial – and expensive!

THE accident is typical of a number that have occurred to light twin-engined aeroplanes during the last few years. In each case, a fuel leak somewhere within the wing space produced an inflammable mixture of fuel vapour and air in the right proportions, which was ignited the next time the engines were started.

Fuel leaks which could lead to this situation can of course develop in a number of ways; a loose connection in the fuel tank outlet, drain, or vent line; a leaking seal in a tank filler neck; or a faulty fuel gauge installation. But a much more insidious source of fuel leaks, and one that has been increasingly a factor in wing explosions in recent years, is the deterioration that takes place in the flexible, wing-installed fuel cells of aircraft that have been in service for some time, particularly in hot dry climates.

This deterioration is a slow process and takes place as a result of the fuel gradually removing the plasticizer from the rubber layers comprising the walls of the flexible fuel cell. All remains well while there is fuel in the tank, because the fuel itself acts as a substitute plasticizer. But if the tanks are allowed to remain empty for any length of time, they dry out and the rubber hardens. In this condition the cells are liable to damage. The deterioration seems most marked in aircraft which have been "hangared" in the open for lengthy periods in hot weather. The effect is also more pronounced on the upper surfaces of the fuel cells, probably because the black synthetic rubber material of the cell acts as an absorbent or trap, for heat radiated into the wing cavity from its upper skin. The effect is greatest when the aircraft is left standing in the sun, as there is no ventilation of the narrow airspace be-

- Keep the fuel tanks topped up as much as possible.
- When it is necessary to operate without filling the auxiliary tanks, leave a gallon or so of fuel in them to prevent the cells drying out.
- As far as possible, avoid leaving the aircraft standing in the sun.
- If for any reason fuel cells have to be left empty for more than five days (whether or not the cells are installed in the aircraft), a thin coating of light oil should be flushed or sprayed on to the inner surfaces. This prevents the cell material from drying out and cracking.
- Be alert for any signs of deterioration, such as fuel staining on the underside of the wings, or any excessive smell of fuel at openings in the wing structure, particularly in the lowest sections of the wings, such as in the undercarriage wheel wells.

For this reason it is important to check carefully for symptoms of fuel leaks during daily inspections. Special attention should be given to the wing areas where the fuel tanks are located, and to openings in the lower sections of the wings where fuel vapour, being heavier than air, is likely to be discharged. Care should also be taken to ensure that all drain holes are clear and free of vapour, and that the surrounding under-surfaces of the wing are carefully inspected for signs of fuel staining. If any signs of a fuel leak are detected, it is of course of vital importance that its source be investigated and corrective action taken without delay.

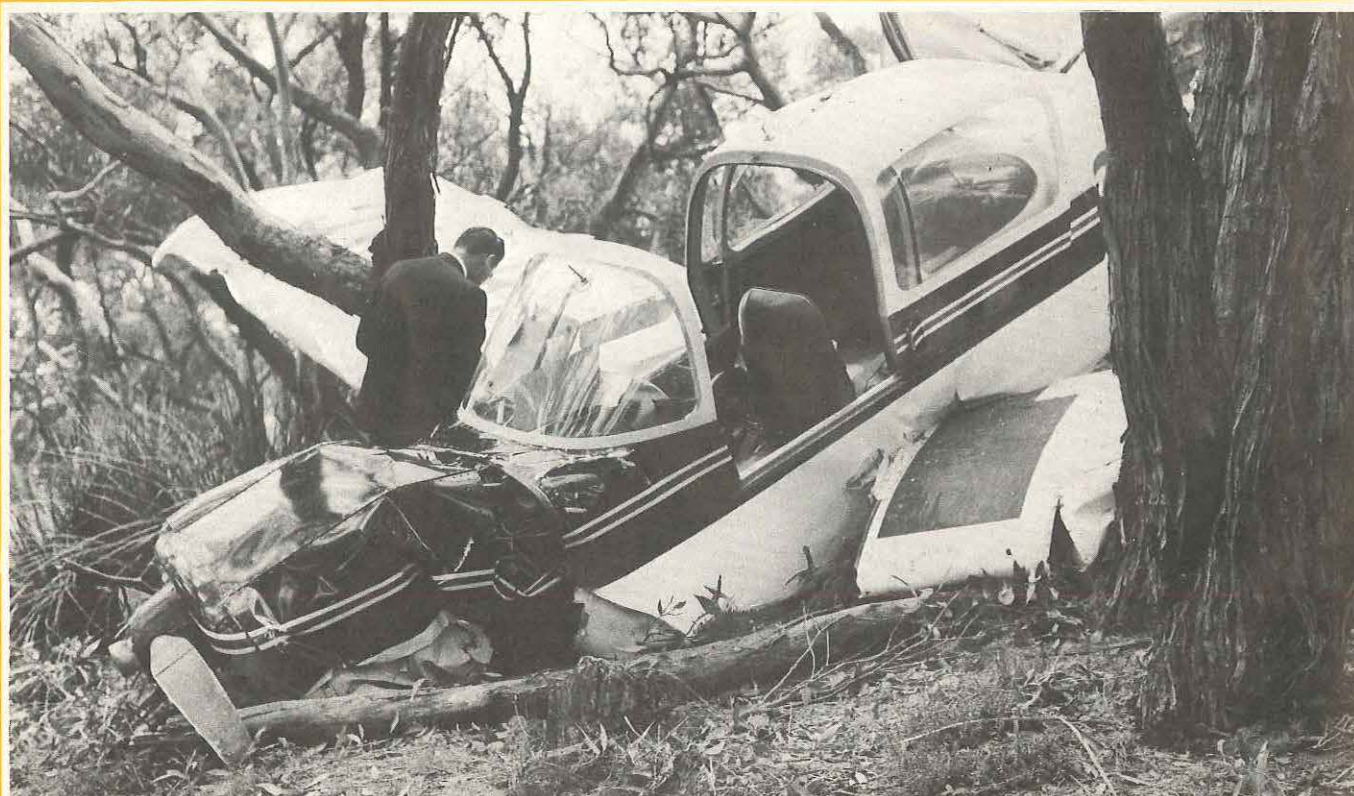
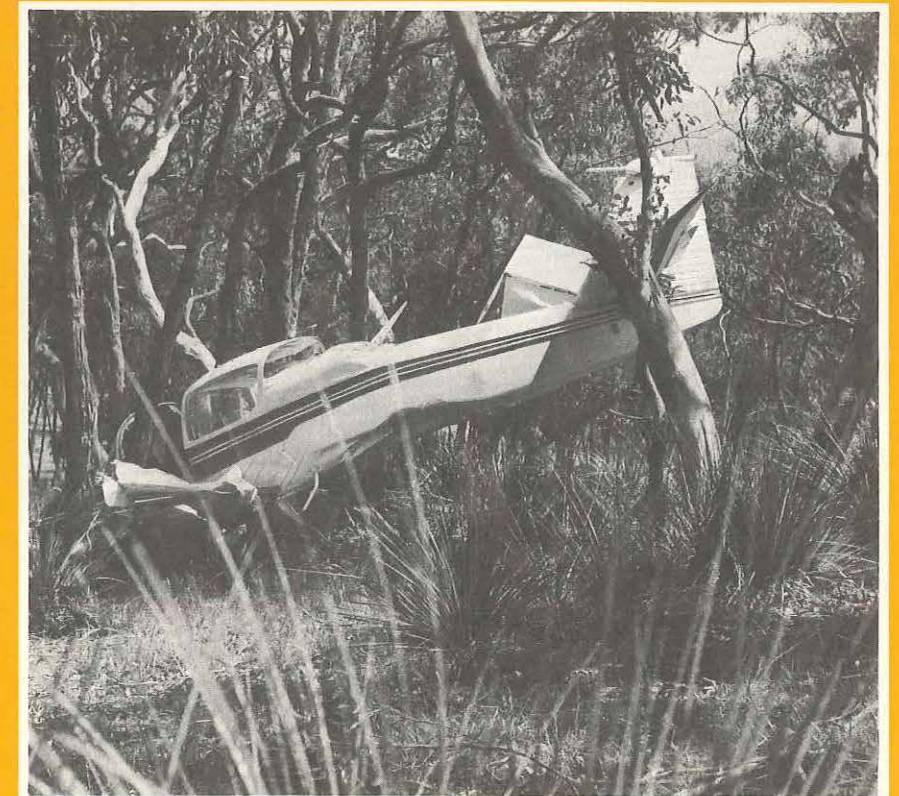
Right: The heavily timbered nature of the ridge on which the aircraft crashed is shown in this view of the wreckage.

craft on its nose amongst the trees close to the crest of the ridge, only 100 yards south of its highest point. Three seriously injured occupants were waiting for rescue a short distance away. The fourth occupant, who had escaped almost unhurt, had already gone to seek help.

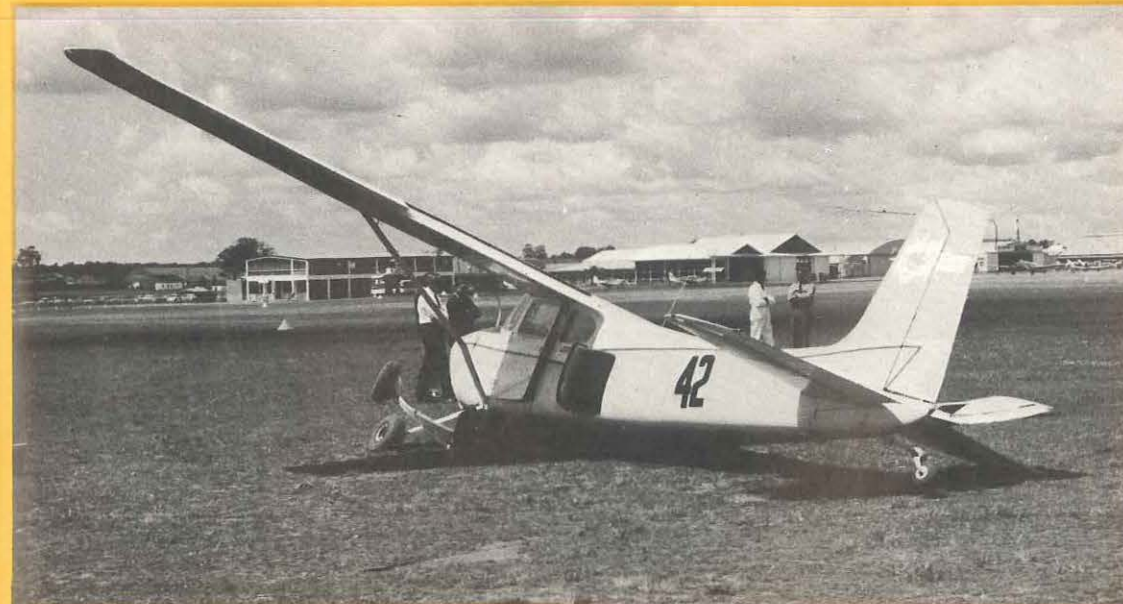
In preparation for an air race, the pilot of this Cessna 180 had spent two and a half hours being endorsed and familiarising himself with the aircraft type. On the morning of the race, he made all necessary preparations and then taxied to the departure point. Given the "go" signal, the pilot advanced the throttle to full power and commenced the take-off. The aircraft ran straight ahead for about 50 yards, then diverged slightly to the right. The pilot corrected, but the aircraft then swung violently to the left. The ensuing ground-loop dislodged the starboard undercarriage and the aircraft finally came to rest on the starboard wing and elevator. Fortunately the occupants were not injured, but the aircraft was substantially damaged. At the time, the weather was calm and could not have contributed to the accident in any way. A commercial pilot experienced on Cessna 180's, who was watching the start of the race, said afterwards that he believed the pilot had tried to raise the tail prematurely and had lost control as a result.

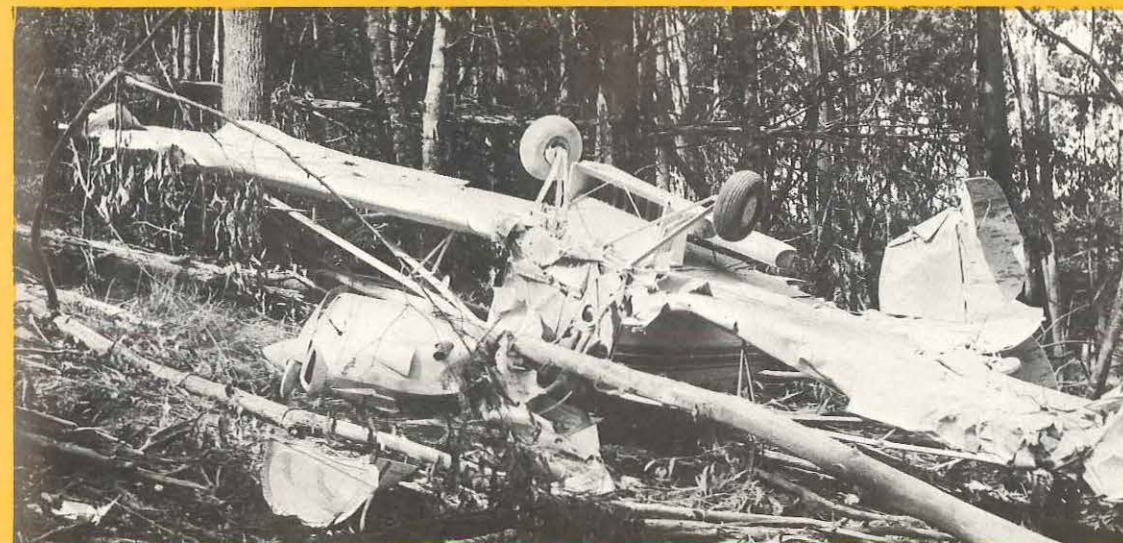
The pilot of this PA25 Pawnee was experienced in agricultural operations and held a Class 1 agricultural rating. The company for whom he worked had been employed by a timber authority to conduct aerial seeding operations in the lightly timbered, mountainous terrain of the Great Dividing Range. On the day of the accident, the pilot had successfully carried out a number of sorties, varying the load as the area dictated.

The pilot had been conducting all his seeding runs down hill, but with only one clean-up run left to do, he decided to turn left, and make his finishing run up-hill. After commencing the run however, the pilot realised he would not be able to outclimb the rising terrain. He dumped the load and turned to the right, but was unable to stop the aircraft from mashing into the trees. As the photograph shows, the aircraft was destroyed, but the pilot escaped with only minor injuries.

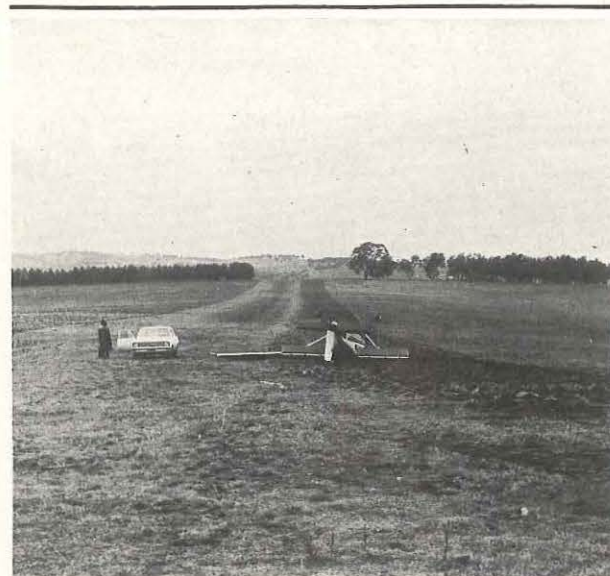
Because of deteriorating weather in the direction of his destination, towards the end of a flight from Moorabbin to Mudgee, the pilot of this Cessna 210 diverted to land at a relative's property in the Orange district.

Although he had landed at the property airstrip only three weeks before, when the area was fully serviceable, he did not know that the pastures on either side of the strip had since been harrowed, leaving a serviceable landing strip only 60 feet wide.

In the late afternoon light, made dull by the heavy overcast cloud, the pilot did not recognise the nature of the surface on either side of the strip. Towards the end of his landing run after a normal touch down, the pilot turned the aircraft to the left, intending to backtrack towards the homestead, but on entering the soft uneven surface, the aircraft decelerated rapidly as the nose wheel dug in and slowly nosed over on to its back. The pilot, who was the only occupant, was not injured.

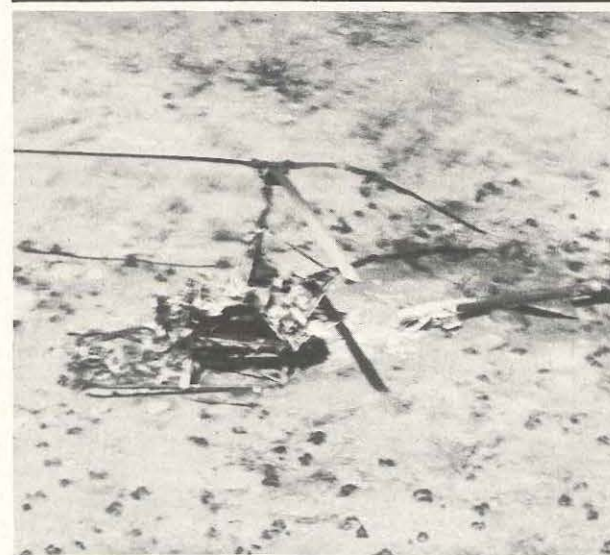
Engaged on survey work in Western Australia, with pilot and a surveyor on board, a Hughes 269B helicopter made a landing in an area covered in patches of spinifex. After the passenger had alighted, he saw that a patch of spinifex beneath the engine exhausts had caught fire. He shouted to the pilot who, still wearing his headphones, was engaged in completing his shut-down checks. The pilot did not hear him so he ran around to the front of the helicopter and signalled to the pilot. The pilot understood the situation immediately and re-engaged the clutch and tried to regain sufficient rotor RPM to take off again. The engine responded initially but then died. By this time the flames had spread and were leaping around the cabin door, and the pilot was forced to abandon the aircraft. Within seconds it was engulfed in fire and was completely destroyed.

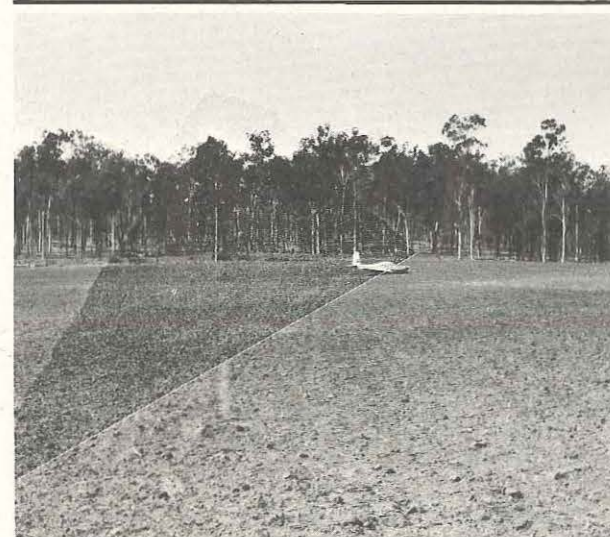
While cruising in level flight between Roma and Maryborough, the engine of this Meta Sokol suddenly began to vibrate severely. The pilot made a quick trouble check but the engine instrument indications seemed normal and a magneto check did not isolate the trouble. With the vibration intensifying, the pilot had no choice but to close the throttle and attempt a forced landing. At the time, the aircraft was flying over heavily timbered terrain and the only area in any way suitable was a cultivated field less than 1,600 feet long with trees 70 feet high at one end and 20 feet high at the other. With the undercarriage lowered, the pilot made a cross-wind approach towards the tall timber. After touching down initially, the aircraft skipped twice on the undulating ground and finally landed only 550 feet from the tall trees. Realising he had no hope of stopping the aircraft in the distance remaining, the pilot attempted to turn the aircraft to the right, but it skidded sideways and the undercarriage collapsed on the rough ground. None of the three occupants was hurt.

The engine was later examined and the severe vibration was attributed to defects in the fuel injection system causing fuel starvation in one cylinder. Performance calculations indicated that, in this type of aircraft, a successful landing in the field would be almost impossible.

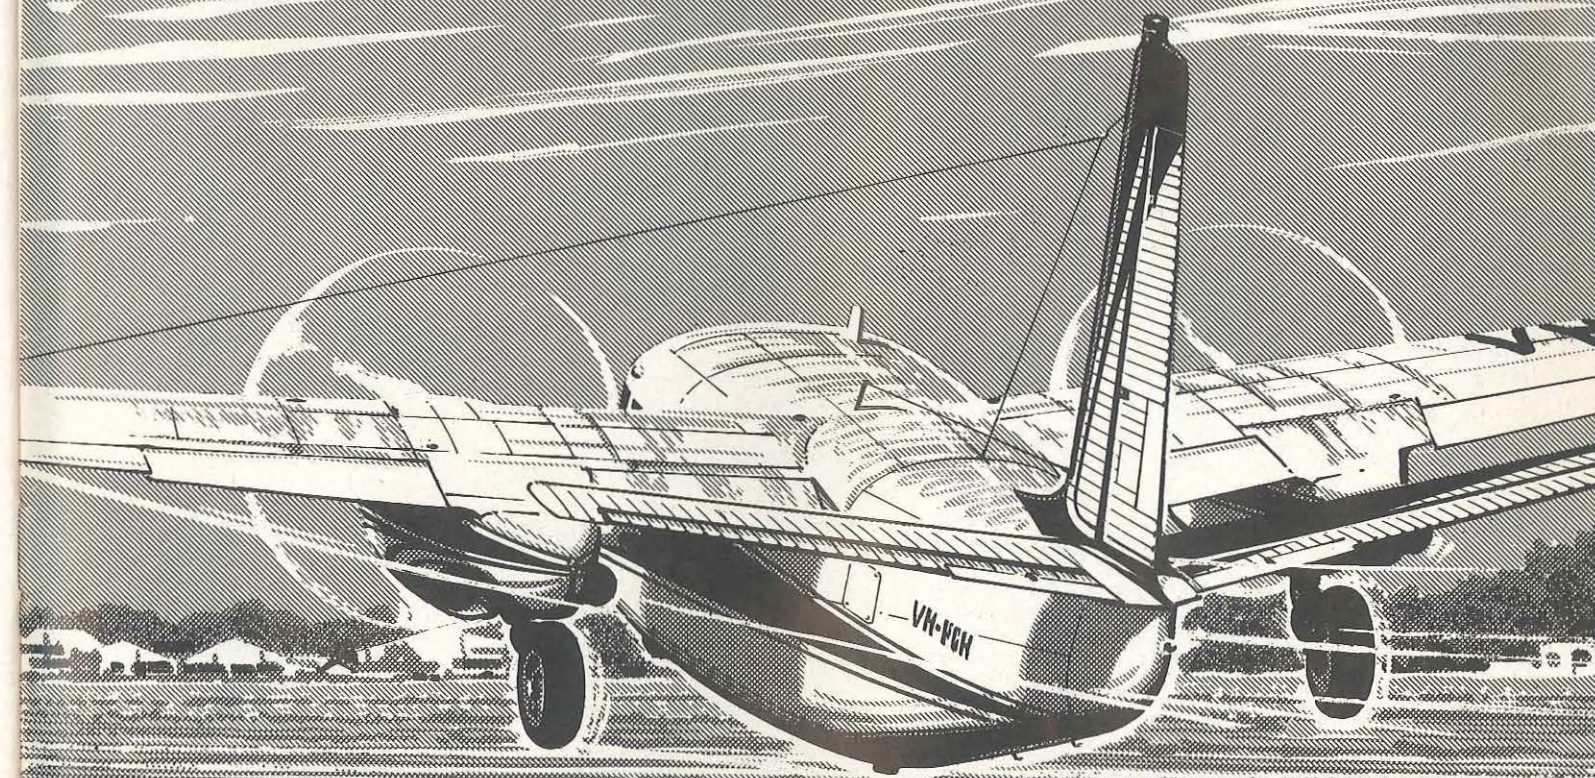
**Retracting the undercarriage
the moment you lift off
may be spectacular —**

even more so than you think!
