Number 80 July 1972

DEPARTMENT OF CIVIL AVIATION AUSTRALIA

AVIATION SAFETY DIGEST

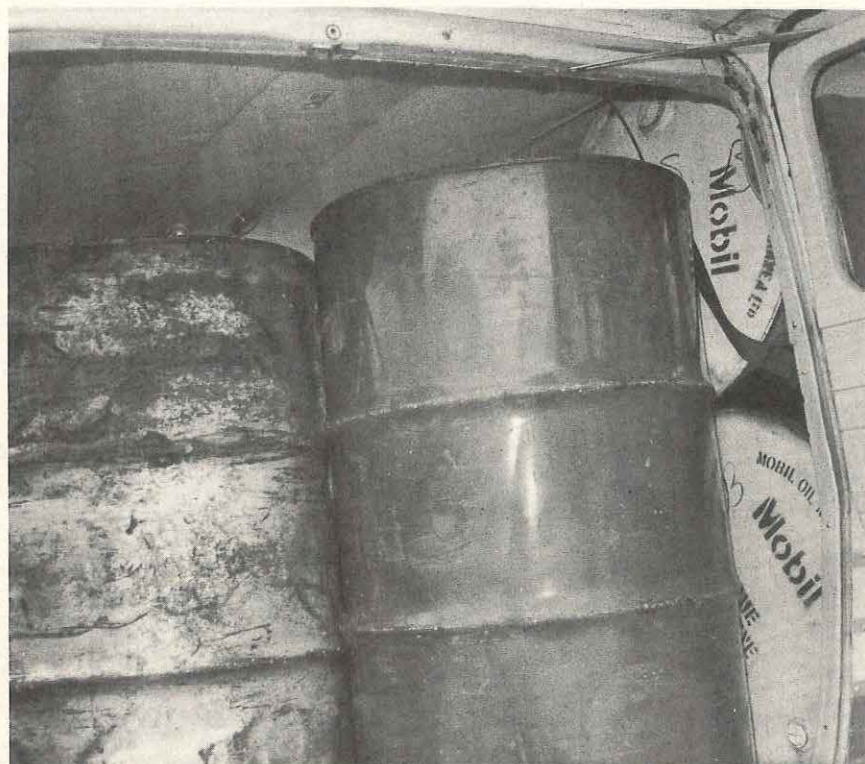
Reconstruction of aircraft loading at time of accident. Above: View taken through main door of aircraft showing relative position of drums. The fifth drum is on its side in the rear of the cabin just out of the picture to the left.

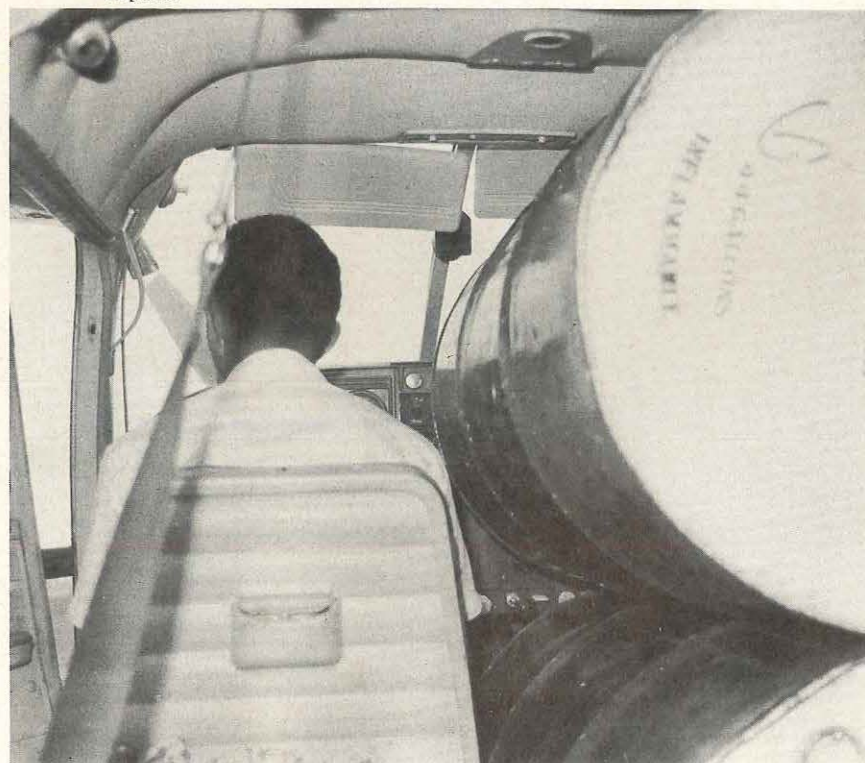
Below: View from rear of cabin showing limited cockpit area available to pilot.

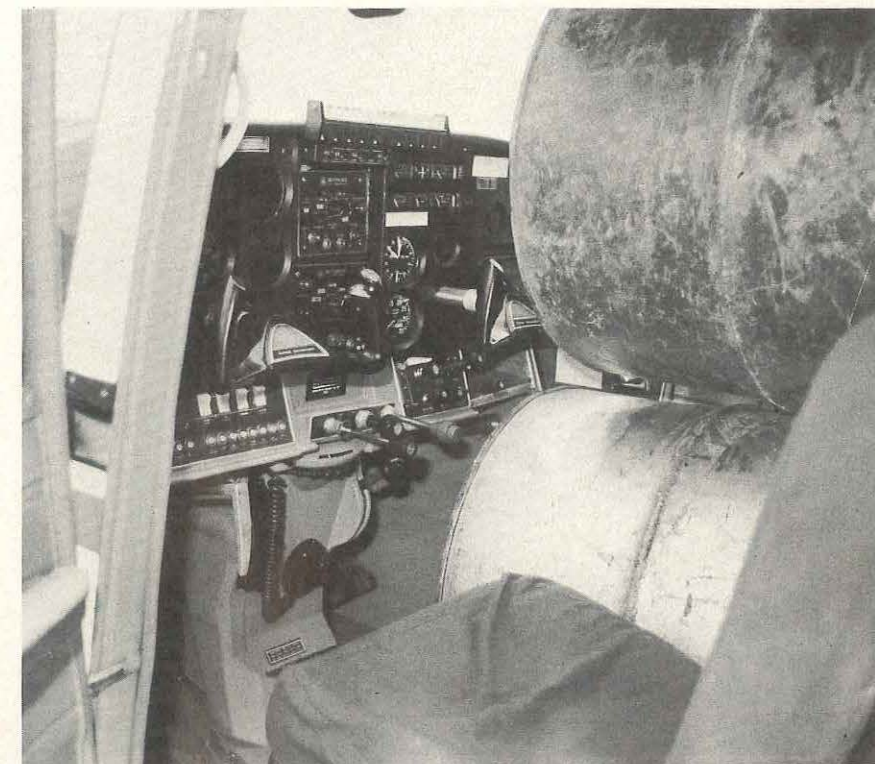
Above: Position of two foremost drums relative to instrument panel and starboard control wheel. In this position the drums prevented full rearward movement of the control column. Any further forward movement of the drums would restrict up-elevator travel even more.

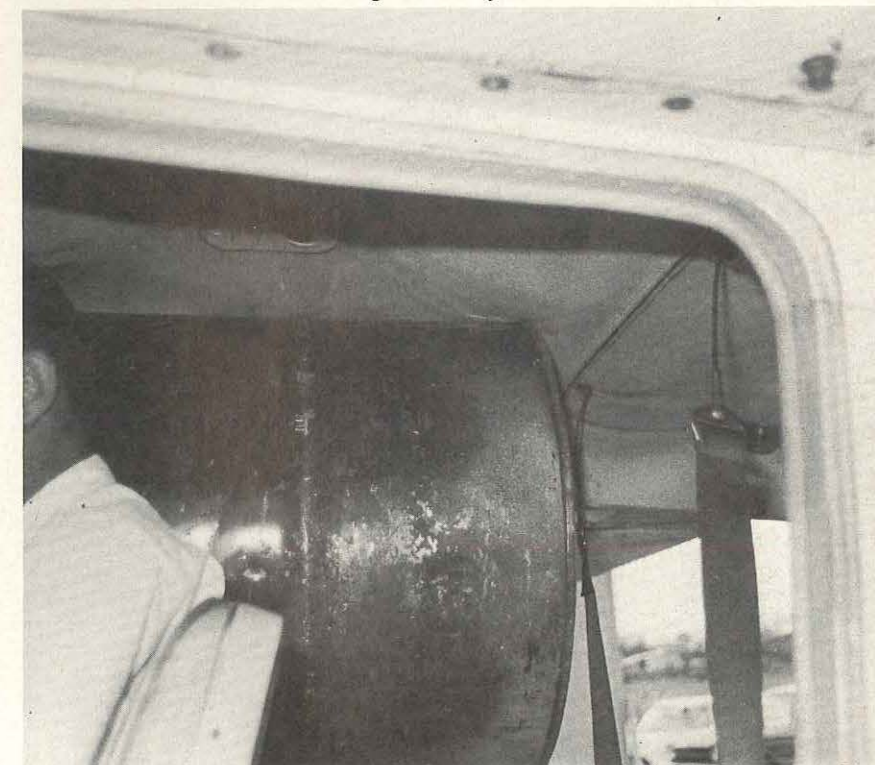
Below: With the aircraft loaded in this manner, it was not possible to secure the drums to the cargo tie-down points.

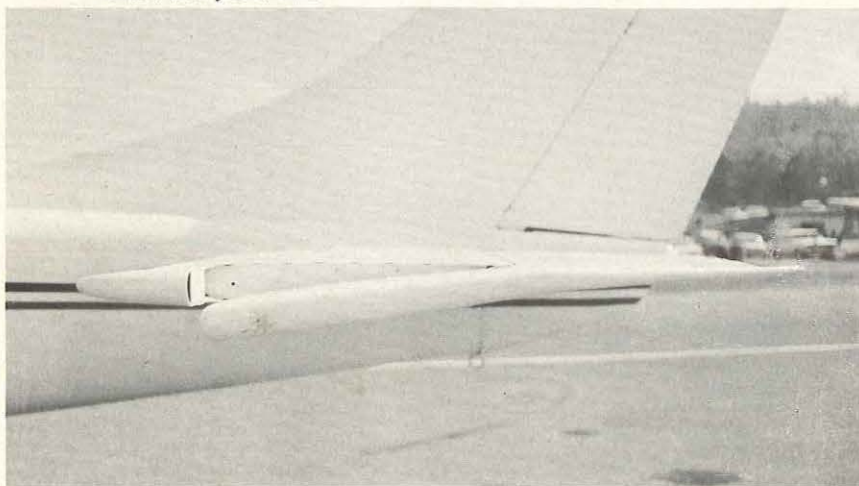
Below: Limited amount of upward deflection available in aircraft loaded with five drums.

The cause of the accident was not determined, but it is likely that the manner in which the aircraft was loaded deprived the pilot of full effective use of the elevator control.

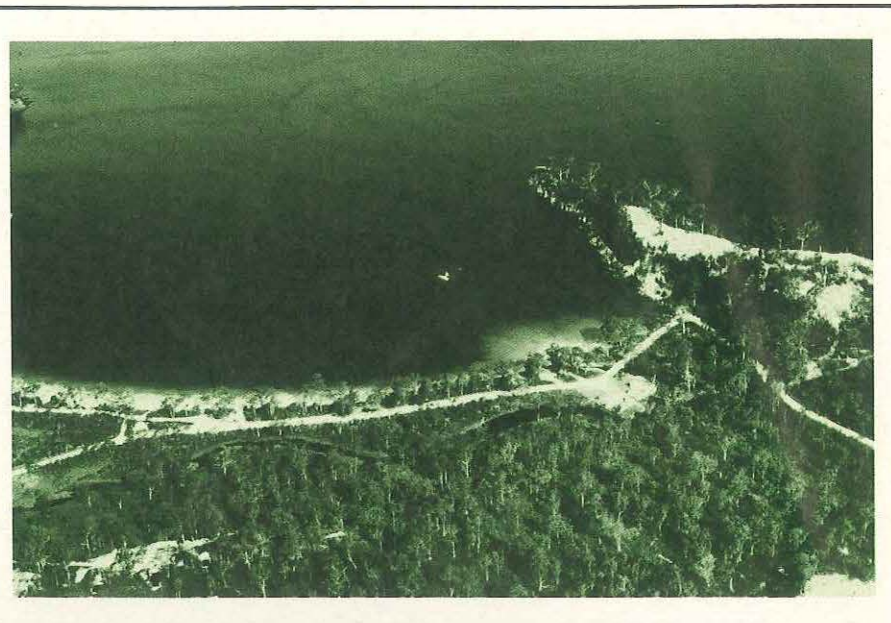
The Cessna Cardinal in the water moments after it had ditched. A ring of ripples can be seen spreading outwards from the floating aircraft.

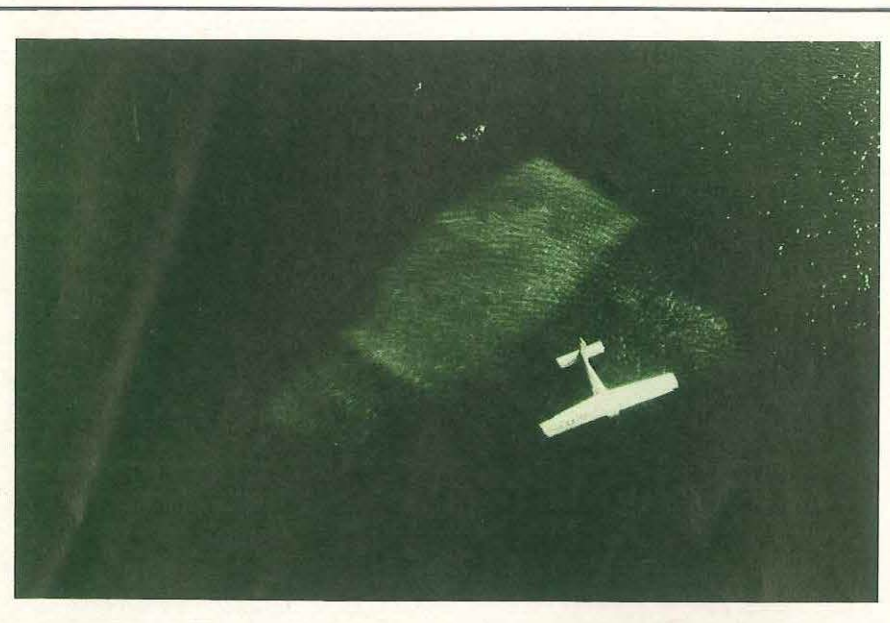
The sinking aircraft photographed from a lower altitude. At the top of the picture the four occupants can be seen swimming towards the beach. This picture, and the one on the preceding page, were taken by a passenger in an accompanying aircraft.

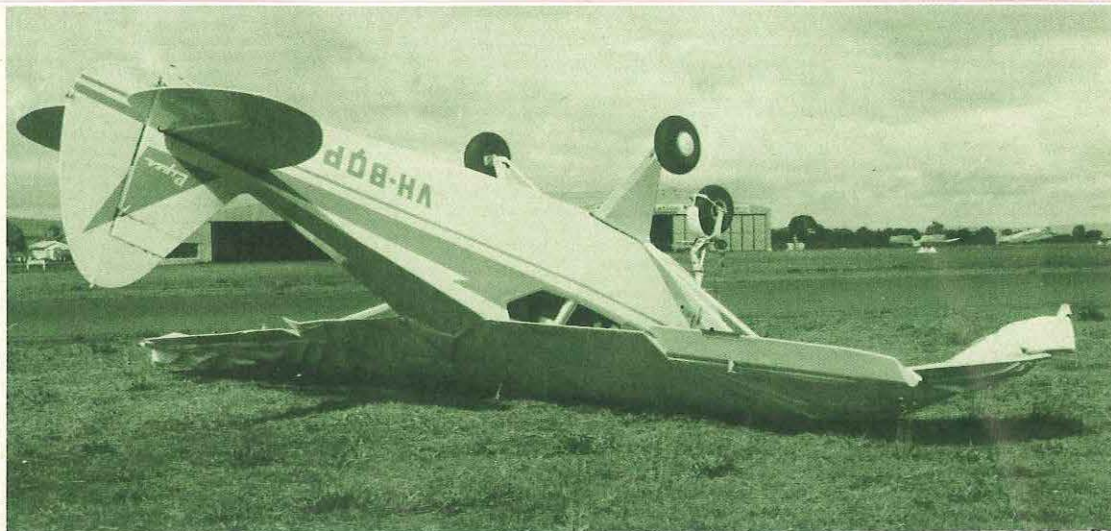
After undergoing a little more than an hour's dual instruction in this Piper Colt, a private pilot taxied out to do some solo circuits to complete his endorsement training. At the time, there were a number of rain squalls in the vicinity but the instructor conducting the training did not believe the weather would close in before the circuits were completed and so he authorised the solo flight. Everything went well until, on the downwind leg of the first circuit, the pilot realised that the squalls were approaching much faster than expected, so he decided to cut the remaining part of the circuit as short as possible. The wind strengthened as he turned on to final approach and he decided to go around again but, just as he was about to do so, it waned again and he continued the approach to land. The aircraft touched down normally but while it was still rolling the wind suddenly increased to more than 30 knots and backed through 90 degrees. Although the pilot tried hard to keep the aircraft on the runway, it drifted off to starboard on to the grass, the port wing lifted digging the starboard wing into the ground and the aircraft was blown over on to its back. The pilot, who was unhurt, turned off all the switches and left the aircraft without assistance. The aircraft was damaged beyond economical repair.

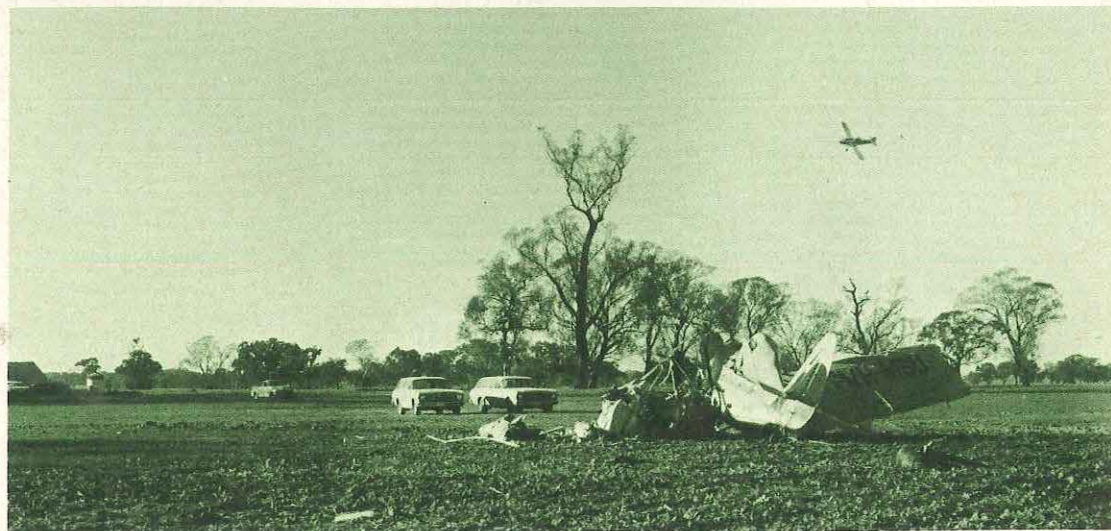
The pilot of this badly damaged Callair was highly experienced in agricultural operations and on the aircraft type, but fell prey to one of the most insidious hazards of aerial spraying operations. After completing a number of spraying sorties in the area, the pilot had found that some of the aircraft's spraying nozzles had begun to leak. To overcome the problem pending the completion of the work, the pilot had adopted the practice of not releasing the fan brake on the spraying pump until he turned on to each run. He would then check to see if the nozzles were leaking before activating the spray. As he turned on to the run on which the accident occurred, the pilot followed this procedure once more but, on looking up again, he saw a tree immediately in front of the aircraft. Before he could take any avoiding action, the port wing struck its upper branches. The aircraft rolled to the left, striking the ground with the port wing tip, and cartwheeled and slid to a stop as shown in the photograph. The pilot received serious injuries. He commented afterwards, "I made the fatal mistake of burying my head in the cockpit".

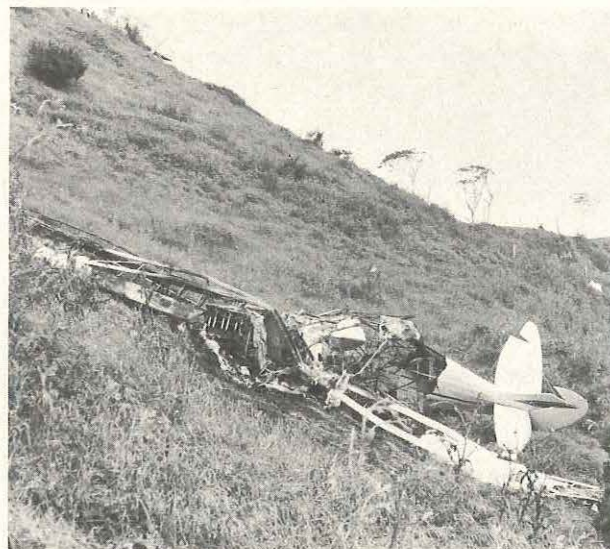
On the day preceding the accident, the pilot of a Piper Pawnee conducted a ground inspection of a property which was to be sprayed the following day. An adjoining property was also to be sprayed but because darkness was approaching he did not have sufficient time to make a proper ground inspection of this second area.

The next morning, after making an aerial inspection of the second area to be treated, the pilot decided he would fly along the escarpment visible in the photograph. He selected a pull-up point which he thought would enable him to climb over two power lines that ran down the slope across the aircraft's path. The pilot commenced his run, positioning the aircraft to fly parallel with the face of the escarpment and, on reaching his pull-up point, eased back the control column. The aircraft cleared the lower power line, but the port wing struck the upper wire, and the Pawnee crashed to the ground and caught fire. Though seriously injured, the pilot escaped from the burning wreckage. The pilot had not sprayed this area before, and did not know the exact height of the upper power line above the ground. Not having made a ground inspection of the rather complex relationship of wires and terrain at this point, he had underestimated the climb path necessary to clear the higher set of wires along the face of the escarpment.

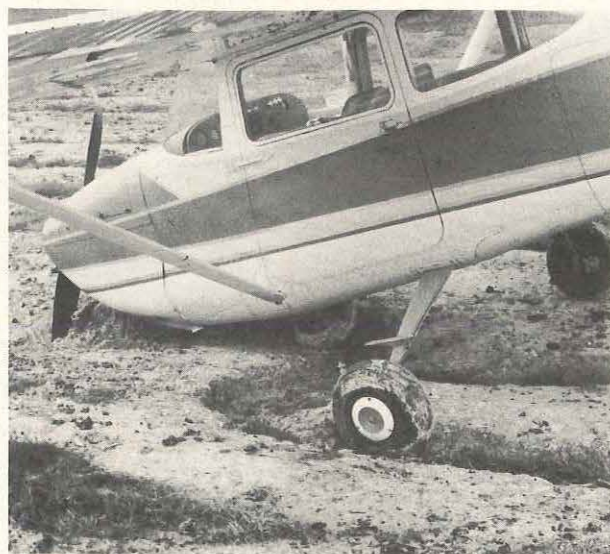
Arrangements had been made for a commercial pilot to ferry this Cessna 172 to a property in Victoria. Before taking-off, the Cessna pilot had been briefed by a private pilot on the location and layout of the property's two airstrips, one of which, because of its soft, wet surface, was unserviceable. However, the private pilot neglected to mention that only a short distance from the serviceable strip, which was not marked, there was another area which had been graded some time previously to form a strip, but which had subsequently been abandoned, leaving the surface badly rutted.

Arriving over the property, the pilot made several low inspection runs and, mistaking the graded area for the strip he had been advised to use, he landed on it, fortunately missing the roughest areas. At the end of the landing roll, the pilot turned the aircraft around and began to taxi back along the strip. But when the aircraft had rolled only a few yards, the nose wheel entered a deep hole. The nose leg was torn off and the aircraft came to a sudden stop on its nose.
