DEPARTMENT OF CIVIL AVIATION AUSTRALIA

Number 84 April 1973

# AVIATION SAFETY DIGEST

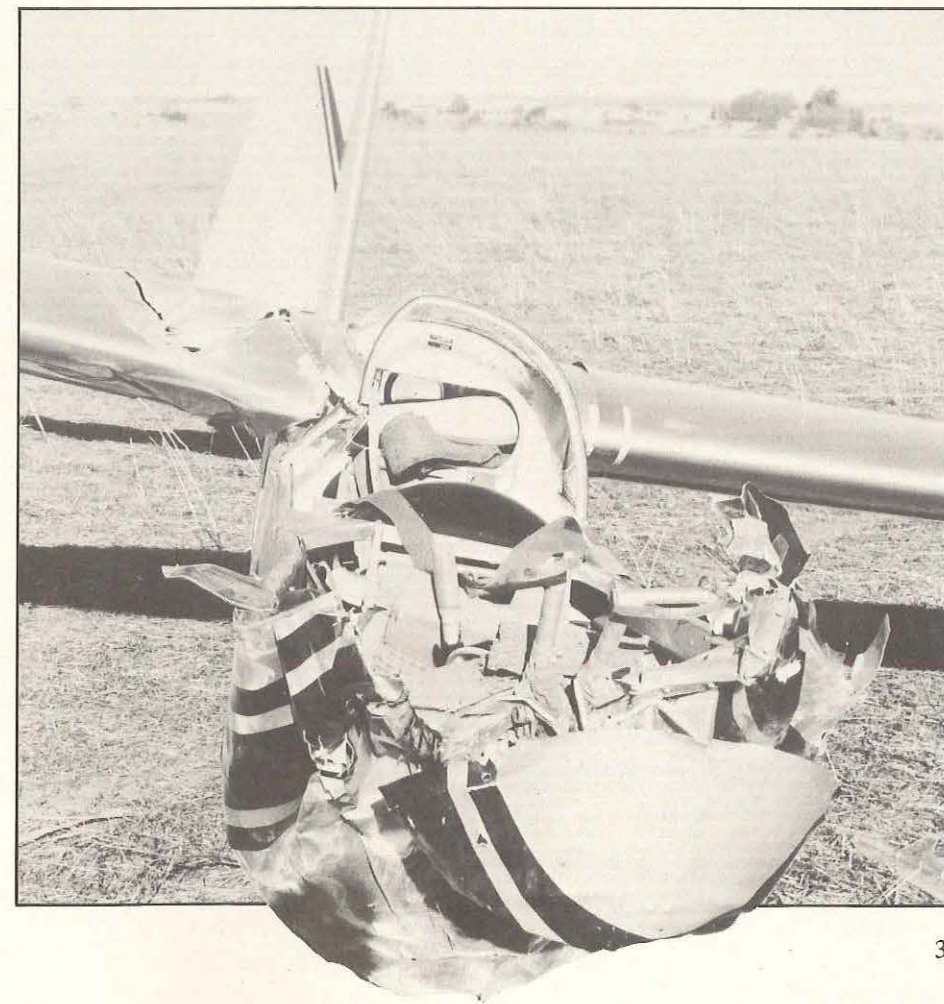
Examination of the wreckage showed that the glider had struck the ground nose-first, while spinning to the left. It was evident that all the damage sustained by the glider was the result of impact with the ground and a close examination of the wreckage established that no airframe defect had contributed to the accident.

*The crushed and distorted nose section and cockpit of the Blanik clearly indicates the force with which the glider struck the ground.*

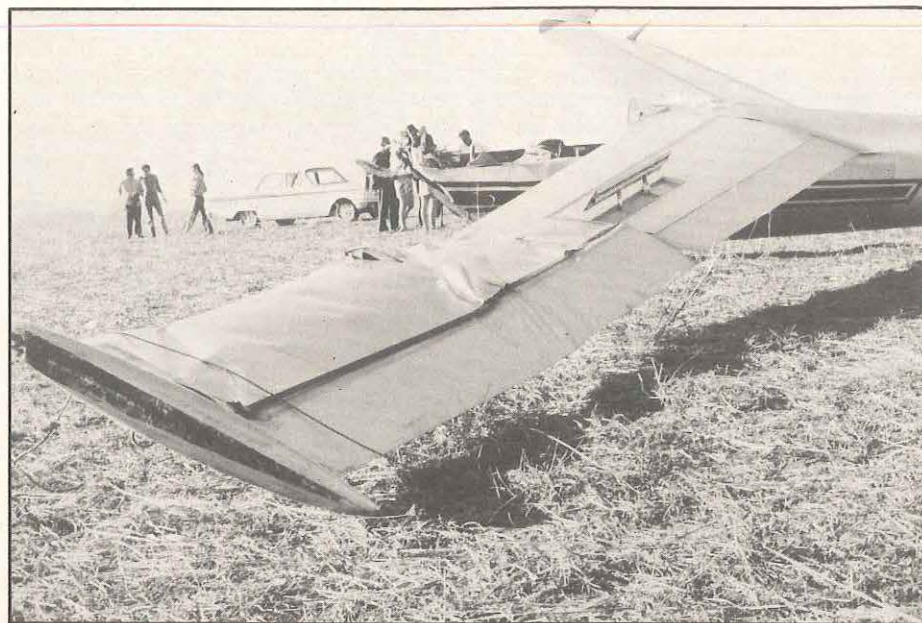
*Top: The main impact was also taken on the glider's port wing. This close-up shows the severe distortion and wrinkling of the wing structure.*

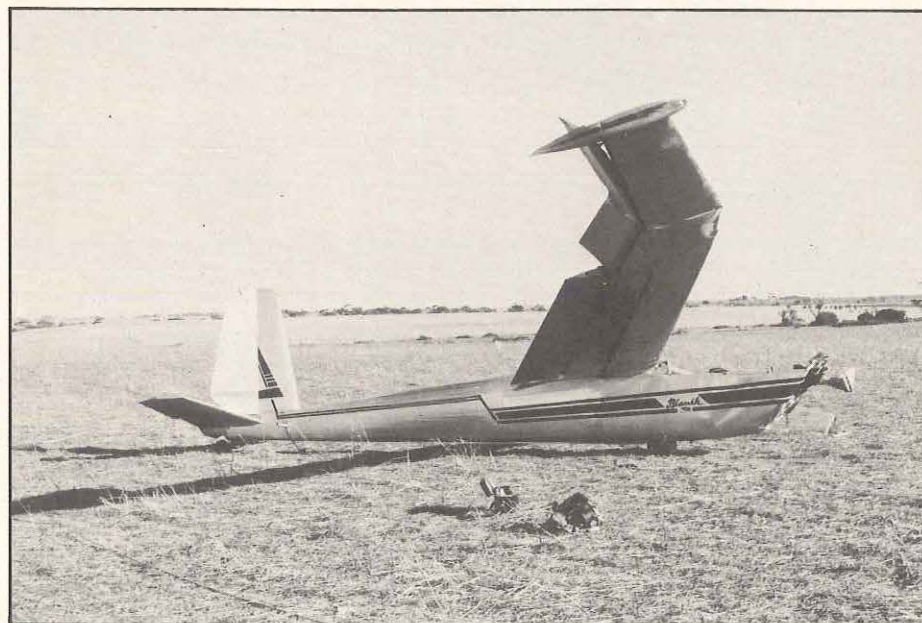
*Bottom: The distortion of the nose section as seen in this picture indicates the attitude of the Blanik at impact.*

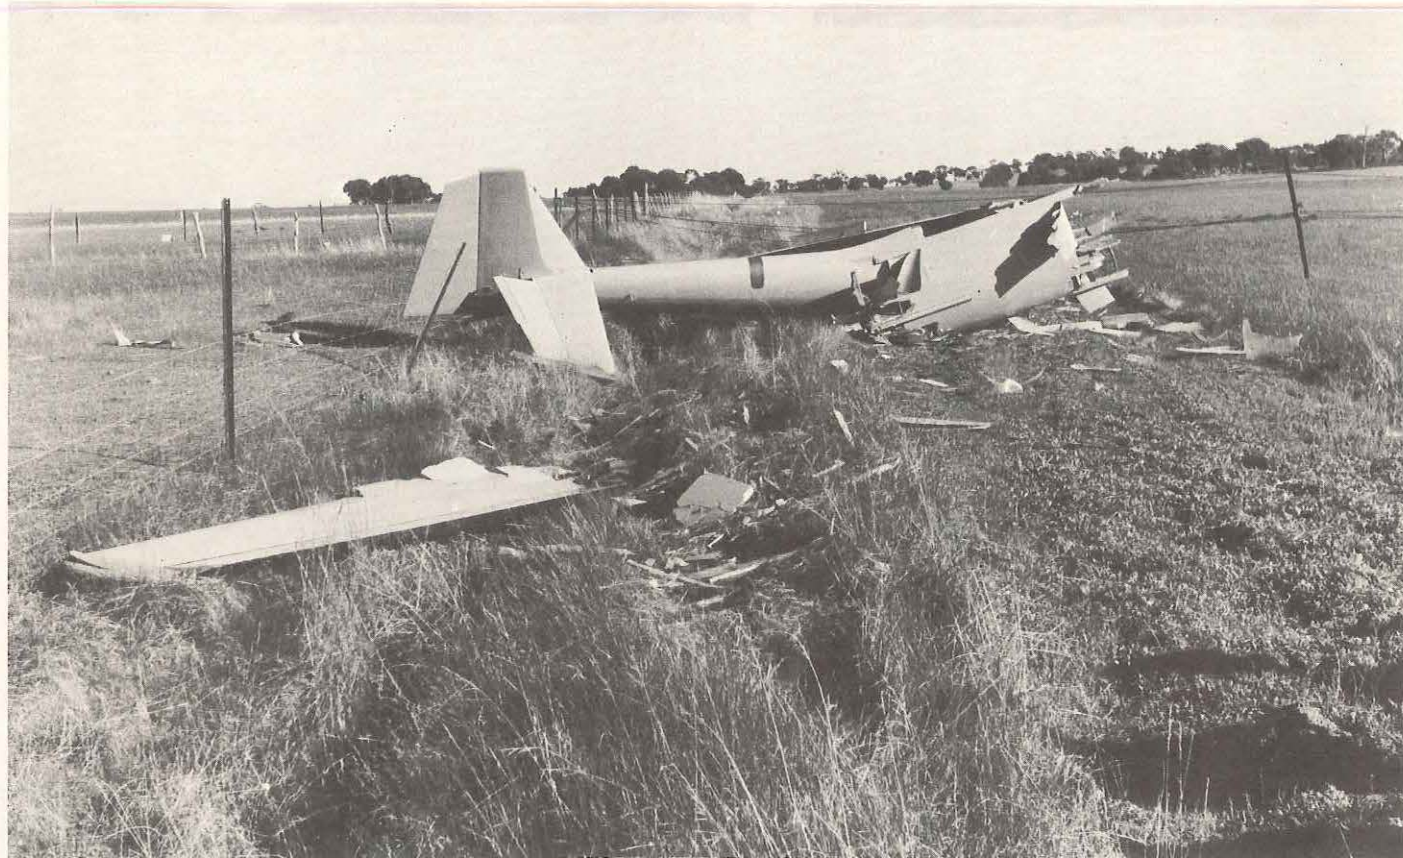
*The trail of wreckage as seen from the point of impact. The airstrip is on the right of the picture and the direction of take-off was towards the camera.*

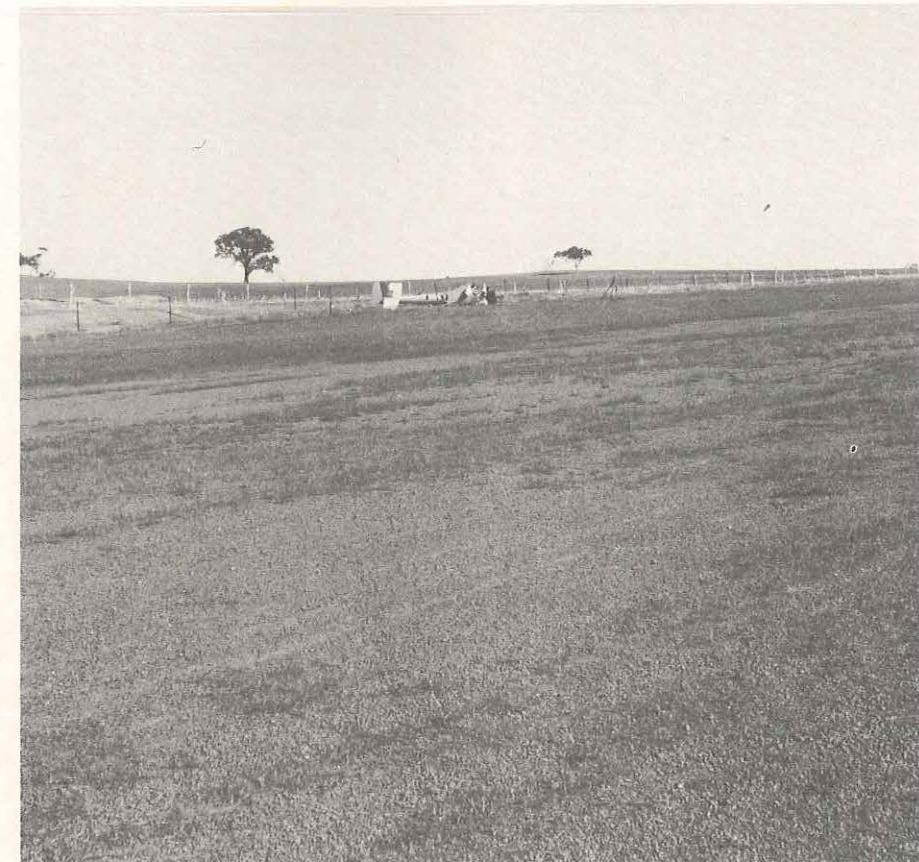
*The wreckage as seen from the point on the airstrip at which the tow-line failed.*

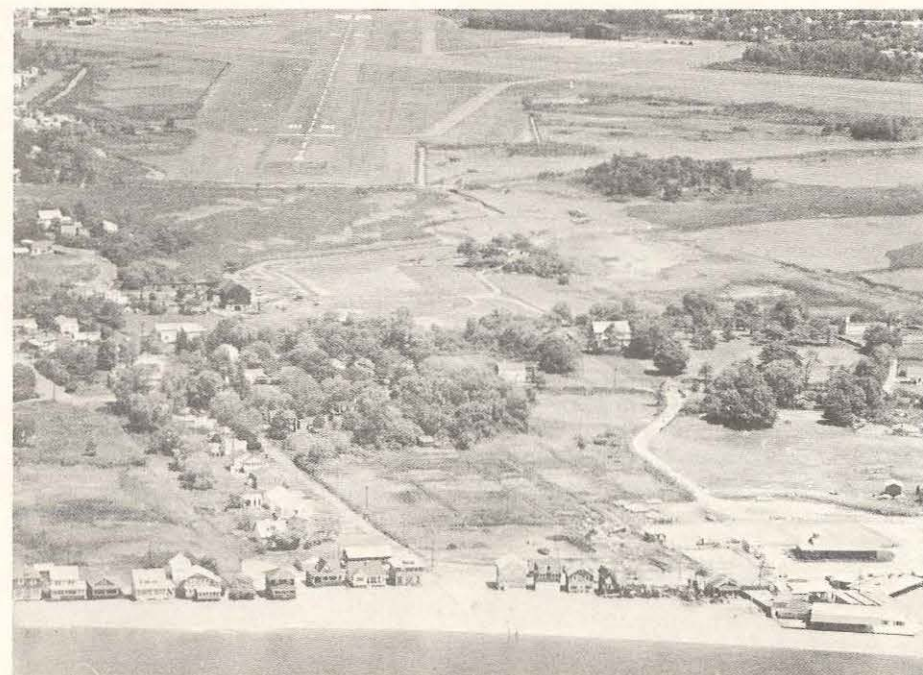
Top: Aerial view of New Haven Airport, showing the approach path to runway 02. The aircraft struck the homes fronting the beach in the lower right of the picture.

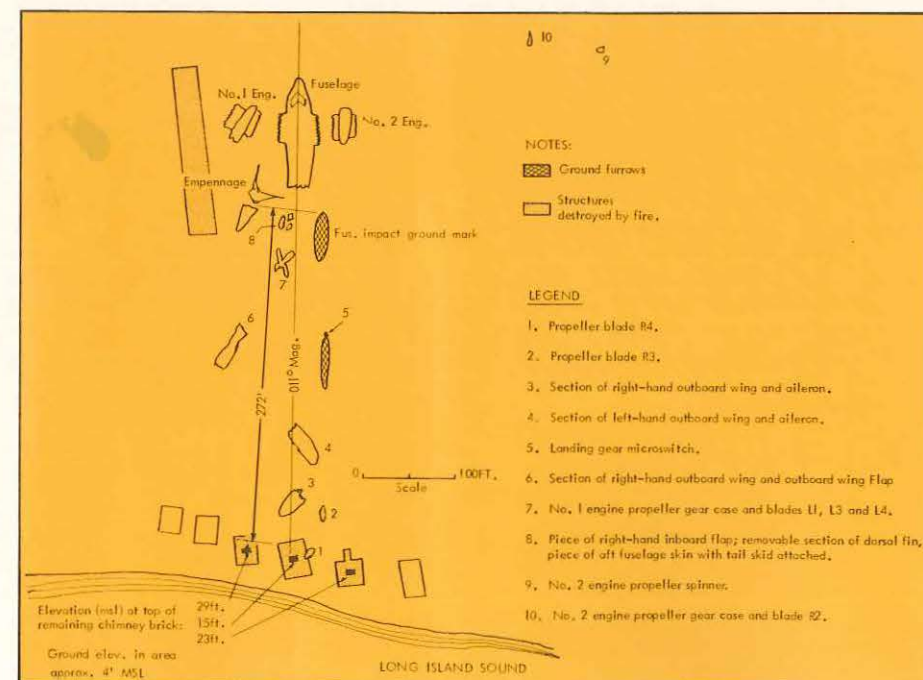
Bottom: Diagram showing direction of impact and wreckage trail.
