For Our 'Other' Readers!

A VICTIM OF CIRCUMSTANCE

THRUST NORMAL—ACCELERATION ASSUMED...

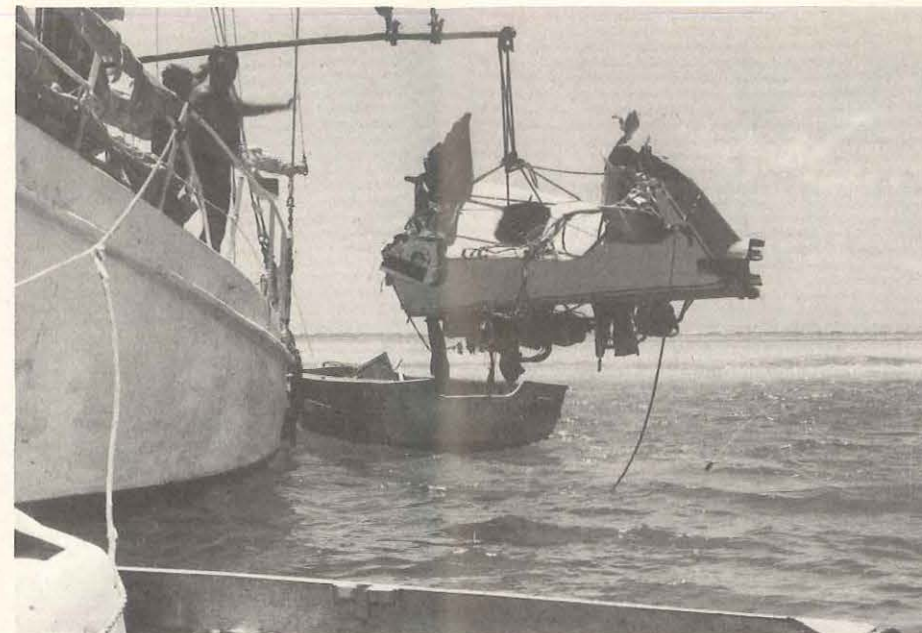
The main wreckage, surrounded by numerous small components which had been torn from the structure by the force of impact, had come to rest in about six feet of water, half a mile off the eastern end of the island. A detailed examination of the wreckage after it had been raised revealed that the helicopter, apparently under control, had probably struck the water in a slightly nose-down attitude while making a shallow turn to the right. All major components were accounted for and there was nothing to suggest that any failure of the aircraft's structure, engine or control systems could have contributed to the accident.

The largest intact section of the fuselage being lifted inverted from the water during salvage operations the day after the accident.

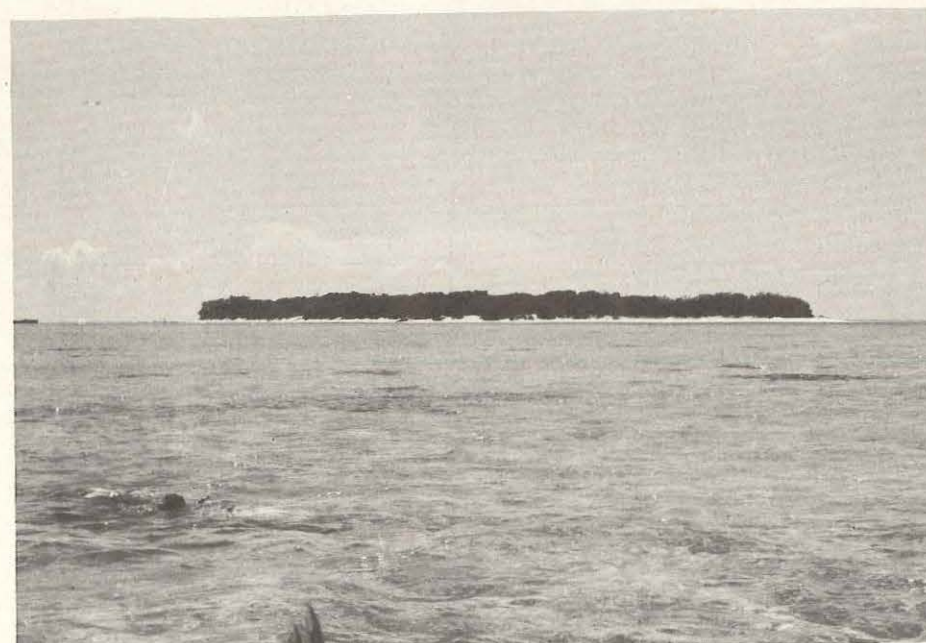
General view of island from approximate point of impact. The main wreckage, lying in shallow water is just visible at lower left.

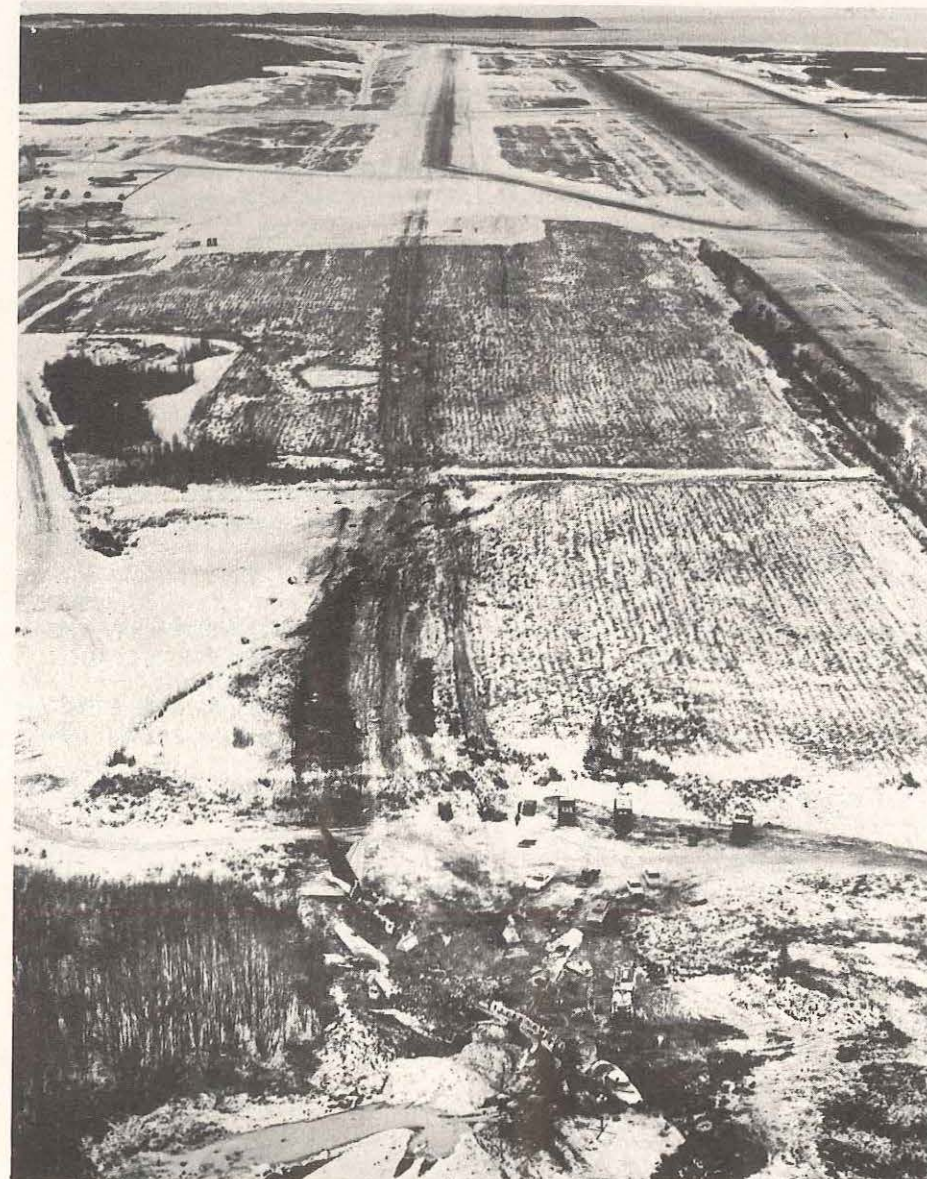
Evidence found on the runway showed that there had been progressive deterioration and destruction of the aircraft's tyres throughout the take-off run. Normal wheel tracks made by the port main undercarriage truck, progressed from the taxi-way, and on to the runway, to a well-defined static footprint melted through the ice where the aircraft had held awaiting a take-off clearance. There was no evidence of skidding in the wheel tracks leading to this footprint, but from it, skidmarks extended in the direction of take-off. Skid marks made by the starboard undercarriage truck were also found leading from the point at which the take-off was commenced. Evidence of the progressive deterioration of all main undercarriage tyres began at the initiation of the take-off, and continued for the entire length of the runway. The first scrap of reverted rubber was found only 560 feet from the start of the take-off and, by 2,700 feet, the amount of fibre in the rubber scraps indicated that at least some of the tyres had been ground down to their reinforcing cords. Four thousand

three hundred feet from the start of the take-off, all the port tyres were flat and by 8,700 feet all of the starboard tyres were flat. Examination of the tyres and wheels not extensively damaged by fire showed that they were all ground down in one place only, with no evidence to show that they had been rotating during the attempt to take-off. The tyre damage and blow-out patterns were typical of that caused by skidding with the wheels locked, and X-ray examination of the tyres showed that none of them had rolled after they had blown out.

Aerial photograph of runway 06R at Anchorage, looking in opposite direction to that of take-off. The wreckage is visible in the foreground.
