AVIATION
SAFETY
DIGEST

Number 87 1974
CONTENTS

Fatal Fuel Mismanagement	2
No Room for Recovery	6
Unlocked Door — Disaster	8
Taking Stock	12
Advice Heeded	16
Wake Turbulence	20
Mixture Control	22
Around the Industry	26
Blind Mans Buff	28

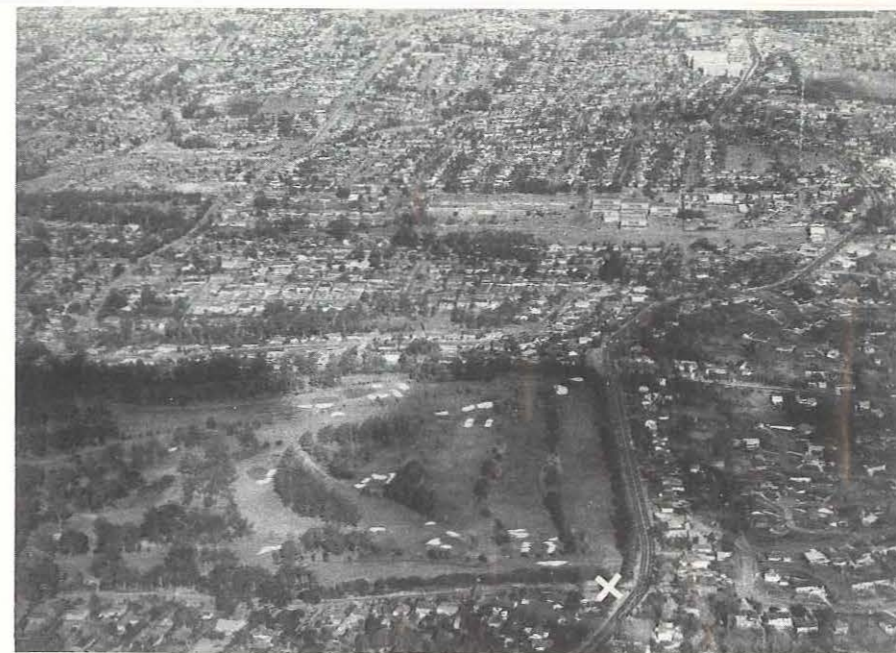
TOP:
Aerial view of the forced landing area, looking in the direction the aircraft was flying when the engine lost power. The landing approach was made towards the camera on the golf fairway nearest to the road. The crash site is indicated.

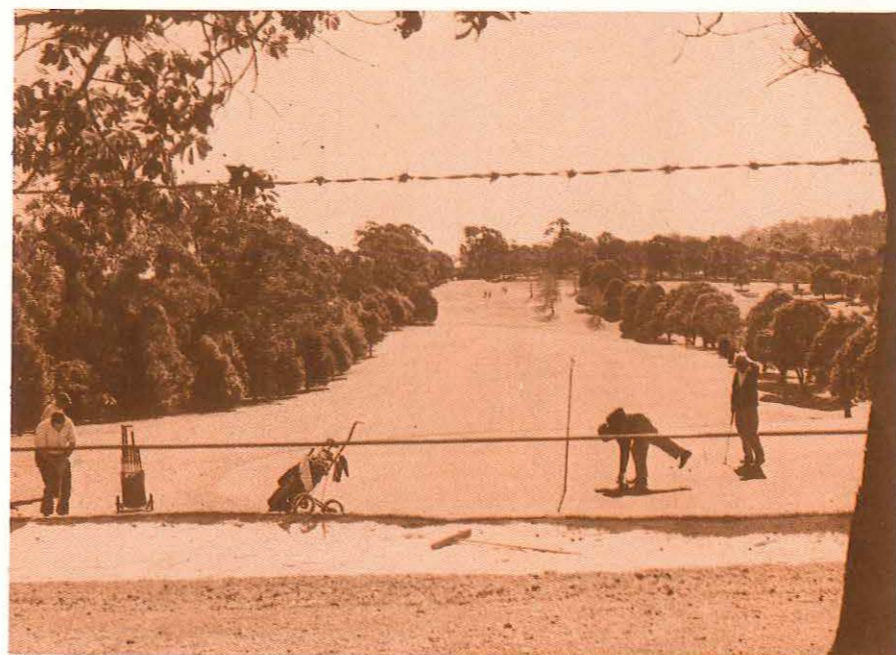
CENTRE:
The fairway on which the forced landing was attempted, looking in the direction of final approach. The trees with which the aircraft collided can be seen at the far end.

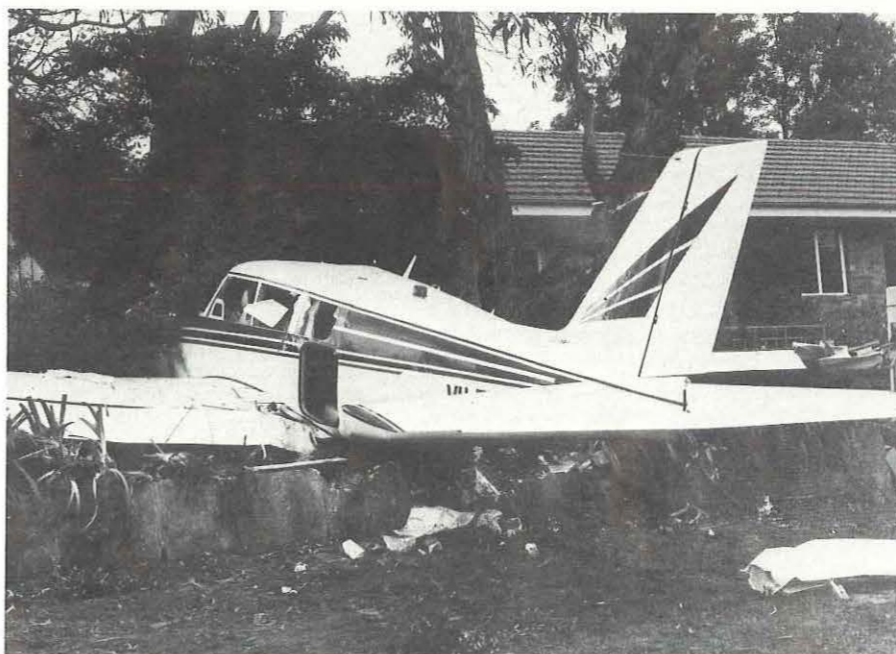
normal operation. The fuel selector was positioned to the port main tank which was empty. There were seven gallons in the port auxiliary tank. It was not possible to determine the quantity in the two starboard tanks because of the damage they had sustained in the final impact, but the soil beneath the damaged starboard wing contained traces of fuel to a depth of several inches and small amounts of fuel remained in the ruptured tanks. Little fuel was present in the fuel lines ahead of the fire wall, but the fuel selector assembly was found to function correctly in all positions. An electrical fault was found in the fuel gauge wiring, which caused the gauge to indicate full for each tank selected, regardless of the tank's actual contents.

BOTTOM:
The aircraft as it finally came to rest in a suburban garden after crossing the road adjoining the golf course.
