AVIATION SAFETY DIGEST

Number 88 1974

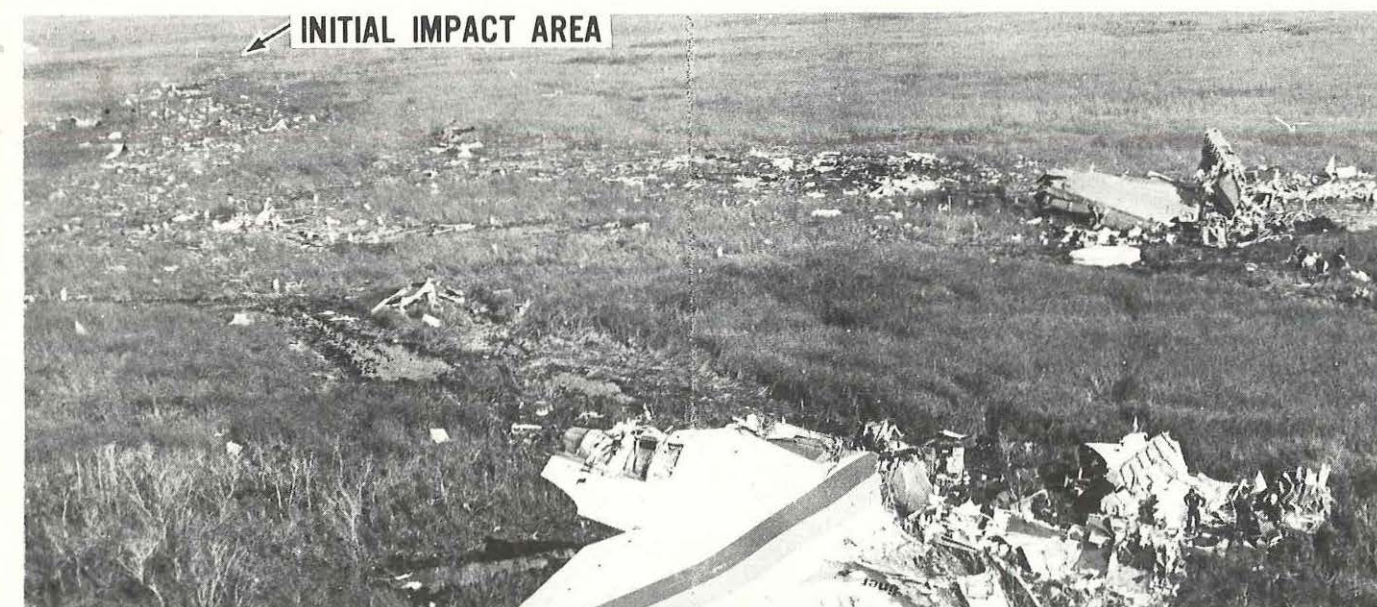
Low level aerial photograph showing the wreckage trail. The tail section is in the foreground. Some idea of scale can be gained from the man standing at the extreme right of the tail-section wreckage.

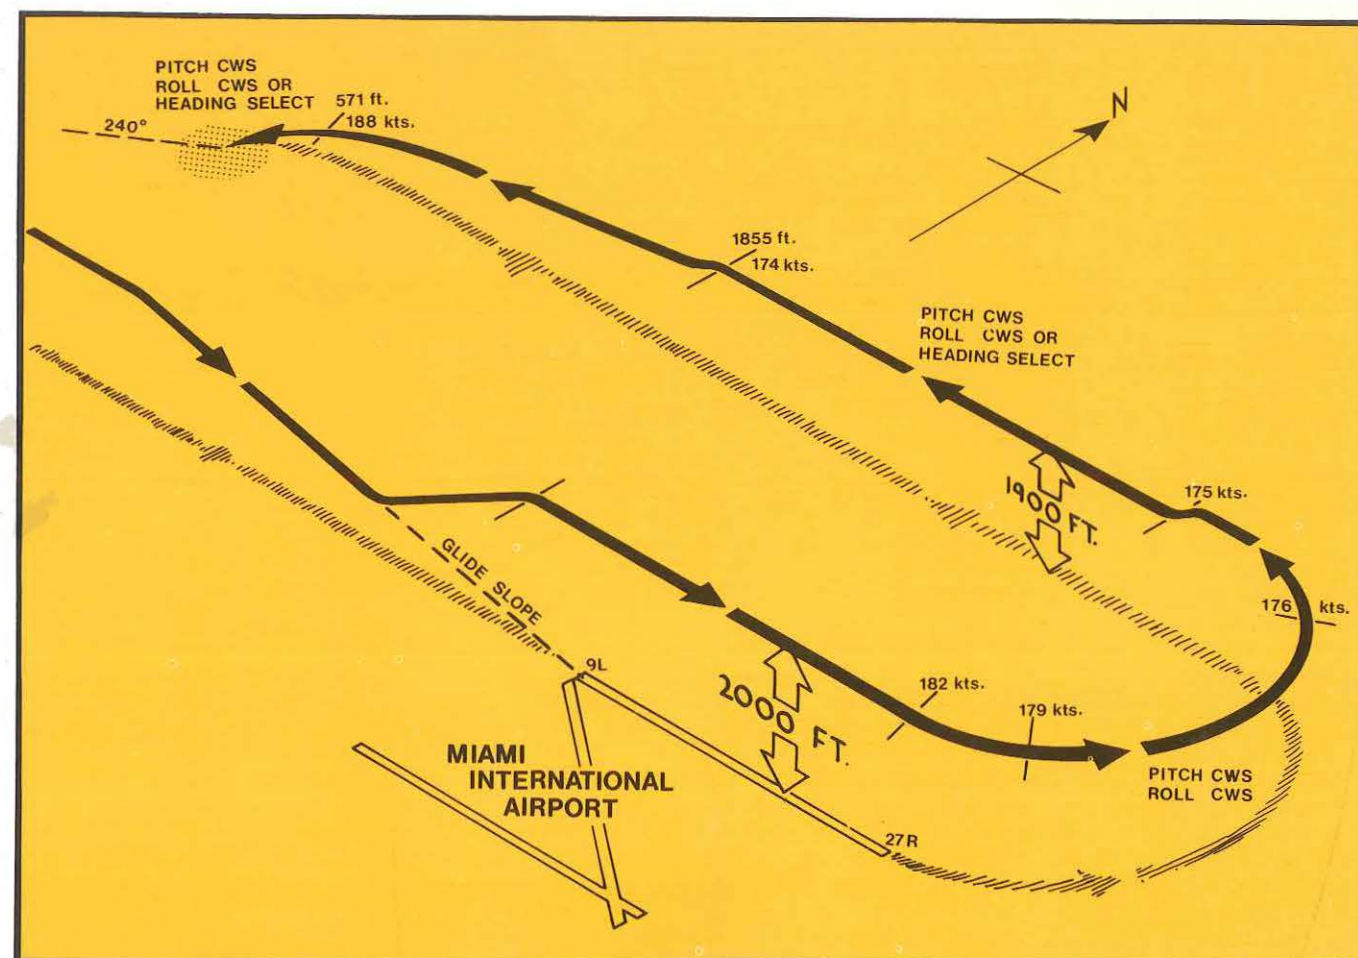
Three-dimensional diagram showing aircraft's initial approach path to runway 09L, subsequent go around and inadvertent descent to point of impact.

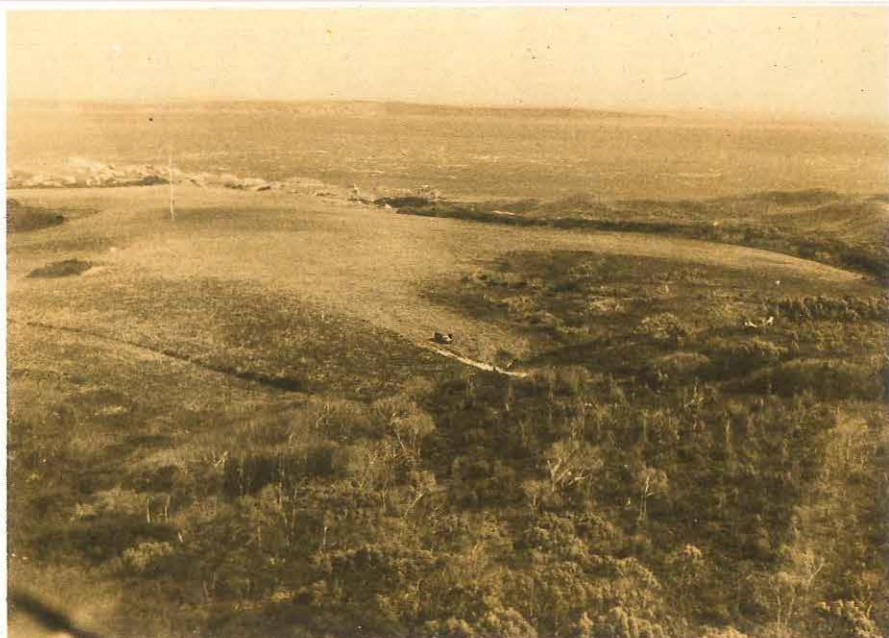
TOP: View of landing area. Wreckage is in scrub at right of picture.

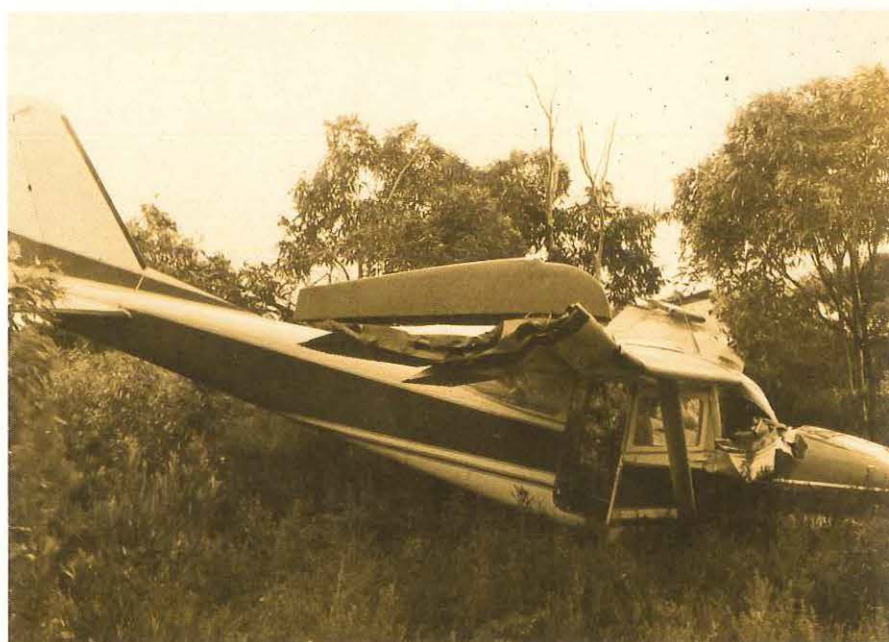
CENTRE: The badly damaged Cessna after the accident.

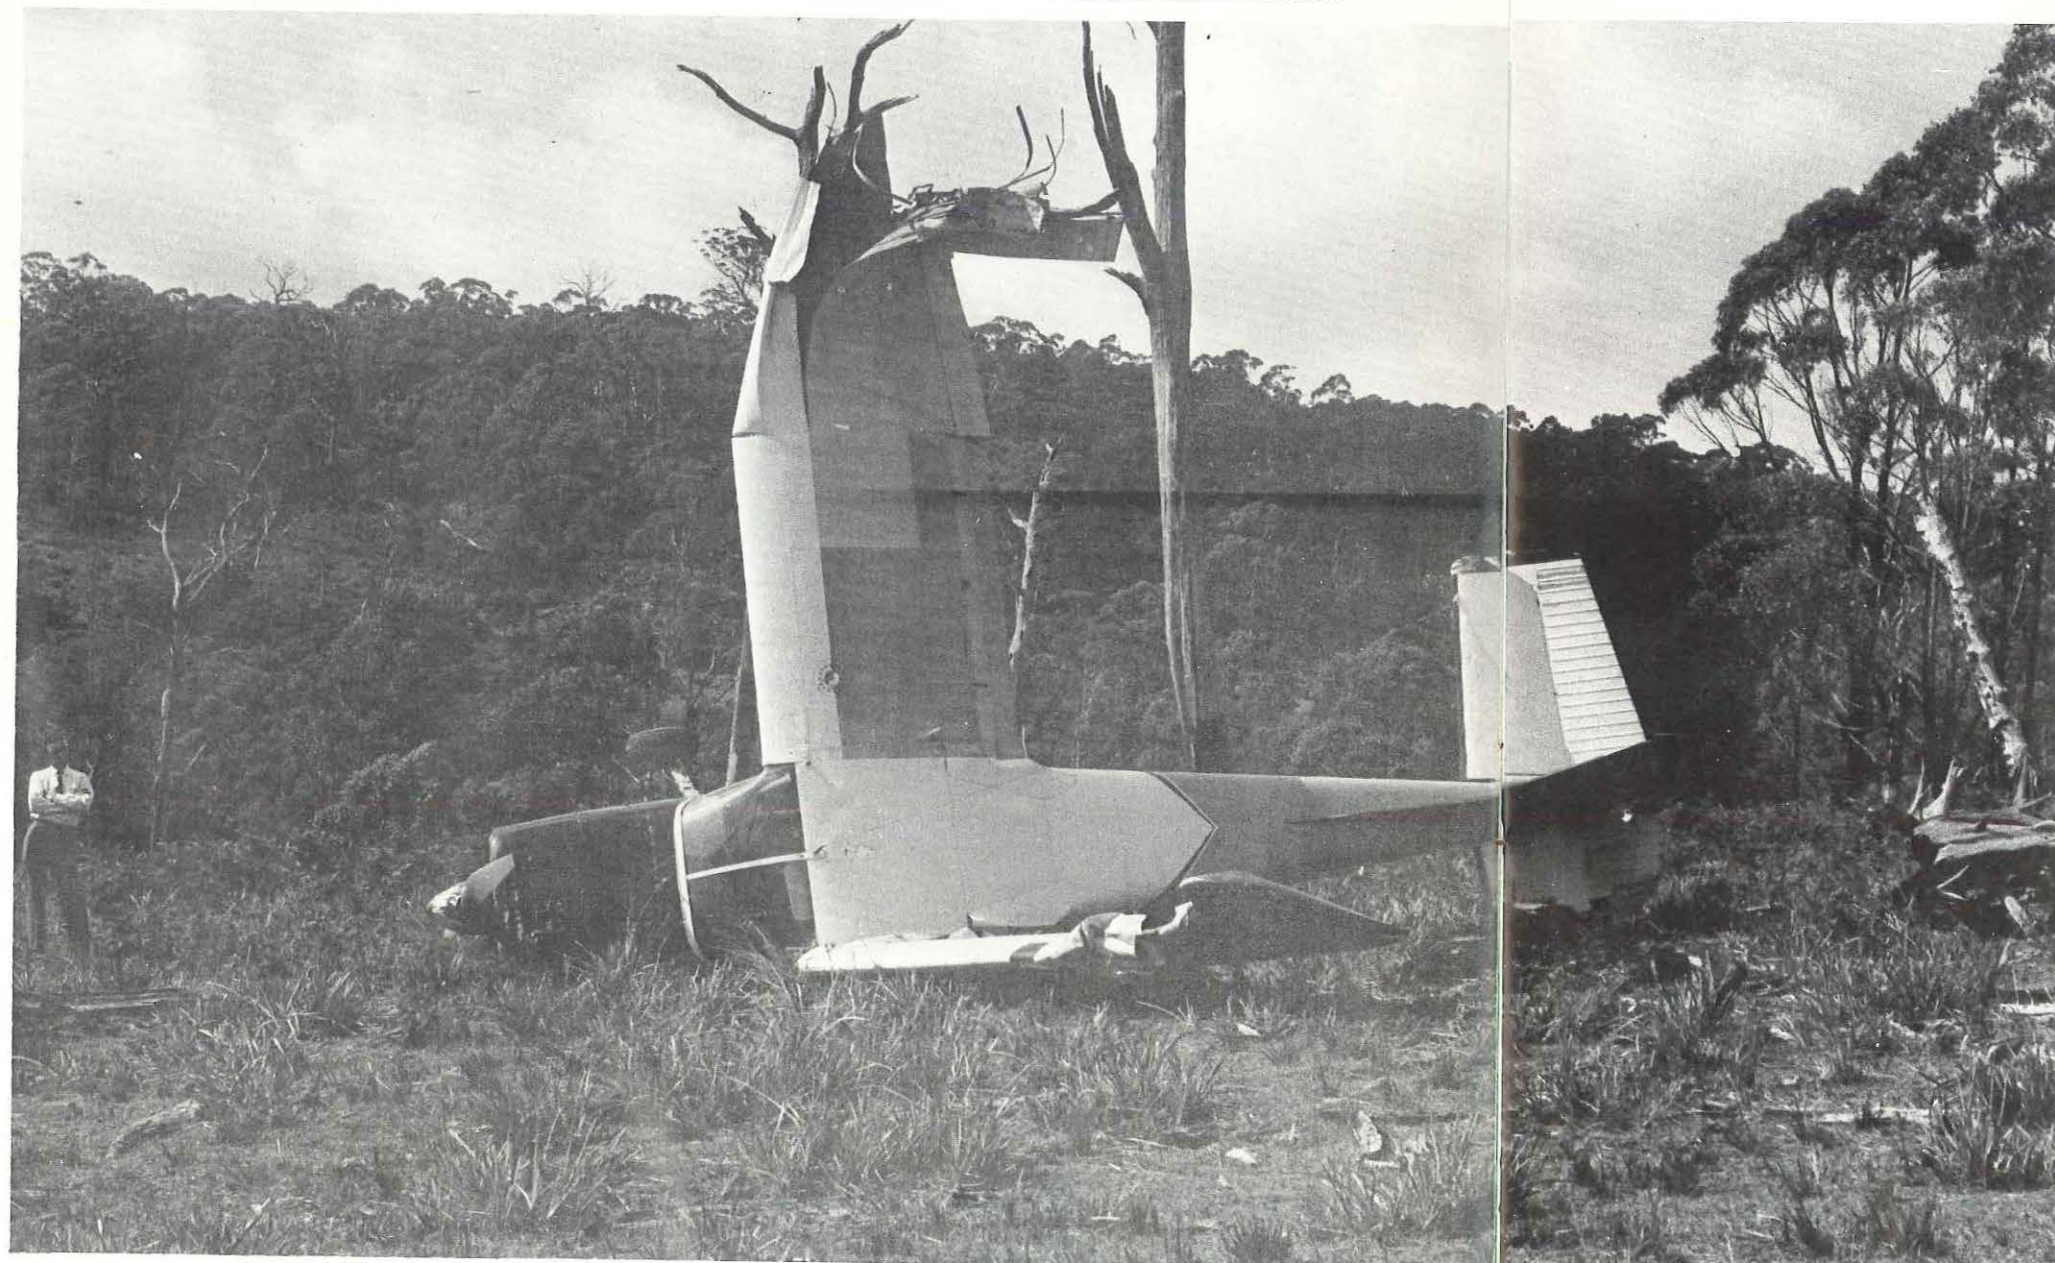
A good example of 'how to crash without
hurting yourself'. The occupants of this
Cessna 180 escaped almost unscathed.

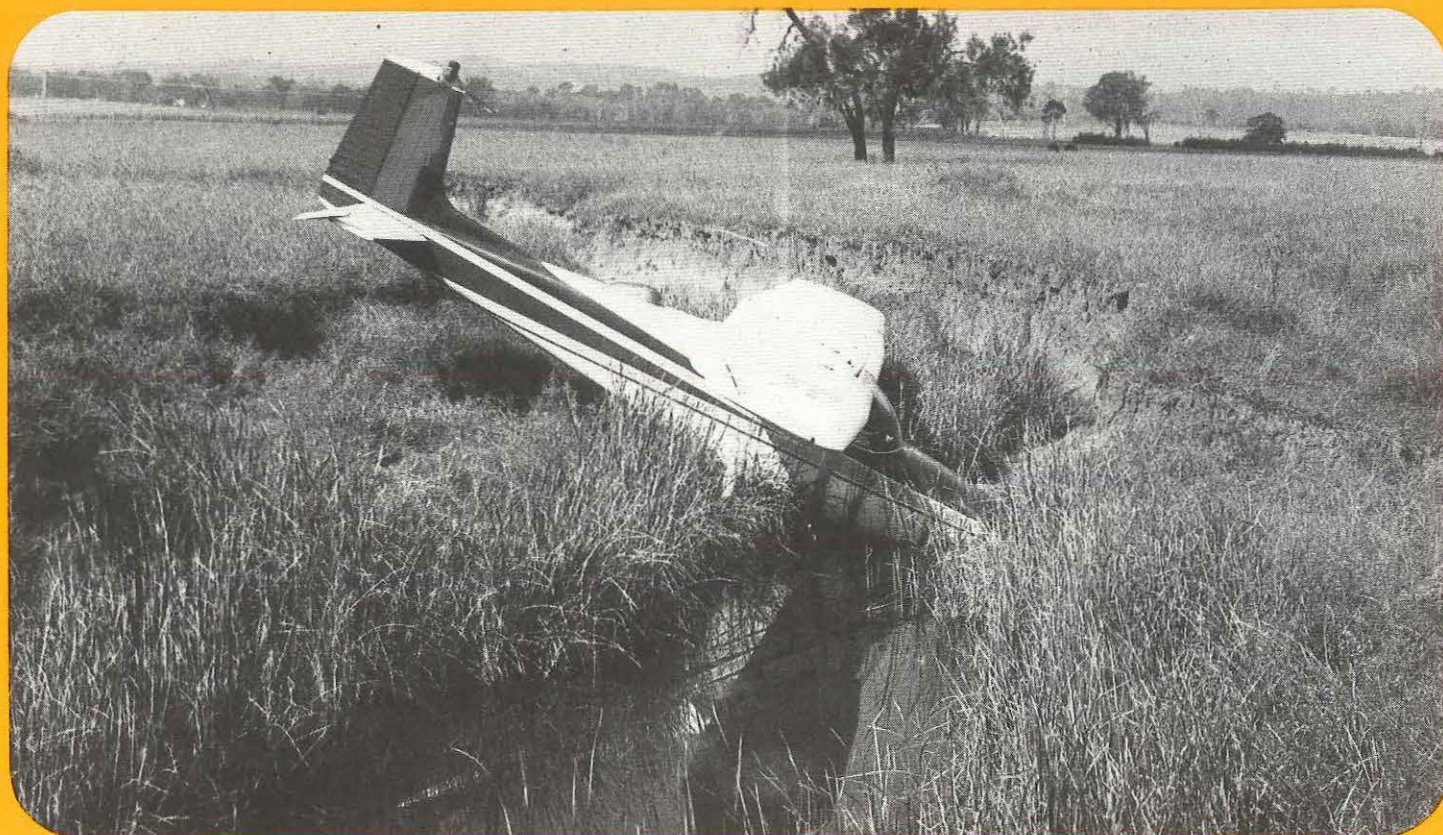
... if the pilot had been properly briefed on the position of a hard-to-see power line before commencing spraying operations.

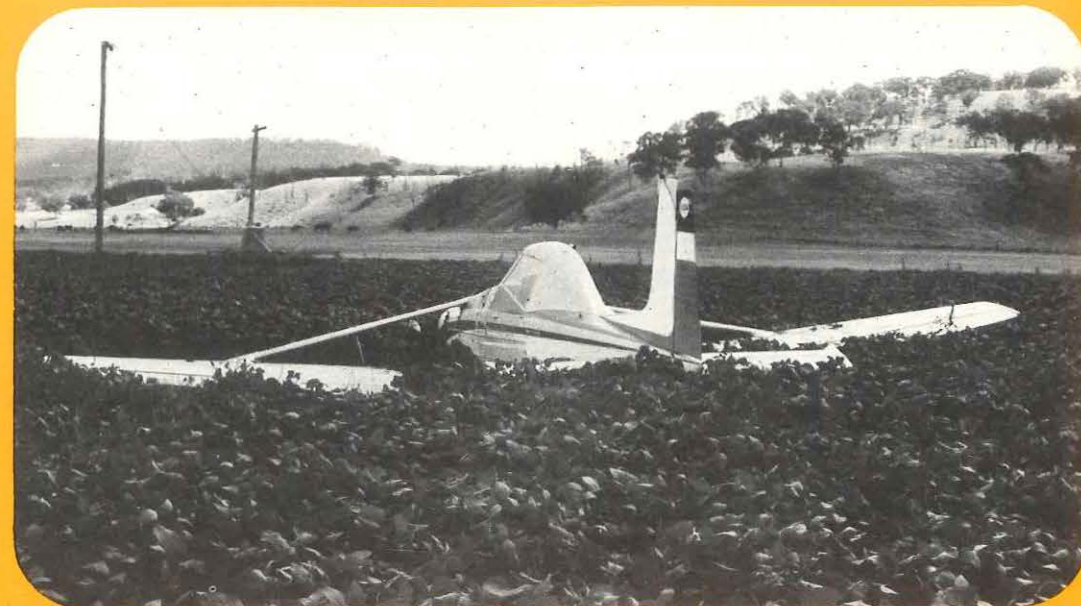
... if the pilot had detected a dragging main wheel brake when he experienced directional control difficulties opposite to those to be expected during a cross-wind take-off.

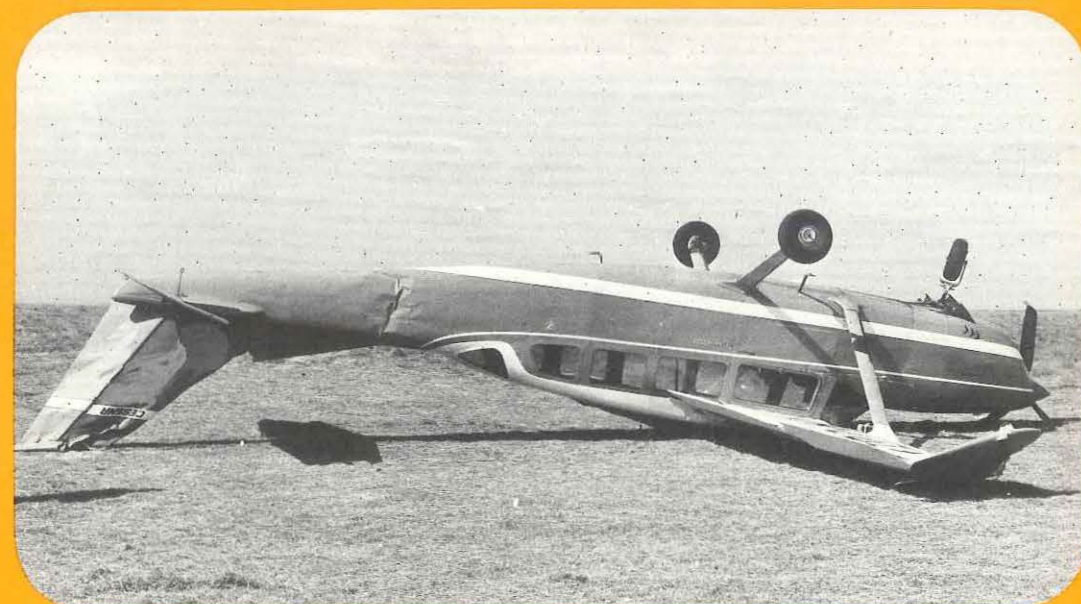
... if the pilot had not attempted to land on an air strip of inadequate length.

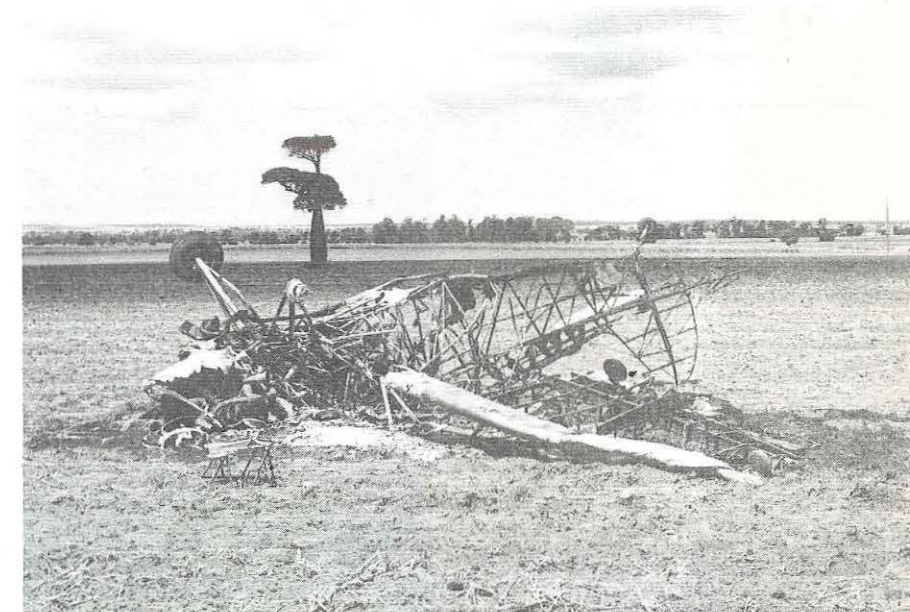
The burnt-out wreckage of the Pawnee as it came to rest inverted. One of the poles of the power line which the aircraft struck can be seen in the background.

wire strike and impact forces, examination of the wreckage did not disclose any pre-existing airframe or engine defect. The floodlight and a section of the wing structure were found on the ground directly beneath the power line.

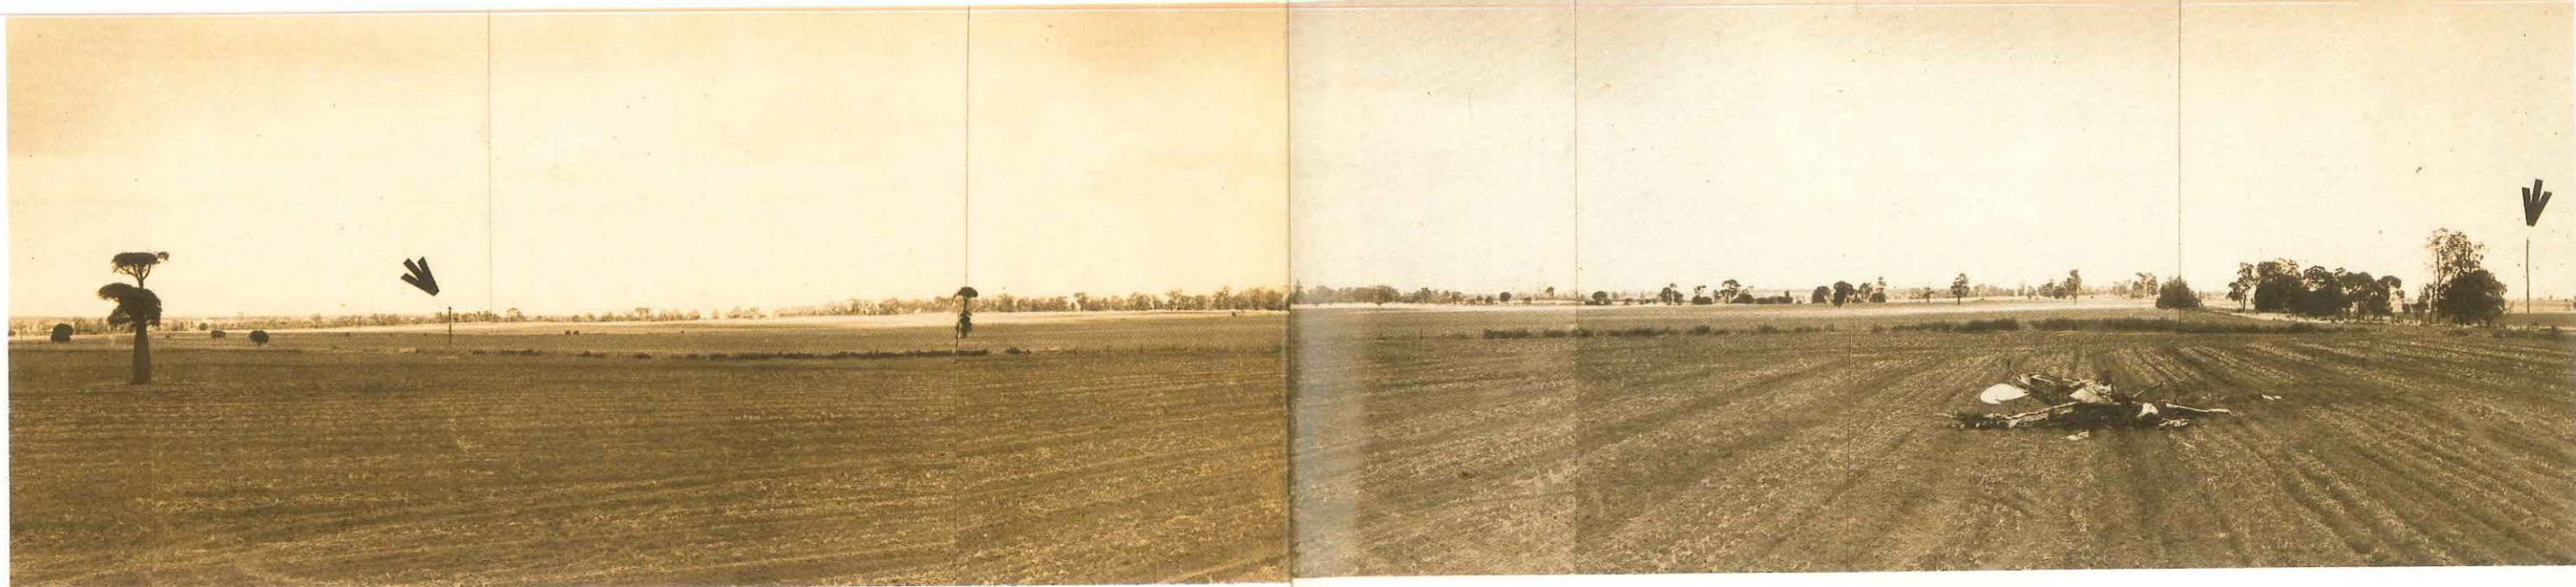
Panoramic view of area in which accident occurred. The crop being treated is in the background. The single wire power line spanned the distance between the two indicated poles.

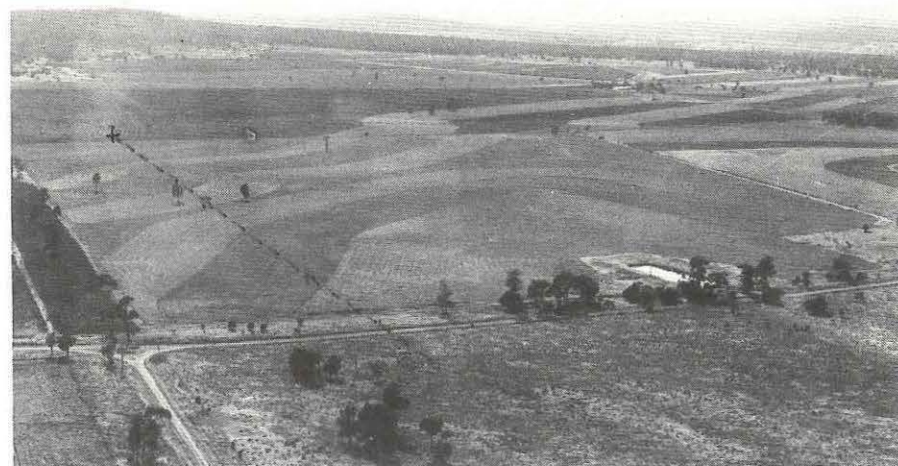
Aerial view of field showing final flight path and accident site. The contoured strips of the crop are clearly visible.

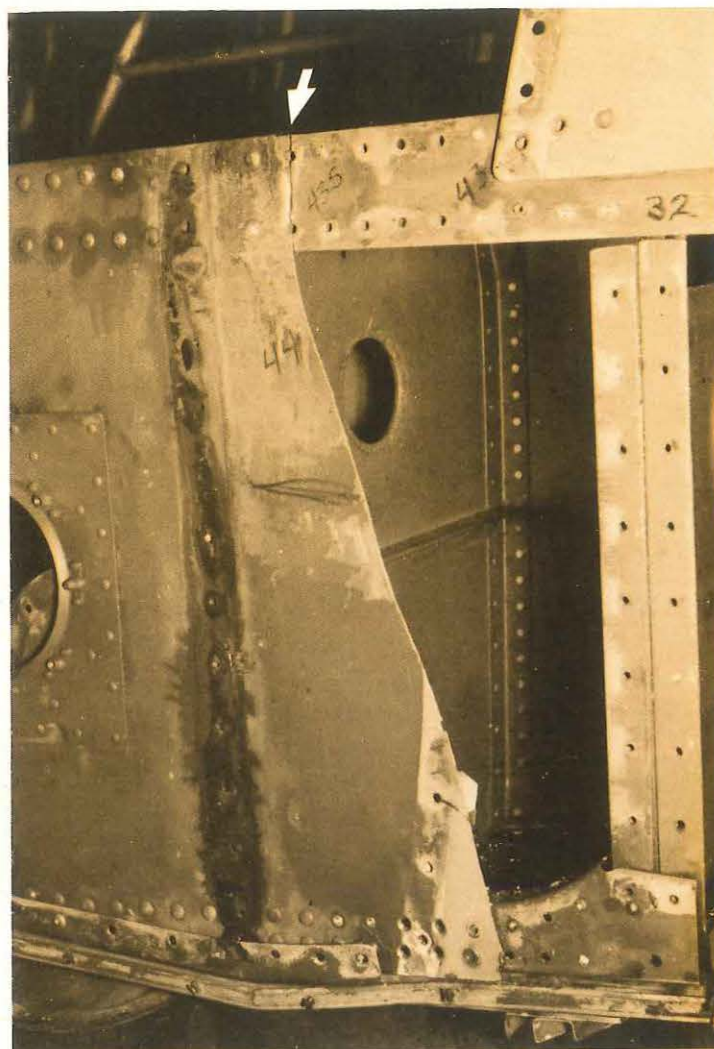
Figure 2 — Left:
Another view from underside of wing showing fractured wing skin panel. Note scorching and charring of skin in vicinity of spar cap failure at top of picture. The engine support beam had been removed before this picture was taken.

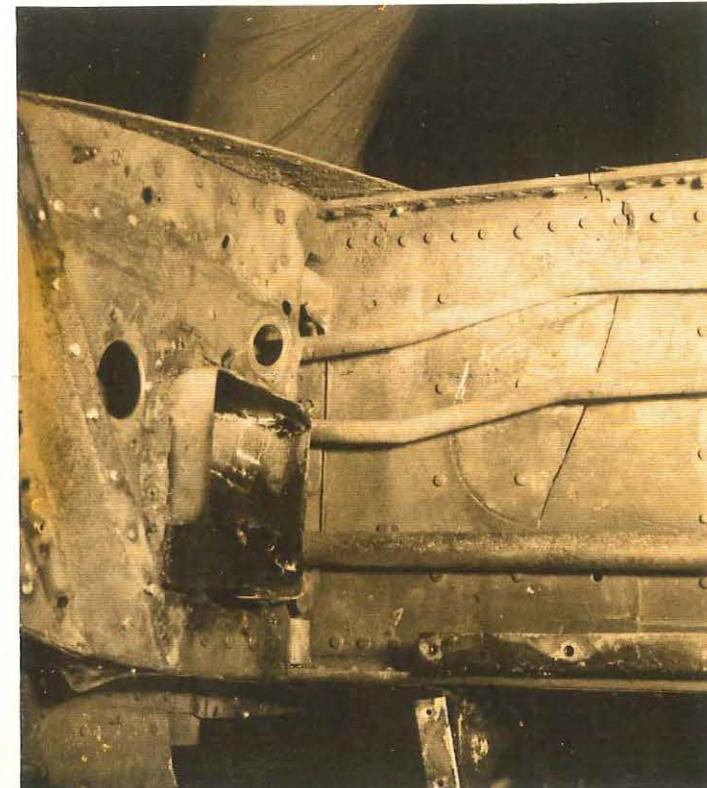
Figure 3 — Above:
View of main spar as seen from wing leading edge. The wing is inverted. Note evidence of burning in rectangular wing ducting.
