AVIATION SAFETY DIGEST

Number 89 1974
CONTENTS

Fatal Collision with Ridge	2
Nowhere to Go	8
Jammed Controls	13
Inviting Disaster	14
Carbon Monoxide Poisoning	18
Visibility Lost During Approach	20
Propeller Dangers	23
Wasps!	24
Another Case of Indigestion	26
Aerosol Cans — They Can Explode!	28

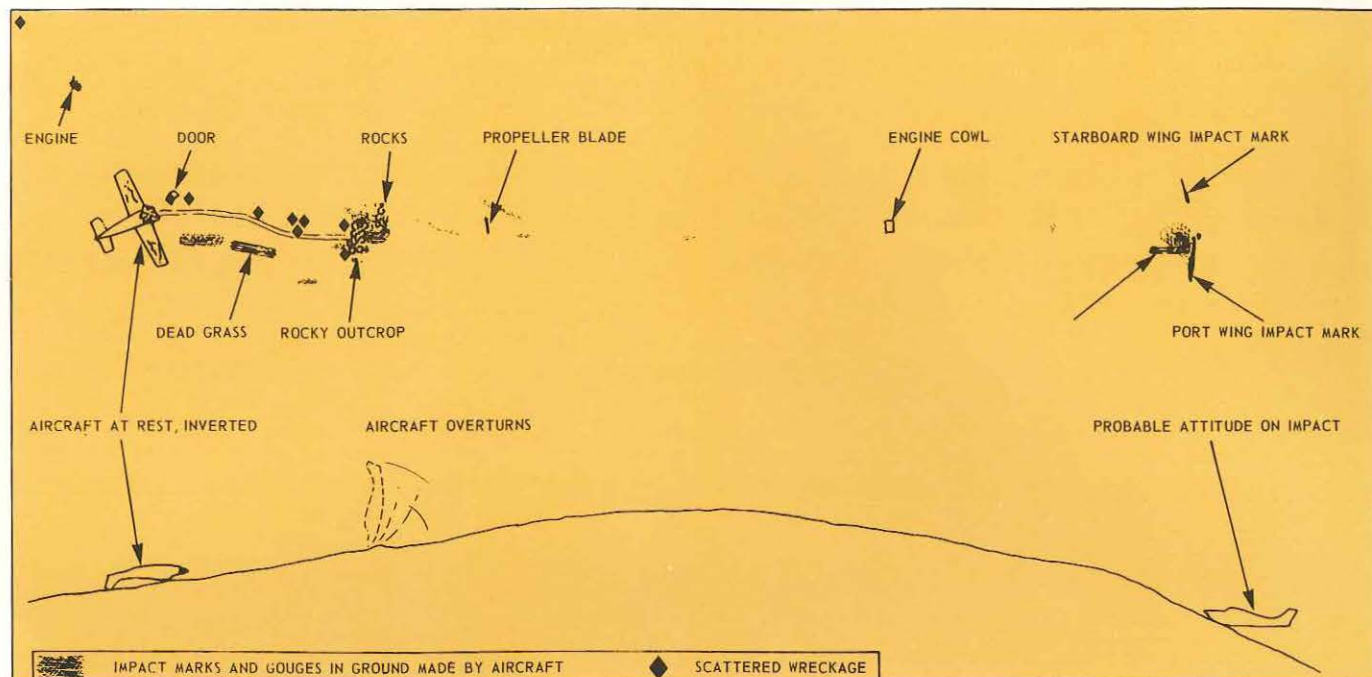
There was no positive evidence that the aircraft had been descending at the time of impact. If it had been descending on a westerly heading prior to impact, however, and the descent was performed at the recommended air-speed of 130 knots, a descent rate of 1233 feet per minute would have been necessary for it to have cleared another ridge immediately east of the accident site.

Above: Composite diagram showing profile of terrain struck by aircraft and wreckage trail from point of impact. The probable accident sequence is indicated.

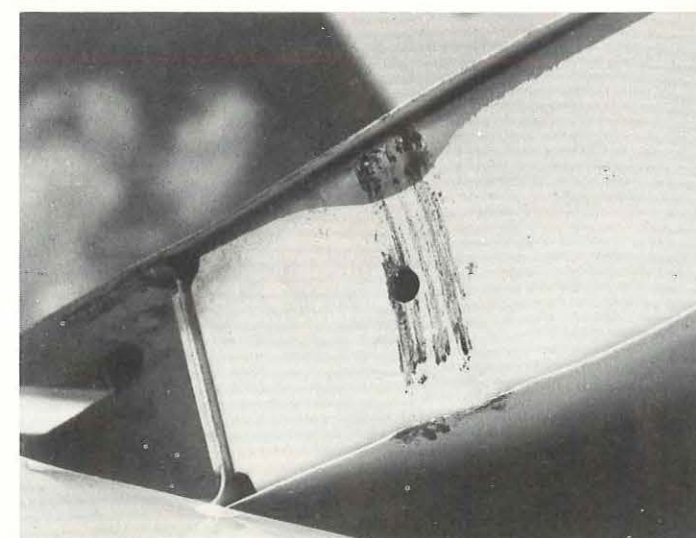
When the aircraft was examined by the operator's chief engineer, he found marks indicating that something had jammed between the starboard elevator horn balance and the tailplane (see photographs).

flapless landing is markedly nose-up, with the tail very close to the ground. Under these conditions, with the elevator fully up, the horn balance could act as a scoop, making it easy to pick up small loose objects such as stones or cinders, particularly at low forward speed. The application of power to go around before the elevators were neutralised, could also have blasted cinders over the tailplane surfaces, particularly while the aircraft was in an exaggerated nose-up attitude.

Close-up of outboard edge of starboard tailplane showing score marks made by cinder jammed between tailplane and elevator horn. The buckled lower skin of the tailplane was partially straightened by an engineer before the photograph was taken.

The experience also suggests that pilots should consider the nature of the strip surface in relation to the type of exercise they are flying. Obviously, in some types of aircraft, flapless landings require special care when carried out on natural surfaces.

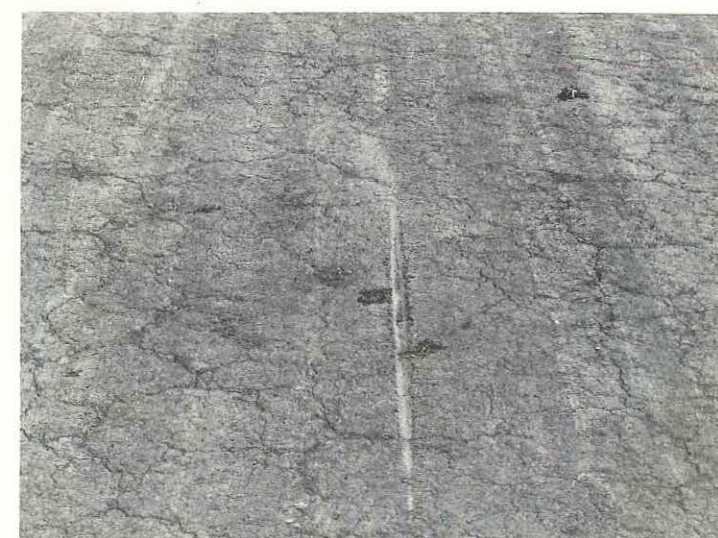
Inspection of the area of the strip on which the aircraft had previously landed, revealed a gouge mark two metres in length, which confirmed that the aircraft's tail had contacted the ground. The strip surface in this area was hard and free of stones, but some thirty metres before reaching this point, the aircraft had passed over a patch where the surface is covered with loose cinders. There was evidence that the tail had also scraped the ground lightly in this area, and that the starboard wheel had passed over some loose cinders just after touchdown.

Gouge in strip surface caused by aircraft's tail after power was applied to go around.

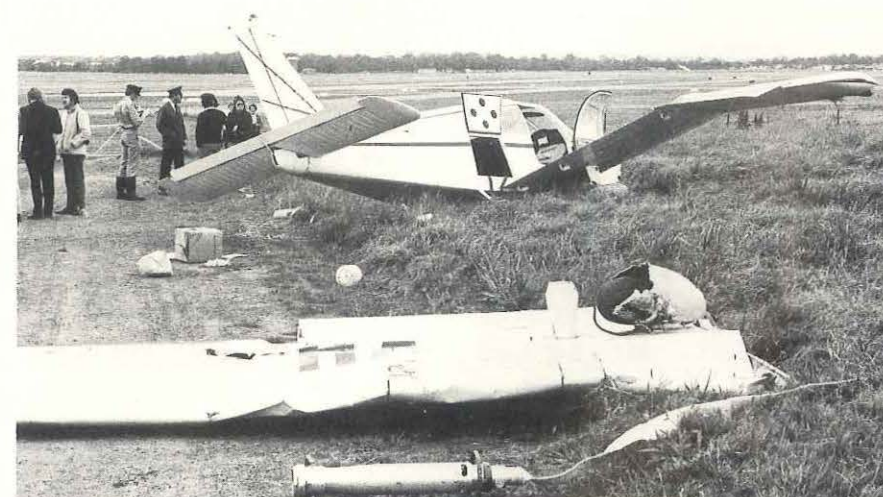
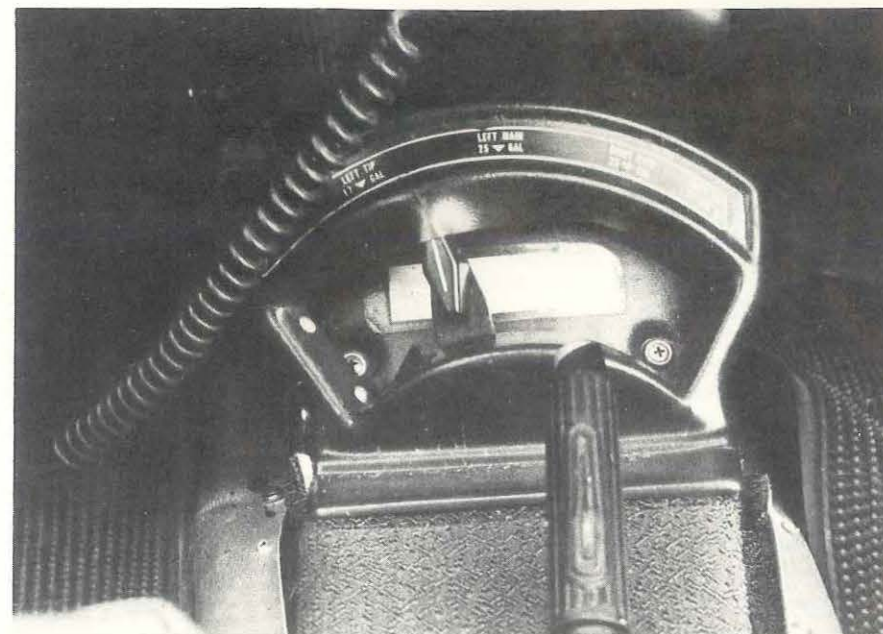
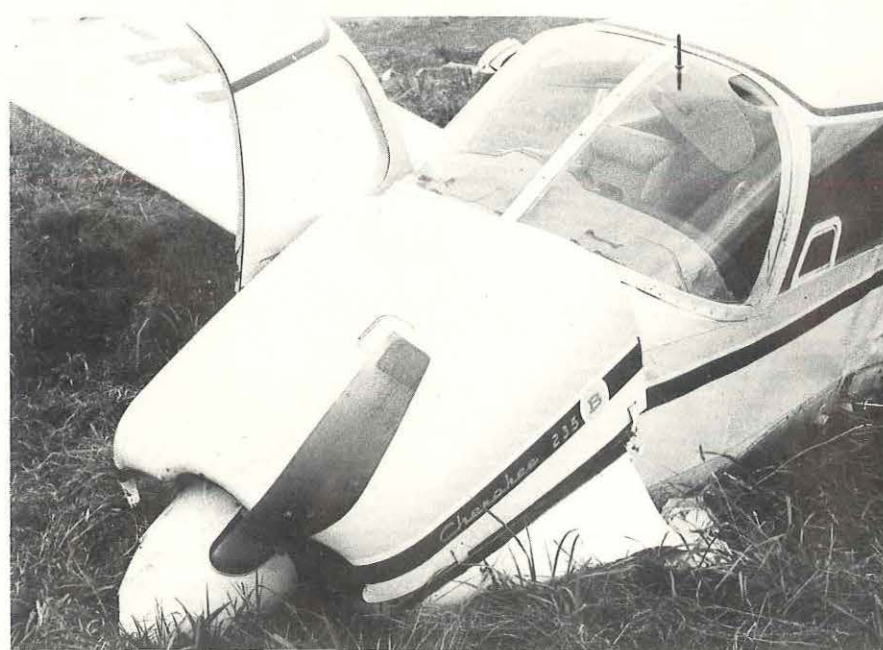
But possibly the most important lesson of all to be drawn from this accident involves the manoeuvre being attempted when the aircraft struck the ground. From the evidence of witnesses, and the pilot in the left-hand seat, it was clear that the aircraft was being turned in an attempt to regain the airport after the engine failed. The instructor, who suffered serious head injuries, was later unable to recall the flight or any details of the accident but, immediately after the crash, he told a witness he had 'tried to get it back'.

Top: The extensively damaged aircraft as it came to rest with the separated port wing in the foreground. The airport movement area can be seen in the middle distance.
Centre: Fuel selector of aircraft showing setting between port tip and port main tanks.
Bottom: Close-up of aircraft's nose showing deformation of forward fuselage. Buckling of the skin is also evident near where the starboard wing was torn off.

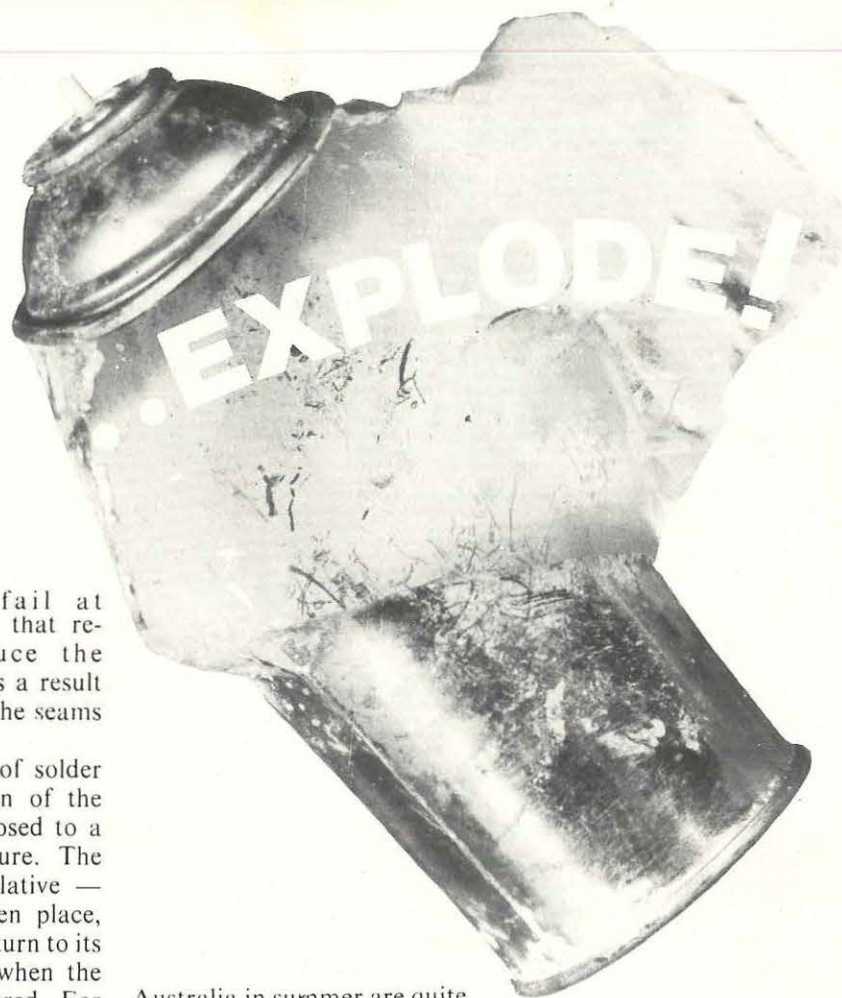
Remains of the dye-penetrant aerosol can itself after it had exploded.

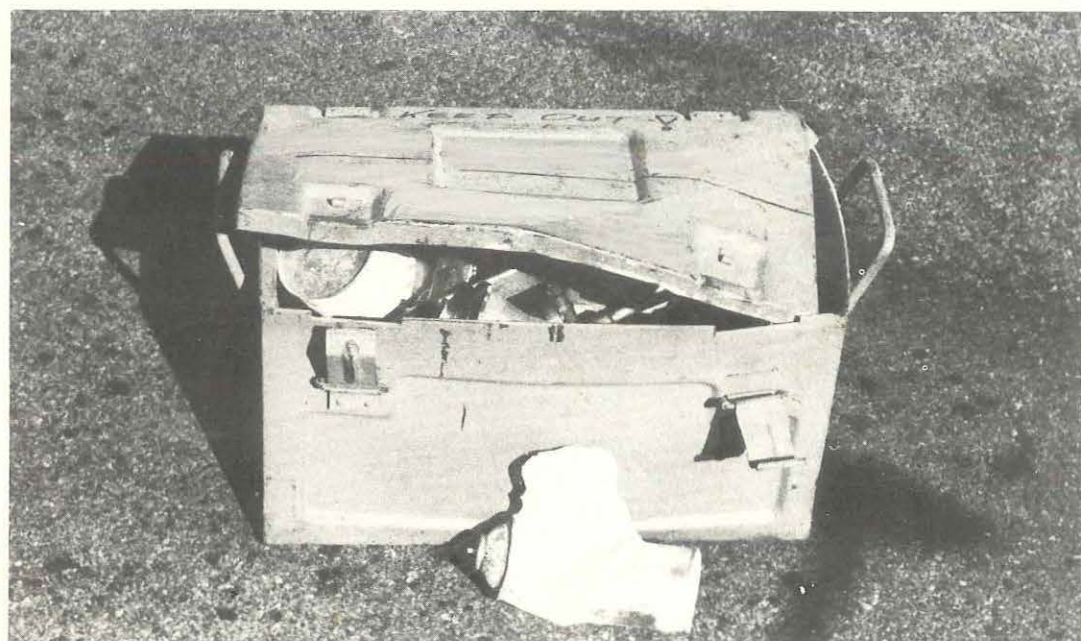
This metal tool box containing an aerosol can of dye penetrant, was left in the bubble cockpit of a helicopter standing in the sun. The can exploded, severely distorting the metal box. Only a little imagination is required to see what could have happened had the can been unprotected and the cockpit occupied!
