AUSTRALIAN DEPARTMENT OF TRANSPORT

Number 98 1977

AVIATION SAFETY DIGEST

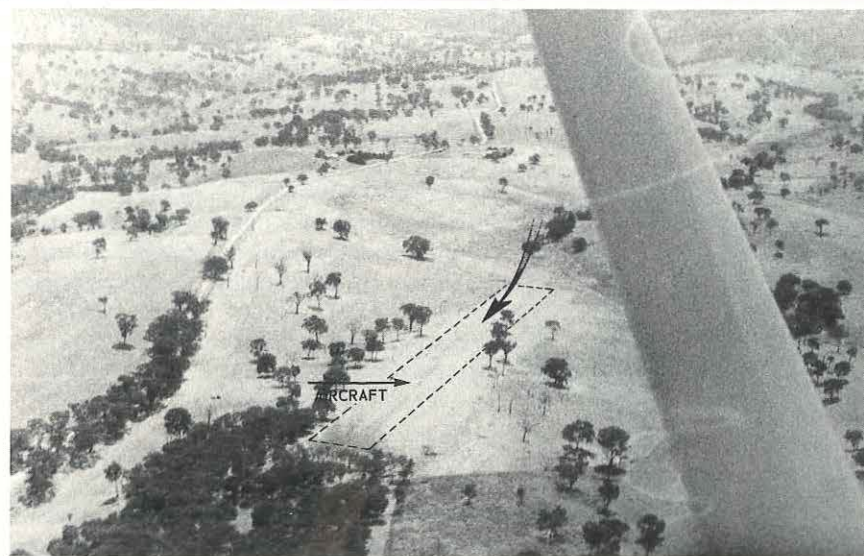
Aerial view of the strip at Tuena. The direction of approach and position of crashed aircraft are shown.

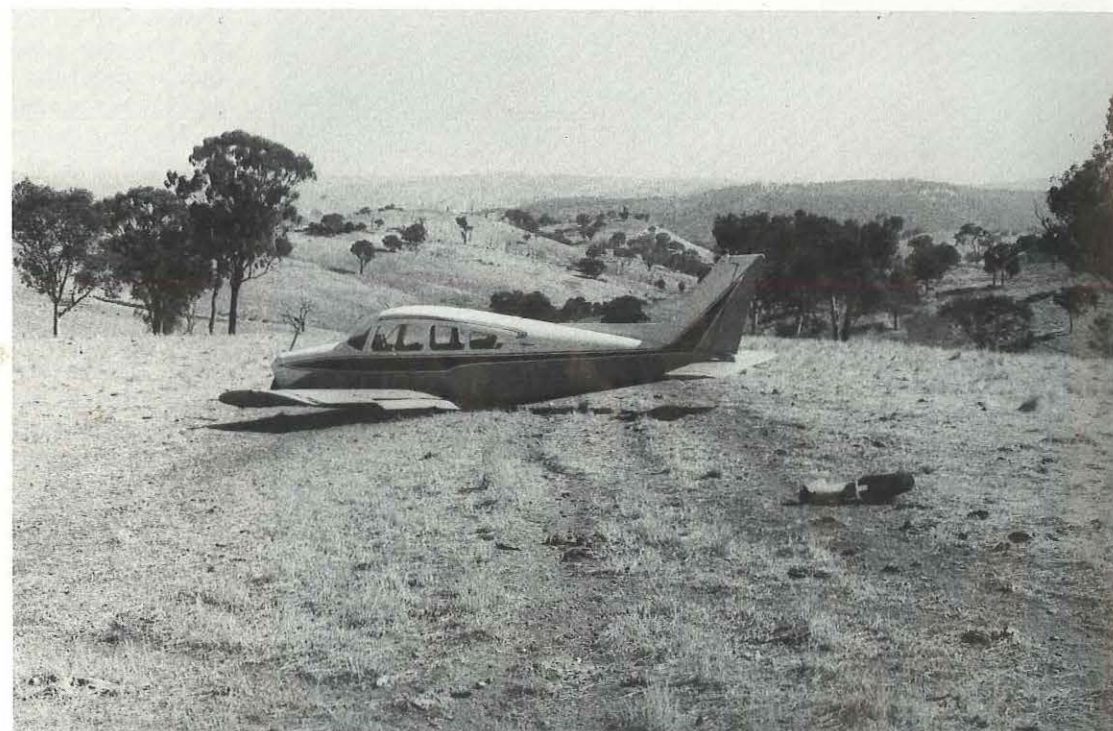
The Musketeer as it came to rest on the strip. The photograph was taken looking back along the approach path.

However, as the pilot was about to flare for landing, the aircraft seemed to sink rapidly. The pilot applied power, but it landed very heavily. All three undercarriage legs collapsed, and the aircraft skidded forward and slewed to a stop about two thirds of the way along the strip. The pilot and his passengers were not injured, but the aircraft was substantially damaged.

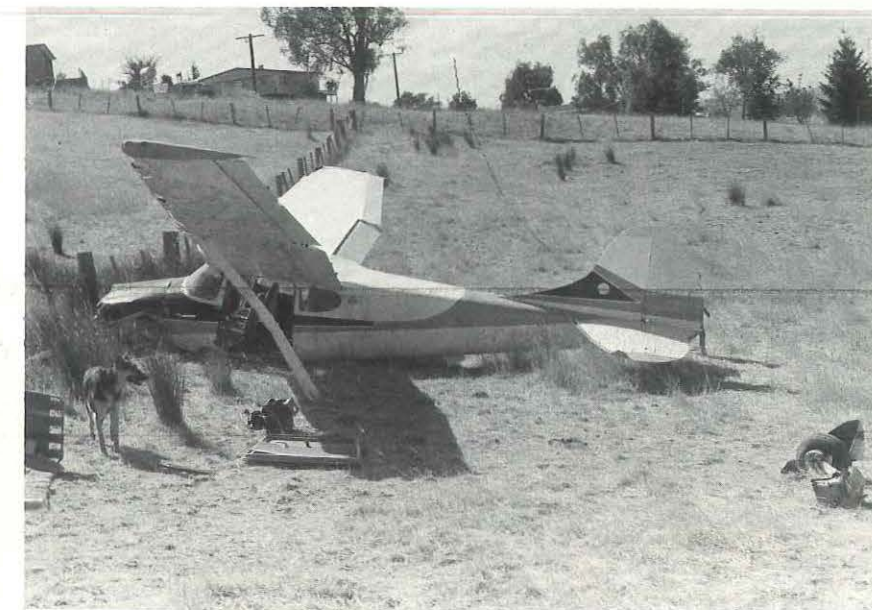
The damaged Cessna 170 as it struck the fence after the pilot was finally forced to put it down.

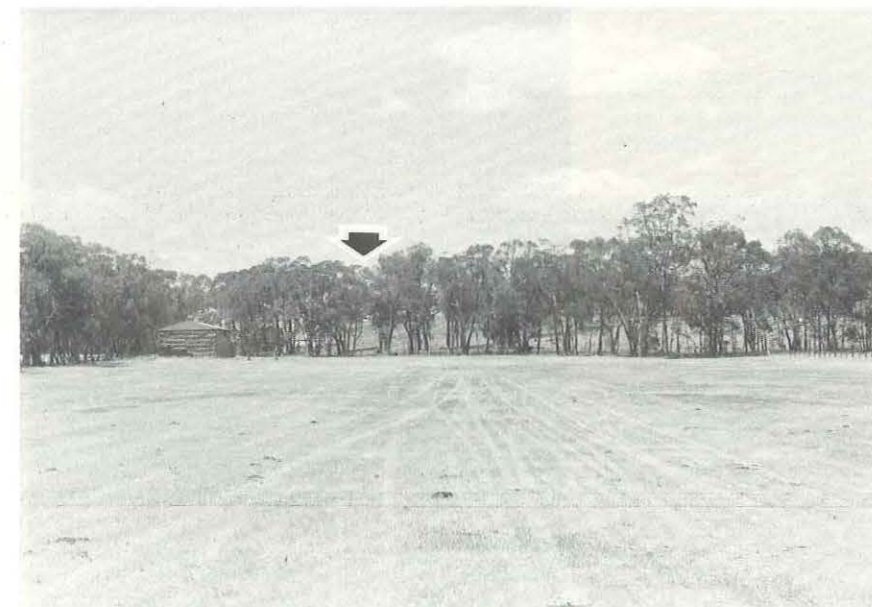
View of remaining strip taken from the point at which the pilot attempted to go around. The aircraft's point of impact with the trees is indicated.

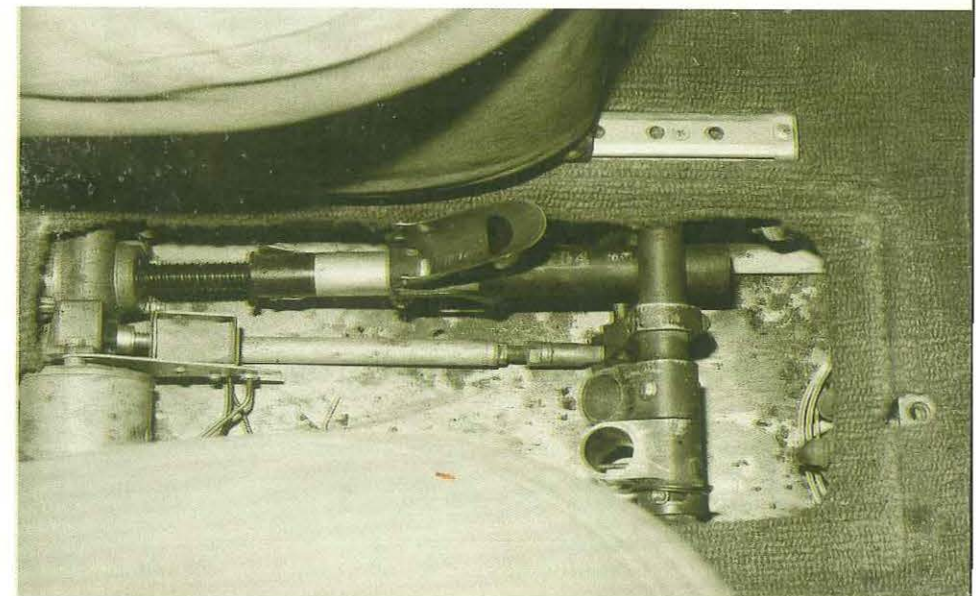
In the course of the investigation, the pilot twice demonstrated the procedure he had used in his attempts to lower the undercarriage manually. But each time he moved the motor release arm forward only to the vertical position, the point at which excessive force became necessary to obtain any further forward movement. With the lever in this position of course, the undercarriage mechanism was not disconnected from the actuating motor and the emergency operating handle could not be moved. In the conditions of darkness and high work load that existed at the time of the accident, it is clear that the pilot moved the motor release arm only to a point where he felt firm resistance against further movement and was misled into believing it had reached the limit of its forward travel.

Bottom: Undercarriage motor release arm in full forward travel position necessary to disengage motor.

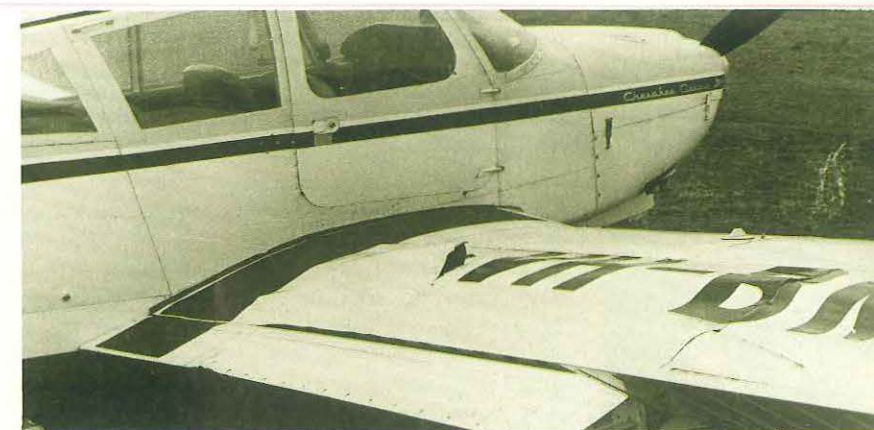
TAXI-ING: Heavy rain had washed out a small erosion gully about two metres into the side of this mining site strip. The washaway happened to be almost opposite the entrance to the strip's taxiway. The pilot of the Cherokee Six in the picture knew the hazard was there, having used the strip many times before.

Climbing out, the pilot found that the port undercarriage had dropped into the washaway, and been torn from its attachments.

Though the pilot had made a most careful inspection run over the strip before landing, 'he had not examined it from the ground or checked its serviceability with the station manager'. The rock, which was the same colour as the surrounding soil, was very difficult to see from any distance away.

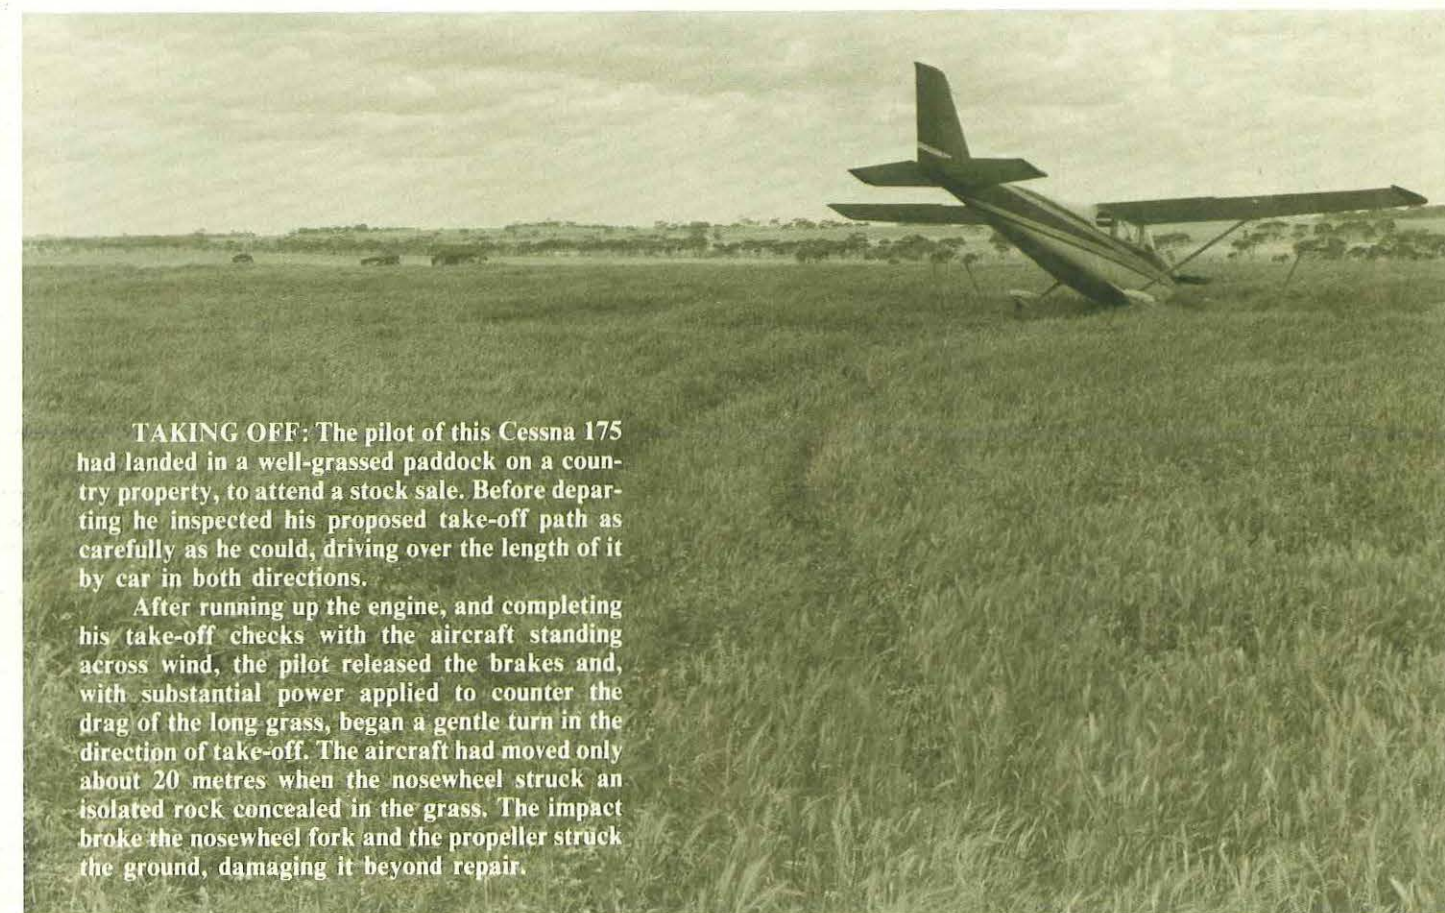
TAKING OFF: The pilot of this Cessna 175 had landed in a well-grassed paddock on a country property, to attend a stock sale. Before departing he inspected his proposed take-off path as carefully as he could, driving over the length of it by car in both directions.

After running up the engine, and completing his take-off checks with the aircraft standing across wind, the pilot released the brakes and, with substantial power applied to counter the drag of the long grass, began a gentle turn in the direction of take-off. The aircraft had moved only about 20 metres when the nosewheel struck an isolated rock concealed in the grass. The impact broke the nosewheel fork and the propeller struck the ground, damaging it beyond repair.
