AUSTRALIAN DEPARTMENT OF TRANSPORT

Number 99 1977

AVIATION SAFETY DIGEST

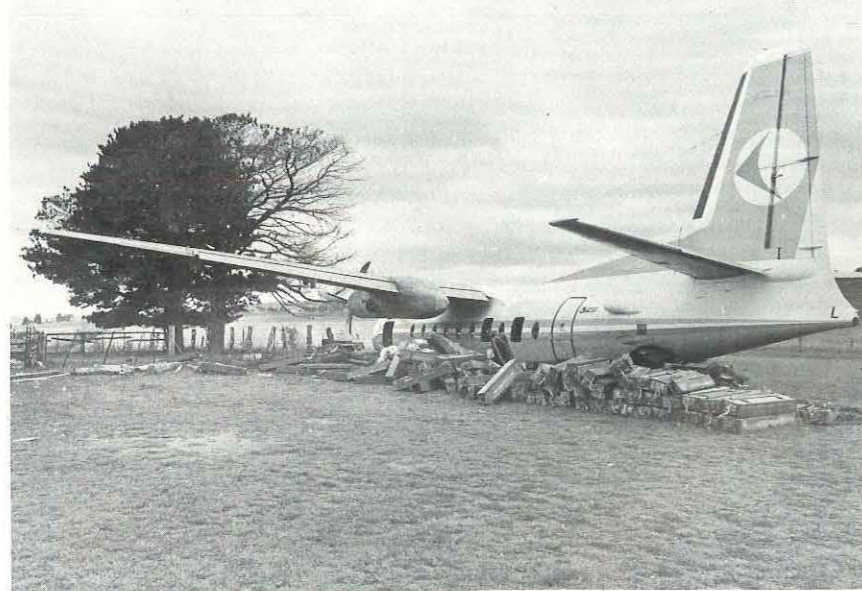
The narrow margin by which the Friendship avoided far more serious damage is evident in this picture.

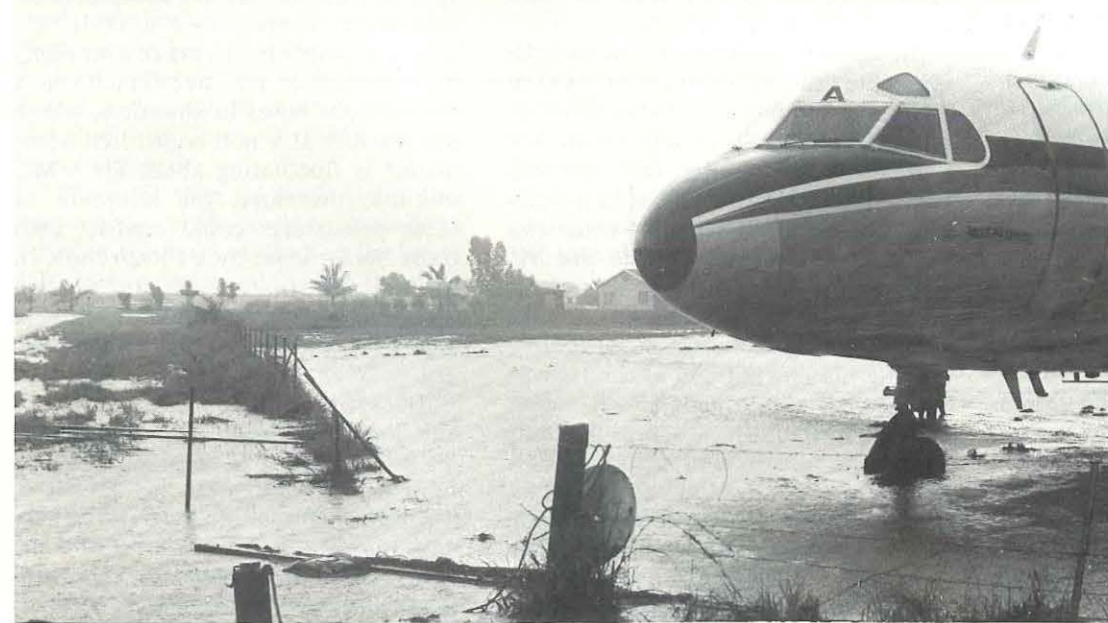
The flooded area in which the Fellowship came to rest. The aircraft was in the process of being recovered when this picture was taken.

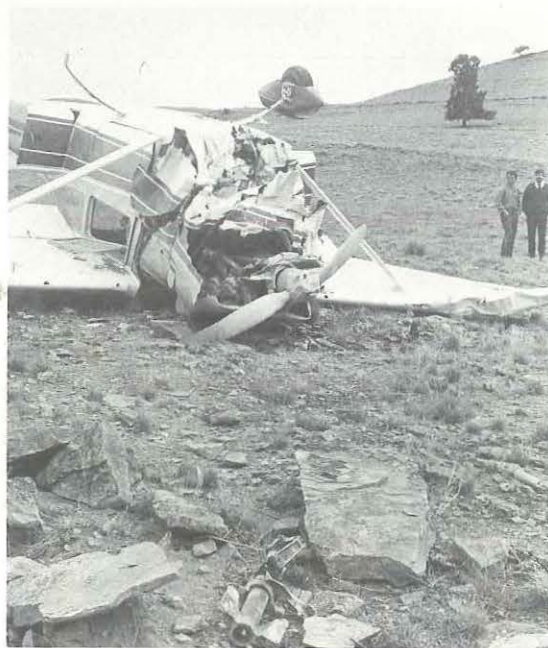
The rock-strewn nature of the terrain and the severe damage to the aircraft are evident in this picture.

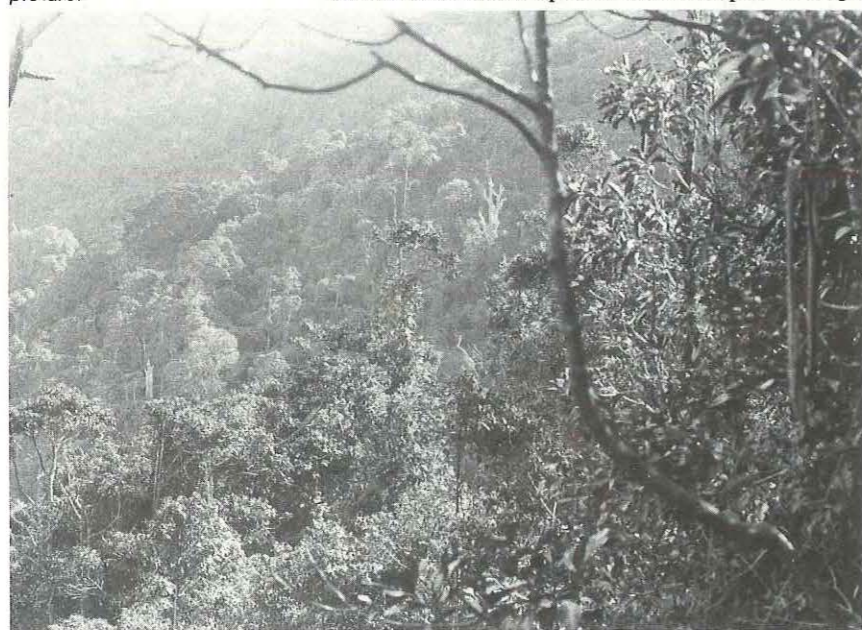
The hillside on which the Cherokee crashed, looking back along the approach path. The swathe which the aircraft cut through the foliage is in the centre of the picture.

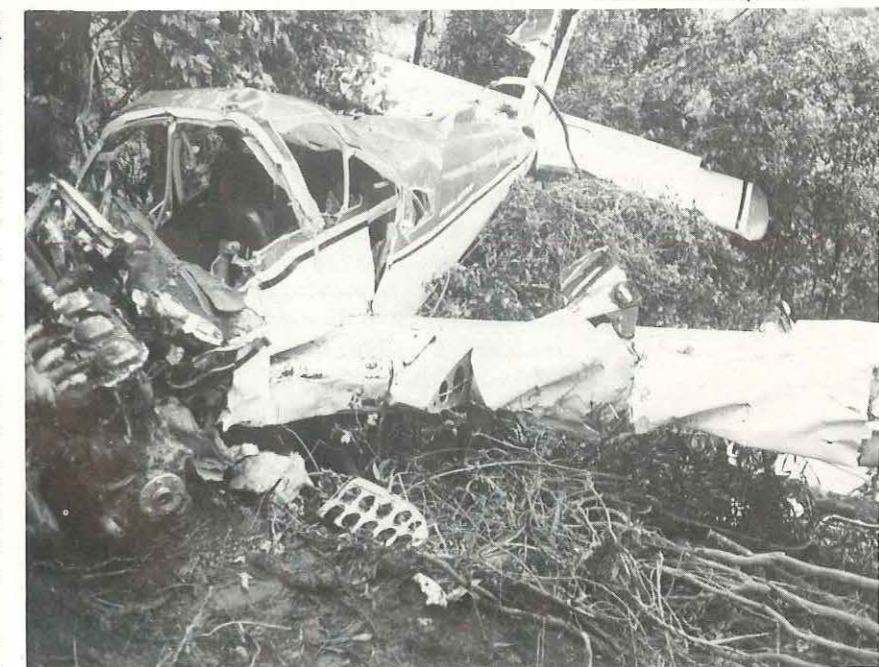
The wrecked aircraft lying on the hillside in dense undergrowth. Impact damage to the cabin area was less severe than the picture indicates as it was necessary to cut into the wreckage to extricate the occupants.

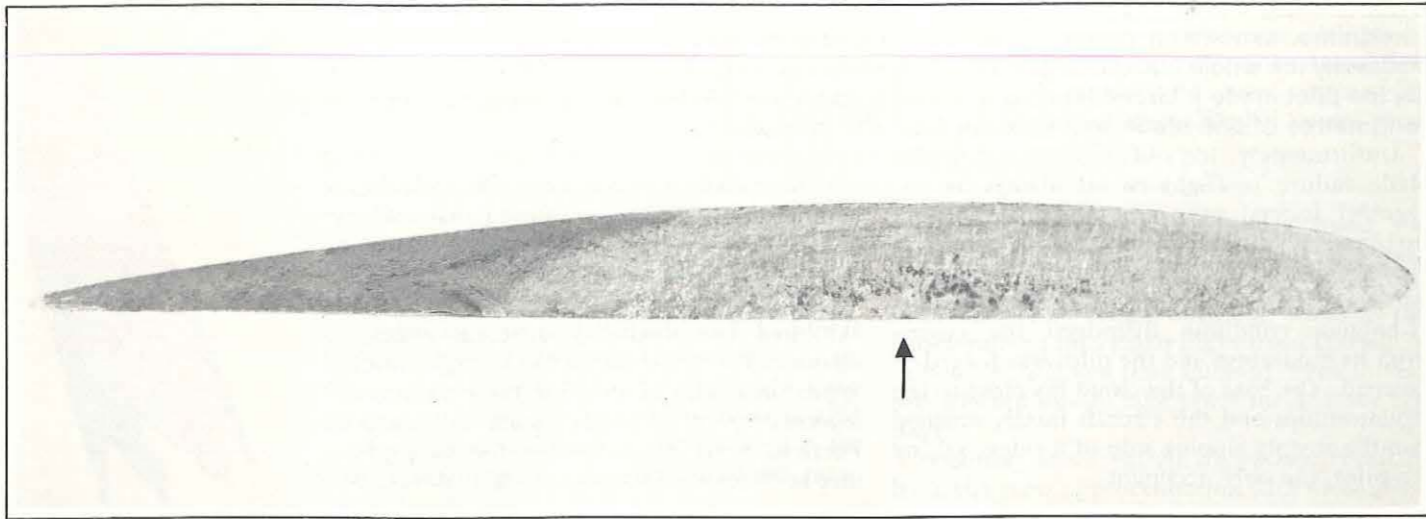
In the case of the Cherokee 180's propeller blade failure, which is typical, metallurgical examination showed that it had resulted from the initiation and growth of a fatigue crack, finally leading to an overload failure. The fatigue crack had begun at a severe indentation in the rear face of the propeller blade. The indentation was in the form of a sharp gouge, typical of that caused by a stone impact. The absence of any peripheral lip around the indentation indicated that it had been partly dressed

Fig. 1 — Fracture face of propeller blade showing fatigue and overload zones. The indentation from which the fatigue crack started is indicated.

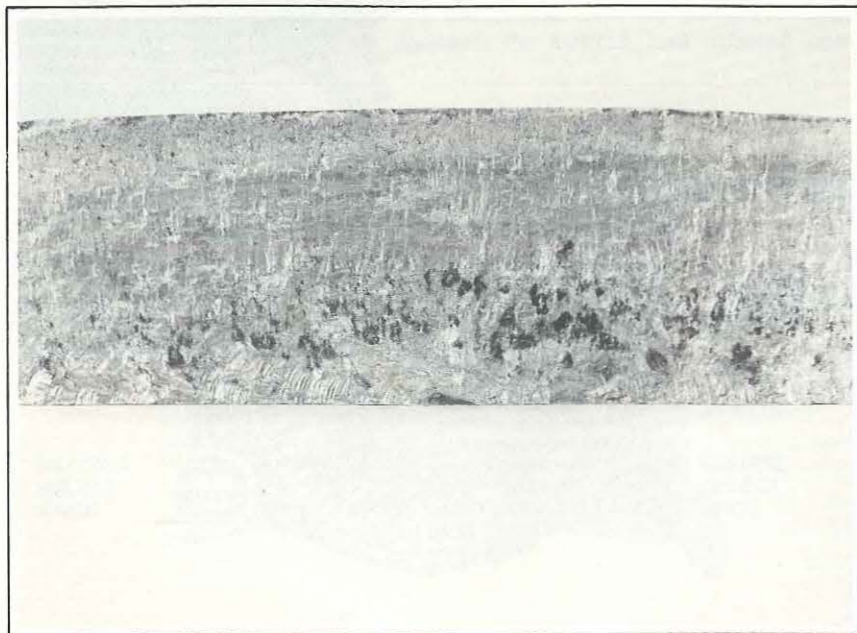
Fig. 2 — Fatigue progression markings radiating from the indentation at which the fatigue began.

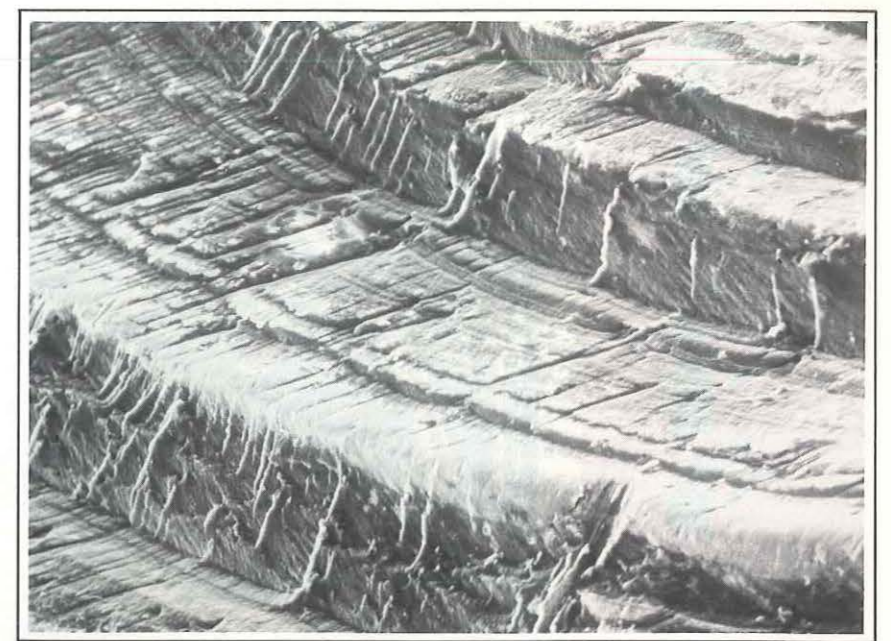
Fractographic examination, using a scanning electron microscope, revealed that the early stages of propagation consisted of a series of 'stepped' crack fronts (Fig. 3), with fine striations between them. The crack front propagated at approximately 45 degrees to the blade rear surface, with a change in the direction of propagation of approximately 90 degrees forming the 'stepped' growth pattern observed. The 'stepped' growth indicates that a significant change in the stress mode occurred periodically.

Fig. 3 — Electron microscope photograph, using a magnification of 525 times, showing the stepped fatigue crack growth.

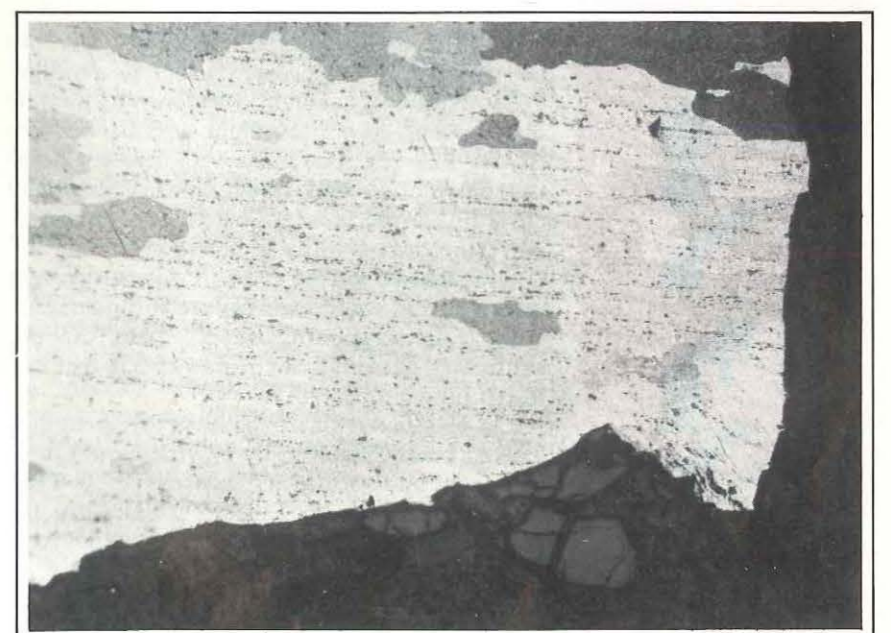
Fig. 4 — Sharp indentation close to fatigue origin, magnified 150 times.
