# Aviation Safety Digest

# Contents

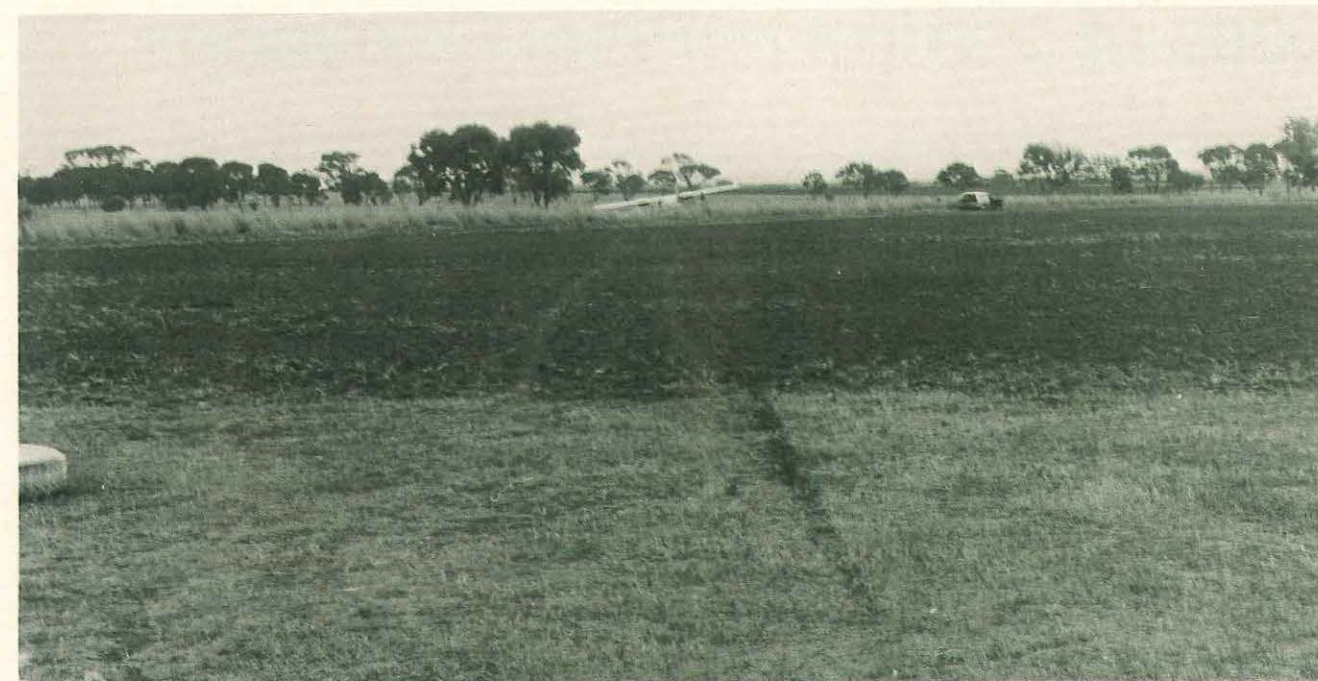
electric trim was used to achieve a more nose-up trim setting. At 90 knots he again attempted to rotate the aircraft. The force used was not excessive but more than he thought was necessary to lift the aircraft off the ground. The pilot then decided to abandon the take-off and, closing both throttles, applied braking. As the aircraft approached the end of the grass strip, the pilot realised it would over-run.

The surface of the airfield outside the strip markers had been ploughed and, though the boundary fence lay across the aircraft's path, the pilot decided not to try and turn on the ploughed ground while the aircraft was still travelling at high speed. The aircraft continued straight ahead, broke through the fence, crossed a shallow drainage ditch and came to rest badly damaged about 130 metres beyond the end of the strip and only a few metres from a large tree. Finding the main passenger door jammed, the pilot and the passengers scrambled unhurt from the aircraft through the starboard emergency exit.

Because the aircraft was overloaded and the pilot did not select the flap to 15 degrees for take-off, the aircraft's actual take-off distance in the prevailing conditions would have been longer than that shown on the take-off weight chart in the approved flight manual. This chart

The development of this accident can be traced through a succession of hasty and ill-considered decisions. The haste of the pilot and passengers to depart, the inadequate loading procedures and the rushed cockpit checks all played their part in bringing the intended flight to a premature conclusion. It was fortunate that the consequences were not more serious.

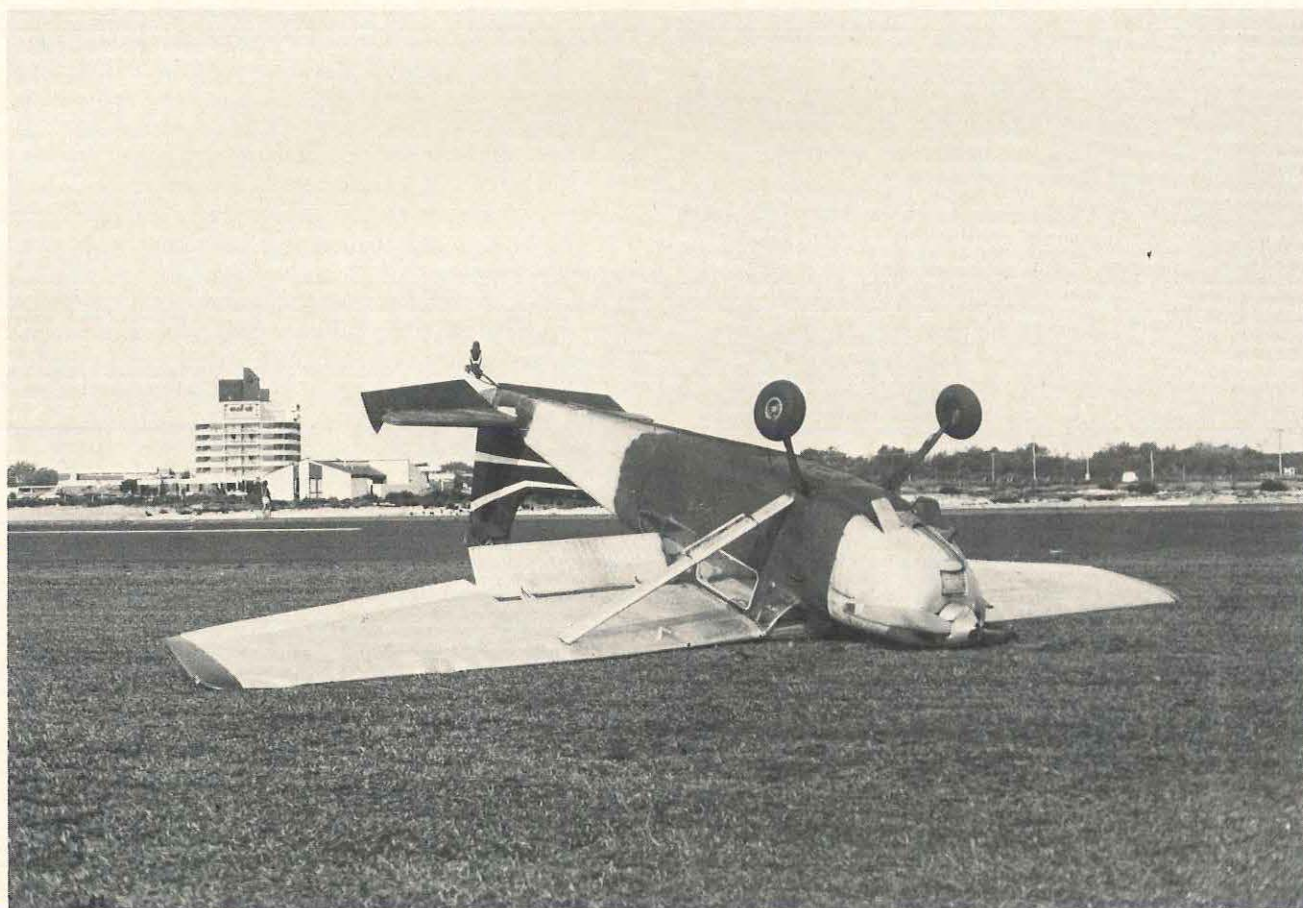
The pilot of a Cessna 185A tug was glider towing from the grassed flight strip on the left-hand side of a runway aligned 01. The weather was fine and the surface wind was about 030 degrees, 10-15 knots.

After completing an aero tow, the pilot of the tug aircraft approached for a wheeler landing on the flight strip. When conducting wheeler landings in cross wind conditions he had developed the technique of holding the tail up with elevator in order to provide directional control with rudder for as long as possible. He states that, normally, he would not apply brakes until the tail wheel was on the ground but other information suggests that he may have developed a habit of applying some braking at about the time the tail was lowering.

It would have been better to have placed the tail wheel on the ground while elevator and rudder control remained effective, utilising tail-wheel steering and judicious braking to maintain directional control, and holding the stick hard back so as to prevent any possibility of nosing over.
