Department of Transport — Australia

106/1979

# Aviation Safety Digest

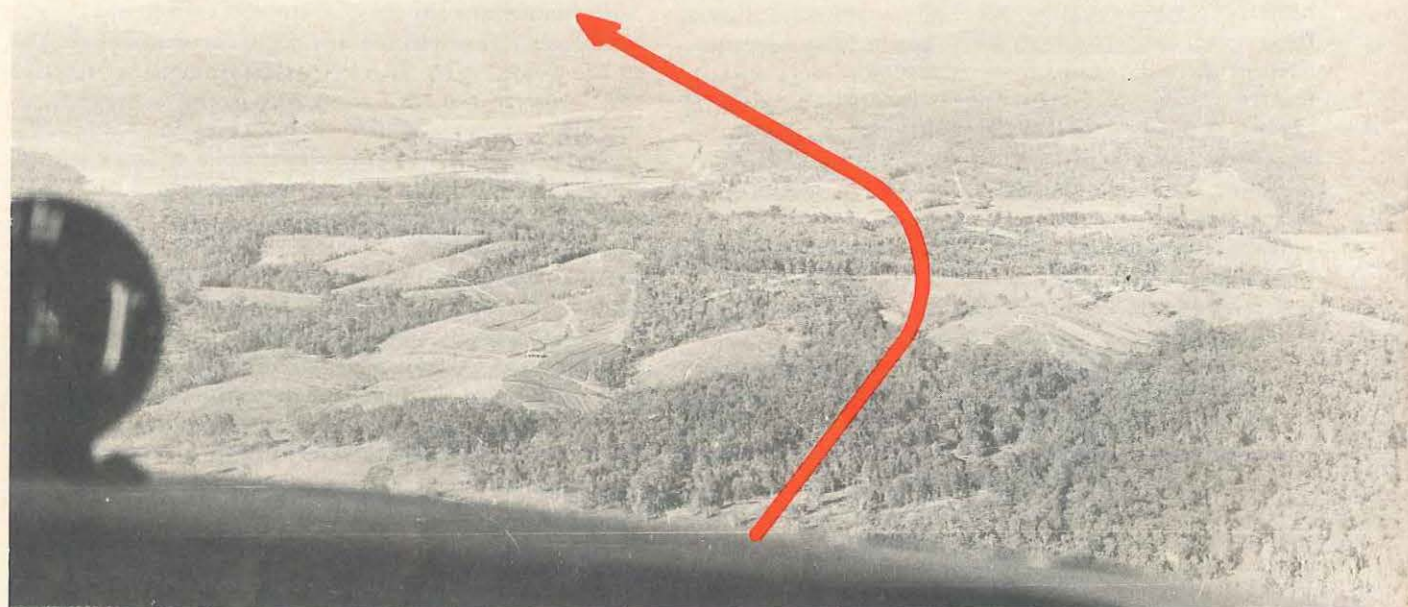
*Pilot's view of the northern entrance to the Archerfield lane of entry. The correct track is shown on the left; the probable flight path of the Comanche is on the right.*

It would appear that for some reason, the pilot flew too far west and turned up the wrong valley. Although the exact reason for his failure to turn is not definitely known, it is likely that in the prevailing conditions and at low level, he would have had difficulty in identifying visual reference points, particularly if diversions around showers were also required. The lane of entry and its northern approaches are difficult areas for map-reading, especially at low level. The countryside consists of undulating ground with a series of small valleys and timbered ridges lying across the lane. There is no clearly defined valley, road, river or railway line leading down the lane towards Archerfield. It has been estimated that the additional distance between the entrance to the lane and the point where the aircraft eventually turned up the valley

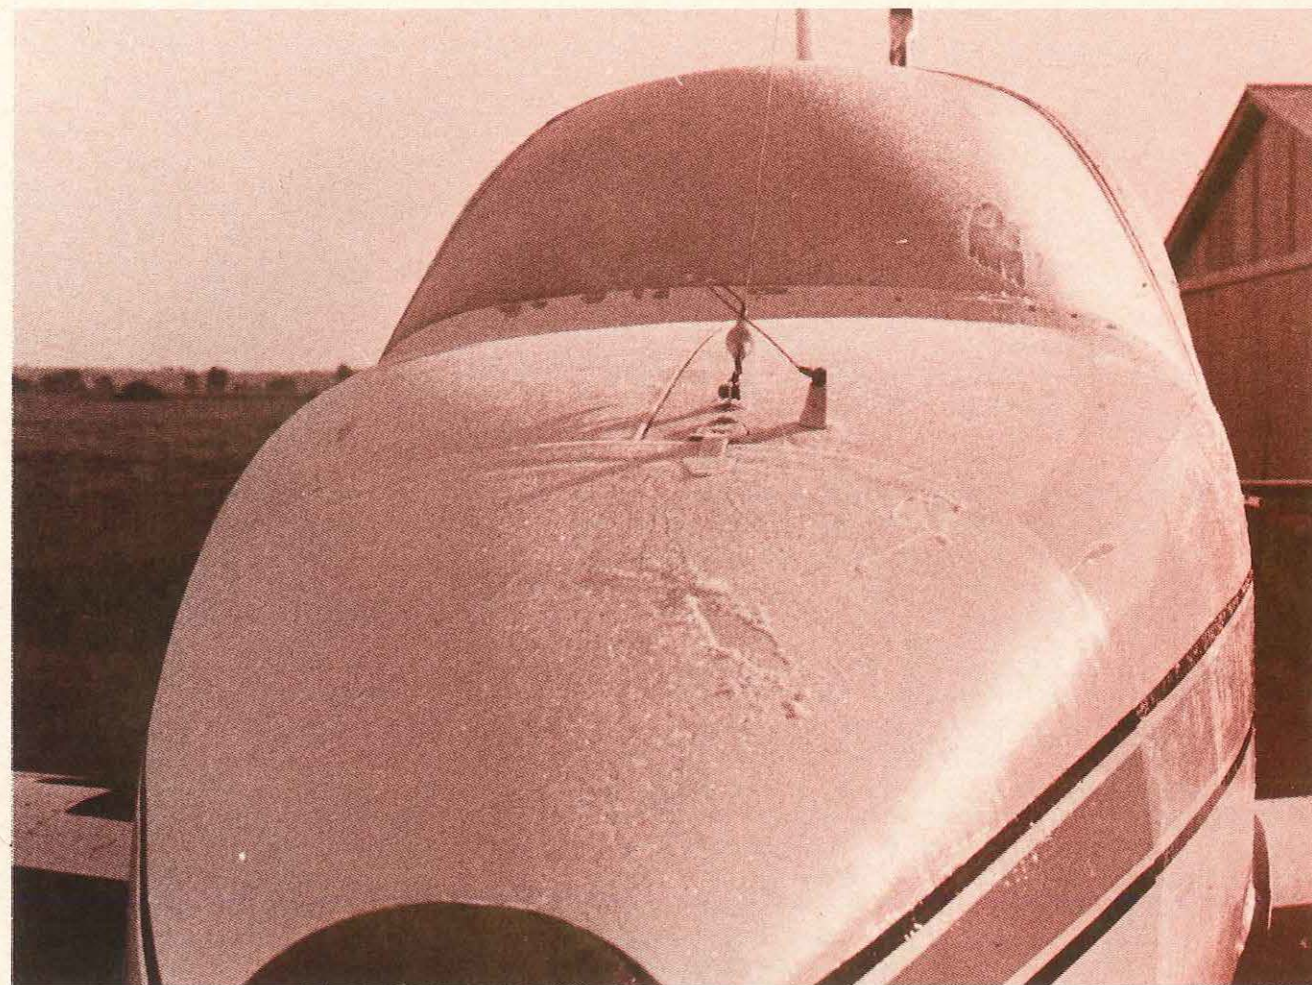
**It is not hard to imagine what a layer of frost like that in the photograph could do to the aerodynamics of an aircraft. Our picture was taken at Roma in Queensland on a clear July morning and shows the amount of frost that can form on the external surfaces of an aircraft in certain weather conditions — even in the 'Sunshine State'.**
