Aviation Safety Digest

Department of Transport

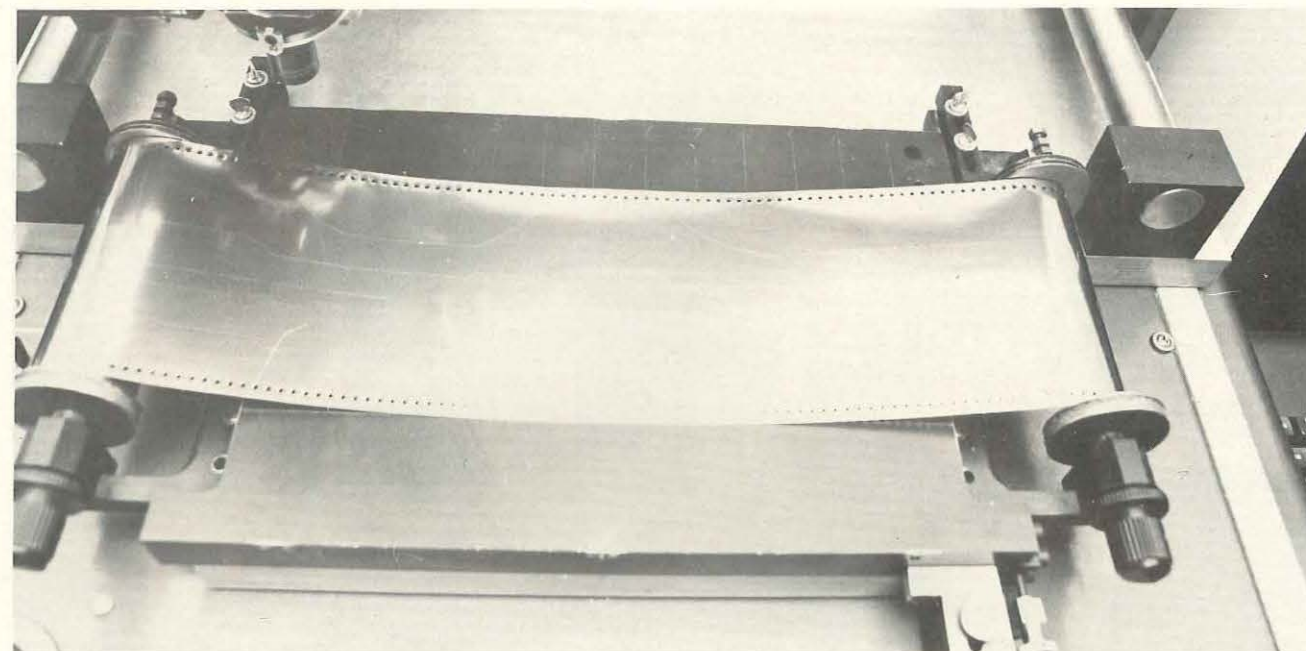
The stainless steel tape from a 'scratch' recorder showing the series of grooves cut in the foil.

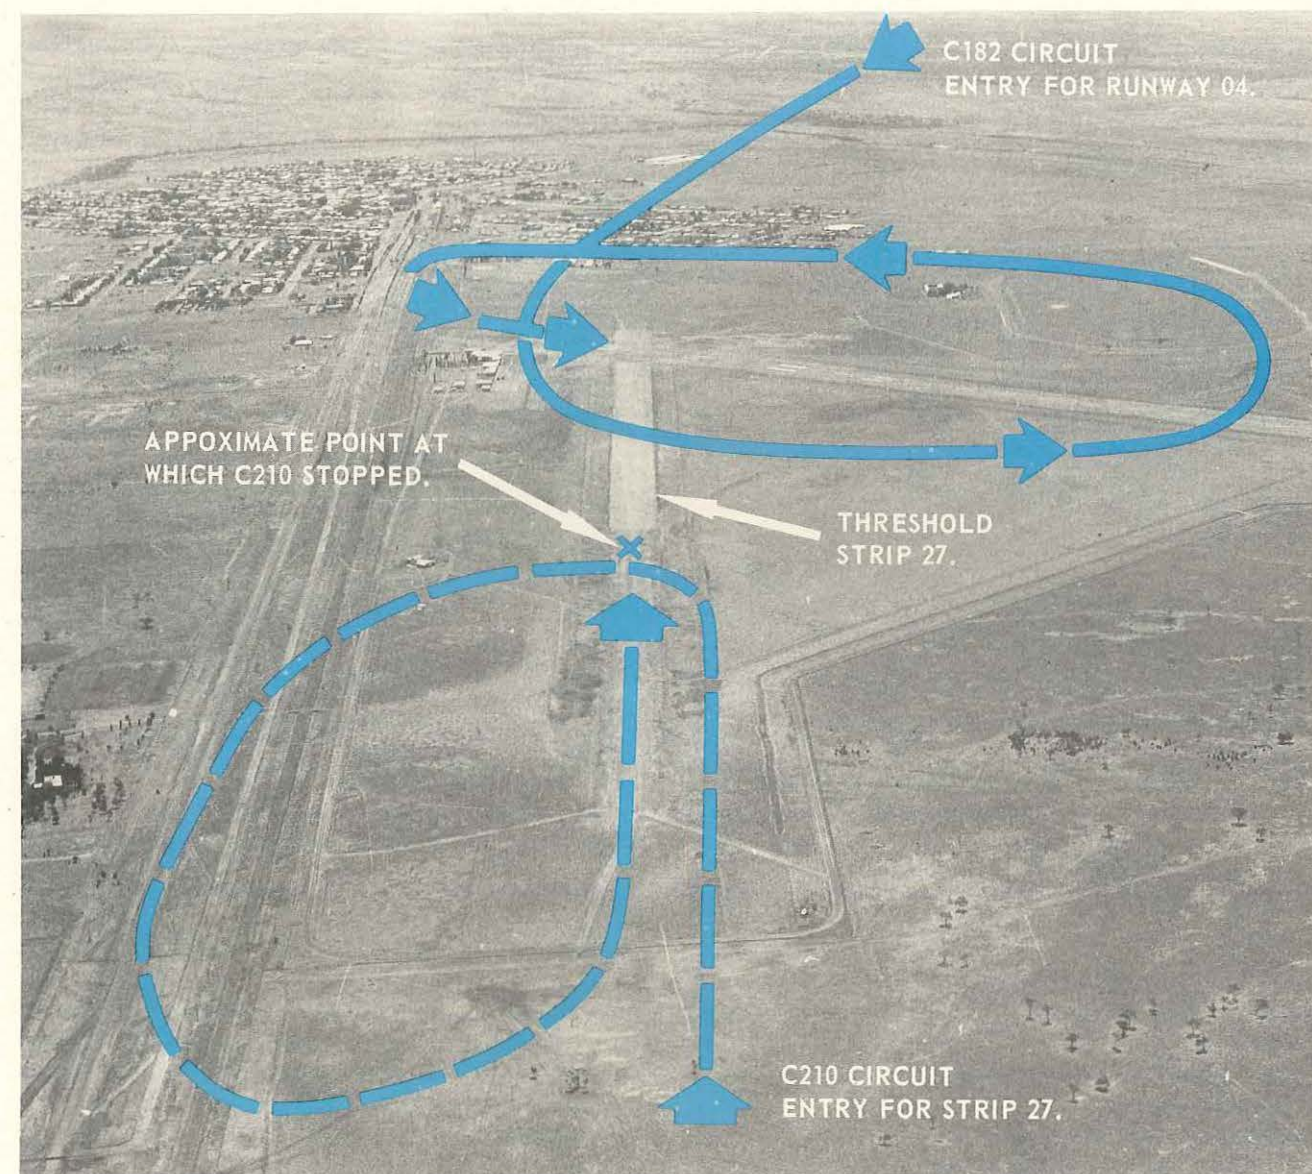
View of the aerodrome facing west, showing the approximate flight paths of the two aircraft during the circuit entry and approach to land.
