Aviation Safety Digest

Contents

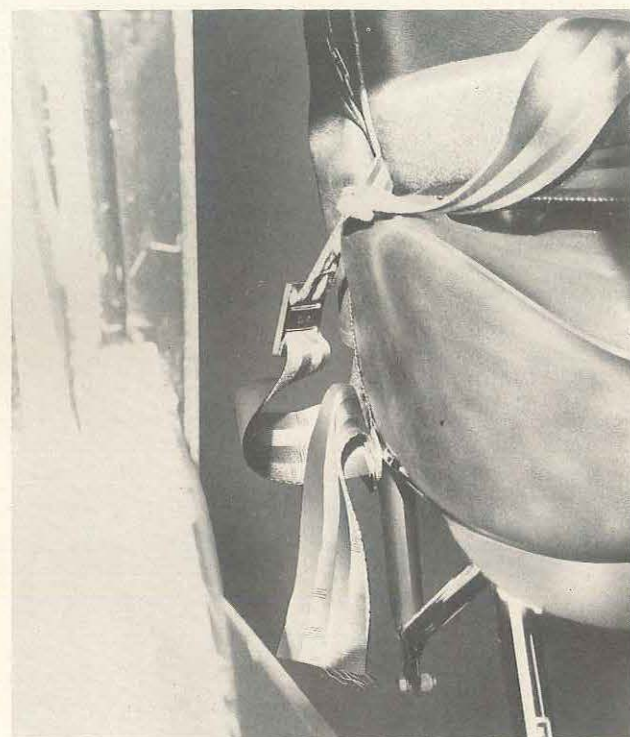
The photograph above shows the harness as found on a Bellanca. Note the limited accessibility, and the fact that this is on the more accessible side, adjacent to the large entry door. The free end of the strap should be passed back through the adjuster, which is too far up from the end fitting.

Occasionally it may be necessary to make a small adjustment on the buckle side when the seat is shifted to extreme positions. This again introduces, by itself, no special hazard in view of the free length of webbing normally available. However, the free ends of many of these straps are not sewn over, and if repeated and incorrect personal adjustments have been carried out on the buckle side the webbing may require only a small amount of slip before the end will pass through the adjuster and render the restraint system ineffective. It is therefore advisable to check, before buckling up, that the buckle is located at the side of the occupant and that a safe free length of webbing protrudes through the adjuster' ●

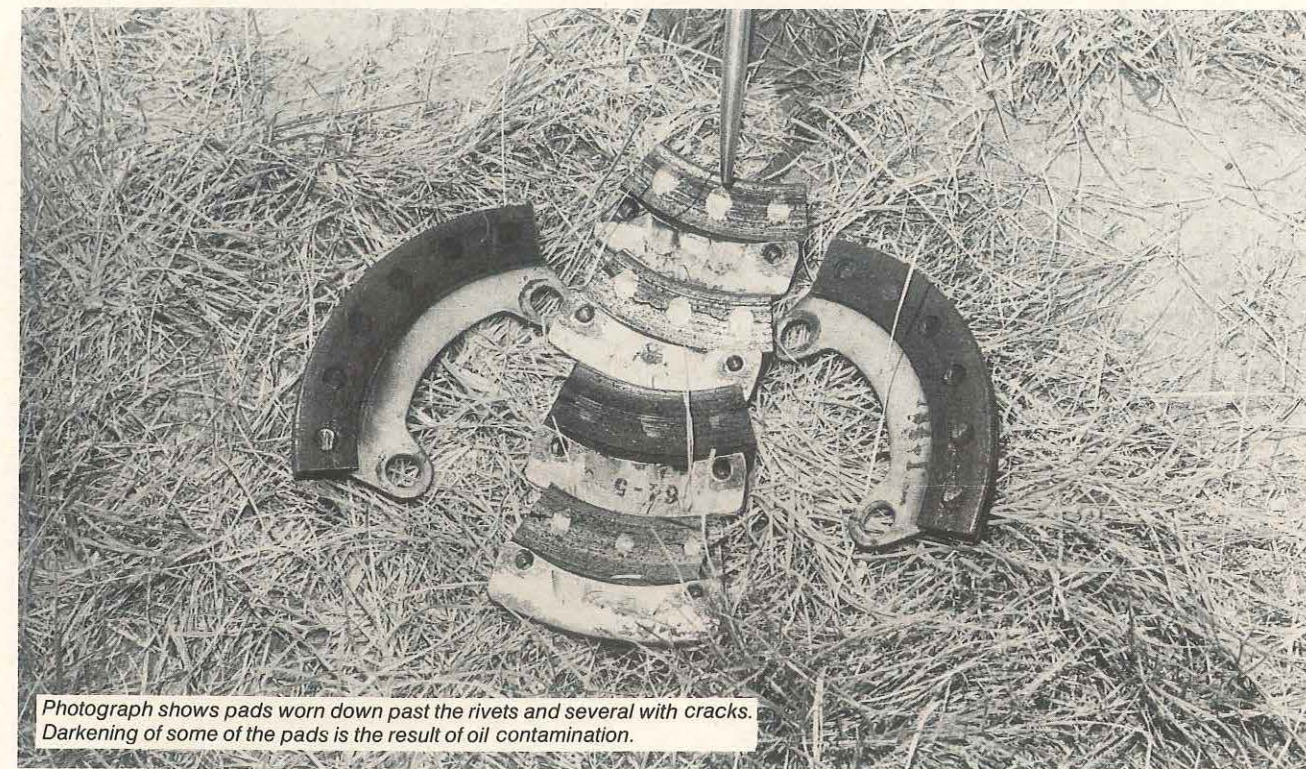
Dirt strips: excessive brake wear

Photograph shows pads worn down past the rivets and several with cracks. Darkening of some of the pads is the result of oil contamination.

The investigation of the accident included close examination of the aircraft braking system. Functional checks revealed that the braking system appeared to be operating normally. The aircraft log books indicated that the brake pads were replaced at the last 100 hourly inspection, which occurred about 60 hours prior to the accident. Inspection of

the brake pads revealed however, that they were worn beyond acceptable limits. This wear had been progressively compensated for by the automatic brake adjusters and braking efficiency had apparently not been affected until the landing on which the accident occurred. A contributing factor was a slight oil weep from the left hand, rear brake caliper assembly. This would have caused an accumulation of dirt around the braking mechanism which accelerated the rate of wear.

In view of the lack of specific directions for wheel brake visual checks between periodic inspections, consideration was given to amending the Daily Inspection Schedule. It was concluded, however, that the excessive wear revealed during this investigation would be restricted to aircraft making a large number of landings, on unsealed strips, which involved high brake usage. In addition, the inspection would be impractical on aircraft fitted with drum brakes or wheel spats. Rather than include a specific requirement in the applicable publications it is strongly recommended that operators ensure that their pilots are aware of the additional brake pad wear which is likely to occur when operating from dirt strips. Any visible sign of oil weeps from the brake actuators should also be attended to in order to reduce accelerated wear of the brake pads and discs ●

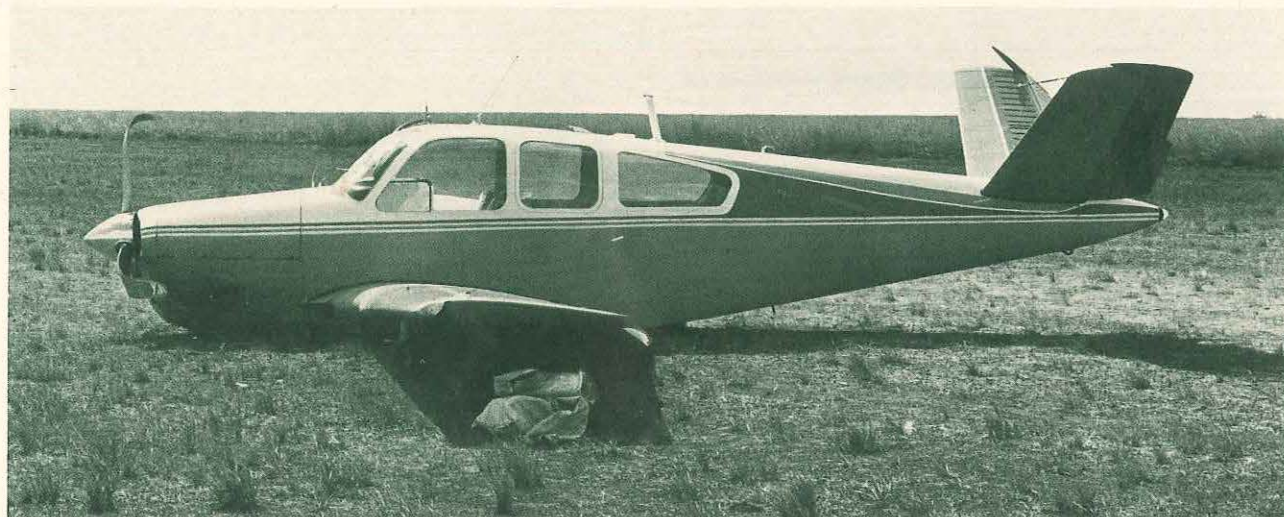
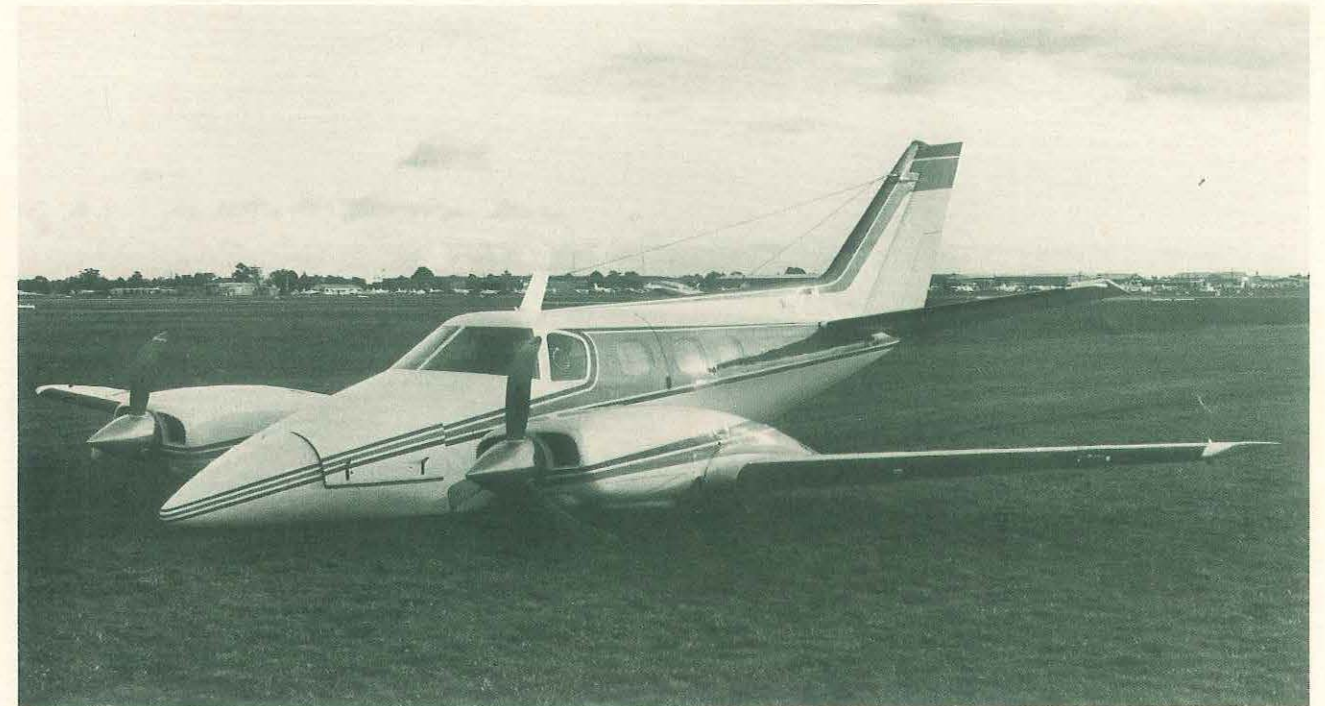
Investigation revealed that the nose gear extend/retract rod had failed at a welded joint. This was subsequently determined to be an isolated occurrence. Because of his handling of the situation, the pilot reduced the risk to his passengers and damage to the aircraft to an absolute minimum. After recovery, it was found that the only damage to the aircraft involved the propellers and various protuberances under the fuselage, such as pitot tubes and radio aerials.

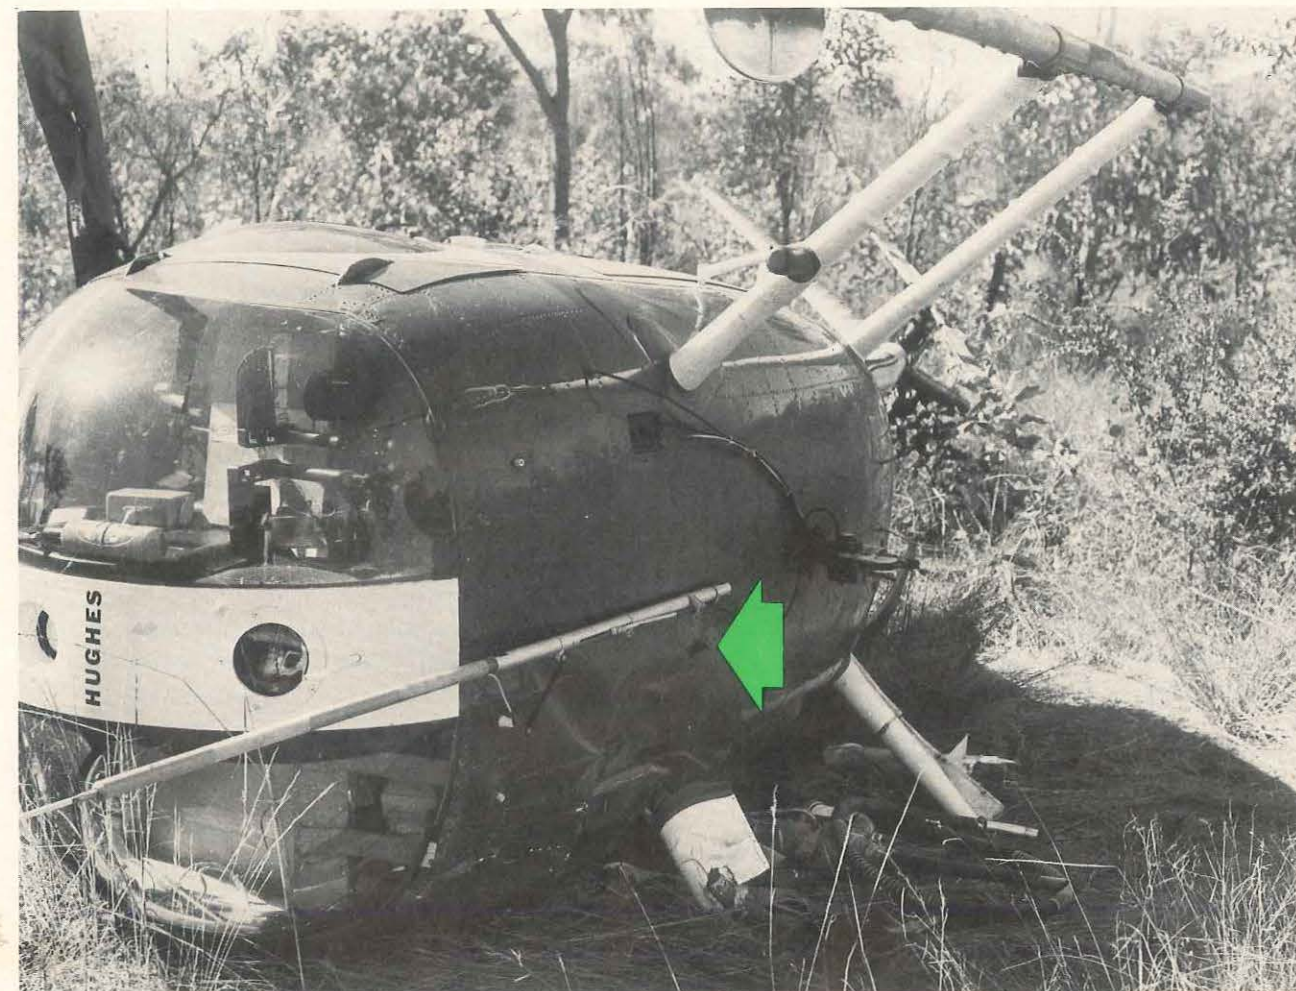
Following this and two previous accidents involving Hughes 500 helicopters suffering fuel starvation, the manufacturer was contacted to ascertain the effect of losing the fuel tank vent fairing. Based on wind tunnel tests conducted very early in the development of the aircraft it was determined that, without the fairing, the differential pressure across the fuel cell bladder could be expected to cause it to collapse as fuel is drawn from the tank and would at some point prevent the float arm of the fuel level sender from dropping, thereby giving an erroneous fuel remaining indication. The manufacturer further advised that because of the problem of blockages to the vent they introduced a

Underside of the wreckage showing the location of the lower vent fairing

modification which adds another vent below the right hand door. This modification is not mandatory and was not fitted to any of the three aircraft involved in accidents in Australia.

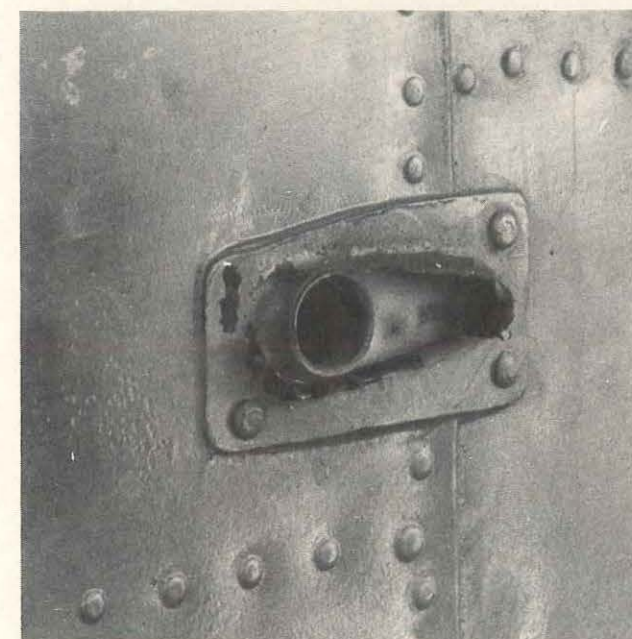
Close up view of the vent fairing fragments still attached to the aircraft

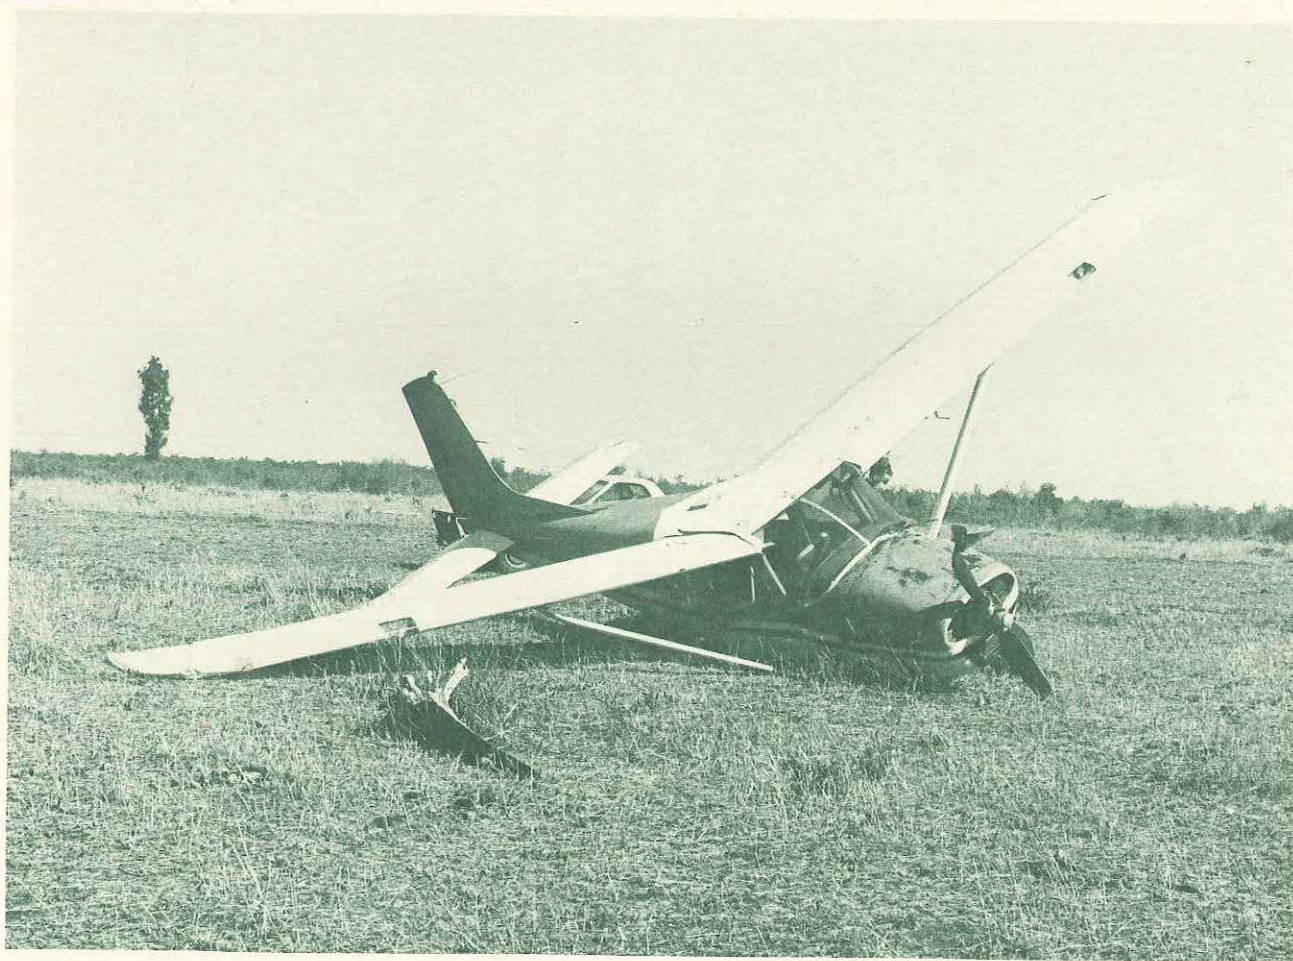
Unlocked seat — loss of control during ground manoeuvring

Subsequent inspection of the aircraft revealed no defects in the seat adjustment mechanism, and it was concluded that the mechanism had not been properly engaged.

Note: Some of our readers may be confused by the fact that, in spite of the substantial damage suffered by the aircraft, this occurrence was classified as an incident rather than an accident. As defined in the Air Navigation Regulations, an accident can only occur when persons have boarded an aircraft 'with the intention of flight'. Because the pilot of this Cessna 180 was merely repositioning the aircraft along the strip, the occurrence was classified as an incident.
